Roof Safety Report

Altona Gate, VIC 3025

Prepared By: Safemaster Safety Products
Date: 27-10-2019

Roof Safety Report for
Altona Gate Shopping Centre, VIC 3025

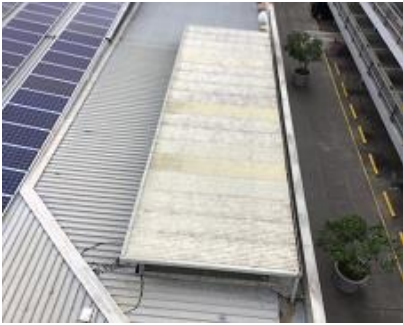
Brittle roof section is present	Trips, Slips and Falls	Restrict Access	High	"Warning-Brittle and Fragile Roof" signs to be installed	Low	Client advised	Outsta nding	OH&S REGULATIONS 3.57
02	Building: General Stores Location Reference: L02 Task: Access to the roof

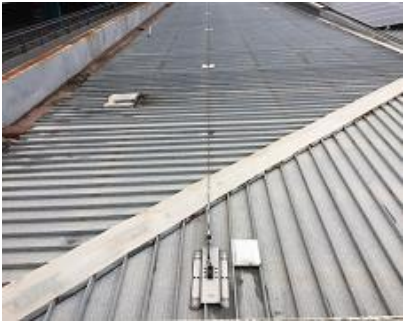
Static line over 10 years old	Trips, Slips and Falls	Awareness induction	High	Existing static line to be replaced	Low	Client advised	Outsta nding	OH&S REGULATIONS 3.55 AS/NZS 1891.4:2009 6.3

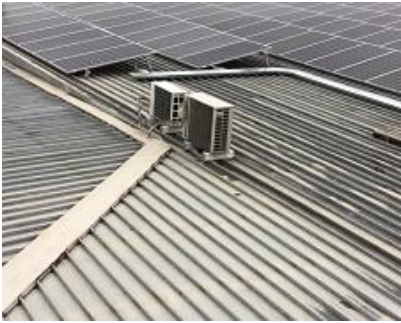
No safe access to the A/c units	Trips, Slips and Falls	N/A	Low	Supply walkway to the A/c units	Low	Client advised	Outstanding	-
04	Building: General Stores Location Reference: L03 Task: Access to the roof

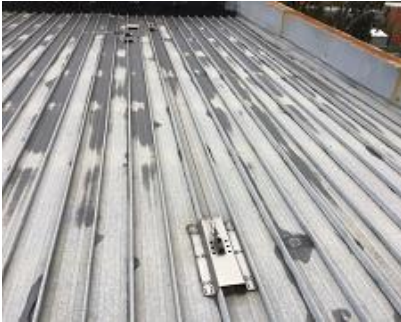
Static line over 10 years old	Trips, Slips and Falls	Awareness induction	High	Existing static line to be replaced	Low	Client advised	Outstanding	OH&S REGULATIONS 3.55 AS/NZS 1891.4:2009 6.3

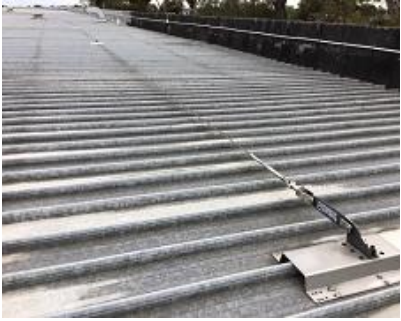
Static line over 10 years old	Trips, Slips and Falls	Awareness induction	High	Existing static line to be replaced	Low	Client advised	Outsta nding	OH&S REGULATIONS 3.55 AS/NZS 1891.4:2009 6.3
06	Building: General Stores Location Reference: L05 Task: Access to the roof

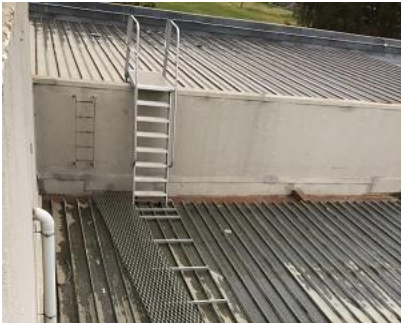
Not able to access the ladder as solar panel in the way and landing platforms at base is missing	Trips, Slips and Falls	Awareness induction	Med	Existing ladder to be re-located and re- installed with landing platforms and brackets	Low	Client advised	Outsta nding	OH&S REGULATIONS 3.7 AS 1657-2018 7.3.6

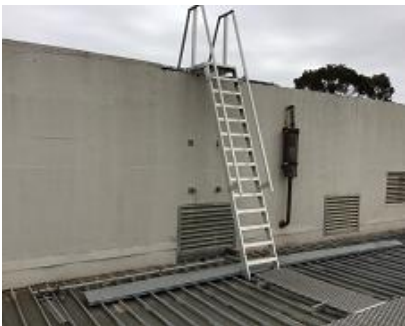
Landing at base is missing	Trips, Slips and Falls	Awareness induction	Med	Landing platforms to be installed	Low	Client advised	Outsta nding	OH&S REGULATIONS 3.7 AS 1657-2018 7.3.6
08	Building: General Stores Location Reference: L06 Task: Restrict access to the roof

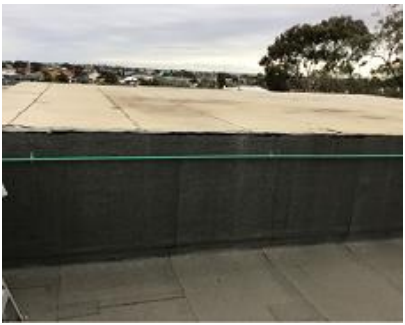
No height safety system installed (No serviceable items on roof)	Trips, Slips and Falls	Restrict Access	High	"Warning-No access to Roof" signs to be installed	Low	Client advised	Outsta nding	OH&S REGULATIONS 3.55 & 3.11

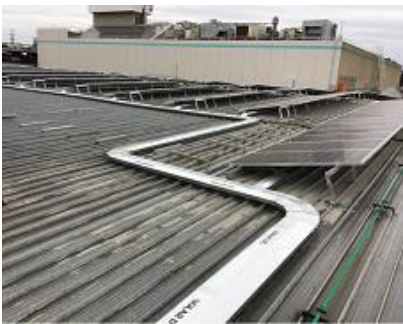
Walkway sections been removed during solar panels installation	Trips, Slips and Falls	N/A	Med	Walkway to be re-routed with additional walkway sections and step bridge	Low	Client advised	Outstanding	-
10	Building: General Stores Location Reference: L08 Task: Access to the A/c units

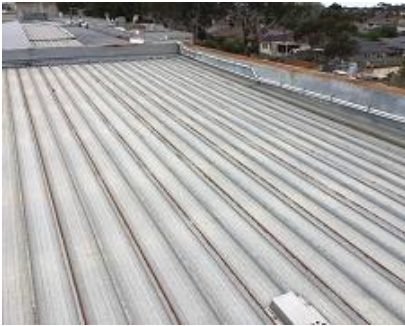
No height safety system installed	Trips, Slips and Falls	Awareness induction	High	Anchors to be installed	Low	Client advised	Outstanding	OH&S REGULATIONS 3.55
12	Building: General Stores Location Reference: L08 Task: Access to the roof

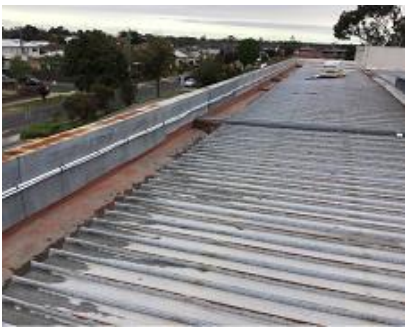
No height safety system installed	Trips, Slips and Falls	Awareness induction	High	Anchors to be installed	Low	Client advised	Outstanding	OH&S REGULATIONS 3.55
14	Building: General Stores Location Reference: L10 Task: Access to the roof

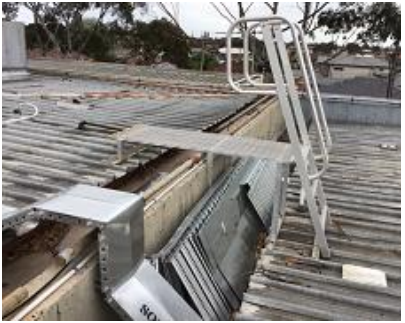
Bottom rung height is less than required minimum, handrail projecting towards the user and handrail is missing for landing	Trips, Slips and Falls	Awareness induction	Med	Existing ladder to be re-installed with landing platforms, preformed handrails and handrails to landing platform	Low	Client advised	Outstanding	OH&S REGULATIONS 3.7 AS 1657-2018 7.4.3.4, 7.4.8.5 & 4.4

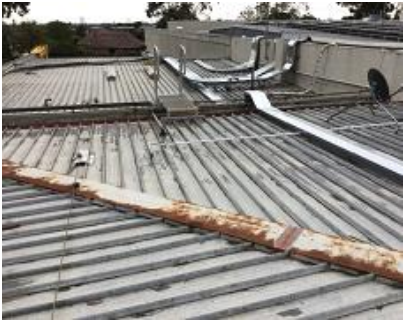
No safe access to the ladder	Trips, Slips and Falls	N/A	Low	Supply walkway to the ladder	Low	Client advised	Outstanding	-
16	Building: General Stores Location Reference: L11 Task: Access to the roof

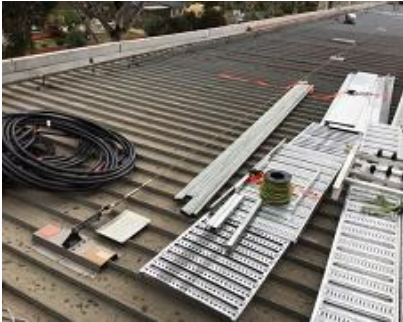
Static line over 10 years old	Trips, Slips and Falls	Awareness induction	High	Existing static line to be replaced	Low	Client advised	Outstanding	OH&S REGULATIONS 3.55 AS/NZS 1891.4:2009 6.3

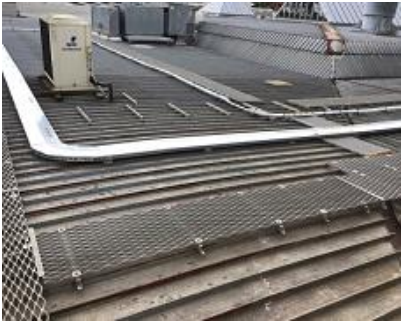
Walkway sections been removed during solar panel installation and cable tray in the way	Trips, Slips and Falls	Awareness induction	Med	Walkway and Step bridges to be installed	Low	Client advised	Outstanding	OH&S REGULATIONS 3.7 AS 1657-2018 3.1.4
18	Building: General Stores Location Reference: L14 Task: Access to the roof

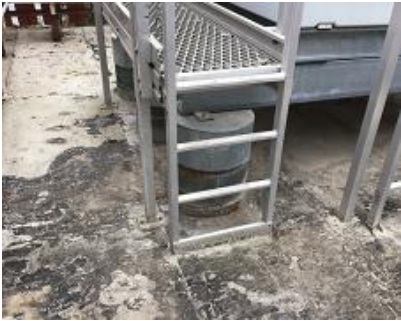
Top rung not levelled with landing	Trips, Slips and Falls	Awareness induction	Med	Existing ladder to be re-installed with landing platform and brackets	Low	Client advised	Outstanding	OH&S REGULATIONS 3.7 AS 1657-2018 7.4.3.3
20	Building: General Stores Location Reference: L15 Task: Access to the roof

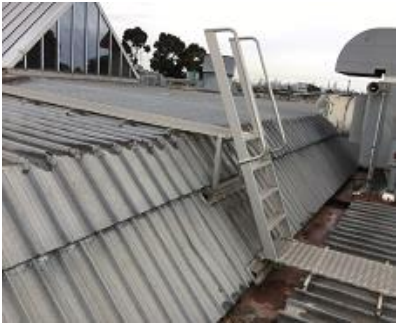
Handrail is missing for top landing	Trips, Slips and Falls	Awareness induction	Med	Handrail to landing to be installed	Low	Client advised	Outstanding	OH&S REGULATIONS 3.7 AS 1657-2018 4.4
22	Building: General Stores Location Reference: L16 Task: Restrict access to the roof

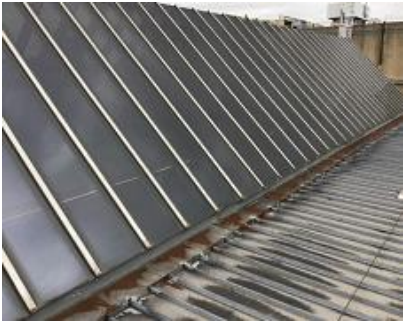
Brittle roof section is present	Trips, Slips and Falls	Restrict Access	High	"Warning-Brittle and Fragile Roof" signs to be installed	Low	Client advised	Outstanding	OH&S REGULATIONS 3.57

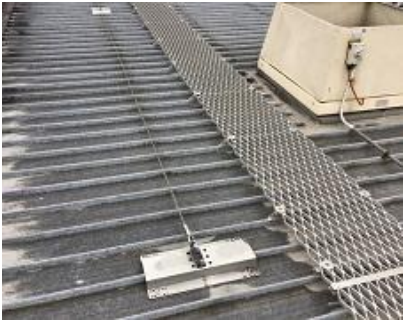
Static line over 10 years old	Trips, Slips and Falls	Awareness induction	High	Existing static line to be replaced	Low	Client advised	Outsta nding	OH&S REGULATIONS 3.55 AS/NZS 1891.4:2009 6.3
24	Building: General Stores Location Reference: L16 Task: Access to the roof

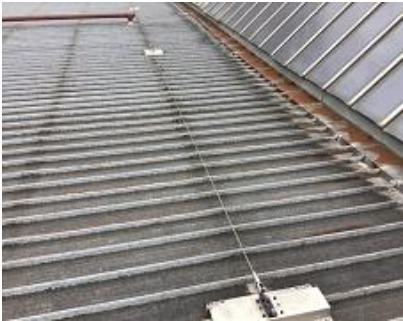
Static line over 10 years old	Trips, Slips and Falls	Awareness induction	High	Existing static line to be replaced	Low	Client advised	Outsta nding	OH&S REGULATIONS 3.55 AS/NZS 1891.4:2009 6.3

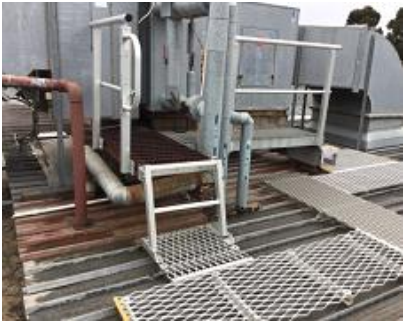
Non-complaint ladder is present	Trips, Slips and Falls	Awareness induction	Med	Existing ladder to be replaced	Low	Client advised	Outstanding	OH&S REGULATIONS 3.7 AS 1657-2018 7.4
26	Building: General Stores Location Reference: L18 Task: Restrict access to the roof

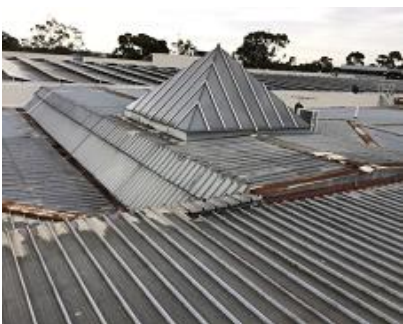
Brittle roof section is present	Trips, Slips and Falls	Restrict Access	High	"Warning-Brittle and Fragile Roof" signs to be installed	Low	Client advised	Outstanding	OH&S REGULATIONS 3.57

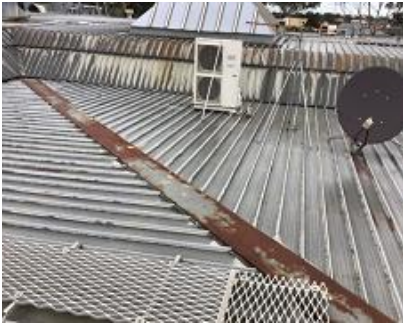
No safe access to the A/c units	Trips, Slips and Falls	N/A	Low	Supply walkway to the A/c units	Low	Client advised	Outstanding	-
28	Building: General Stores Location Reference: L19 Task: Access to the roof

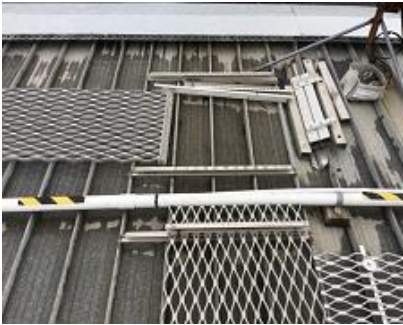
Pipe installed over the walkway path	Trips, Slips and Falls	Awareness induction	Med	Step bridge to be installed	Low	Client advised	Outstanding	OH&S REGULATIONS 3.7 AS 1657-2018 3.1.4
30	Building: General Stores Location Reference: L19 Task: Access to the roof

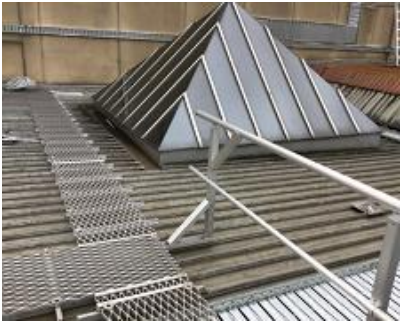
Brittle roof section is present	Trips, Slips and Falls	Restrict Access	High	"Warning-Brittle and Fragile Roof" signs to be installed	Low	Client advised	Outstanding	OH&S REGULATIONS 3.57
32	Building: General Stores Location Reference: L21 Task: Access to the A/c units

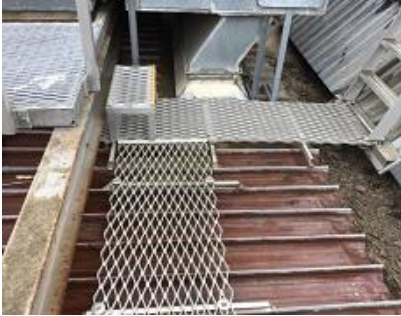
Walkway section is missing to provide to continuous access	Trips, Slips and Falls	Awareness induction	Med	Additional walkway section to be installed	Low	Client advised	Outstanding	OH&S REGULATIONS 3.7
34	Building: General Stores Location Reference: L21 Task: Access to the roof

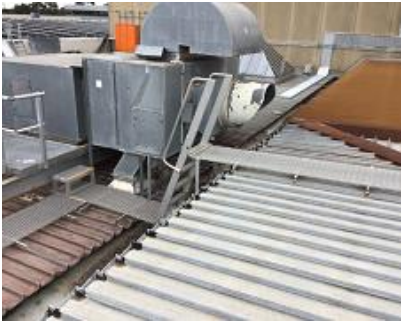
Handrail is missing for landing	Trips, Slips and Falls	Awareness induction	Med	Handrail to be installed	Low	Client advised	Outstanding	OH&S REGULATIONS 3.7 AS 1657-2018 4.4

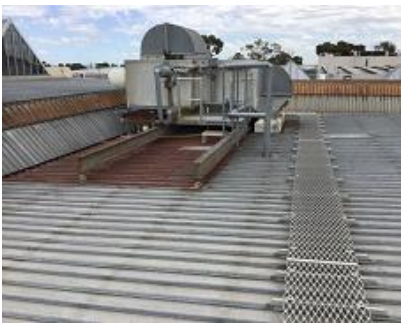
No safe access to the A/c units	Trips, Slips and Falls	N/A	Low	Supply walkway to the A/c units	Low	Client advised	Outstanding	-
36	Building: General Stores Location Reference: L22 Task: Access to the roof

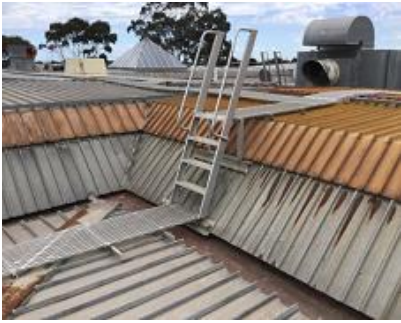
Handrail is missing for landing	Trips, Slips and Falls	Awareness induction	Med	Handrail to be installed	Low	Client advised	Outstanding	OH&S REGULATIONS 3.7 AS 1657-2018 4.4

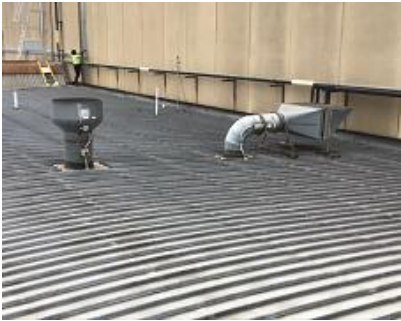
No safe access to the A/c units	Trips, Slips and Falls	N/A	Low	Supply walkway to the A/c units	Low	Client advised	Outstanding	-
38	Building: General Stores Location Reference: L24 Task: Access to the roof

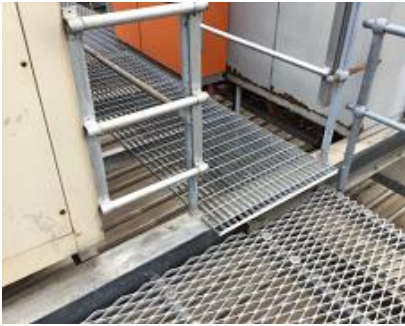
Variation in height between walkway panels are greater than required maximum	Trips, Slips and Falls	Awareness induction	Med	High visibility safety yellow nosing's to be installed	Low	Client advised	Outstanding	OH&S REGULATIONS 3.7 AS 1657-2018 3.3.4
40	Building: General Stores Location Reference: L24 Task: Access to the roof

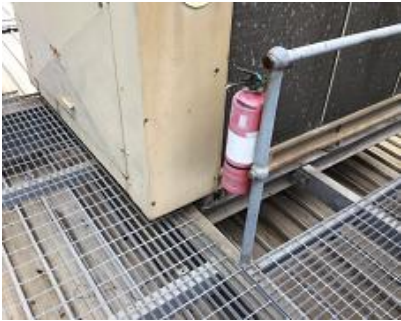
Gap between unit and existing handrail is greater than required maximum	Trips, Slips and Falls	Awareness induction	Med	Handrail to be installed	Low	Client advised	Outstanding	OH&S REGULATIONS 3.7 AS 1657-2018 4.4
42	Building: General Stores Location Reference: L25 Task: Restrict access to the roof

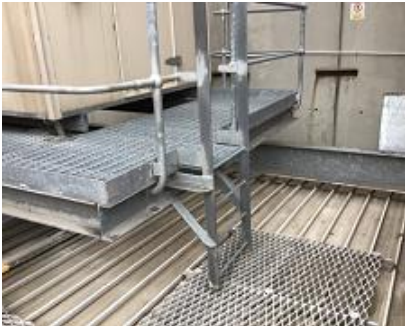
Bottom rung height is less than required minimum and no slip resistance on ladder rungs	Trips, Slips and Falls	Awareness induction	Med	Landing platform and non-slip rung caps to be installed	Low	Client advised	Outstanding	OH&S REGULATIONS 3.7 AS 1657-2018 7.4.3.1 & 7.4.3.4
44	Building: General Stores Location Reference: L26 Task: Access to the roof

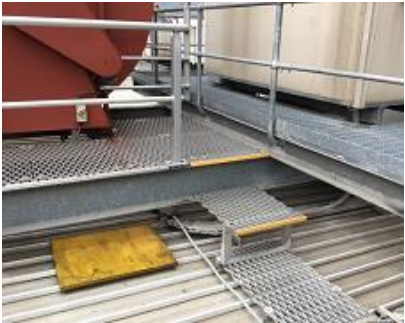
Non-complaint step is present	Trips, Slips and Falls	Awareness induction	Med	Existing step to be replaced with ladder	Low	Client advised	Outstanding	OH&S REGULATIONS 3.7 AS 1657-2018 7.2

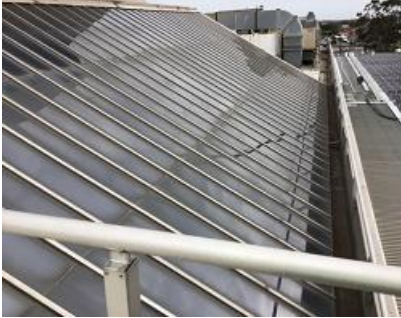
Brittle roof section is present	Trips, Slips and Falls	Restrict Access	High	"Warning-Brittle and Fragile Roof" signs to be installed	Low	Client advised	Outsta nding	OH&S REGULATIONS 3.57
46	Building: General Stores Location Reference: L29 Task: Access to the roof

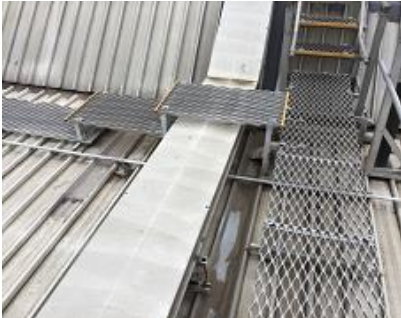
Handrail is missing steps	Trips, Slips and Falls	Awareness induction	Med	Handrail to be installed	Low	Client advised	Outsta nding	OH&S REGULATIONS 3.7 AS 1657-2018 7.2

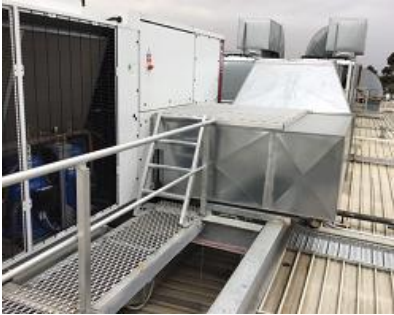
Non-complaint ladder is present	Trips, Slips and Falls	Awareness induction	Med	Existing ladder to be replaced	Low	Client advised	Outstanding	OH&S REGULATIONS 3.7 AS 1657-2018 7.4
48	Building: General Stores Location Reference: L29 Task: Access to the roof

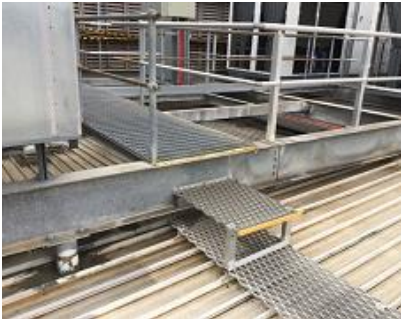
Non-complaint step is present	Trips, Slips and Falls	Awareness induction	Med	Existing step to be replaced with ladder	Low	Client advised	Outstanding	OH&S REGULATIONS 3.7 AS 1657-2018 3.1.4

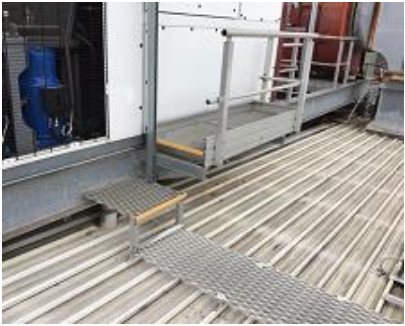
Non-complaint step is present	Trips, Slips and Falls	Awareness induction	Med	Existing step to be replaced with ladder	Low	Client advised	Outstanding	OH&S REGULATIONS 3.7 AS 1657-2018 3.1.4
50	Building: General Stores Location Reference: L30 Task: Access to the roof

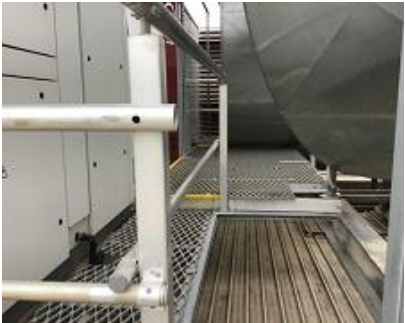
Handrail section is missing	Trips, Slips and Falls	Awareness induction	Med	Handrail to be installed	Low	Client advised	Outstanding	OH&S REGULATIONS 3.7 AS 1657-2018 4.4

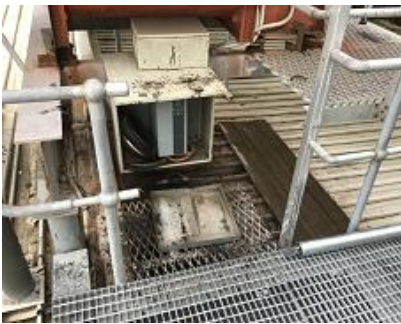
Handrail section is missing	Trips, Slips and Falls	Awareness induction	Med	Handrail to be installed	Low	Client advised	Outsta nding	OH&S REGULATIONS 3.7 AS 1657-2018 4.4
52	Building: General Stores Location Reference: L30 Task: Access to the roof

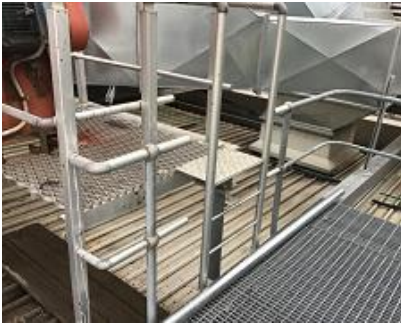
No slip resistance on ladder rungs	Trips, Slips and Falls	Awareness induction	Med	Non-slip rung caps to be installed	Low	Client advised	Outsta nding	OH&S REGULATIONS 3.7 AS 1657-2018 7.4.3.1

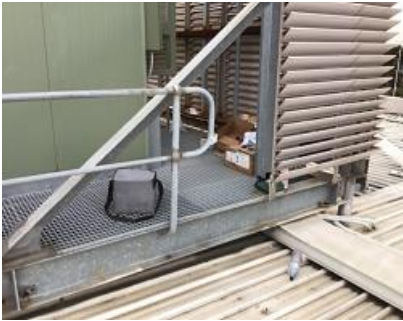
Handrail section is missing	Trips, Slips and Falls	Awareness induction	Med	Handrail to be installed	Low	Client advised	Outsta nding	OH&S REGULATIONS 3.7 AS 1657-2018 4.4
54	Building: General Stores Location Reference: L31 Task: Access to the roof

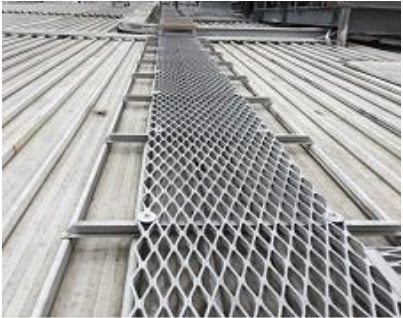
Walkway section not secured to roof	Trips, Slips and Falls	Awareness induction	Med	Walkway to be secured	Low	Client advised	Outsta nding	OH&S REGULATIONS 3.7

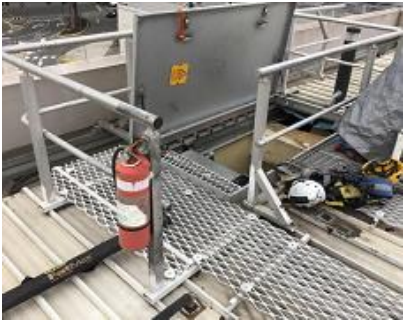
Handrail is missing for ladder	Trips, Slips and Falls	Awareness induction	Med	Extendable stiles to be installed	Low	Client advised	Outsta nding	OH&S REGULATIONS 3.7 AS 1657-2018 7.4
56	Building: General Stores Location Reference: L32 Task: Access to the roof

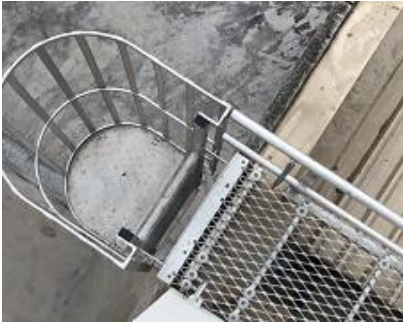
Gap between top rung and landing is greater than required maximum	Trips, Slips and Falls	Awareness induction	Med	Gap to be closed and handrail to be installed	Low	Client advised	Outsta nding	OH&S REGULATIONS 3.7 AS 1657-2018 7.4.8.4

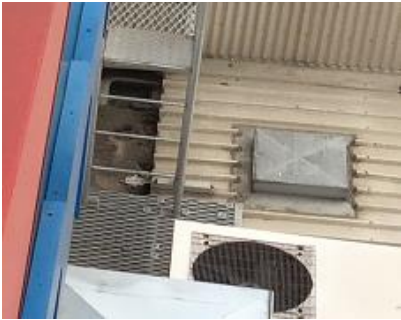
No slip resistance on ladder rungs	Trips, Slips and Falls	Awareness induction	Med	Non-slip rung caps to be installed	Low	Client advised	Outstanding	OH&S REGULATIONS 3.7 AS 1657-2018 7.4.3.1
58	Building: General Stores Location Reference: L33 Task: Access to the roof

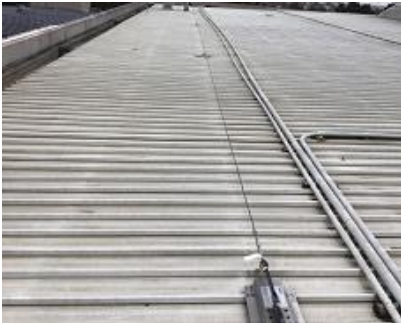
Static line over 10 years old	Trips, Slips and Falls	Awareness induction	High	Existing static line to be replaced	Low	Client advised	Outstanding	OH&S REGULATIONS 3.55 AS/NZS 1891.4:2009 6.3

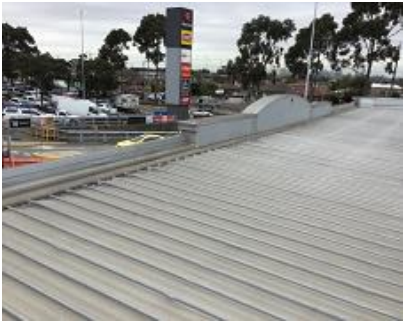
No height safety system installed	Trips, Slips and Falls	Awareness induction	High	Anchors to be installed	Low	Client advised	Outstanding	OH&S REGULATIONS 3.55
60	Building: General Stores Location Reference: L36 Task: Access to the A/c units

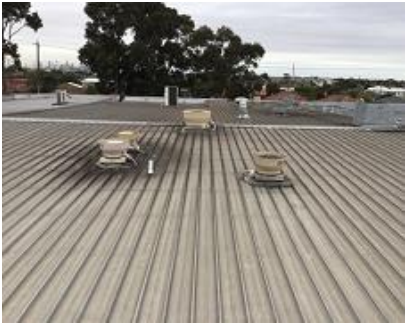
No safe access to the A/c units	Trips, Slips and Falls	N/A	Low	Supply walkway to the A/c units	Low	Client advised	Outstanding	-
62	Building: General Stores Location Reference: L37 Task: Access to the roof

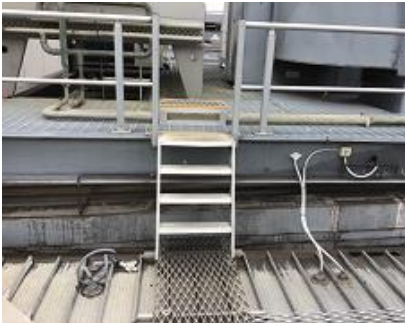
Non-complaint ladder is present	Trips, Slips and Falls	Awareness induction	Med	Existing ladder to be replaced	Low	Client advised	Outstanding	OH&S REGULATIONS 3.7 AS 1657-2018 7.4

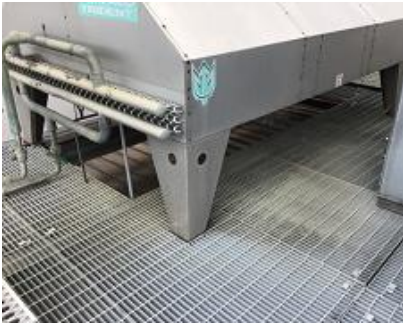
Gap between plant deck and unit is greater than required maximum	Trips, Slips and Falls	Awareness induction	Med	Mid rail to be installed	Low	Client advised	Outstanding	OH&S REGULATIONS 3.7 AS 1657-2018 4.4
64	Building: General Stores Location Reference: L39 Task: Access to the roof
