# Roof Safety Report

**Armidale Central,  
NSW 2350**

Prepared By: Safemaster Safety Products  
Date: 09 Aug 2017

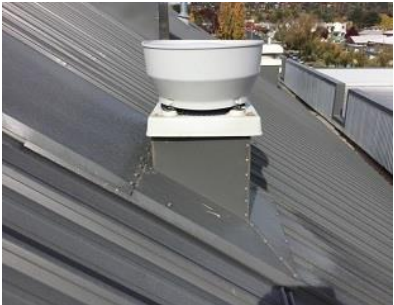
No safe access to the A/c units	Trips, Slips and Falls	N/A	Low	Levelled roof walkway including handrails to be installed	Low	Client advised	Outstanding	-
02	Building: Woolworths Location Reference: <a href="#">L02</a> Task: Access to the plant deck

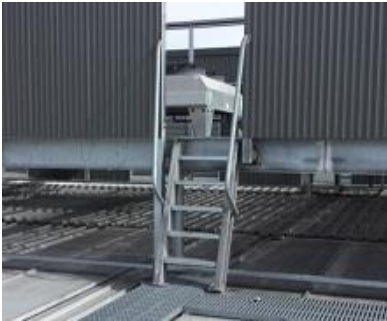
Handrails projecting towards the user and Landing at base is less than required minimum	Trips, Slips and Falls	Awareness induction	Med	Existing handrails to be removed and New aluminium handrails and landing platform to be installed	Low	Client advised	Outstanding	OH&S REGULATIONS 3.7  AS/NZS 1657-2013 7.4.8.5 & 7.3.6
04	Building: Woolworths Location Reference: <a href="#">L04</a> Task: Access to the A/c unit

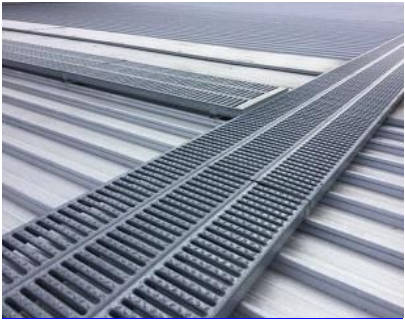
Variation in height between roof walkway panels are greater than required maximum	Trips, Slips and Falls	Awareness induction	Med	High visibility safety yellow nosing to be installed	Low	Client advised	Outstanding	OH&S REGULATIONS 3.7  AS/NZS 1657-2013 3.3.4
06	Building: Woolworths Location Reference: <a href="#">L05</a> Task: Access to the A/c unit

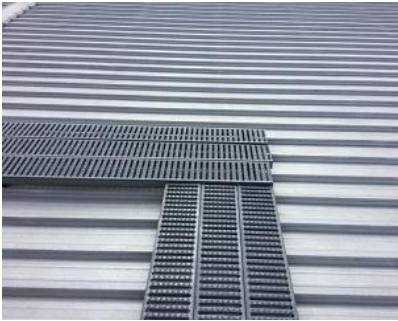
Variation in height between roof walkway panels are greater than required maximum	Trips, Slips and Falls	Awareness induction	Med	High visibility safety yellow nosing to be installed	Low	Client advised	Outstanding	OH&S REGULATIONS 3.7  AS/NZS 1657-2013 3.3.4
08	Building: Woolworths Location Reference: <a href="#">L07</a> Task: Access to the A/c unit

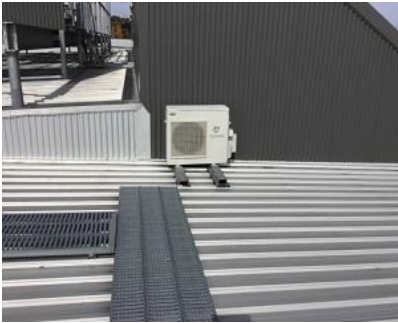
No safe access to the A/c unit	Trips, Slips and Falls	N/A	Low	Supply walkway to the A/c units	Low	Client advised	Outstanding	-
10	Building: Woolworths Location Reference: <a href="#">L08</a> Task: Access to the roof

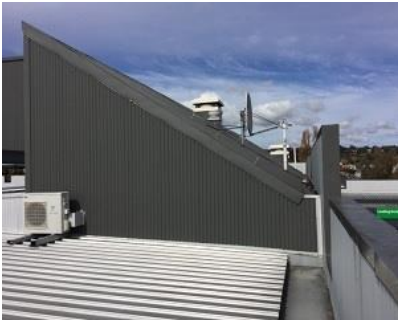
Variation in height between roofs are greater than required maximum	Trips, Slips and Falls	Awareness induction	Med	Access ladder including handrails to be installed	Low	Client advised	Outstanding	OH&S REGULATIONS 3.7  AS/NZS 1657-2013 3.1.4

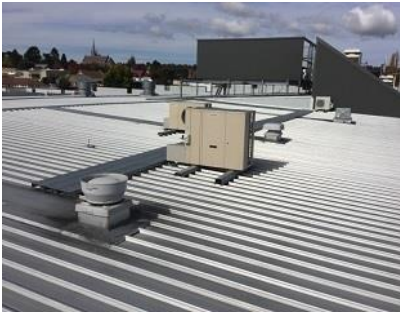
No safe access to the A/c units	Trips, Slips and Falls	N/A	Low	Supply walkway to the A/c units	Low	Client advised	Outstanding	-
12	Building: Woolworths Location Reference: <a href="#">L10</a> Task: Access to the roof

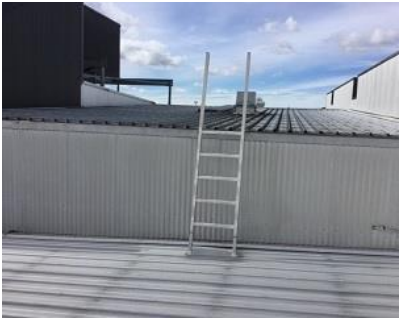
Bottom rung height is less than required minimum and Top rung not levelled with landing	Trips, Slips and Falls	Awareness induction	Med	Existing ladder to be re-installed with new landing platforms	Low	Client advised	Outstanding	OH&S REGULATIONS 3.7  AS/NZS 1657-2013 7.4.3.4 & 7.4.3.3

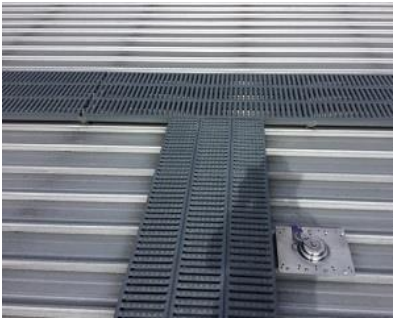
Variation in height between roof walkway panels are greater than required maximum	Trips, Slips and Falls	Awareness induction	Med	High visibility safety yellow nosing to be installed	Low	Client advised	Outstanding	OH&S REGULATIONS 3.7  AS/NZS 1657-2013 3.3.4
16	Building: Woolworths Location Reference: <a href="#">L14</a> Task: Access to the A/c unit

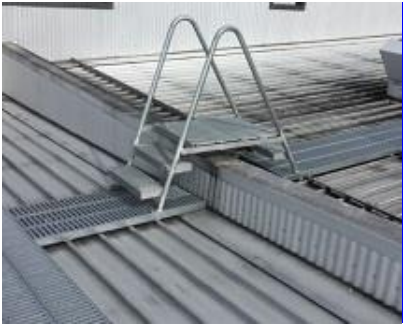
Stair width is less than required minimum	Trips, Slips and Falls	Awareness induction	Med	Existing stair to be removed and New access ladder including handrails to be installed	Low	Client advised	Outstanding	OH&S REGULATIONS 3.7  AS/NZS 1657-2013 7.2.1
18	Building: Woolworths Location Reference: <a href="#">L15</a> Task: Access to the Switch

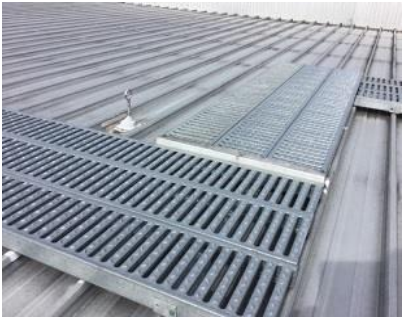
Variation in height between walkway panels are greater than required maximum	Trips, Slips and Falls	Awareness induction	Med	High visibility safety yellow nosing's to be installed	Low	Client advised	Outstanding	OH&S REGULATIONS 3.6  AS/NZS 1657-2013 3.3.4
20	Building: Woolworths Location Reference: <a href="#">L16</a> Task: Access to the A/c unit

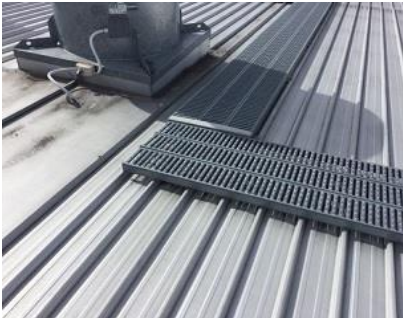
No safe access to the A/c unit	Trips, Slips and Falls	N/A	Low	Supply walkway to the A/c unit	Low	Client advised	Outstanding	-

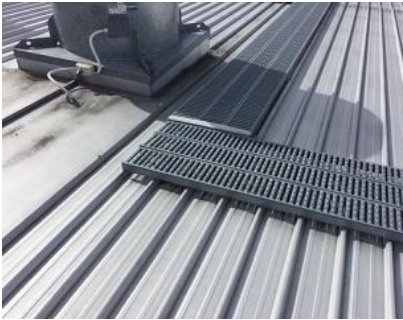
Variation in height between walkway panels are greater than required maximum	Trips, Slips and Falls	Awareness induction	Med	High visibility safety yellow nosing's to be installed	Low	Client advised	Outstanding	OH&S REGULATIONS 3.6  AS/NZS 1657-2013 3.3.4
22	Building: Woolworths Location Reference: <a href="#">L17</a> Task: Access to the A/c unit

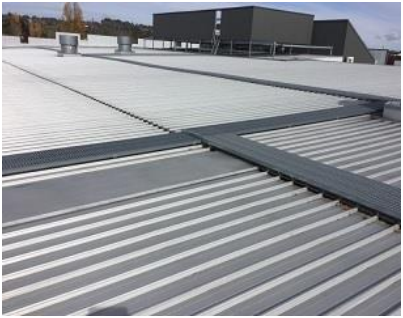
Variation in height between walkway panels are greater than required maximum	Trips, Slips and Falls	Awareness induction	Med	High visibility safety yellow nosing's to be installed	Low	Client advised	Outstanding	OH&S REGULATIONS 3.6  AS/NZS 1657-2013 3.3.4

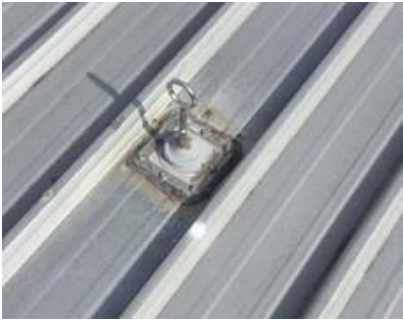
Anchor is damaged	Trips, Slips and Falls	Awareness induction	High	Existing anchor to be removed and new anchor to be installed	Low	Client advised	Outstanding	OH&S REGULATIONS 3.55
24	Building: Woolworths Location Reference: <a href="#">L18</a> Task: Access to the roof

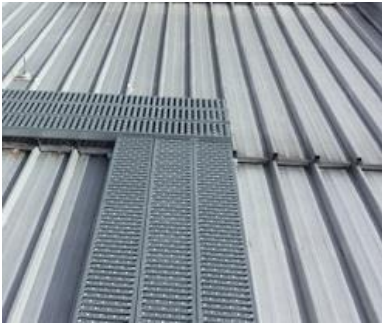
Variation in height between walkway panels are greater than required maximum	Trips, Slips and Falls	Awareness induction	Med	High visibility safety yellow nosing's to be installed	Low	Client advised	Outstanding	OH&S REGULATIONS 3.6  AS/NZS 1657-2013 3.3.4

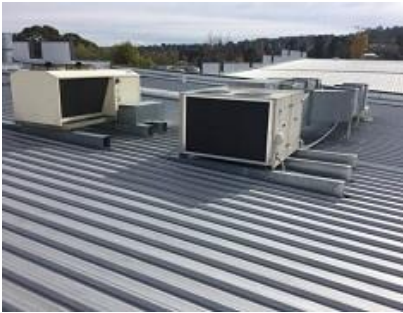
No safe access to the A/c units	Trips, Slips and Falls	N/A	Low	Supply walkway to the A/c units	Low	Client advised	Outstanding	-
26	Building: General Stores Location Reference: <a href="#">L20</a> Task: Access to the roof

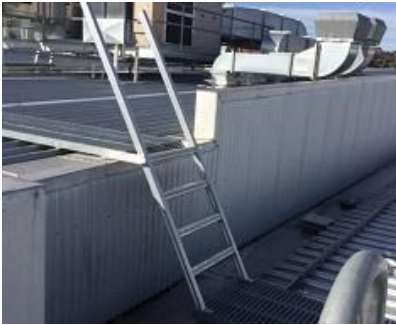
Ladder slope is less than required minimum	Trips, Slips and Falls	Awareness induction	Med	Existing ladder to be removed and New ladder to be installed	Low	Client advised	Outstanding	OH&S REGULATIONS 3.7  AS/NZS 1657-2013 7.4.1
28	Building: General Stores Location Reference: <a href="#">L22</a> Task: Access to the A/c unit

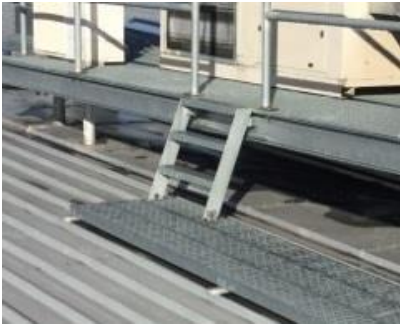
Landing is less than required minimum and handrail is missing for ladder	Trips, Slips and Falls	Awareness induction	Med	Existing ladder to be removed and new ladder to be installed	Low	Client advised	Outstanding	OH&S REGULATIONS 3.7  AS/NZS 1657-2013 7.3.6 & 7.3.4
30	Building: General Stores Location Reference: <a href="#">L23</a> Task: Access to the plant deck

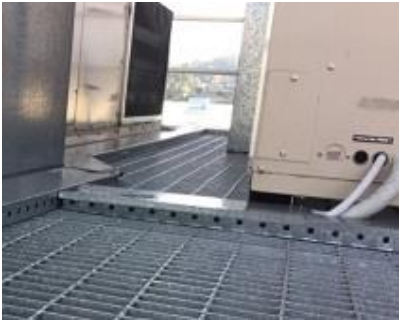
Cable tray installed over the walkway path	Trips, Slips and Falls	Awareness induction	Med	High visibility safety yellow tape to be installed	Low	Client advised	Outstanding	OH&S REGULATIONS 3.6

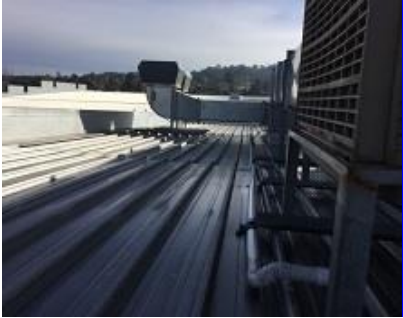
No safe access to the A/c unit	Trips, Slips and Falls	N/A	Low	Supply walkway to the A/c unit	Low	Client advised	Outstanding	-
32	Building: General Stores Location Reference: <a href="#">L24</a> Task: Access to the switch's

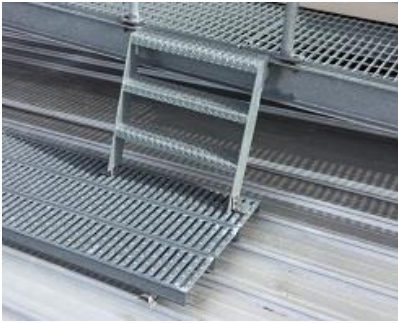
Landing at base is less than required minimum, ladder slope is greater than required maximum and handrails is missing	Trips, Slips and Falls	Awareness induction	Med	Existing ladder to be removed and new ladder to be installed	Low	Client advised	Outstanding	OH&S REGULATIONS 3.7  AS/NZS 1657-2013 7.3.6 & 7.2.1
34	Building: General Stores Location Reference: <a href="#">L25</a> Task: Access to the plant deck

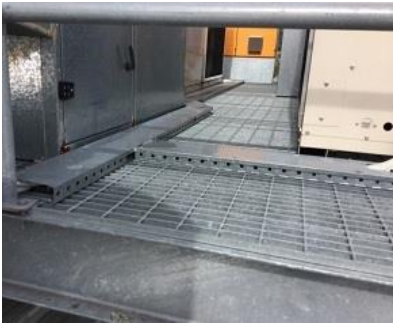
Cable tray installed over the walkway path	Trips, Slips and Falls	Awareness induction	Med	High visibility safety yellow tape to be installed	Low	Client advised	Outstanding	OH&S REGULATIONS 3.6

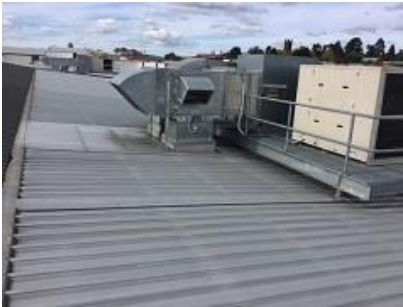
No safe access to the switch's	Trips, Slips and Falls	N/A	Low	Supply walkway to the switch's	Low	Client advised	Outstanding	-
36	Building: General Stores Location Reference: <a href="#">L26</a> Task: Access to the A/c unit

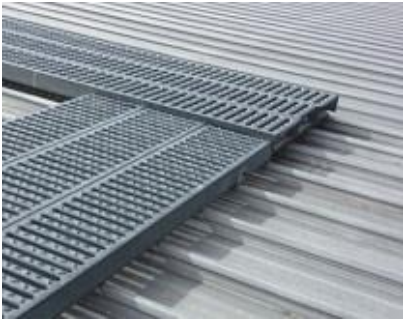
Variation in height between walkway panels are greater than required maximum	Trips, Slips and Falls	Awareness induction	Med	High visibility safety yellow nosing's to be installed	Low	Client advised	Outstanding	OH&S REGULATIONS 3.6  AS/NZS 1657-2013 3.3.4
38	Building: General Stores Location Reference: <a href="#">L27</a> Task: Access to the A/c unit

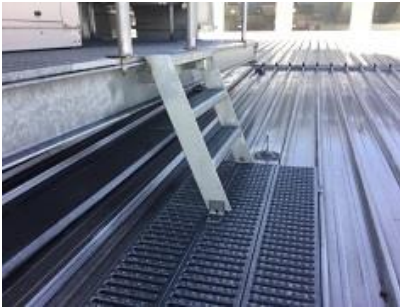
Landing is less than required minimum and Handrail is missing	Trips, Slips and Falls	Awareness induction	Med	Existing ladder to be removed and New ladder to be installed	Low	Client advised	Outstanding	OH&S REGULATIONS 3.7  AS/NZS 1657-2013 7.3.6 & 7.3.4
40	Building: General Stores Location Reference: <a href="#">L27</a> Task: Access to the plant deck

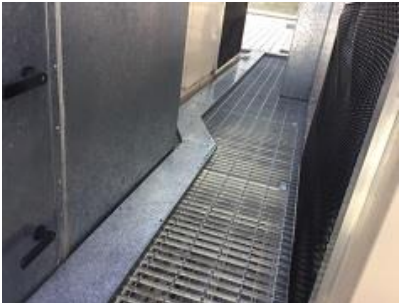
Cable tray installed over the walkway path	Trips, Slips and Falls	Awareness induction	Med	High visibility safety yellow tape to be installed	Low	Client advised	Outstanding	OH&S REGULATIONS 3.6

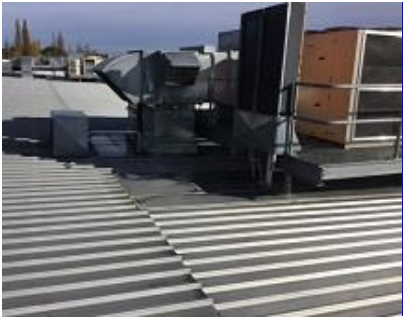
No safe access to the switch's	Trips, Slips and Falls	N/A	Low	Supply walkway to the switch's	Low	Client advised	Outstanding	-
42	Building: General Stores Location Reference: <a href="#">L28</a> Task: Access to the A/c units

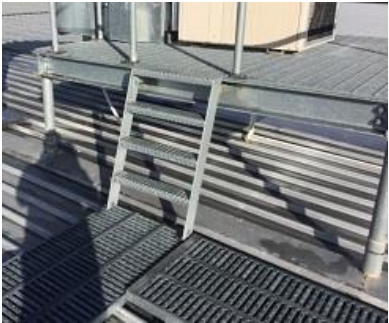
Ladder slope is greater than required maximum and handrails is missing	Trips, Slips and Falls	Awareness induction	Med	Existing ladder to be removed and New ladder to be installed	Low	Client advised	Outstanding	OH&S REGULATIONS 3.7  AS/NZS 1657-2013 7.2.1 & 7.3.4
44	Building: General Stores Location Reference: <a href="#">L29</a> Task: Access to the switch

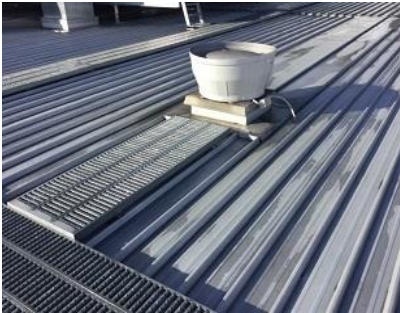
No safe access to the switch	Trips, Slips and Falls	N/A	Low	Supply walkway to the switch	Low	Client advised	Outstanding	-

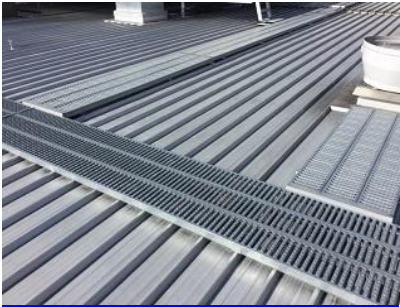
Variation in height between walkway panels are greater than required maximum	Trips, Slips and Falls	Awareness induction	Med	High visibility safety yellow nosing's to be installed	Low	Client advised	Outstanding	OH&S REGULATIONS 3.6  AS/NZS 1657-2013 3.3.4
46	Building: General Stores Location Reference: <a href="#">L30</a> Task: Access to the A/c unit

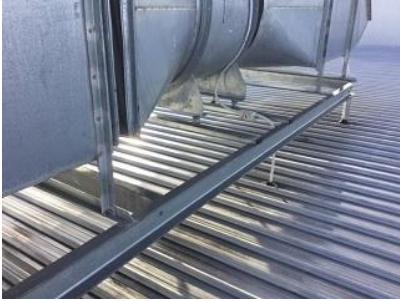
No safe access to the switch's	Trips, Slips and Falls	N/A	Low	Supply walkway to the switch	Low	Client advised	Outstanding	-
48	Building: General Stores Location Reference: <a href="#">L33</a> Task: Access to the plant deck

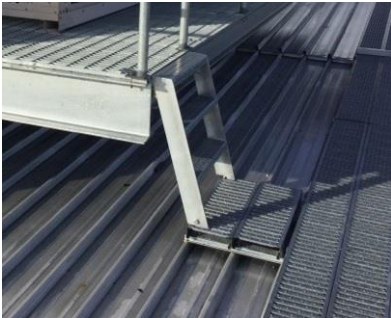
Ladder slope is greater than required maximum and handrails is missing	Trips, Slips and Falls	Awareness induction	Med	Existing ladder to be removed and New ladder to be installed	Low	Client advised	Outstanding	OH&S REGULATIONS 3.7  AS/NZS 1657-2013 7.2.1 & 7.3.4

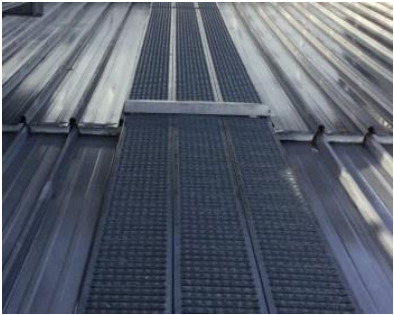
Variation in height between walkway panels are greater than required maximum	Trips, Slips and Falls	Awareness induction	Med	High visibility safety yellow nosing's to be installed	Low	Client advised	Outstanding	OH&S REGULATIONS 3.6  AS/NZS 1657-2013 3.3.4
50	Building: General Stores Location Reference: <a href="#">L34</a> Task: Access to the roof

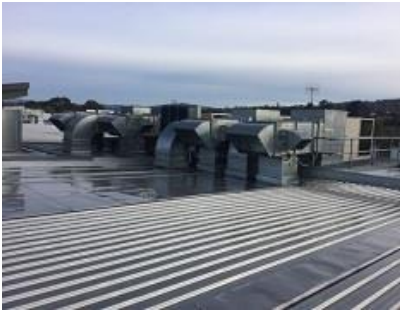
No safe access to the switch's	Trips, Slips and Falls	N/A	Low	Supply walkway to the switch's	Low	Client advised	Outstanding	-
52	Building: General Stores Location Reference: <a href="#">L35</a> Task: Access to the plant deck

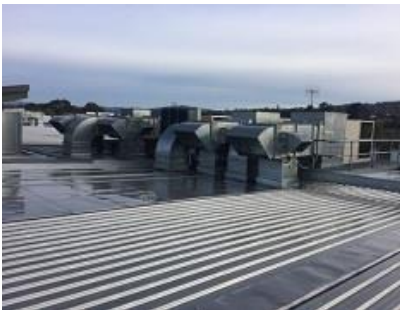
Handrail sections are missing at plant deck	Trips, Slips and Falls	Awareness induction	Med	Supply handrail to the plant deck	Low	Client advised	Outstanding	OH&S REGULATIONS 3.6  AS/NZS 1657-2013 4.4

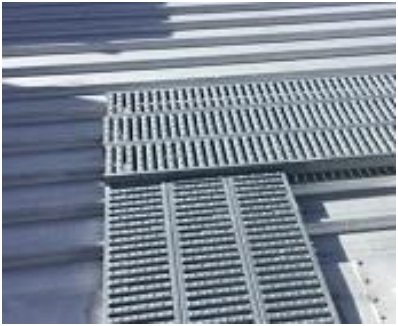
Variation in height between walkway panels are greater than required maximum	Trips, Slips and Falls	Awareness induction	Med	High visibility safety yellow nosing's to be installed	Low	Client advised	Outstanding	OH&S REGULATIONS 3.6  AS/NZS 1657-2013 3.3.4
54	Building: General Stores Location Reference: <a href="#">L36</a> Task: Access to the switch's

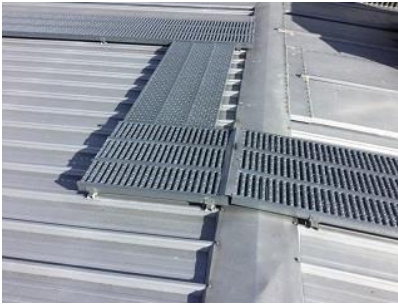
Variation in height between walkway panels are greater than required maximum	Trips, Slips and Falls	Awareness induction	Med	High visibility safety yellow nosing's to be installed	Low	Client advised	Outstanding	OH&S REGULATIONS 3.6  AS/NZS 1657-2013 3.3.4
56	Building: General Stores Location Reference: <a href="#">L37</a> Task: Access to the A/c units

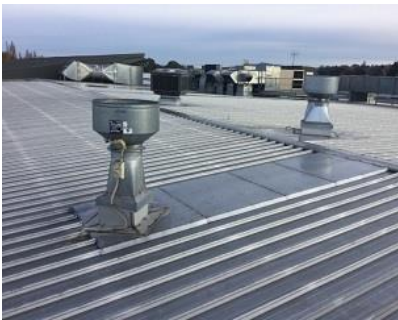
No safe access to the A/c units	Trips, Slips and Falls	N/A	Low	Supply walkway to the A/c units	Low	Client advised	Outstanding	-

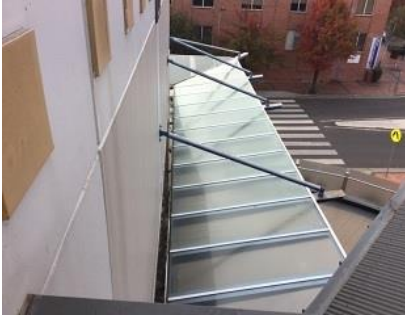
Glass roof (No serviceable items)	Trips, Slips and Falls	Awareness induction	High	"EWP Access Only" signs to be installed	Low	Client advised	Outstanding	OH&S REGULATIONS 3.55 & 3.11
58	Building: General Stores Location Reference: <a href="#">L40</a> Task: Access to the roof

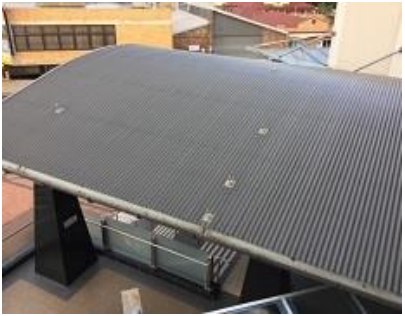
Ladder access bracket and sign is missing	Trips, Slips and Falls	Awareness induction	High	Ladder access bracket and signage to be installed	Low	Client advised	Outstanding	OH&S REGULATIONS 3.55 & 3.7

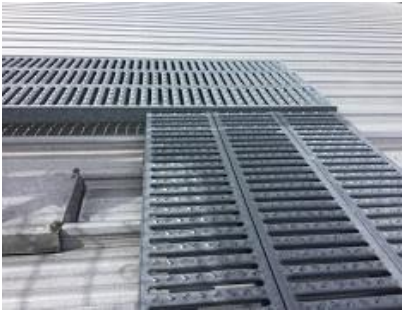
Variation in height between walkway panels are greater than required maximum	Trips, Slips and Falls	Awareness induction	Med	High visibility safety yellow nosing's to be installed	Low	Client advised	Outstanding	OH&S REGULATIONS 3.6  AS/NZS 1657-2013 3.3.4
60	Building: General Stores Location Reference: <a href="#">L41</a> Task: Access to the A/c units

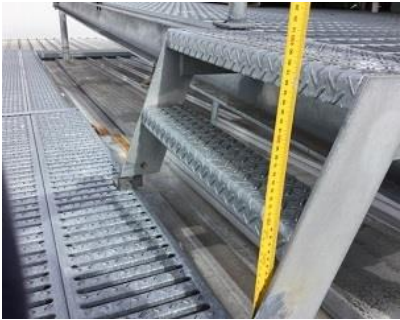
Landing is less than required minimum and slope of ladder is greater than required maximum	Trips, Slips and Falls	Awareness induction	Med	Existing ladder to be removed and New ladder to be installed	Low	Client advised	Outstanding	OH&S REGULATIONS 3.7  AS/NZS 1657-2013 7.3.6 & 7.2.1
62	Building: General Stores Location Reference: <a href="#">L41</a> Task: Access to the switch's

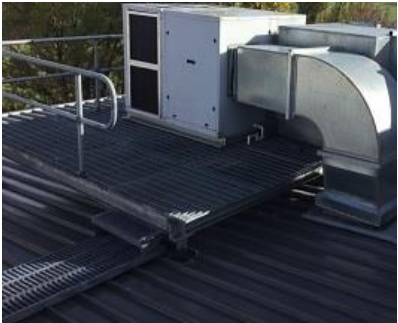
Variation in height between plant deck and roof is greater than required maximum and Handrail section is missing, No safe access to the gutter	Trips, Slips and Falls	Awareness induction	High	Handrail sections and Fall arrest anchors to be installed	Low	Client advised	Outstanding	OH&S REGULATIONS 3.7 & 3.55  AS/NZS 1657-2013 4.4
64	Building: General Stores Location Reference: <a href="#">L43</a> Task: Access to the roof

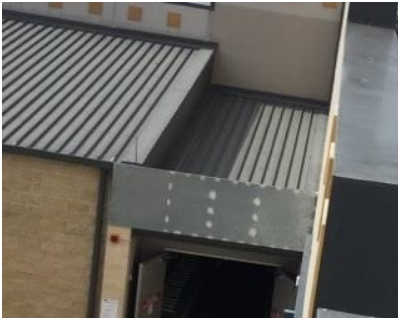
Variation in height between roofs are greater than required maximum	Trips, Slips and Falls	Awareness induction	Med	Access ladder including handrails to be installed	Low	Client advised	Outstanding	OH&S REGULATIONS 3.7  AS/NZS 1657-2013 3.1.4

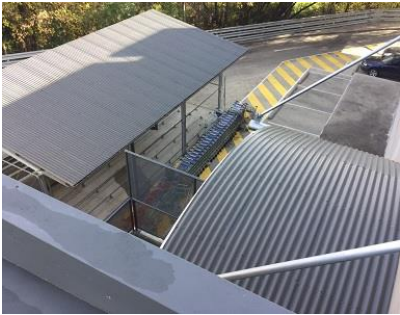
No height safety system installed (No serviceable items)	Trips, Slips and Falls	Awareness induction	High	"EWP Access Only" signs to be installed	Low	Client advised	Outstanding	OH&S REGULATIONS 3.55 & 3.11
66	Building: General Stores Location Reference: <a href="#">L46</a> Task: Access to the roof

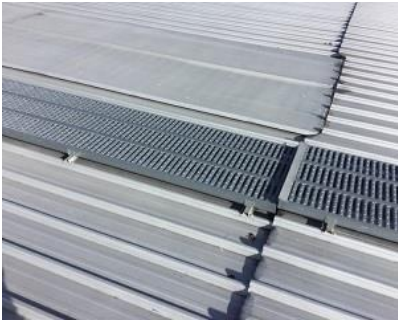
Variation in height between walkway panels are greater than required maximum	Trips, Slips and Falls	Awareness induction	Med	High visibility safety yellow nosing's to be installed	Low	Client advised	Outstanding	OH&S REGULATIONS 3.6  AS/NZS 1657-2013 3.3.4
68	Building: General Stores Location Reference: <a href="#">L48</a> Task: Access to the roof

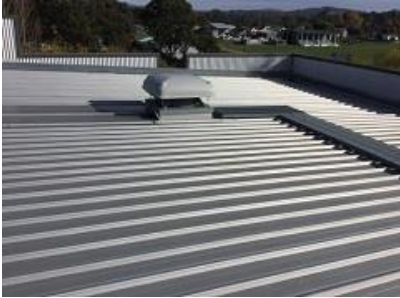
No safe access to the switch	Trips, Slips and Falls	N/A	Low	Supply walkway to the switch	Low	Client advised	Outstanding	-
70	Building: General Stores Location Reference: <a href="#">L50</a> Task: Access to the switch

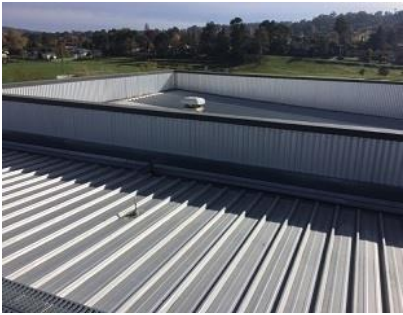
Variation in height between roofs are greater than required maximum	Trips, Slips and Falls	Awareness induction	Med	Access ladder including handrails to be installed	Low	Client advised	Outstanding	OH&S REGULATIONS 3.7  AS/NZS 1657-2013 3.1.4
72	Building: General Stores Location Reference: <a href="#">L52</a> Task: Access to the A/c unit
