Roof Safety Report

**Armidale Central,
NSW 2350**

Prepared By: Safemaster Safety Products
Date: 01-11-2019

Roof Safety Report for
Armidale Central, NSW 2350

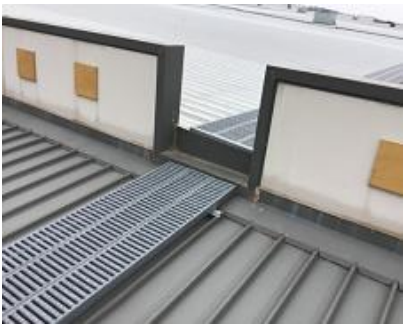
No	Photo of Hazard	Details of Hazard	Details of Risk	Existing/ Immediate Control Measure	Curren t Risk Level	Proposed Permanent Solution	Residu al Risk Assess ment	Details of Action Taken	Status	Reference
83	Building: General Stores Location Reference: L42 Task: Access to the roof

Variation in height between walkway panels are greater than required maximum	Trips, Slips and Falls	Awareness induction	Med	High visibility safety yellow nosing's to be installed	Low	Client advised	Outstanding	OH&S REGULATIONS 3.7 AS/NZS 1657-2018 3.3.4
84	Building: General Stores Location Reference: L20 Task: Access to the Roof

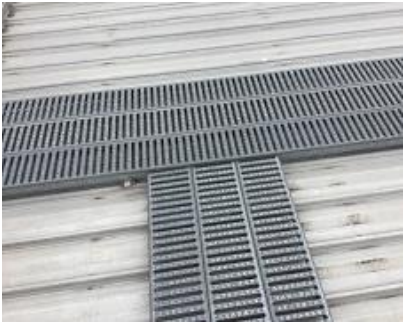
Variation in height between walkway panels are greater than required maximum	Trips, Slips and Falls	Awareness induction	Med	High visibility safety yellow nosing's to be installed	Low	Client advised	Outstanding	OH&S REGULATIONS 3.7 AS/NZS 1657-2018 3.3.4

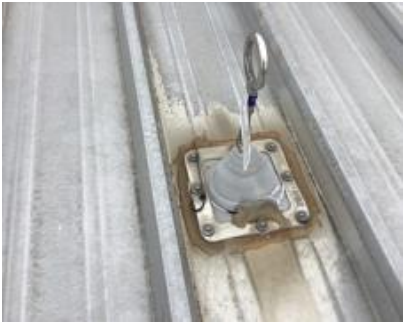
No	Photo of Hazard	Details of Hazard	Details of Risk	Existing/ Immediate Control Measure	Current Risk Level	Proposed Permanent Solution	Residual Risk Assessment	Details of Action Taken	Status	Reference
85	Building: General Stores Location Reference: L50 Task: Access to the roof

Corroded dektite is present	Trips, Slips and Falls	Awareness induction	Med	Dektite to be replaced	Low	Client advised	Outstanding	OH&S REGULATIONS 3.7
86	Building: General Stores Location Reference: L53 Task: Access to the roof

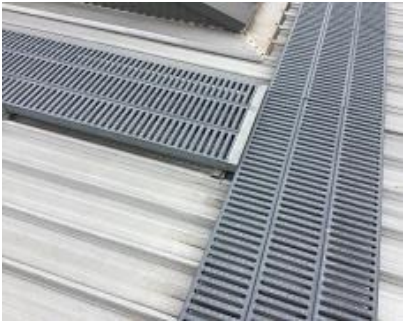
Variation in height between walkway panels are greater than required maximum	Trips, Slips and Falls	Awareness induction	Med	High visibility safety yellow nosing's to be installed	Low	Client advised	Outstanding	OH&S REGULATIONS 3.7 AS/NZS 1657-2018 3.3.4
