Roof Safety Report

Buranda Village, QLD 4102

Prepared By: Safemaster Safety Products
Date: 18-08-2020

Roof Safety Report for
Buranda Village, QLD 4102

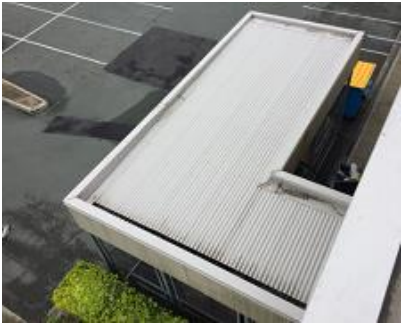
No	Photo of Hazard	Details of Hazard	Details of Risk	Existing/ Immediate Control Measure	Curre nt Risk Level	Proposed Permanent Solution	Resid ual Risk Asse sme nt	Details of Action Taken	Status	Reference
01	Building: General Stores Location Reference: L01 Task: Restrict access to the roof

No height safety system installed	Trips, Slips and Falls	Restrict Access	High	"EWP Access Only" sign to be installed	Low	Client advised	Outstanding	OH&S REGULATIONS 3.55 & 3.11
02	Building: General Stores Location Reference: L02 Task: Access to the A/c units

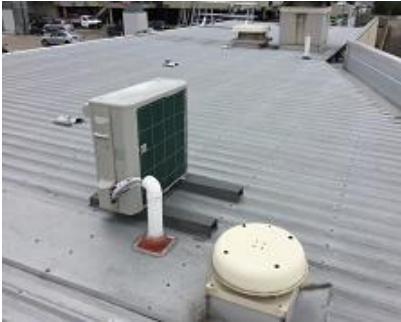
No safe access to the A/c units	Trips, Slips and Falls	N/A	Low	Supply walkway to the A/c units	Low	Client advised	Outstanding	-

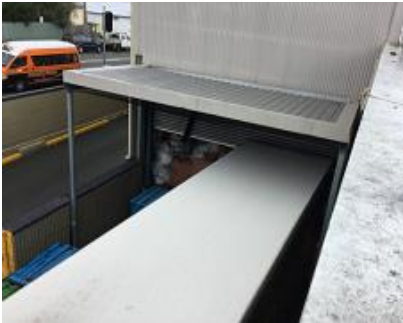
No	Photo of Hazard	Details of Hazard	Details of Risk	Existing/ Immediate Control Measure	Curre nt Risk Level	Proposed Permanent Solution	Resid ual Risk Asse sme nt	Details of Action Taken	Status	Reference
03	Building: General Stores Location Reference: L03 Task: Restrict access to the roof

No height safety system installed	Trips, Slips and Falls	Restrict Access	High	"EWP Access Only" sign to be installed	Low	Client advised	Outstanding	OH&S REGULATIONS 3.55 & 3.11
04	Building: General Stores Location Reference: L04 Task: Access to the roof

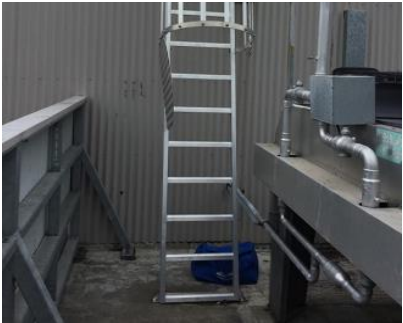
Bottom rung height is less than required minimum	Trips, Slips and Falls	Awareness induction	Med	Landing platform to be installed	Low	Client advised	Outstanding	OH&S REGULATIONS 3.7 AS/NZS 1657-2013 7.4.3.4

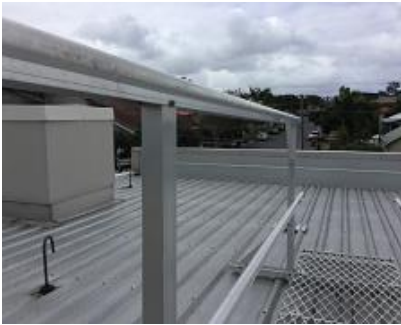
No	Photo of Hazard	Details of Hazard	Details of Risk	Existing/ Immediate Control Measure	Curre nt Risk Level	Proposed Permanent Solution	Resid ual Risk Asse sme nt	Details of Action Taken	Status	Reference
05	Building: General Stores Location Reference: L04 Task: Access to the roof

Sharp edges on handrails	Trips, Slips and Falls	Awareness induction	Med	Tek screws to be replaced with rivets	Low	Client advised	Outsta nding	OH&S REGULATIONS 3.7 AS/NZS 1657- 2013 5.6
06	Building: General Stores Location Reference: L05 Task: Access to the roof

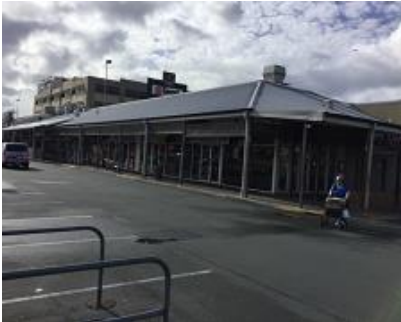
No height safety system installed	Trips, Slips and Falls	Awareness induction	High	Fall arrest anchors to be installed	Low	Client advised	Outsta nding	OH&S REGULATIONS 3.55

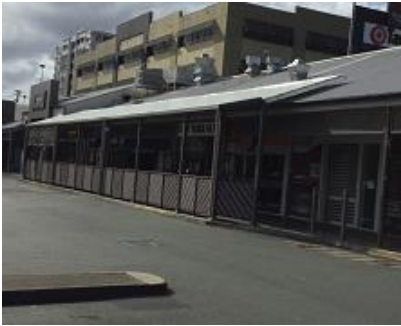
No	Photo of Hazard	Details of Hazard	Details of Risk	Existing/ Immediate Control Measure	Curre nt Risk Level	Proposed Permanent Solution	Resid ual Risk Asse sme nt	Details of Action Taken	Status	Reference
07	Building: General Stores Location Reference: L06 Task: Restrict access to the roof

Brittle roof (Non-trafficable roof)	Trips, Slips and Falls	Restrict Access	High	"Warning-Keep Off-Brittle and Fragile Roof" signs to be installed	Low	Client advised	Outstanding	OH&S REGULATIONS 3.57
08	Building: General Stores Location Reference: L07 Task: Access to the A/c units

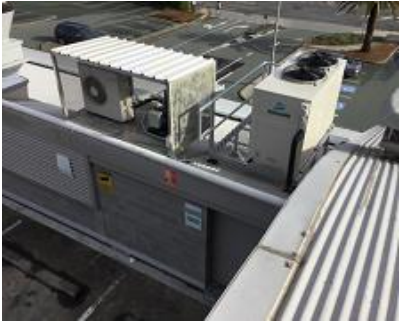
No safe access to the A/c units	Trips, Slips and Falls	Awareness induction	Med	Additional handrail and ladder to be installed	Low	Client advised	Outstanding	OH&S REGULATIONS 3.7 & 3.55 AS/NZS 1657-2013 3.1.4

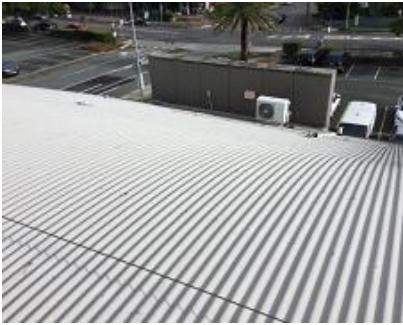
No	Photo of Hazard	Details of Hazard	Details of Risk	Existing/ Immediate Control Measure	Curre nt Risk Level	Proposed Permanent Solution	Resid ual Risk Asse sme nt	Details of Action Taken	Status	Reference
09	Building: General Stores Location Reference: L08 Task: Access to the A/c unit

No safe access to the A/c units	Trips, Slips and Falls	Awareness induction	Med	Cleats on roof to be installed	Low	Client advised	Outstanding	OH&S REGULATIONS 3.7 AS/NZS 1657-2013 5.3.2
10	Building: General Stores Location Reference: L09 Task: Access to the roof

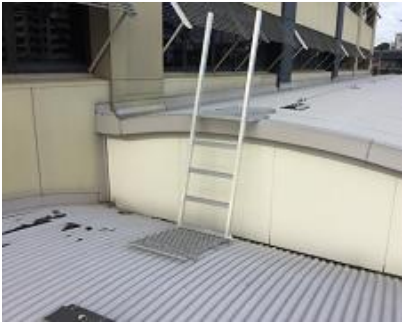
Non-complaint landing is present	Trips, Slips and Falls	Awareness induction	Med	Existing ladder to be re-installed with landing platforms and brackets	Low	Client advised	Outstanding	OH&S REGULATIONS 3.7 AS/NZS 1657-2013 7.4.3.5

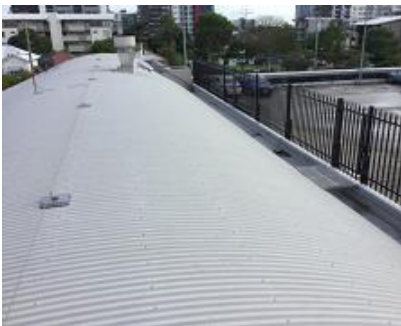
No	Photo of Hazard	Details of Hazard	Details of Risk	Existing/ Immediate Control Measure	Curre nt Risk Level	Proposed Permanent Solution	Resid ual Risk Asse sme nt	Details of Action Taken	Status	Reference
11	Building: General Stores Location Reference: L10 Task: Access to the roof

No safe access to the A/c units	Trips, Slips and Falls	Awareness induction	Med	Cleats on roof to be installed	Low	Client advised	Outstanding	OH&S REGULATIONS 3.7 AS/NZS 1657-2013 5.3.2
12	Building: General Stores Location Reference: L10 Task: Access to the roof

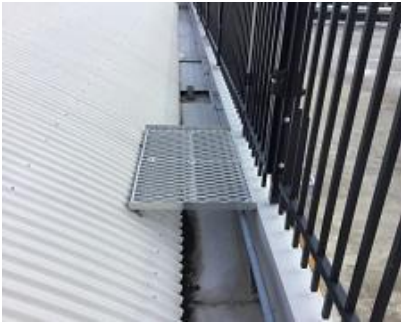
Non-complaint step is present	Trips, Slips and Falls	Awareness induction	Med	Additional steps to be installed	Low	Client advised	Outstanding	OH&S REGULATIONS 3.7 AS/NZS 1657-2013 3.1.4

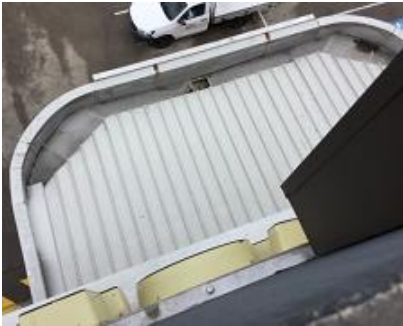
No	Photo of Hazard	Details of Hazard	Details of Risk	Existing/ Immediate Control Measure	Curre nt Risk Level	Proposed Permanent Solution	Resid ual Risk Asse sme nt	Details of Action Taken	Status	Reference
13	Building: General Stores Location Reference: L1 Task: Restrict access to the roof

No height safety system installed	Trips, Slips and Falls	Restrict Access	High	"EWP Access Only" sign to be installed	Low	Client advised	Outstanding	OH&S REGULATIONS 3.55 & 3.11
14	Building: General Stores Location Reference: L1 Task: Access to the roof

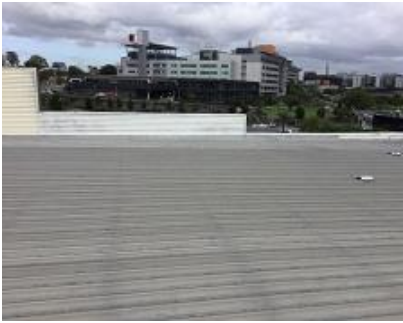
No height safety system installed	Trips, Slips and Falls	Awareness induction	High	Fall arrest anchors to be installed	Low	Client advised	Outstanding	OH&S REGULATIONS 3.55

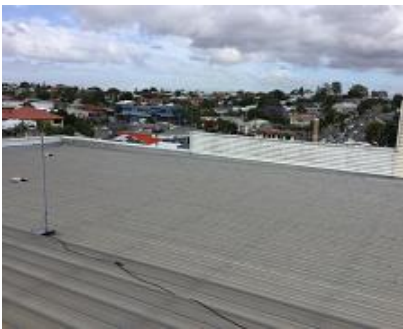
No	Photo of Hazard	Details of Hazard	Details of Risk	Existing/ Immediate Control Measure	Curre nt Risk Level	Proposed Permanent Solution	Resid ual Risk Asse sme nt	Details of Action Taken	Status	Reference
15	Building: General Stores Location Reference: L11 Task: Access to the roof

No height safety system installed	Trips, Slips and Falls	Awareness induction	High	Fall arrest anchors to be installed	Low	Client advised	Outstanding	OH&S REGULATIONS 3.55
16	Building: General Stores Location Reference: L12 Task: Access to the roof

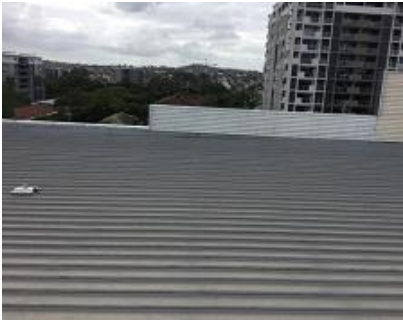
No height safety system installed	Trips, Slips and Falls	Awareness induction	High	Fall arrest anchors to be installed	Low	Client advised	Outstanding	OH&S REGULATIONS 3.55

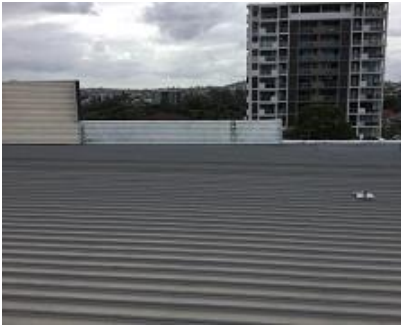
No	Photo of Hazard	Details of Hazard	Details of Risk	Existing/ Immediate Control Measure	Curre nt Risk Level	Proposed Permanent Solution	Resid ual Risk Asse sme nt	Details of Action Taken	Status	Reference
17	Building: General Stores Location Reference: L12 Task: Access to the roof

No height safety system installed	Trips, Slips and Falls	Awareness induction	High	Fall arrest anchors to be installed	Low	Client advised	Outstanding	OH&S REGULATIONS 3.55
18	Building: General Stores Location Reference: L13 Task: Access to the roof

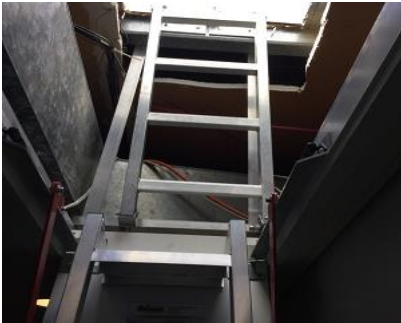
Bottom rung height is less than required minimum and ladder not lined up with fold down ladder	Trips, Slips and Falls	Awareness induction	Med	Existing ladder to be removed and new ladder to be installed	Low	Client advised	Outstanding	OH&S REGULATIONS 3.7 AS/NZS 1657-2013 7.4.3.4

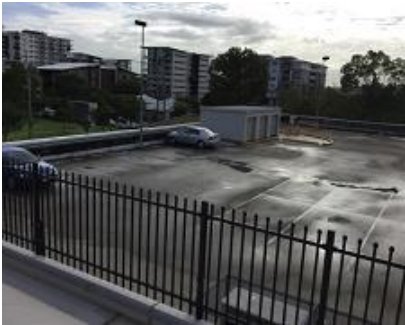
No	Photo of Hazard	Details of Hazard	Details of Risk	Existing/ Immediate Control Measure	Curre nt Risk Level	Proposed Permanent Solution	Resid ual Risk Asse sme nt	Details of Action Taken	Status	Reference
19	Building: General Stores Location Reference: L14 Task: Restrict access to the roof

No height safety system installed	Trips, Slips and Falls	Restrict Access	High	"EWP Access Only" sign to be installed	Low	Client advised	Outstanding	OH&S REGULATIONS 3.55 & 3.11
