# Roof Safety Report

**Castle Plaza, SA 5039**

Prepared By: Safemaster Safety Products  
Date: 01 March 2018

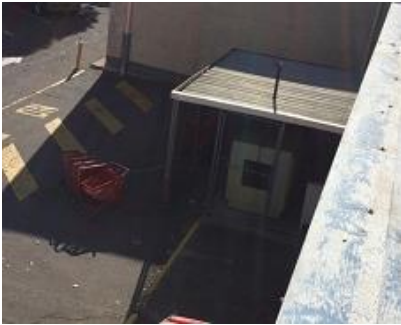
No height safety system installed (No serviceable items on roof)	Trips, Slips and Falls	Restrict Access	High	"EWP Access Only" sign to be installed	Low	Client advised	Outstanding	OH&S REGULATIONS 3.55 & 3.11
02	Building: General Stores Location Reference: <a href="#">L02</a> Task: Access to the roof

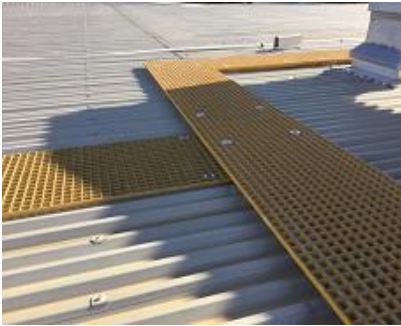
Variation in height between walkway panels are greater than required maximum	Trips, Slips and Falls	Awareness induction	Med	High visibility safety nosing to be installed	Low	Client advised	Outstanding	OH&S REGULATIONS 3.7  AS/NZS 1657-2013 3.3.4
04	Building: General Stores Location Reference: <a href="#">L02</a> Task: Access to the roof

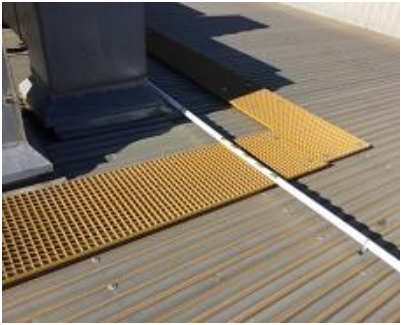
Pipe installed over the walkway path	Trips, Slips and Falls	Awareness induction	Med	Step bridge to be installed	Low	Client advised	Outstanding	OH&S REGULATIONS 3.7  AS/NZS 1657-2013 3.1.4
06	Building: General Stores Location Reference: <a href="#">L03</a> Task: Access to the roof

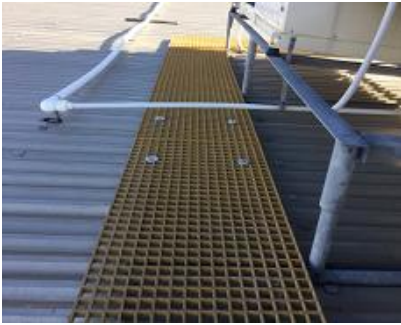
Pipe installed over the walkway path	Trips, Slips and Falls	Awareness induction	Med	Step bridge to be installed	Low	Client advised	Outstanding	OH&S REGULATIONS 3.7  AS/NZS 1657-2013 3.1.4
08	Building: General Stores Location Reference: <a href="#">L05</a> Task: Restrict access to the roof

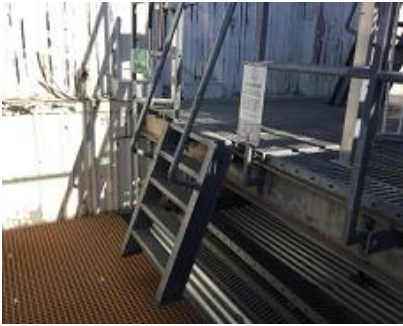
Un even treads are present	Trips, Slips and Falls	Awareness induction	Med	Existing ladder to be removed and new ladder to be installed	Low	Client advised	Outsta nding	OH&S REGULATIONS 3.7  AS/NZS 1657- 2013 7.3
10	Building: General Stores Location Reference: <a href="#">L06</a> Task: Access to the plant deck

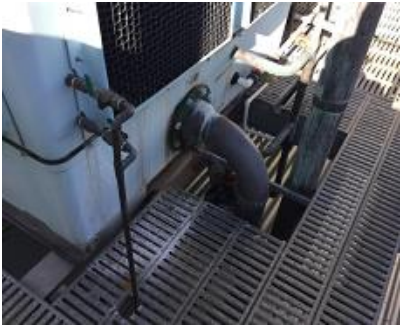
Gap between plant deck and permanent structure is greater than required maximum	Trips, Slips and Falls	Awareness induction	Med	Gap to be closed	Low	Client advised	Outstanding	OH&S REGULATIONS 3.7  AS/NZS 1657-2013 4.4
12	Building: General Stores Location Reference: <a href="#">L06</a> Task: Access to the plant deck

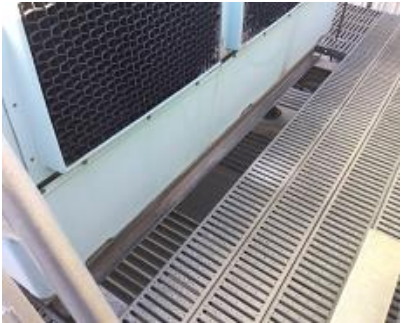
Gap between plant deck and permanent structure is greater than required maximum	Trips, Slips and Falls	Awareness induction	Med	Gap to be closed	Low	Client advised	Outstanding	OH&S REGULATIONS 3.7  AS/NZS 1657-2013 4.4

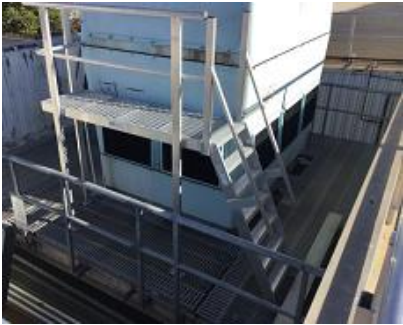
Non-complaint ladder is present	Trips, Slips and Falls	Awareness induction	Med	Existing ladder to be removed and new ladder to be installed	Low	Client advised	Outstanding	OH&S REGULATIONS 3.7  AS/NZS 1657-2013 7.3
14	Building: General Stores Location Reference: <a href="#">L06</a> Task: Access to the roof

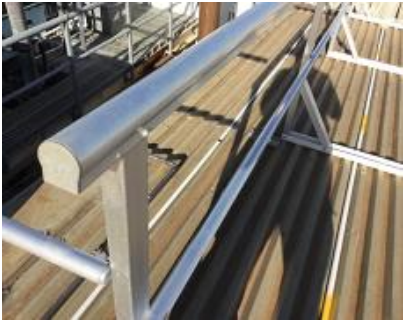
Sharp edges on handrails	Trips, Slips and Falls	Awareness induction	Med	Tek screws to be replaced with rivets	Low	Client advised	Outstanding	OH&S REGULATIONS 3.7  AS/NZS 1657-2013 5.6

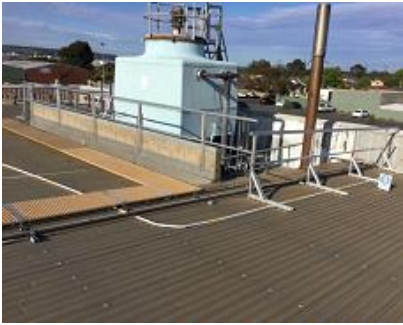
Handrail not fully secured	Trips, Slips and Falls	Awareness induction	Med	Additional handrail post to be installed	Low	Client advised	Outsta nding	OH&S REGULATIONS 3.7  AS/NZS 1657- 2013 4.4
16	Building: General Stores Location Reference: <a href="#">L06</a> Task: Access to the roof

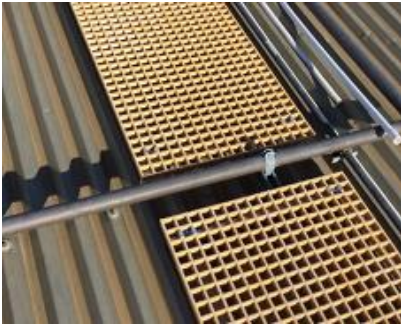
Pipe installed over the walkway path	Trips, Slips and Falls	Awareness induction	Med	Step bridge to be installed	Low	Client advised	Outstanding	OH&S REGULATIONS 3.7  AS/NZS 1657-2013 3.1.4
18	Building: General Stores Location Reference: <a href="#">L07</a> Task: Access to the roof

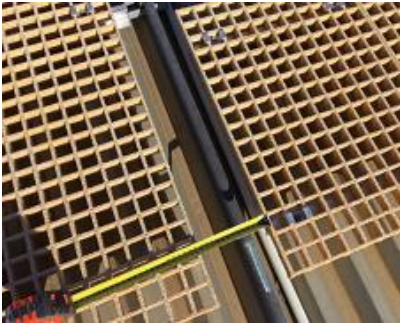
Gap between walkway panels are greater than required maximum	Trips, Slips and Falls	Awareness induction	Med	Additional walkway section to be installed	Low	Client advised	Outstanding	OH&S REGULATIONS 3.7  AS/NZS 1657-2013 3.2.3.4

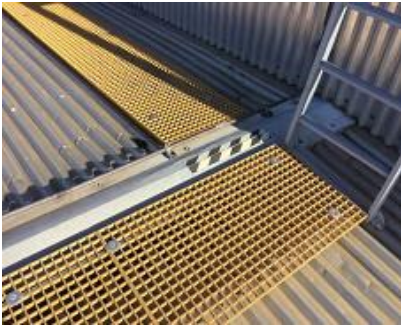
Gap between walkway panels are greater than required maximum	Trips, Slips and Falls	Awareness induction	Med	Additional walkway section to be installed	Low	Client advised	Outstanding	OH&S REGULATIONS 3.7  AS/NZS 1657-2013 3.2.3.4
20	Building: General Stores Location Reference: <a href="#">L08</a> Task: Access to the roof

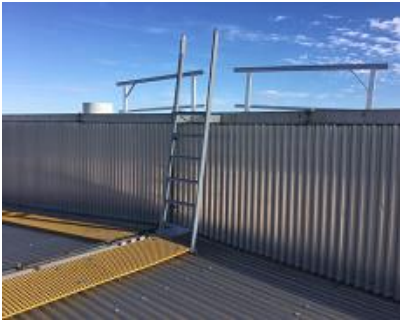
Non-complaint ladder is present	Trips, Slips and Falls	Awareness induction	Med	Existing ladder to be removed and new ladder to be installed	Low	Client advised	Outstanding	OH&S REGULATIONS 3.7  AS/NZS 1657-2013 7.3

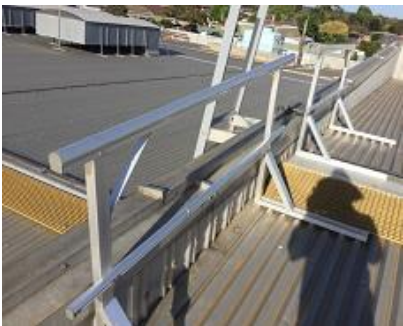
Sharp edges on handrails	Trips, Slips and Falls	Awareness induction	Med	Tek screws to be replaced with rivets	Low	Client advised	Outsta nding	OH&S REGULATIONS 3.7  AS/NZS 1657- 2013 5.6
22	Building: General Stores Location Reference: <a href="#">L08</a> Task: Access to the roof

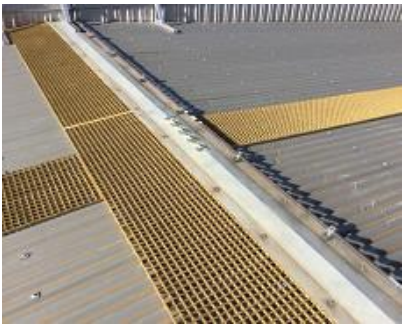
Gap between walkway panels are greater than required maximum	Trips, Slips and Falls	Awareness induction	Med	Additional walkway bridge to be installed	Low	Client advised	Outsta nding	OH&S REGULATIONS 3.7  AS/NZS 1657- 2013 3.2.3.4

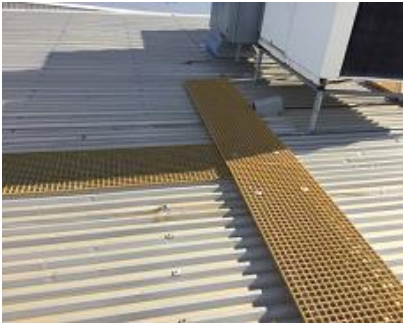
Variation in height between walkway panels are greater than required maximum	Trips, Slips and Falls	Awareness induction	Med	High visibility safety nosing to be installed	Low	Client advised	Outstanding	OH&S REGULATIONS 3.7  AS/NZS 1657-2013 3.3.4
26	Building: General Stores Location Reference: <a href="#">L09</a> Task: Access to the roof

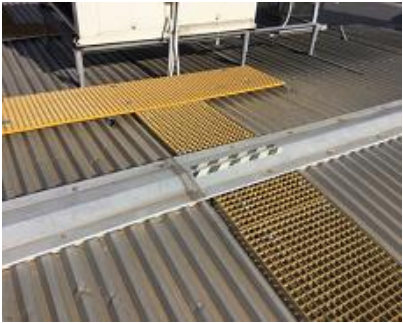
Gap between walkway panels are greater than required maximum	Trips, Slips and Falls	Awareness induction	Med	Additional walkway bridge to be installed	Low	Client advised	Outstanding	OH&S REGULATIONS 3.7  AS/NZS 1657-2013 3.2.3.4

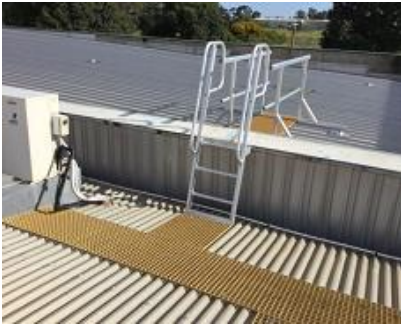
Non-complaint ladder is present	Trips, Slips and Falls	Awareness induction	Med	Existing ladder to be removed and new ladder to be installed	Low	Client advised	Outstanding	OH&S REGULATIONS 3.7  AS/NZS 1657-2013 7.3
28	Building: General Stores Location Reference: <a href="#">L10</a> Task: Access to the roof

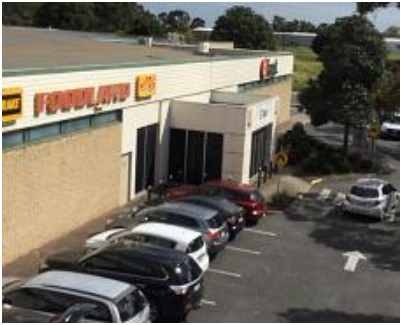
No height safety system installed (No serviceable items on roof)	Trips, Slips and Falls	Restrict Access	High	"EWP Access Only" sign to be installed	Low	Client advised	Outstanding	OH&S REGULATIONS 3.55 & 3.11
30	Building: General Stores Location Reference: <a href="#">L12</a> Task: Access to the roof

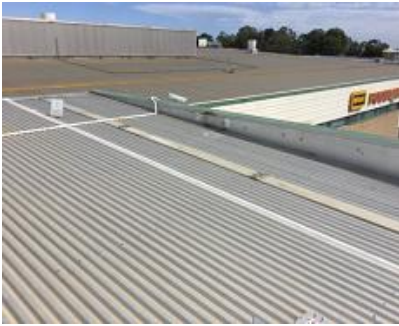
No height safety system installed	Trips, Slips and Falls	Awareness induction	High	Fall arrest anchors to be installed	Low	Client advised	Outstanding	OH&S REGULATIONS 3.55
32	Building: General Stores Location Reference: <a href="#">L13</a> Task: Restrict access to the roof

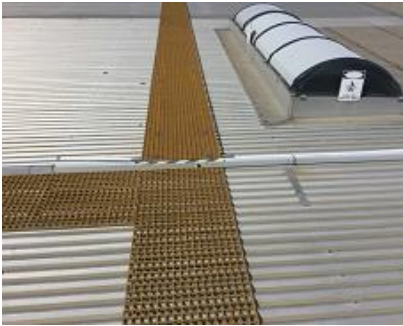
Variation in height between walkway panels are greater than required maximum	Trips, Slips and Falls	Awareness induction	Med	High visibility safety nosing to be installed	Low	Client advised	Outstanding	OH&S REGULATIONS 3.7  AS/NZS 1657-2013 3.3.4
34	Building: General Stores Location Reference: <a href="#">L14</a> Task: Access to the roof

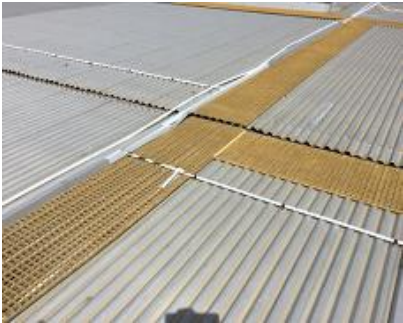
Pipe installed over the walkway path	Trips, Slips and Falls	Awareness induction	Med	Step bridge to be installed	Low	Client advised	Outstanding	OH&S REGULATIONS 3.7  AS/NZS 1657-2013 3.1.4

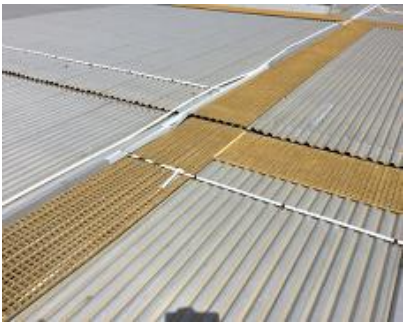
Variation in height between walkway panels are greater than required maximum	Trips, Slips and Falls	Awareness induction	Med	High visibility safety nosing to be installed	Low	Client advised	Outstanding	OH&S REGULATIONS 3.7  AS/NZS 1657-2013 3.3.4
36	Building: General Stores Location Reference: <a href="#">L14</a> Task: Access to the roof

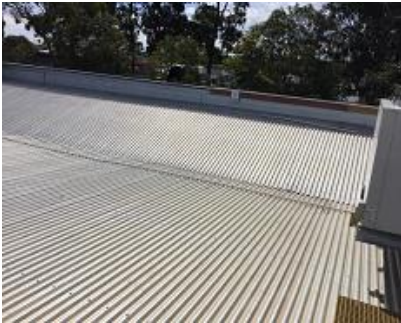
No height safety system installed	Trips, Slips and Falls	Awareness induction	High	Fall arrest anchors to be installed	Low	Client advised	Outstanding	OH&S REGULATIONS 3.55
40	Building: General Stores Location Reference: <a href="#">L15</a> Task: Access to the roof

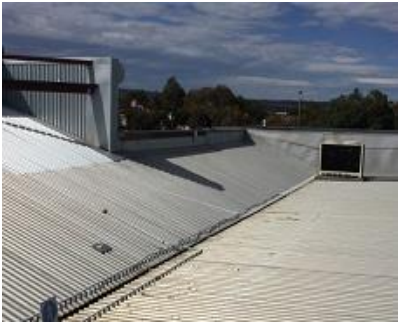
No height safety system installed	Trips, Slips and Falls	Awareness induction	High	Fall arrest anchors to be installed	Low	Client advised	Outstanding	OH&S REGULATIONS 3.55

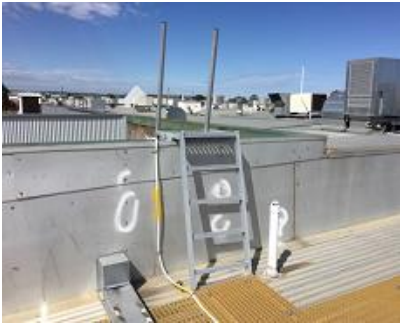
Top rung not levelled with landing and bottom rung height is less than required minimum	Trips, Slips and Falls	Awareness induction	Med	Existing ladder to be re-installed with landing platforms, brackets and preformed handrails	Low	Client advised	Outstanding	OH&S REGULATIONS 3.7  AS/NZS 1657-2013 7.4.3.3 & 7.4.3.4
42	Building: General Stores Location Reference: <a href="#">L16</a> Task: Access to the roof

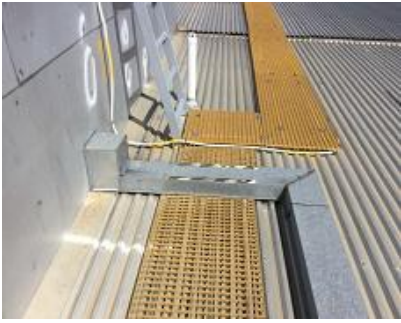
Pipe installed over the walkway path	Trips, Slips and Falls	Awareness induction	Med	Step bridge to be installed	Low	Client advised	Outstanding	OH&S REGULATIONS 3.7  AS/NZS 1657-2013 3.1.4

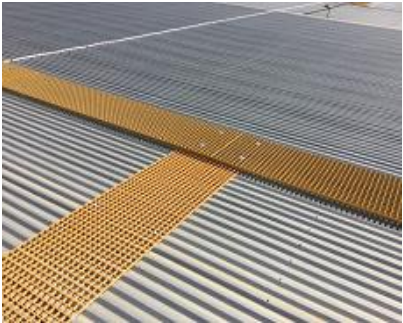
Variation in height between walkway panels are greater than required maximum	Trips, Slips and Falls	Awareness induction	Med	High visibility safety nosing to be installed	Low	Client advised	Outstanding	OH&S REGULATIONS 3.7  AS/NZS 1657-2013 3.3.4

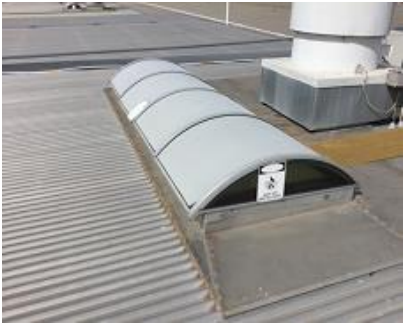
Existing signs are faded	Trips, Slips and Falls	Awareness induction	Med	Existing signs to be replaced with new signs	Low	Client advised	Outstanding	OH&S REGULATIONS 3.11
48	Building: General Stores Location Reference: <a href="#">L18</a> Task: Access to the roof

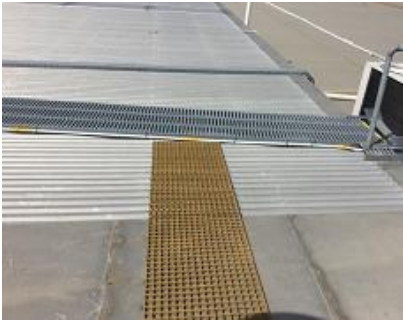
Variation in height between walkway panels are greater than required maximum	Trips, Slips and Falls	Awareness induction	Med	High visibility safety nosing to be installed	Low	Client advised	Outstanding	OH&S REGULATIONS 3.7  AS/NZS 1657-2013 3.3.4

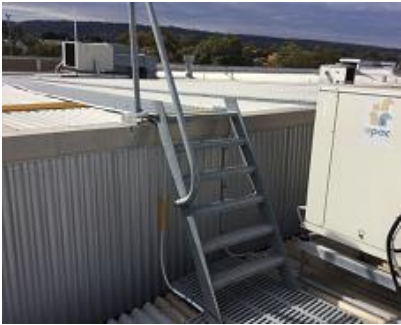
Non-complaint ladder is present	Trips, Slips and Falls	Awareness induction	Med	Existing ladder to be removed and new ladder to be installed	Low	Client advised	Outstanding	OH&S REGULATIONS 3.7  AS/NZS 1657-2013 7.3
50	Building: General Stores Location Reference: <a href="#">L18</a> Task: Access to the roof

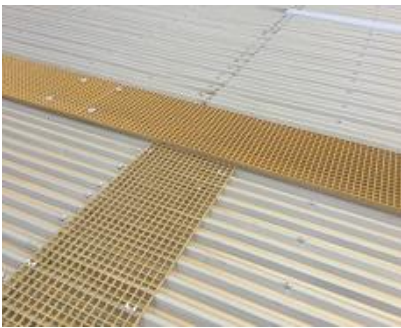
Variation in height between walkway panels are greater than required maximum	Trips, Slips and Falls	Awareness induction	Med	High visibility safety nosing to be installed	Low	Client advised	Outstanding	OH&S REGULATIONS 3.7  AS/NZS 1657-2013 3.3.4
54	Building: General Stores Location Reference: <a href="#">L19</a> Task: Access to the roof

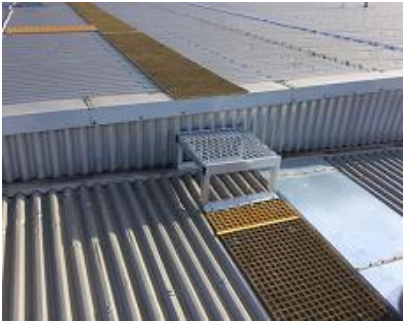
Non-complaint step is present	Trips, Slips and Falls	Awareness induction	Med	Existing step to be removed and new ladder to be installed	Low	Client advised	Outstanding	OH&S REGULATIONS 3.7  AS/NZS 1657-2013 7.2
60	Building: General Stores Location Reference: <a href="#">L22</a> Task: Access to the roof

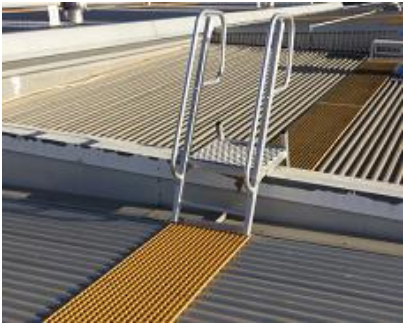
Top rung not levelled with landing, bottom rung height is less than required minimum and handrails projecting towards the user	Trips, Slips and Falls	Awareness induction	Med	Existing ladder to be re-installed with landing platforms, brackets and handrails	Low	Client advised	Outstanding	OH&S REGULATIONS 3.7  AS/NZS 1657-2013 7.4.3.3, 7.4.3.4 & 7.4.8.5

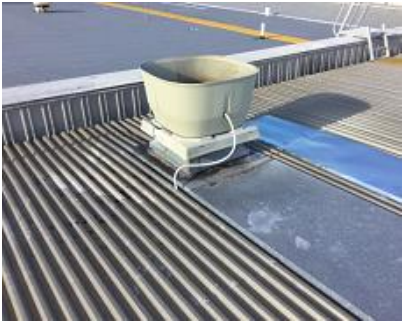
No safe access to the A/c units	Trips, Slips and Falls	N/A	Low	Supply walkway and handrails to the A/c units	Low	Client advised	Outstanding	-
62	Building: General Stores Location Reference: <a href="#">L23</a> Task: Restrict access to the roof

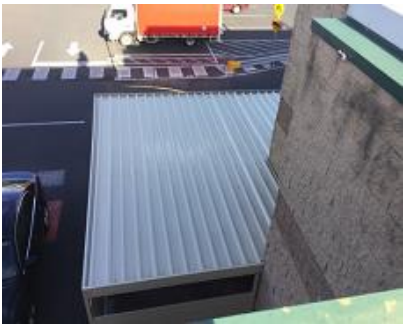
No height safety system installed	Trips, Slips and Falls	Restrict Access	High	"EWP Access Only" signs to be installed	Low	Client advised	Outstanding	OH&S REGULATIONS 3.55 & 3.11

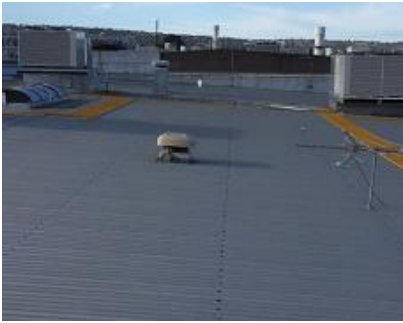
No safe access to the A/c units	Trips, Slips and Falls	N/A	Low	Supply walkway to the A/c units	Low	Client advised	Outstanding	-
64	Building: General Stores Location Reference: <a href="#">L25</a> Task: Access to the roof

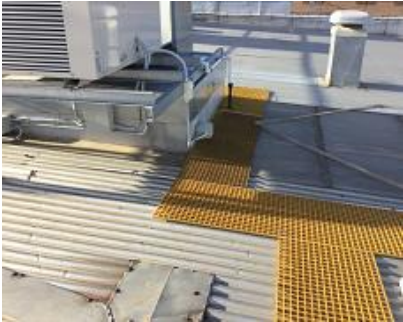
Units protrudes over the walkway path	Trips, Slips and Falls	Awareness induction	Med	Additional walkway sections to be installed	Low	Client advised	Outstanding	OH&S REGULATIONS 3.7  AS/NZS 1657-2013 3.1.4

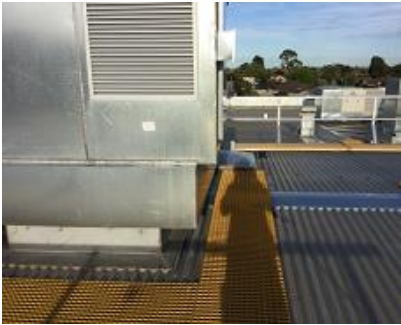
A/c unit protrudes over the walkway path	Trips, Slips and Falls	Awareness induction	Med	Additional walkway sections to be installed	Low	Client advised	Outstanding	OH&S REGULATIONS 3.7  AS/NZS 1657-2013 3.1.4
72	Building: General Stores Location Reference: <a href="#">L26</a> Task: Access to the roof

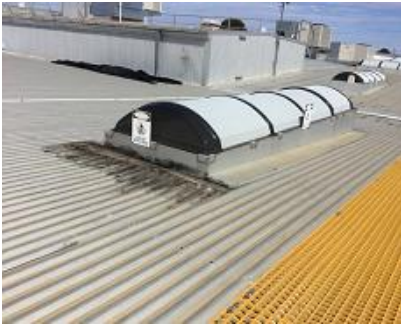
Existing signs are faded	Trips, Slips and Falls	Awareness induction	Med	Existing signs to be replaced with new signs	Low	Client advised	Outstanding	OH&S REGULATIONS 3.11
76	Building: General Stores Location Reference: <a href="#">L27</a> Task: Access to the roof

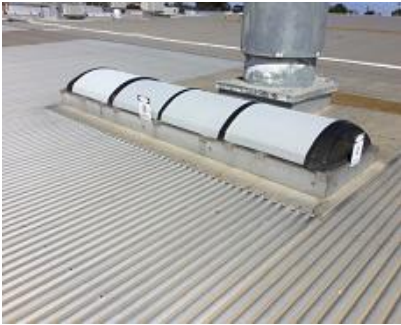
Existing signs are faded	Trips, Slips and Falls	Awareness induction	Med	Existing signs to be replaced with new signs	Low	Client advised	Outstanding	OH&S REGULATIONS 3.11
84	Building: General Stores Location Reference: <a href="#">L30</a> Task: Access to the roof

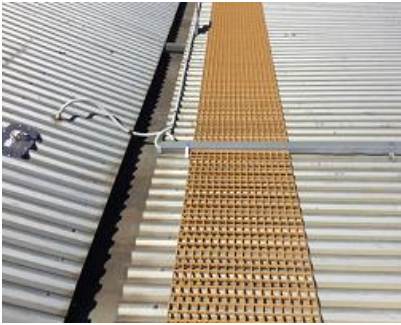
Pipe installed over the walkway path	Trips, Slips and Falls	Awareness induction	Med	Step bridge to be installed	Low	Client advised	Outstanding	OH&S REGULATIONS 3.7  AS/NZS 1657-2013 3.1.4
88	Building: General Stores Location Reference: <a href="#">L31</a> Task: Access to the roof

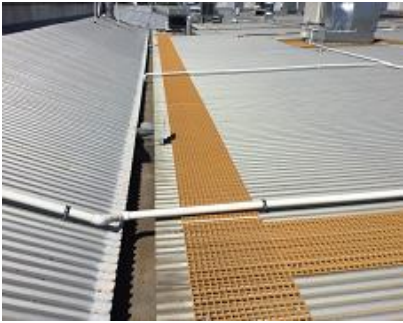
Pipe installed over the walkway path	Trips, Slips and Falls	Awareness induction	Med	Step bridges to be installed	Low	Client advised	Outstanding	OH&S REGULATIONS 3.7  AS/NZS 1657-2013 3.1.4
90	Building: General Stores Location Reference: <a href="#">L31</a> Task: Access to the roof

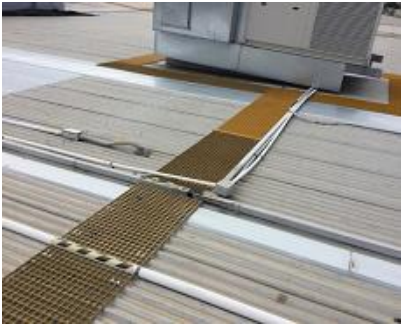
Pipe installed over the walkway path	Trips, Slips and Falls	Awareness induction	Med	Step bridges to be installed	Low	Client advised	Outstanding	OH&S REGULATIONS 3.7  AS/NZS 1657-2013 3.1.4
94	Building: General Stores Location Reference: <a href="#">L32</a> Task: Access to the roof

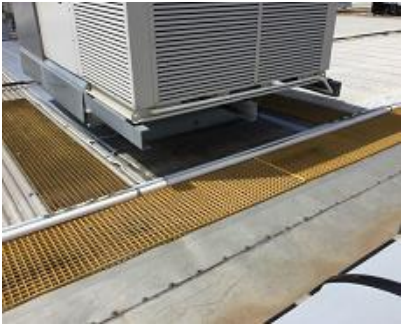
Pipe installed over the walkway path	Trips, Slips and Falls	Awareness induction	Med	Step bridge to be installed	Low	Client advised	Outstanding	OH&S REGULATIONS 3.7  AS/NZS 1657-2013 3.1.4
96	Building: General Stores Location Reference: <a href="#">L33</a> Task: Access to the roof

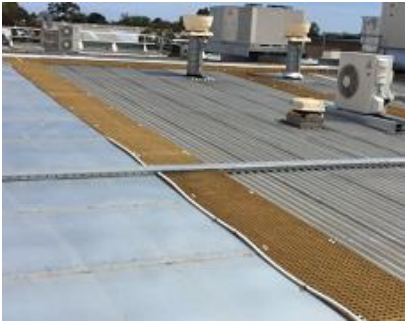
Pipe installed over the walkway path	Trips, Slips and Falls	Awareness induction	Med	Step bridge to be installed	Low	Client advised	Outstanding	OH&S REGULATIONS 3.7  AS/NZS 1657-2013 3.1.4
102	Building: General Stores Location Reference: <a href="#">L34</a> Task: Access to the roof

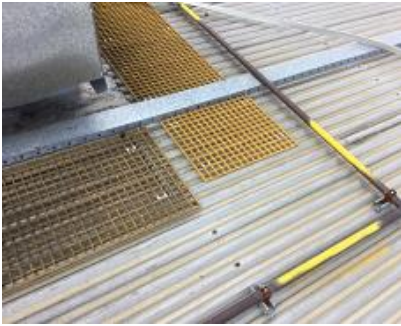
Pipe installed over the walkway path	Trips, Slips and Falls	Awareness induction	Med	Step bridge and additional walkway section to be installed	Low	Client advised	Outstanding	OH&S REGULATIONS 3.7  AS/NZS 1657-2013 3.1.4
104	Building: General Stores Location Reference: <a href="#">L34</a> Task: Access to the roof

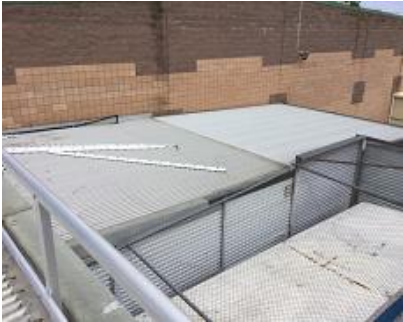
No height safety system installed	Trips, Slips and Falls	Restrict Access	High	"EWP Access Only" signs to be installed	Low	Client advised	Outstanding	OH&S REGULATIONS 3.55 & 3.11

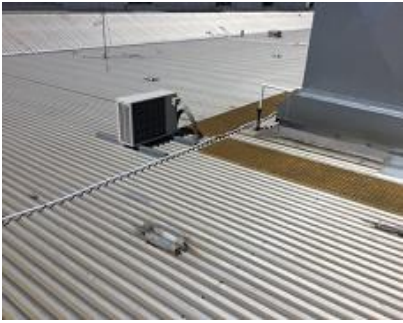
No safe access to the A/c units	Trips, Slips and Falls	N/A	Low	Supply walkway to the A/c units	Low	Client advised	Outstanding	-
