Roof Safety Report

**Chadstone Shopping Centre,
VIC 3148**

Prepared By: Safemaster Safety Products
Date: 20 April 2018

Roof Safety Report for
Chadstone Shopping Centre, VIC 3148

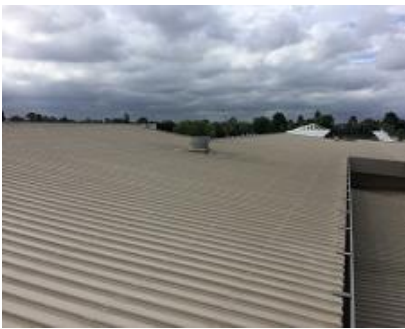
No height safety system installed	Trips, Slips and Falls	Awareness induction	High	Fall arrest anchors to be installed	Low	Client advised	Outstanding	OH&S REGULATIONS 3.55
06	Building: General Stores Location Reference: L03 Task: Access to the A/c units

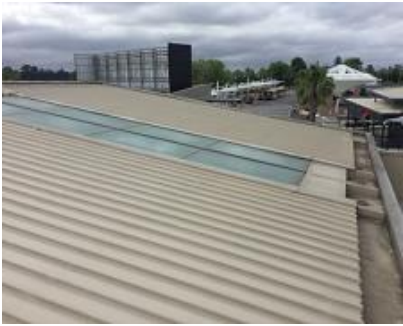
No height safety system installed	Trips, Slips and Falls	Awareness induction	High	Fall arrest anchors to be installed	Low	Client advised	Outstanding	OH&S REGULATIONS 3.55
08	Building: General Stores Location Reference: L05 Task: Restrict access to the roof

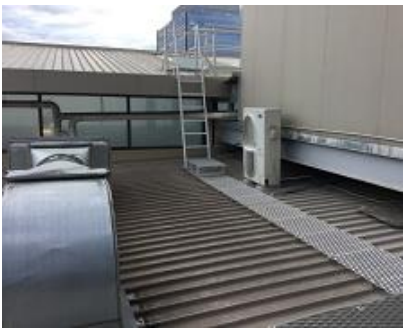
Variation in height between walkway panels are greater than required maximum	Trips, Slips and Falls	Awareness induction	Med	High visibility safety yellow nosing to be installed	Low	Client advised	Outstanding	OH&S REGULATIONS 3.7 AS/NZS 1657-2013 3.3.4
10	Building: General Stores Location Reference: L07 Task: Access to the roof

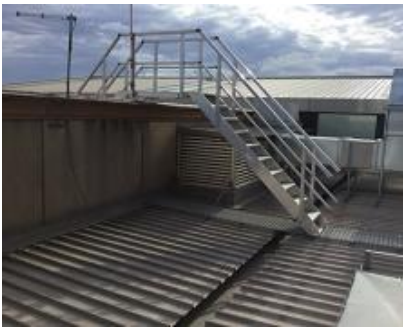
Landing is less than required minimum	Trips, Slips and Falls	Awareness induction	Med	Additional walkway sections to be installed	Low	Client advised	Outstanding	OH&S REGULATIONS 3.7 AS/NZS 1657-2013 7.2.4
12	Building: General Stores Location Reference: L09 Task: Access to the A/c units

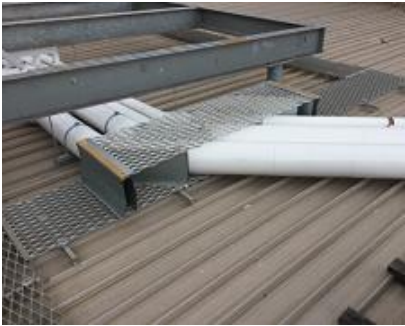
Variation in height between walkway and adjacent surface is greater than required maximum	Trips, Slips and Falls	Awareness induction	Med	Handrail to be installed	Low	Client advised	Outstanding	OH&S REGULATIONS 3.7 AS/NZS 1657-2013 4.4
24	Building: General Stores Location Reference: L13 Task: Restrict access to the roof

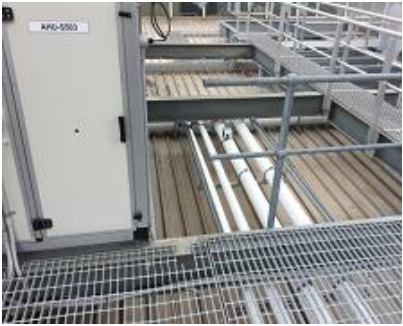
Handrail section is missing	Trips, Slips and Falls	Awareness induction	Med	Handrail to be installed	Low	Client advised	Outstanding	OH&S REGULATIONS 3.7 AS/NZS 1657-2013 4.4
30	Building: General Stores Location Reference: L15 Task: Access to the plant deck

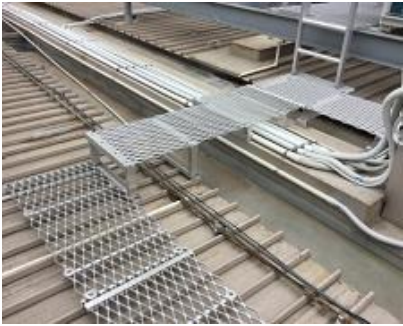
Variation in height between walkway and adjacent surface is greater than required maximum	Trips, Slips and Falls	Awareness induction	Med	Handrail to be installed	Low	Client advised	Outstanding	OH&S REGULATIONS 3.7 AS/NZS 1657-2013 4.4
34	Building: General Stores Location Reference: L18 Task: Access to the roof

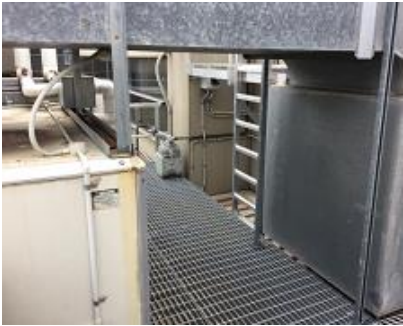
Headroom is less than required minimum	Trips, Slips and Falls	Awareness induction	Med	"Caution low head room" signs to be installed	Low	Client advised	Outstanding	OH&S REGULATIONS 3.7 AS/NZS 1657-2013 3.1.5
38	Building: General Stores Location Reference: L19 Task: Access to the roof

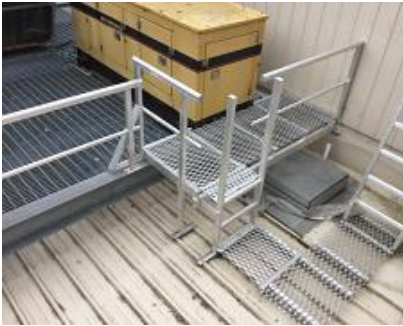
Handrail section is missing	Trips, Slips and Falls	Awareness induction	Med	Handrail to be installed	Low	Client advised	Outsta nding	OH&S REGULATIONS 3.7 AS/NZS 1657- 2013 4.4
44	Building: General Stores Location Reference: L22 Task: Access to the roof

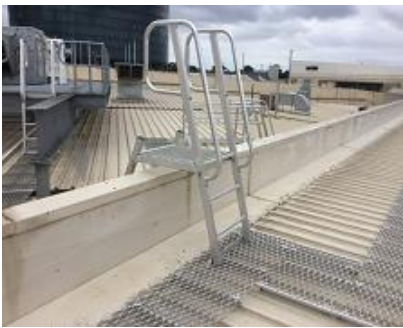
Bottom rung heights are less than required minimum and handrails projecting the user	Trips, Slips and Falls	Awareness induction	Med	Existing handrail to be removed. Existing ladder to be re-installed with landing platforms, brackets and handrails	Low	Client advised	Outstanding	OH&S REGULATIONS 3.7 AS/NZS 1657-2013 7.4.3.4 & 7.4.8.5
48	Building: General Stores Location Reference: L25 Task: Access to the roof

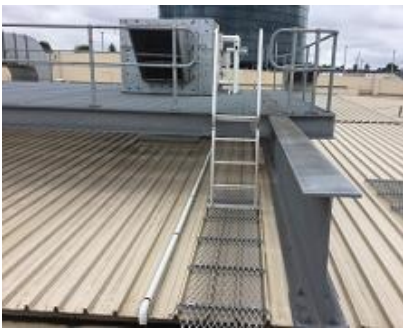
Top rung not levelled with landing and handrails projecting towards the user	Trips, Slips and Falls	Awareness induction	Med	Existing handrail to be removed. Existing ladder to be re-installed with landing platforms, brackets and handrails	Low	Client advised	Outstanding	OH&S REGULATIONS 3.7 AS/NZS 1657-2013 7.4.3.3 & 7.4.8.5
50	Building: General Stores Location Reference: L26 Task: Access to the plant deck

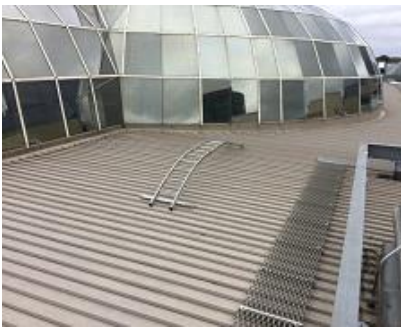
Non-complaint ladder is present	Trips, Slips and Falls	Awareness induction	Med	Further investigation required with Centre Management and Window cleaners to propose permanent solution	Low	Client advised	Outstanding	OH&S REGULATIONS 3.7 AS/NZS 1657-2013 3.1.4
58	Building: General Stores Location Reference: L29 Task: Access to the plant deck

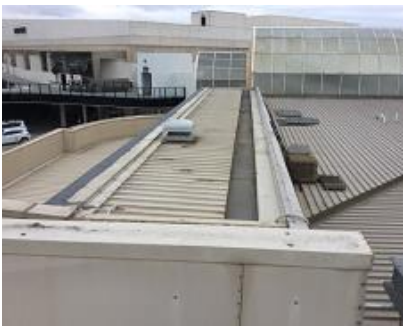
No height safety system installed	Trips, Slips and Falls	Awareness induction	High	Fall arrest anchors to be installed	Low	Client advised	Outstanding	OH&S REGULATIONS 3.55
74	Building: General Stores Location Reference: L34 Task: Access to the roof

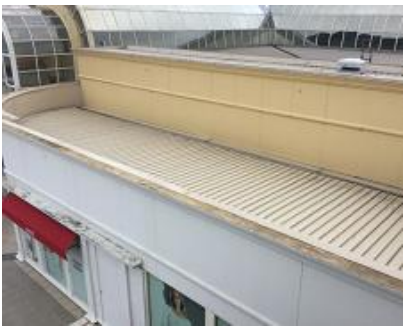
Variation in height between roofs are greater than required maximum	Trips, Slips and Falls	Awareness induction	Med	Access ladder to be installed	Low	Client advised	Outstanding	OH&S REGULATIONS 3.7 AS/NZS 1657-2013 3.1.4
76	Building: General Stores Location Reference: L35 Task: Access to the roof

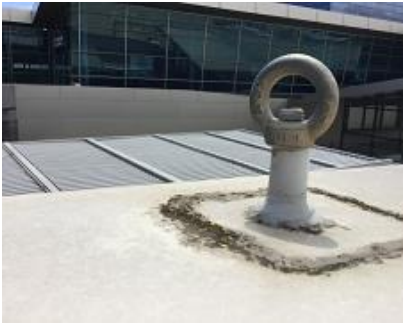
Non-complaint concrete anchors are present	Trips, Slips and Falls	Awareness induction	High	Existing anchors to be removed and new anchors to be installed	Low	Client advised	Outstanding	OH&S REGULATIONS 3.55
80	Building: General Stores Location Reference: L38 Task: Access to the roof

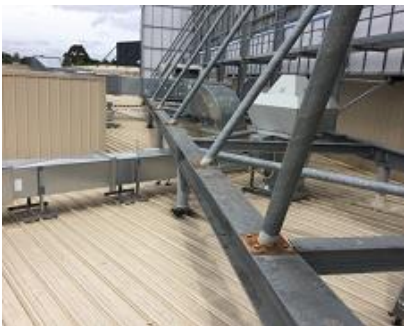
Head room is less than required minimum and no safe access to the A/c units	Trips, Slips and Falls	Awareness induction	Med	"Caution-Low headroom" signs and walkway to be installed	Low	Client advised	Outstanding	OH&S REGULATIONS 3.7 AS/NZS 1657-2013 3.1.5
82	Building: General Stores Location Reference: L38 Task: Access to the roof

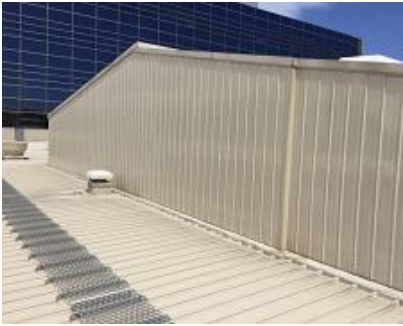
No height safety system installed	Trips, Slips and Falls	Awareness induction	High	Fall arrest anchors, anchor stop, walkway and ladder to be installed	Low	Client advised	Outstanding	OH&S REGULATIONS 3.55
104	Building: General Stores Location Reference: L51 Task: Access to the roof

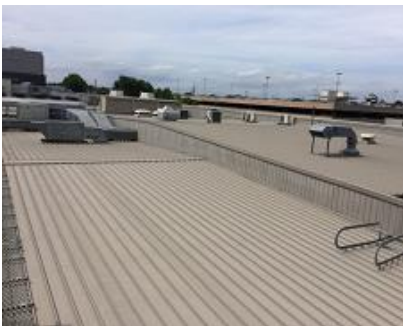
Variation in height between roofs are greater than required maximum	Trips, Slips and Falls	Awareness induction	Med	Access ladder to be installed	Low	Client advised	Outstanding	OH&S REGULATIONS 3.7 AS/NZS 1657-2013 3.1.4
110	Building: General Stores Location Reference: L54 Task: Access to the A/c units

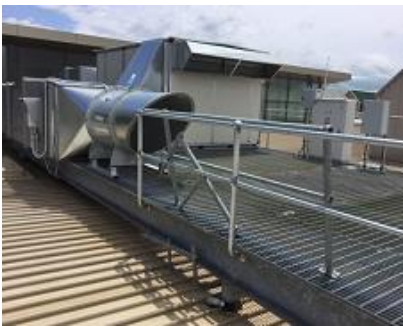
No safe access to the A/c units	Trips, Slips and Falls	N/A	Low	Supply walkway to the A/c units	Low	Client advised	Outstanding	-
122	Building: General Stores Location Reference: L56 Task: Access to the plant deck

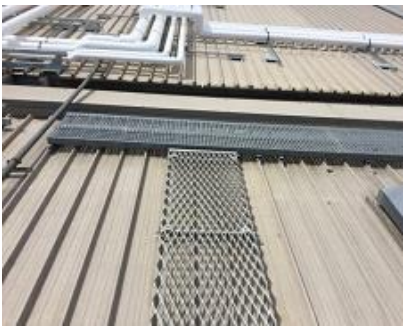
Variation in height between walkway panels is greater than required maximum	Trips, Slips and Falls	Awareness induction	Med	High visibility safety yellow nosing to be installed	Low	Client advised	Outstanding	OH&S REGULATIONS 3.7 AS/NZS 1657-2013 3.3.4
126	Building: General Stores Location Reference: L57 Task: Access to the plant deck

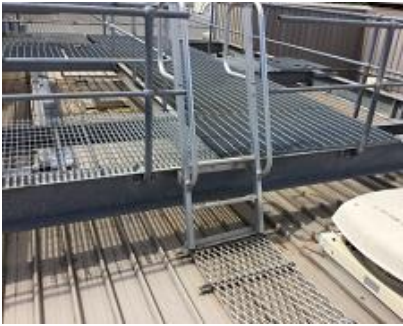
Top rung not levelled with landing and handrail projecting towards the user	Trips, Slips and Falls	Awareness induction	Med	Existing handrail to be removed. Existing ladder to be re-installed with landing platform, bracket and handrails	Low	Client advised	Outstanding	OH&S REGULATIONS 3.7 AS/NZS 1657-2013 7.4.3.3 & 7.4.8.5
146	Building: General Stores Location Reference: L59 Task: Access to the roof

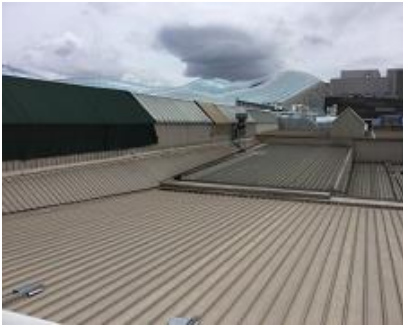
No safe access to the A/c units	Trips, Slips and Falls	N/A	Low	Supply walkway to the A/c units	Low	Client advised	Outstanding	-
150	Building: General Stores Location Reference: L62 Task: Access to the roof

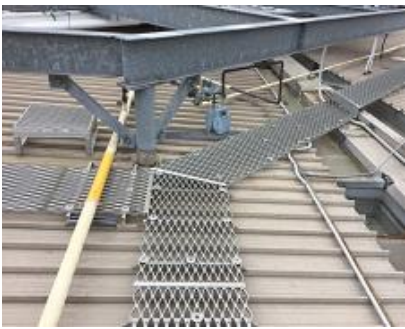
Pipe installed over the walkway path	Trips, Slips and Falls	Awareness induction	Med	Step over to be installed	Low	Client advised	Outstanding	OH&S REGULATIONS 3.7 AS/NZS 1657-2013 3.1.4
154	Building: General Stores Location Reference: L63 Task: Access to the plant deck

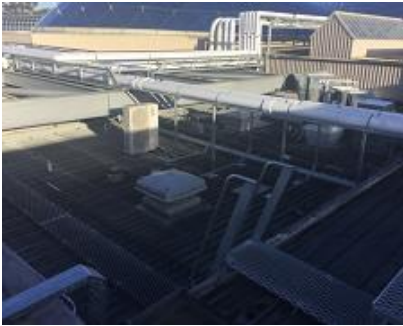
No safe access to the A/c units	Trips, Slips and Falls	N/A	Low	Supply walkway to the A/c units	Low	Client advised	Outstanding	-
162	Building: General Stores Location Reference: L64 Task: Access to the A/c units

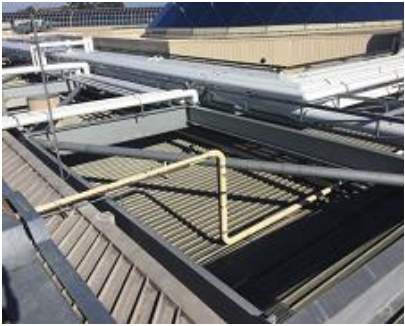
Headroom is less than required minimum	Trips, Slips and Falls	Awareness induction	High	"Caution-Low Headroom" signs to be installed	Low	Client advised	Outstanding	OH&S REGULATIONS 3.7 AS/NZS 1657-2013 3.1.5
164	Building: General Stores Location Reference: L65 Task: Access to the roof

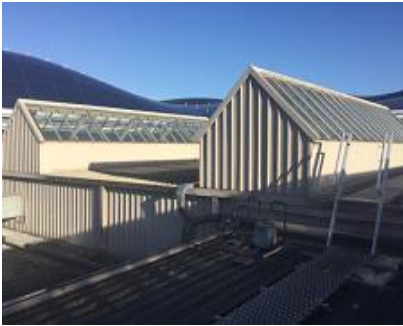
Brittle roof (Non-trafficable roof)	Trips, Slips and Falls	Restrict Access	High	"Warning-Keep Off-Brittle and Fragile Roof" signs to be installed	Low	Client advised	Outstanding	OH&S REGULATIONS 3.57
166	Building: General Stores Location Reference: L66 Task: Access to the plant deck

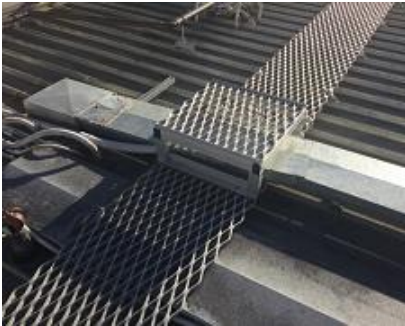
Variation in height between landing and adjacent surface is greater than required maximum	Trips, Slips and Falls	Awareness induction	Med	Handrail to be installed	Low	Client advised	Outstanding	OH&S REGULATIONS 3.7 AS/NZS 1657-2013 4.4
172	Building: General Stores Location Reference: L68 Task: Access to the A/c units

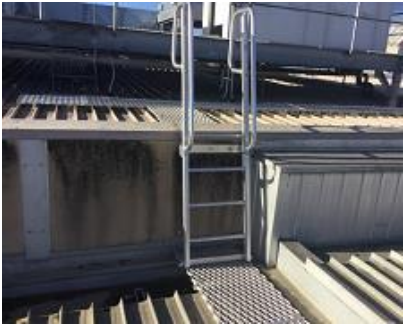
Bottom rung height is less than required minimum, landing is less than required minimum and handrail projecting towards the user	Trips, Slips and Falls	Awareness induction	Med	Existing handrail to be removed. Existing ladder to be re-installed with landing platforms, brackets and handrail	Low	Client advised	Outstanding	OH&S REGULATIONS 3.7 AS/NZS 1657-2013 7.4.3.4, 7.3.6 & 7.4.8.5
174	Building: General Stores Location Reference: L70 Task: Access to the roof

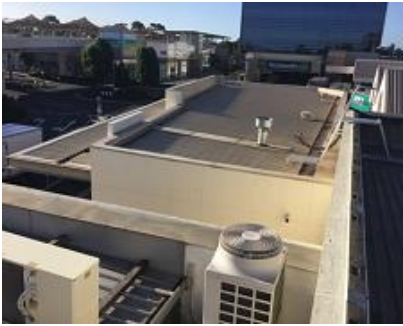
No safe access to the A/c units	Trips, Slips and Falls	N/A	Low	Supply walkway and handrail to the A/c units	Low	Client advised	Outstanding	-
178	Building: General Stores Location Reference: L71 Task: Access to the roof

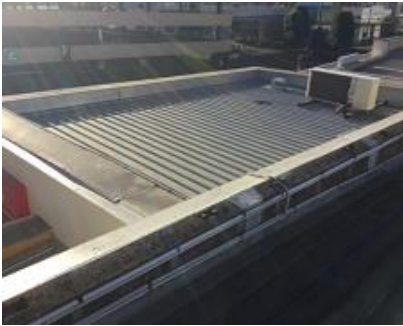
No height safety system installed	Trips, Slips and Falls	Awareness induction	High	Fall arrest anchors, Anchor stop and access ladder to be installed	Low	Client advised	Outstanding	OH&S REGULATIONS 3.7 & 3.55 AS/NZS 1657-2013 3.1.4
180	Building: General Stores Location Reference: L71 Task: Access to the A/c units

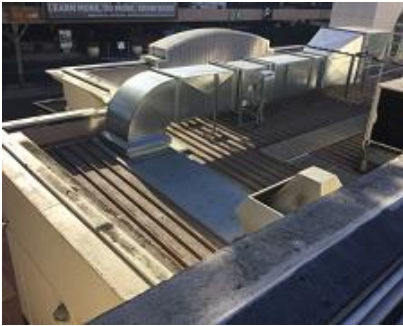
No height safety system installed	Trips, Slips and Falls	Awareness induction	High	Fall arrest anchors to be installed	Low	Client advised	Outstanding	OH&S REGULATIONS 3.55
184	Building: General Stores Location Reference: L74 Task: Access to the roof

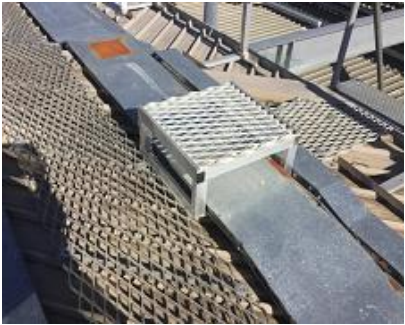
Variation in height between landing and roof is greater than required maximum	Trips, Slips and Falls	Awareness induction	Med	Handrail to be installed or Existing step to be modified and re-installed	Low	Client advised	Outstanding	OH&S REGULATIONS 3.7 AS/NZS 1657-2013 4.4
188	Building: General Stores Location Reference: L75 Task: Access to the roof

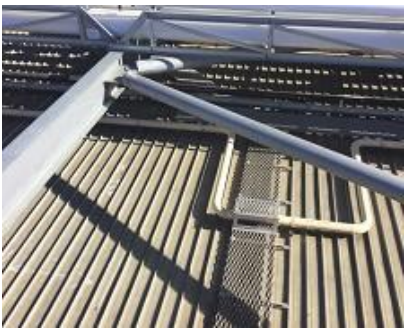
Variation in height between landing and roof is greater than required maximum and headroom is less than required minimum	Trips, Slips and Falls	Awareness induction	Med	Handrail to be installed or Existing step to be modified and re-installed with "Caution-Low Headroom" signs	Low	Client advised	Outstanding	OH&S REGULATIONS 3.7 AS/NZS 1657-2013 4.4 & 3.1.5
190	Building: General Stores Location Reference: L75 Task: Access to the roof

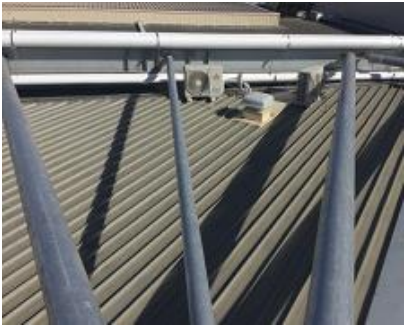
No safe access to the A/c units	Trips, Slips and Falls	N/A	Low	Supply walkway, Access ladders, step bridges and handrails	Low	Client advised	Outstanding	-
192	Building: General Stores Location Reference: L77 Task: Access to the plant deck

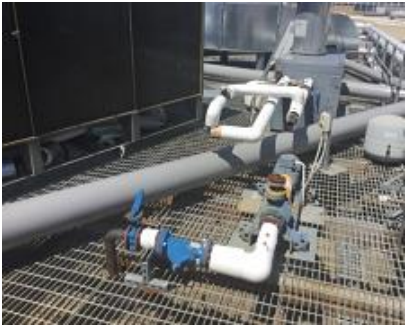
Pipes installed over the plant deck	Trips, Slips and Falls	Awareness induction	Med	High visibility safety yellow tape to be installed	Low	Client advised	Outstanding	OH&S REGULATIONS 3.7 AS/NZS 1657-2013 3.1.4
194	Building: General Stores Location Reference: L77 Task: Access to the plant deck

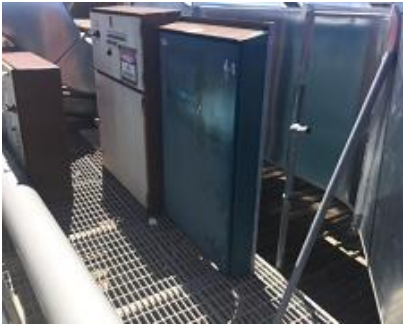
Variation in height between plant deck and roof is greater than required maximum	Trips, Slips and Falls	Awareness induction	Med	Handrail to be installed or gap to be closed	Low	Client advised	Outstanding	OH&S REGULATIONS 3.7 AS/NZS 1657-2013 4.4
196	Building: General Stores Location Reference: L78 Task: Access to the A/c units

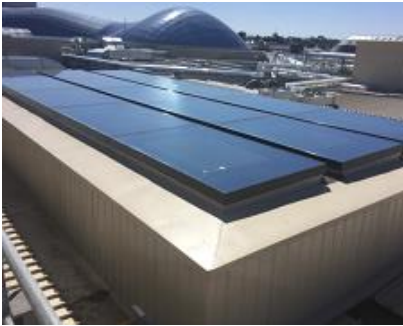
Brittle roof (Non-trafficable roof)	Trips, Slips and Falls	Restrict Access	High	"Warning-Keep Off-Brittle and Fragile Roof" signs to be installed	Low	Client advised	Outstanding	OH&S REGULATIONS 3.57
20 6	Building: General Stores Location Reference: L83 Task: Access to the A/c units

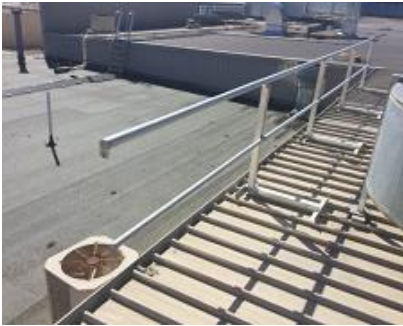
Handrail not fully secured	Trips, Slips and Falls	Awareness induction	Med	Additional handrail post to be installed	Low	Client advised	Outsta nding	OH&S REGULATIONS 3.7 AS/NZS 1657- 2013 4.4
20 8	Building: General Stores Location Reference: L85 Task: Access to the roof

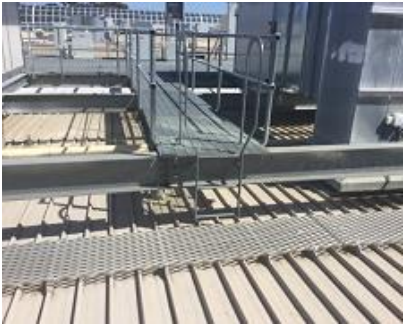
No slip resistance on rungs and landing is less than required minimum	Trips, Slips and Falls	Awareness induction	Med	Existing ladder to be removed and new ladder to be installed	Low	Client advised	Outstanding	OH&S REGULATIONS 3.7 AS/NZS 1657-2013 7.4.3.1 & 7.3.6
222	Building: General Stores Location Reference: L90 Task: Access to the plant deck

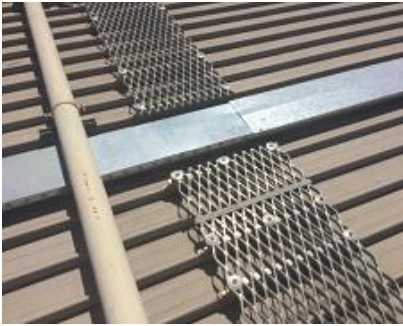
Cable tray installed over the walkway path	Trips, Slips and Falls	Awareness induction	Med	Step bridge to be installed	Low	Client advised	Outstanding	OH&S REGULATIONS 3.7 AS/NZS 1657-2013 3.1.4 & 3.2.3.4
22 4	Building: General Stores Location Reference: L91 Task: Restrict access to the roof

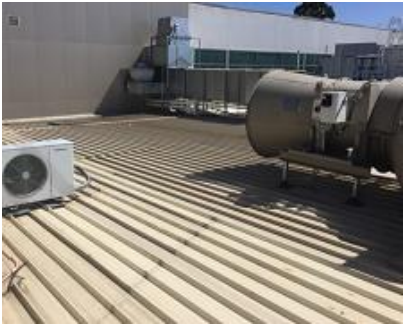
No safe access to the A/c units	Trips, Slips and Falls	N/A	Low	Supply walkway and handrail to the A/c units	Low	Client advised	Outstanding	-
22 6	Building: General Stores Location Reference: L92 Task: Access to the plant deck

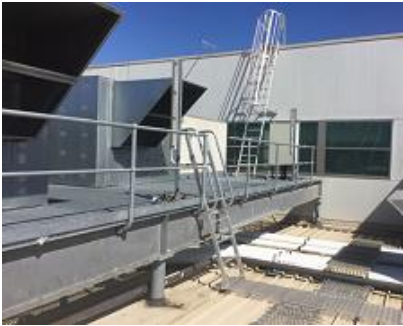
Clearance behind the ladder is less than required minimum, bottom rung heights are less than required minimum and handrail projecting towards the user	Trips, Slips and Falls	Awareness induction	Med	Existing handrail to be removed. Existing ladder to be re-installed with landing platforms, brackets and handrails	Low	Client advised	Outstanding	OH&S REGULATIONS 3.7 AS/NZS 1657-2013 7.4.5, 7.4.3.4 & 7.4.8.5
23 0	Building: General Stores Location Reference: L92 Task: Access to the roof

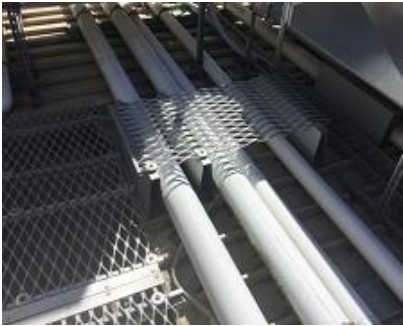
Variation in height between landing and roof is greater than required maximum	Trips, Slips and Falls	Awareness induction	Med	Handrail to be installed	Low	Client advised	Outstanding	OH&S REGULATIONS 3.7 AS/NZS 1657-2013 4.4
232	Building: General Stores Location Reference: L93 Task: Access to the roof

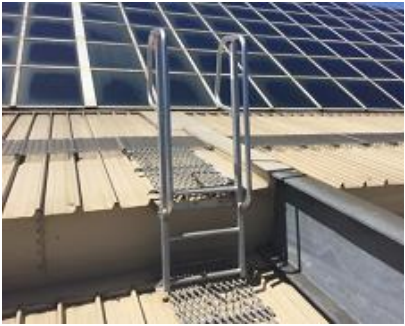
Top rung not levelled with landing, bottom rung height is less than required minimum and handrail projecting towards the user	Trips, Slips and Falls	Awareness induction	Med	Existing ladder to be removed and new ladder to be installed	Low	Client advised	Outstanding	OH&S REGULATIONS 3.7 AS/NZS 1657-2013 7.4.3.3, 7.4.3.4 & 7.4.8.5
242	Building: General Stores Location Reference: L97 Task: Access to the roof

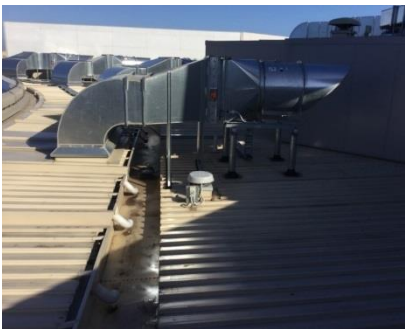
No safe access to the A/c units	Trips, Slips and Falls	N/A	Low	Supply walkway, step overs and handrail to the A/c units	Low	Client advised	Outstanding	-
28 6	Building: General Stores Location Reference: L112 Task: Access to the plant deck

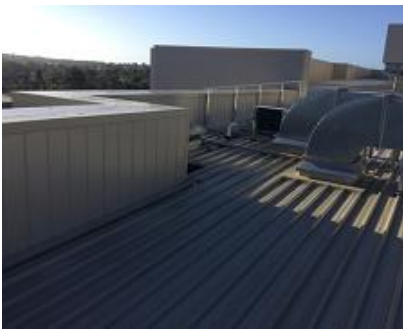
No safe access to the A/c units	Trips, Slips and Falls	N/A	Low	Supply walkway to the A/c units	Low	Client advised	Outstanding	-
29 6	Building: General Stores Location Reference: L116 Task: Access to the A/c units

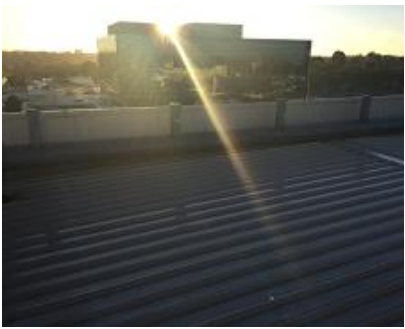
No height safety system installed	Trips, Slips and Falls	Awareness induction	High	Fall arrest anchors to be installed	Low	Client advised	Outstanding	OH&S REGULATIONS 3.55
33 8	Building: General Stores Location Reference: L129 Task: Access to the roof

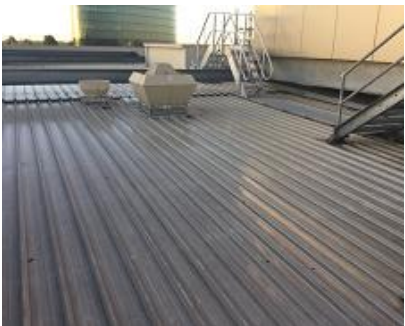
No safe access to the A/c units	Trips, Slips and Falls	N/A	Low	Supply walkway to the A/c units	Low	Client advised	Outstanding	-
34 0	Building: General Stores Location Reference: L129 Task: Access to the roof

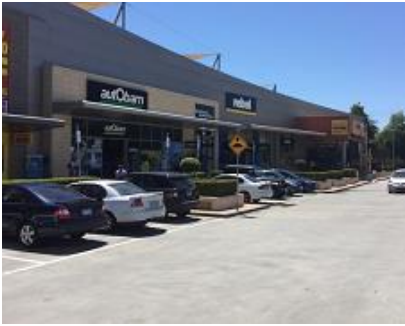
No height safety system installed	Trips, Slips and Falls	Restrict Access	High	"EWP Access to Roof" signs to be installed	Low	Client advised	Outstanding	OH&S REGULATIONS 3.55 & 3.11
35 8	Building: General Stores Location Reference: L138 Task: Access to the roof
