# Roof Safety Report

**Chatswood Chase Sydney,  
NSW 2067**

Prepared By: Safemaster Safety Products  
Date: 05-11-2019

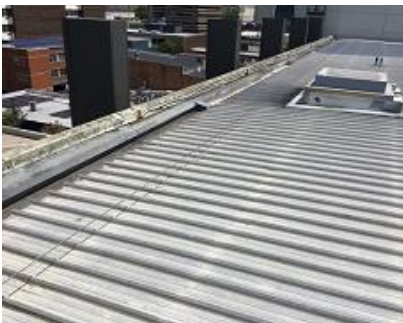
No	Photo of Hazard	Details of Hazard	Details of Risk	Existing/ Immediate Control Measure	Current Risk Level	Proposed Permanent Solution	Residual Risk Assessment	Details of Action Taken	Status	Reference
65	Building: General Stores Location Reference: <a href="#">L03</a> Task: Access to the roof

Static line over 10 years old	Trips, Slips and Falls	Awareness induction	High	Existing static line to be replaced	Low	Client advised	Outstanding	OH&S REGULATIONS 3.7 & 3.55  AS 1891.4:2009 6.3
66	Building: General Stores Location Reference: <a href="#">L04</a> Task: Access to the roof

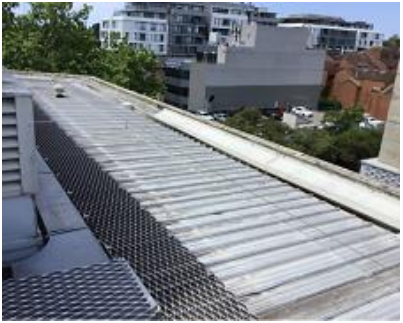
Static line over 10 years old	Trips, Slips and Falls	Awareness induction	High	Existing static line to be replaced	Low	Client advised	Outstanding	OH&S REGULATIONS 3.7 & 3.55  AS 1891.4:2009 6.3

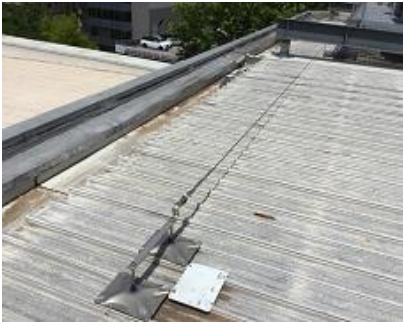
No	Photo of Hazard	Details of Hazard	Details of Risk	Existing/ Immediate Control Measure	Curren t Risk Level	Proposed Permanent Solution	Residu al Risk Assess ment	Details of Action Taken	Status	Reference
67	Building: General Stores Location Reference: <a href="#">L05</a> Task: Access to the roof

Static line over 10 years old	Trips, Slips and Falls	Awareness induction	High	Existing static line to be replaced	Low	Client advised	Outsta nding	OH&S REGULATIONS 3.7 & 3.55  AS 1891.4:2009 6.3
68	Building: General Stores Location Reference: <a href="#">L07</a> Task: Access to the roof

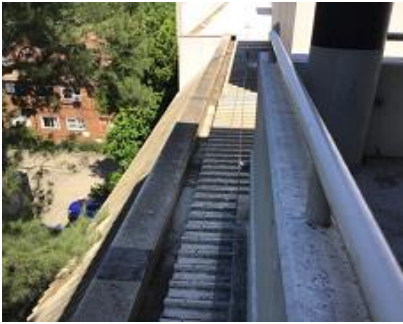
Static line over 10 years old	Trips, Slips and Falls	Awareness induction	High	Existing static line to be replaced	Low	Client advised	Outsta nding	OH&S REGULATIONS 3.7 & 3.55  AS 1891.4:2009 6.3

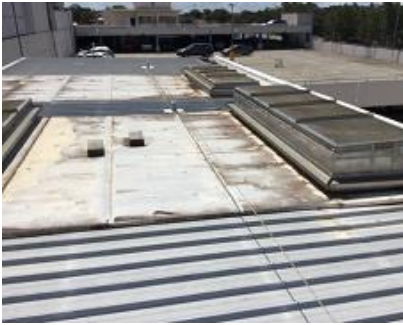
No	Photo of Hazard	Details of Hazard	Details of Risk	Existing/ Immediate Control Measure	Curren t Risk Level	Proposed Permanent Solution	Residu al Risk Assess ment	Details of Action Taken	Status	Reference
69	Building: General Stores Location Reference: <a href="#">L08</a> Task: Access to the roof

Static line over 10 years old	Trips, Slips and Falls	Awareness induction	High	Existing static line to be replaced	Low	Client advised	Outsta nding	OH&S REGULATIONS 3.7 & 3.55  AS 1891.4:2009 6.3
70	Building: General Stores Location Reference: <a href="#">L10</a> Task: Access to the roof

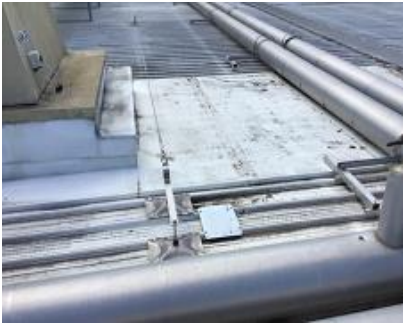
Static line over 10 years old	Trips, Slips and Falls	Awareness induction	High	Existing static line to be replaced	Low	Client advised	Outsta nding	OH&S REGULATIONS 3.7 & 3.55  AS 1891.4:2009 6.3
