Roof Safety Report

**Colonnades Shopping Centre,
SA 5168**

Prepared By: Safemaster Safety Products
Date: 02 October 2018

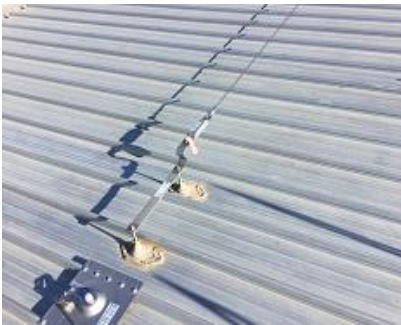
Incorrect installation of static line is present	Trips, Slips and Falls	Awareness induction	High	Existing static line to be replaced	Low	Client advised	Outstanding	OH&S REGULATIONS 3.55

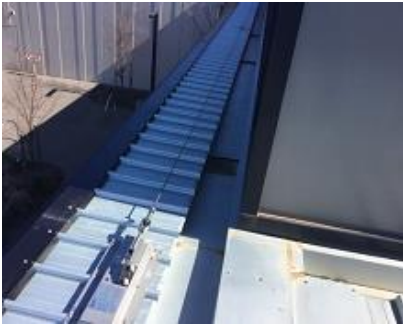
Incorrect installation of static line is present. Roof is very narrow for static line	Trips, Slips and Falls	Awareness induction	High	Existing static line to be removed and "EWP Access to Roof" sign to be installed	Low	Client advised	Outstanding	OH&S REGULATIONS 3.55 & 3.11
04	Building: General Stores Location Reference: L08 Task: Access to the roof

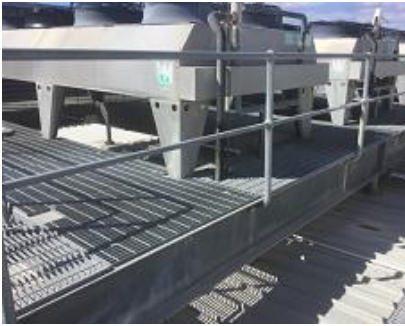
Variation in height between plant deck and unit is greater than required maximum	Trips, Slips and Falls	Awareness induction	Med	Mid rail to be installed	Low	Client advised	Outstanding	OH&S REGULATIONS 3.7 AS/NZS 1657-2013 6.1
16	Building: General Stores Location Reference: L17 Task: Access to the roof

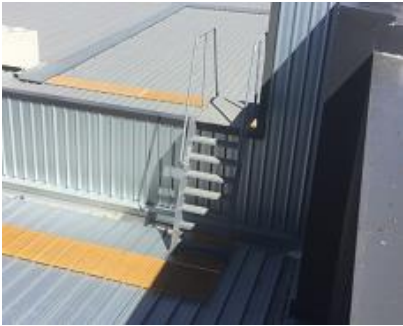
Bottom tread heights are less than required minimum	Trips, Slips and Falls	Awareness induction	Med	Landing platforms to be installed	Low	Client advised	Outstanding	OH&S REGULATIONS 3.7 AS/NZS 1657-2013 7.3.3
26	Building: General Stores Location Reference: L20 Task: Access to the A/c units

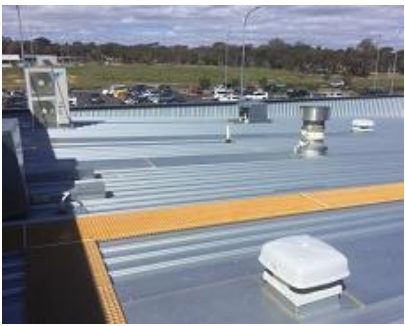
No safe access to the A/c units	Trips, Slips and Falls	N/A	Low	Supply Walkway to the A/c units	Low	Client advised	Outstanding	-
30	Building: General Stores Location Reference: L06 Task: Access to the A/c units

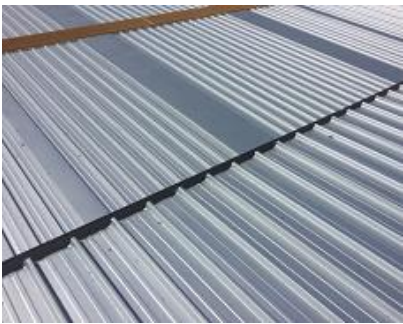
Variation in height between roofs are greater than required maximum	Trips, Slips and Falls	Awareness induction	Med	Access ladder and walkway to be installed	Low	Client advised	Outstanding	OH&S REGULATIONS 3.7 AS/NZS 1657-2013 3.1.4
32	Building: General Stores Location Reference: L10 Task: Access to the A/c units

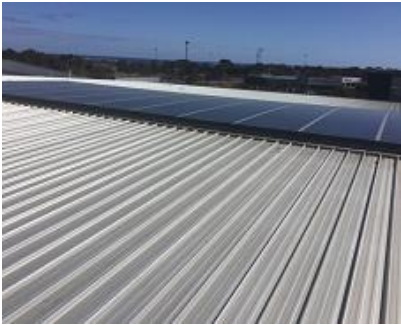
Brittle and Fragile roof is present	Trips, Slips and Falls	Restrict Access	High	"Brittle and Fragile Roof" signs to be installed	Low	Client advised	Outstanding	OH&S REGULATIONS 3.57
38	Building: General Stores Location Reference: L24 Task: Access to the roof

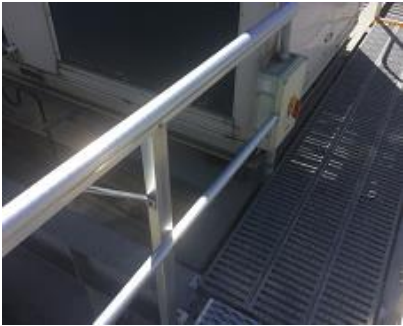
Handrail ends not fully secured	Trips, Slips and Falls	Awareness induction	Med	Additional post to be installed	Low	Client advised	Outstanding	OH&S REGULATIONS 3.7 AS/NZS 1657-2013 4.4
44	Building: General Stores Location Reference: L26 Task: Access to the roof

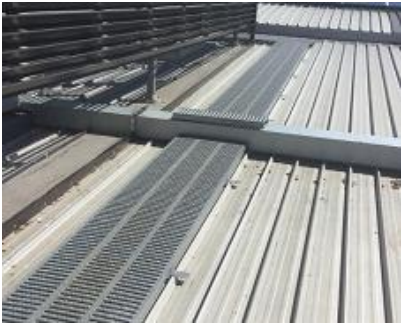
Cable tray installed over the walkway path	Trips, Slips and Falls	Awareness induction	Med	Step bridge including handrail to be installed	Low	Client advised	Outstanding	OH&S REGULATIONS 3.7 AS/NZS 1657-2013 4.4
46	Building: General Stores Location Reference: L09 Task: Access to the A/c units

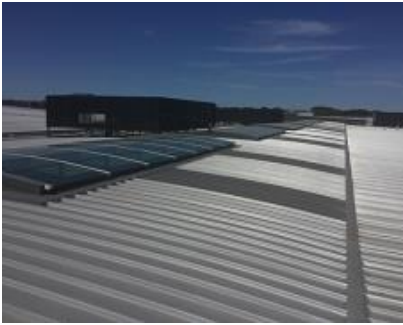
Brittle and Fragile roof sections are present	Trips, Slips and Falls	Restrict Access	High	"Brittle and Fragile Roof" signs to be installed	Low	Client advised	Outstanding	OH&S REGULATIONS 3.57
48	Building: General Stores Location Reference: L28 Task: Access to the roof

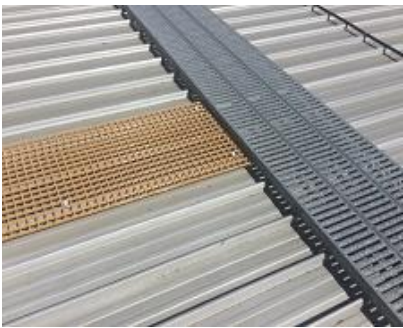
Variation in height between walkway panels are greater than required maximum	Trips, Slips and Falls	Awareness induction	Med	High visibility safety yellow nosing's to be installed	Low	Client advised	Outstanding	OH&S REGULATIONS 3.7 AS/NZS 1657-2013 3.3.4
50	Building: General Stores Location Reference: L30 Task: Access to the roof

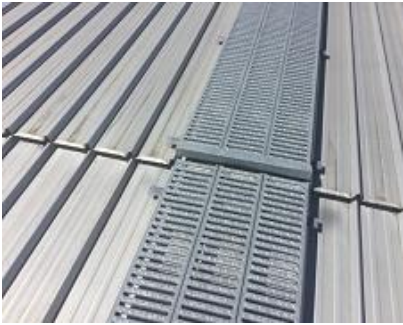
Variation in height between walkway panels are greater than required maximum	Trips, Slips and Falls	Awareness induction	Med	High visibility safety yellow nosing's to be installed	Low	Client advised	Outstanding	OH&S REGULATIONS 3.7 AS/NZS 1657-2013 3.3.4
58	Building: General Stores Location Reference: L30 Task: Access to the roof

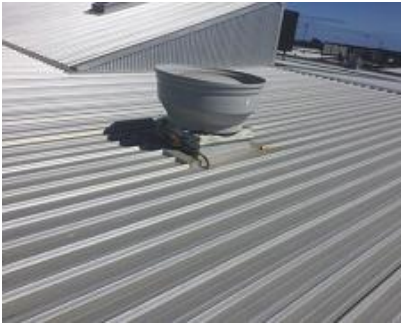
No safe access to the A/c units	Trips, Slips and Falls	N/A	Low	Supply Walkway to the A/c units	Low	Client advised	Outstanding	-
60	Building: General Stores Location Reference: L30 Task: Access to the A/c units

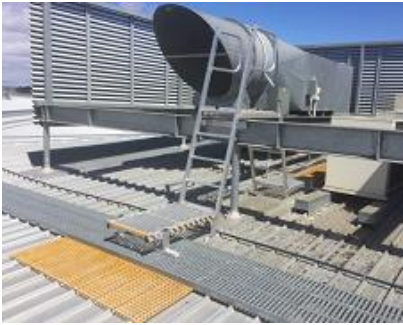
Variation in height between walkway panels are greater than required maximum	Trips, Slips and Falls	Awareness induction	Med	High visibility safety yellow nosing's to be installed	Low	Client advised	Outstanding	OH&S REGULATIONS 3.7 AS/NZS 1657-2013 3.3.4
64	Building: General Stores Location Reference: L32 Task: Access to the roof

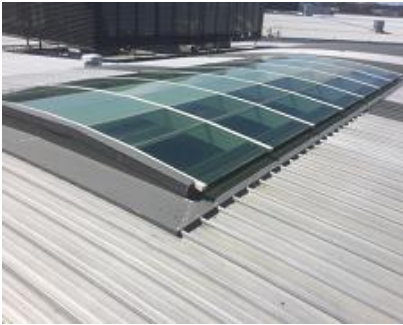
Brittle and Fragile roof sections are present	Trips, Slips and Falls	Restrict Access	High	"Brittle and Fragile Roof" signs to be installed	Low	Client advised	Outstanding	OH&S REGULATIONS 3.57
68	Building: General Stores Location Reference: L34 Task: Access to the roof

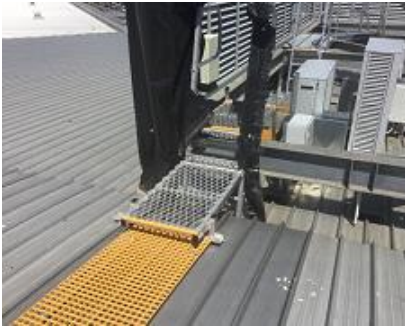
Variation in height between landing and adjacent surface is greater than required maximum	Trips, Slips and Falls	Awareness induction	Med	Handrail to be installed	Low	Client advised	Outstanding	OH&S REGULATIONS 3.7 AS/NZS 1657-2013 4.4
70	Building: General Stores Location Reference: L35 Task: Access to the roof

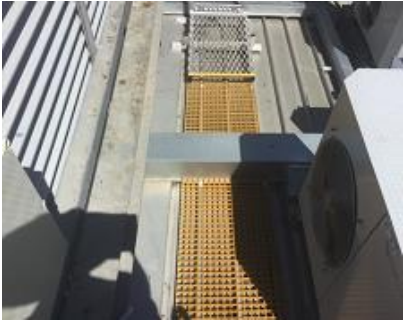
Cable tray installed over the walkway path	Trips, Slips and Falls	Awareness induction	Med	Step bridge including handrail to be installed	Low	Client advised	Outstanding	OH&S REGULATIONS 3.7 AS/NZS 1657-2013 3.1.4

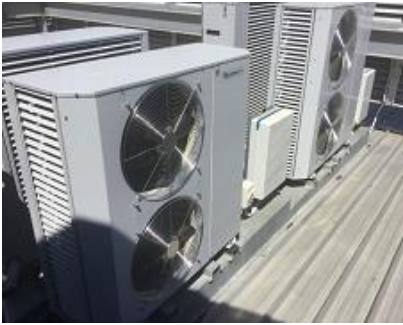
No safe access to the A/c units	Trips, Slips and Falls	N/A	Low	Supply Walkway to the A/c units	Low	Client advised	Outstanding	-
74	Building: General Stores Location Reference: L36 Task: Access to the roof

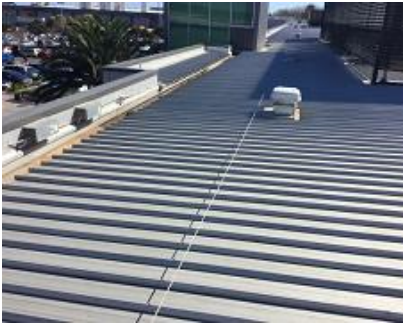
Non-complaint static line is present	Trips, Slips and Falls	Awareness induction	High	Existing static line to be replaced	Low	Client advised	Outstanding	OH&S REGULATIONS 3.55
76	Building: General Stores Location Reference: L37 Task: Access to the roof

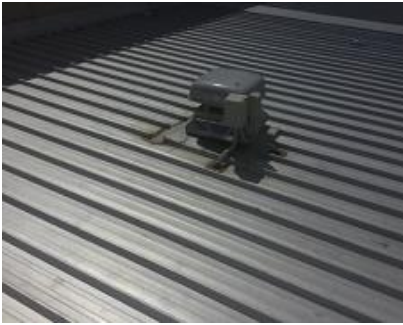
No safe access to the A/c units	Trips, Slips and Falls	N/A	Low	Supply Walkway to the A/c units	Low	Client advised	Outstanding	-
82	Building: General Stores Location Reference: L38 Task: Access to the A/c units

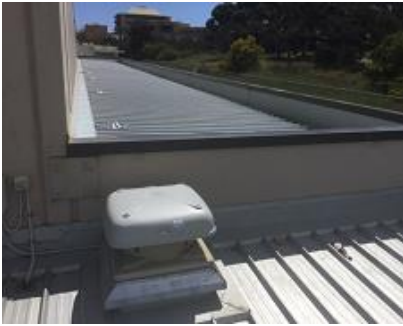
Variation in height between roofs are greater than required maximum	Trips, Slips and Falls	Awareness induction	Med	Access ladder to be installed	Low	Client advised	Outstanding	OH&S REGULATIONS 3.7 AS/NZS 1657-2013 3.1.4
84	Building: General Stores Location Reference: L38 Task: Access to the roof

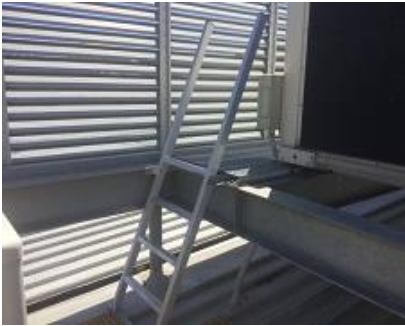
Gap between ladder and permanent structure is greater than required maximum	Trips, Slips and Falls	Awareness induction	Med	Handrails to ladder to be installed	Low	Client advised	Outstanding	OH&S REGULATIONS 3.7 AS/NZS 1657-2013 4.4
86	Building: General Stores Location Reference: L40 Task: Restrict access to the roof

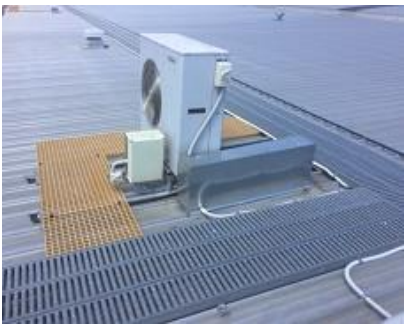
Variation in height between walkway panels are greater than required maximum	Trips, Slips and Falls	Awareness induction	Med	High visibility safety yellow nosing's to be installed	Low	Client advised	Outstanding	OH&S REGULATIONS 3.7 AS/NZS 1657-2013 3.3.4
90	Building: General Stores Location Reference: L41 Task: Access to the roof

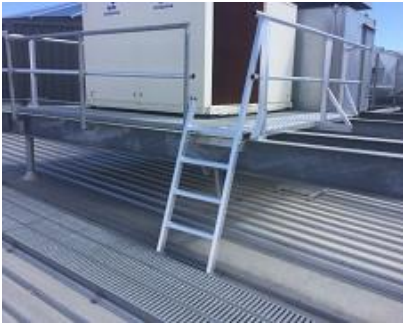
Non-complaint ladder is present	Trips, Slips and Falls	Awareness induction	Med	Existing ladder to be replaced	Low	Client advised	Outstanding	OH&S REGULATIONS 3.7 AS/NZS 1657-2013 7.4
92	Building: General Stores Location Reference: L42 Task: Access to the roof

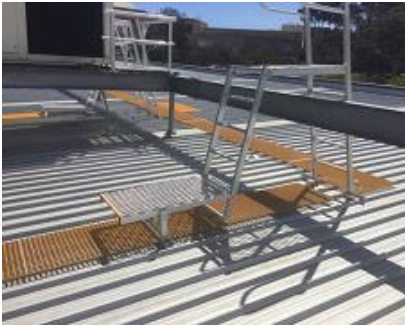
Landing height is greater than required maximum	Trips, Slips and Falls	Awareness induction	Med	Existing landing to be removed and new walkway section to level with bottom rung to be installed	Low	Client advised	Outstanding	OH&S REGULATIONS 3.7 AS/NZS 1657-2013 7.4.3.4
96	Building: General Stores Location Reference: L43 Task: Access to the roof

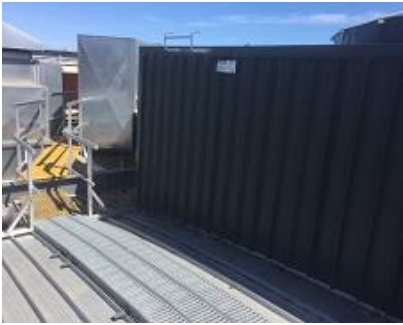
Non-complaint ladder access bracket	Trips, Slips and Falls	Awareness induction	Med	Ladder access bracket to be replaced with ladder	Low	Client advised	Outstanding	OH&S REGULATIONS 3.7 AS/NZS 1657-2013 3.1.4
100	Building: General Stores Location Reference: L45 Task: Access to the roof

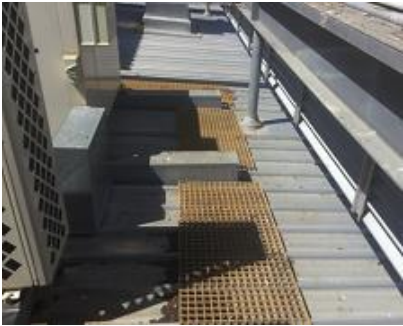
Cable tray installed over the walkway path	Trips, Slips and Falls	Awareness induction	Med	Step bridges including handrail to be installed	Low	Client advised	Outstanding	OH&S REGULATIONS 3.7 AS/NZS 1657-2013 3.1.4
102	Building: General Stores Location Reference: L45 Task: Access to the roof

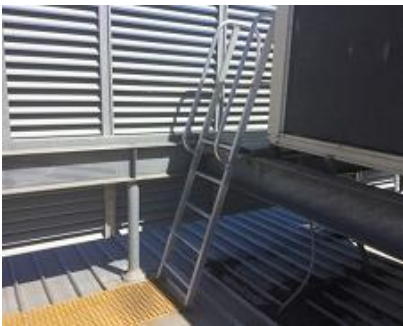
Bottom rung height is less than required minimum, handrail projecting towards the user and gap between ladder and permanent structure is greater than required maximum	Trips, Slips and Falls	Awareness induction	Med	Existing handrail to be removed. Landing platform, handrail to ladder and gap between ladder and structure to be filled	Low	Client advised	Outstanding	OH&S REGULATIONS 3.7 AS/NZS 1657-2013 7.4.3.4 & 7.4.8.5
104	Building: General Stores Location Reference: L45 Task: Access to the roof

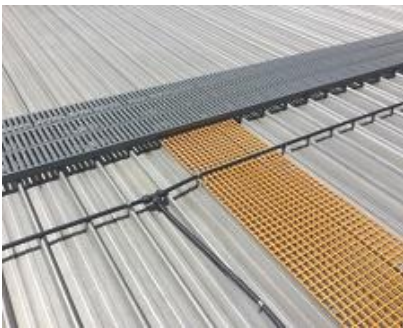
Variation in height between walkway panels are greater than required maximum and pipe installed over the walkway path	Trips, Slips and Falls	Awareness induction	Med	Step bridge and High visibility safety yellow nosing's to be installed	Low	Client advised	Outstanding	OH&S REGULATIONS 3.7 AS/NZS 1657-2013 3.3.4
106	Building: General Stores Location Reference: L46 Task: Access to the roof

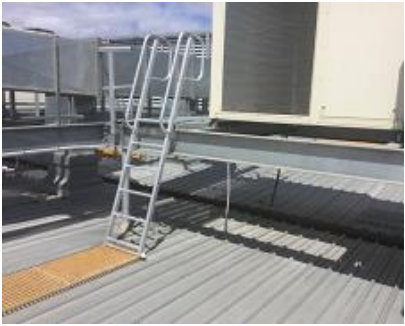
Bottom rung height is less than required minimum and handrail projecting towards the user	Trips, Slips and Falls	Awareness induction	Med	Existing handrails to be replaced for ladder and landing platform to be installed at base	Low	Client advised	Outstanding	OH&S REGULATIONS 3.7 AS/NZS 1657-2013 7.4.3.4 & 7.4.8.5
110	Building: General Stores Location Reference: L46 Task: Access to the roof

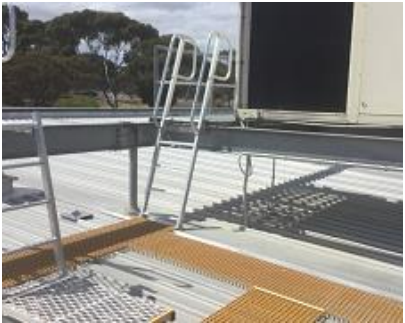
Bottom rung height is less than required minimum and handrail projecting towards the user	Trips, Slips and Falls	Awareness induction	Med	Existing handrails to be replaced for ladder and landing platform to be installed at base	Low	Client advised	Outstanding	OH&S REGULATIONS 3.7 AS/NZS 1657-2013 7.4.3.4 & 7.4.8.5

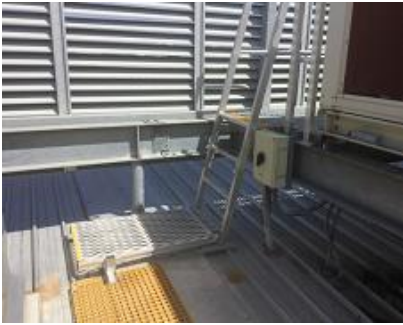
Variation in height between walkway panels are greater than required maximum	Trips, Slips and Falls	Awareness induction	Med	High visibility safety yellow nosing's to be installed	Low	Client advised	Outstanding	OH&S REGULATIONS 3.7 AS/NZS 1657-2013 3.3.4
112	Building: General Stores Location Reference: L47 Task: Access to the roof

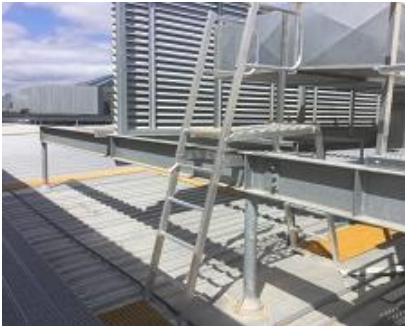
Landing is less than required minimum	Trips, Slips and Falls	Awareness induction	Med	Levelled landing platform at base to be installed	Low	Client advised	Outstanding	OH&S REGULATIONS 3.7 AS/NZS 1657-2013 7.3.6
114	Building: General Stores Location Reference: L47 Task: Access to the roof

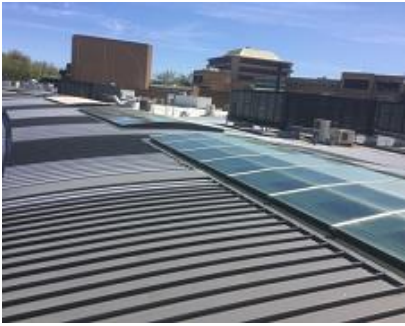
Brittle and Fragile roof sections are present	Trips, Slips and Falls	Restrict Access	High	"Brittle and Fragile Roof" signs to be installed	Low	Client advised	Outstanding	OH&S REGULATIONS 3.57
116	Building: General Stores Location Reference: L49 Task: Access to the roof

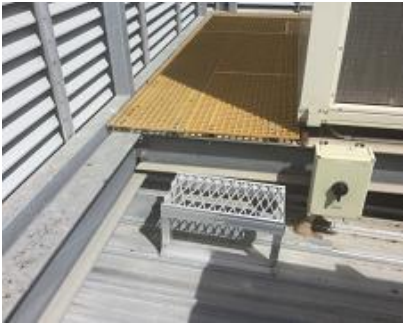
Non-complaint step is present and handrail is missing for landing	Trips, Slips and Falls	Awareness induction	Med	Levelled access step and handrail to be installed	Low	Client advised	Outsta nding	OH&S REGULATIONS 3.7 AS/NZS 1657- 2013 3.1.4
128	Building: General Stores Location Reference: L50 Task: Access to the A/c units

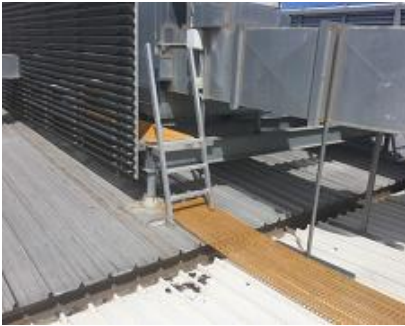
Bottom rung height is less than required minimum	Trips, Slips and Falls	Awareness induction	Med	Landing platform to be installed	Low	Client advised	Outstanding	OH&S REGULATIONS 3.7 AS/NZS 1657-2013 7.4.3.4
130	Building: General Stores Location Reference: L50 Task: Access to the roof

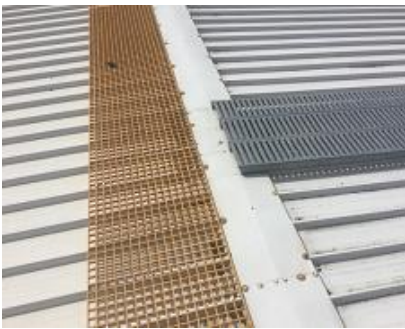
Gap between walkway panels are greater than required maximum	Trips, Slips and Falls	Awareness induction	Med	Walkway section to be installed	Low	Client advised	Outstanding	OH&S REGULATIONS 3.7 AS/NZS 1657-2013 3.2.3.4
132	Building: General Stores Location Reference: L51 Task: Access to the roof

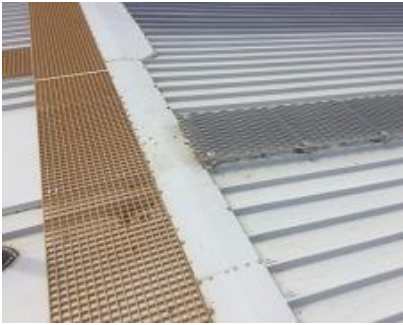
Gap between walkway panels are greater than required maximum	Trips, Slips and Falls	Awareness induction	Med	Walkway section to be installed	Low	Client advised	Outstanding	OH&S REGULATIONS 3.7 AS/NZS 1657-2013 3.2.3.4
136	Building: General Stores Location Reference: L51 Task: Access to the roof

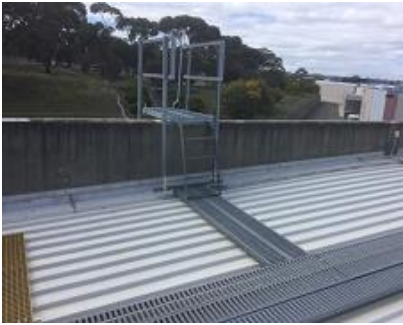
Non-complaint ladder is present	Trips, Slips and Falls	Awareness induction	Med	Existing ladder to be replaced	Low	Client advised	Outstanding	OH&S REGULATIONS 3.7 AS/NZS 1657-2013 7.4
138	Building: General Stores Location Reference: L53 Task: Access to the roof

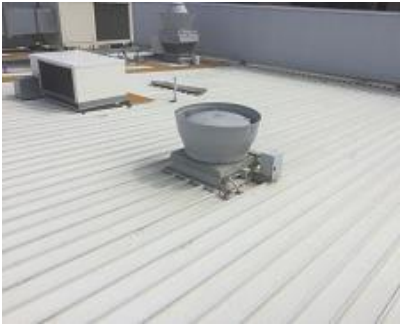
No safe access to the A/c units	Trips, Slips and Falls	N/A	Low	Supply Walkway to the A/c units	Low	Client advised	Outstanding	-
140	Building: General Stores Location Reference: L54 Task: Restrict access to the roof

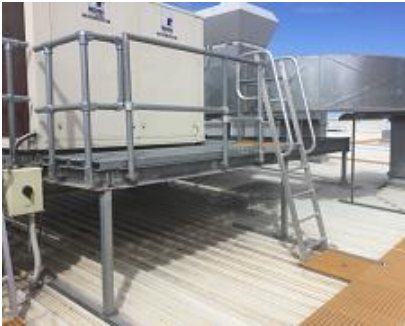
Gap between mid-rail and handrail is greater than required maximum	Trips, Slips and Falls	Awareness induction	Med	Additional mid rail section to be installed to reduce the gap	Low	Client advised	Outstanding	OH&S REGULATIONS 3.7 AS/NZS 1657-2013 4.4
152	Building: General Stores Location Reference: L56 Task: Access to the A/c units

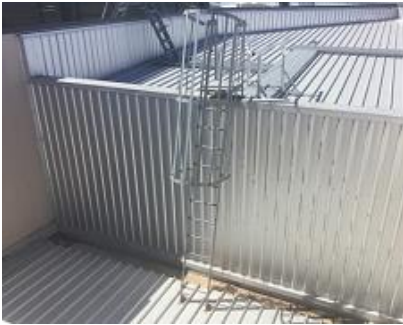
Non-complaint ladder is present	Trips, Slips and Falls	Awareness induction	Med	Existing ladder to be replaced	Low	Client advised	Outstanding	OH&S REGULATIONS 3.7 AS/NZS 1657-2013 7.4
166	Building: General Stores Location Reference: L61 Task: Access to the roof

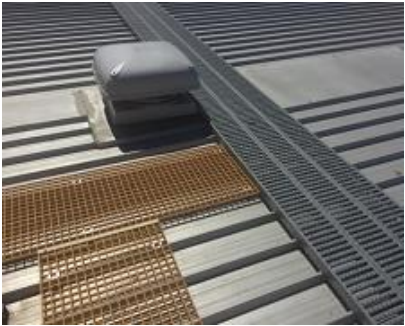
Variation in height between walkway panels are greater than required maximum	Trips, Slips and Falls	Awareness induction	Med	High visibility safety yellow nosing's to be installed	Low	Client advised	Outstanding	OH&S REGULATIONS 3.7 AS/NZS 1657-2013 3.3.4
168	Building: General Stores Location Reference: L61 Task: Access to the A/c units

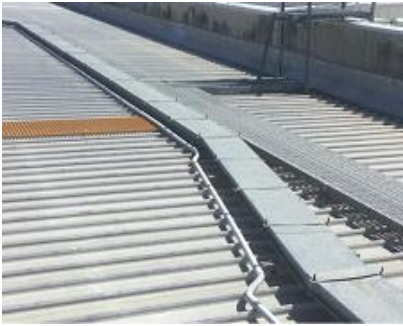
Cable tray installed over the walkway path	Trips, Slips and Falls	Awareness induction	Med	Step bridge including handrail to be installed	Low	Client advised	Outstanding	OH&S REGULATIONS 3.7 AS/NZS 1657-2013 3.1.4
172	Building: General Stores Location Reference: L63 Task: Access to the roof

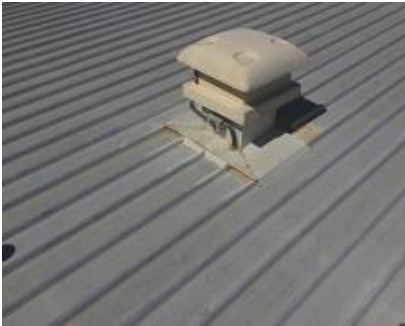
No safe access to the A/c units	Trips, Slips and Falls	N/A	Low	Supply walkway to the A/c units	Low	Client advised	Outstanding	-
174	Building: General Stores Location Reference: L63 Task: Access to the A/c units

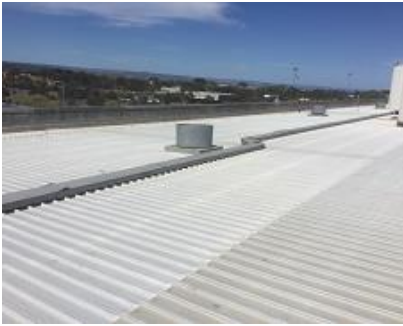
No safe access to the A/c units	Trips, Slips and Falls	N/A	Low	Supply walkway to the A/c units	Low	Client advised	Outstanding	-
176	Building: General Stores Location Reference: L64 Task: Access to the roof

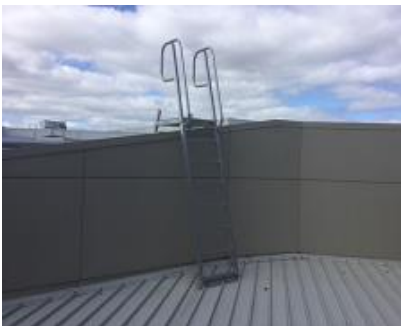
Bottom rung heights are less than required minimum and handrails projecting towards the user	Trips, Slips and Falls	Awareness induction	Med	Existing handrail to be replaced and landing platforms to be installed	Low	Client advised	Outstanding	OH&S REGULATIONS 3.7 AS/NZS 1657-2013 7.4.3.4 & 7.4.8.5
180	Building: General Stores Location Reference: L66 Task: Access to the roof

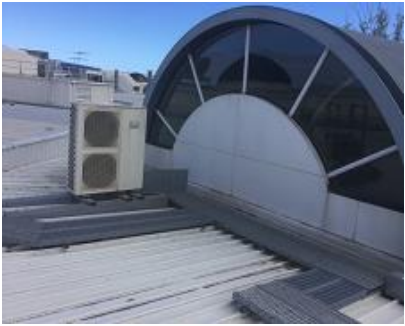
No safe access to the A/c units	Trips, Slips and Falls	N/A	Low	Supply walkway to the A/c units	Low	Client advised	Outstanding	-
182	Building: General Stores Location Reference: L66 Task: Access to the roof

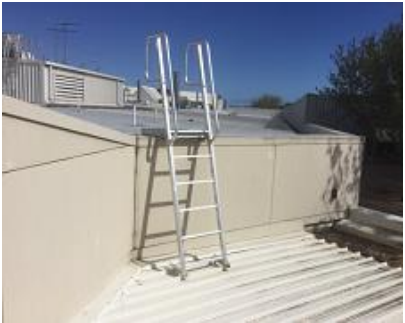
Bottom rung heights are less than required minimum and handrails projecting towards the user	Trips, Slips and Falls	Awareness induction	Med	Existing handrail to be replaced and landing platforms to be installed	Low	Client advised	Outstanding	OH&S REGULATIONS 3.7 AS/NZS 1657-2013 7.4.3.4 & 7.4.8.5
