Roof Safety Report

**Corio Central Shopping Centre,
VIC 3214**

Prepared By: Safemaster Safety Products
Date: 23 April 2018

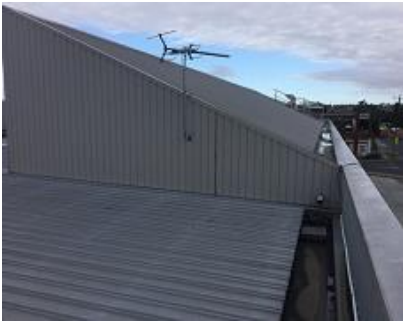
No height safety system installed	Trips, Slips and Falls	Awareness induction	High	Fall arrest anchors to be installed	Low	Client advised	Outstanding	OH&S REGULATIONS 3.55
02	Building: General Stores Location Reference: L04 Task: Access to the roof

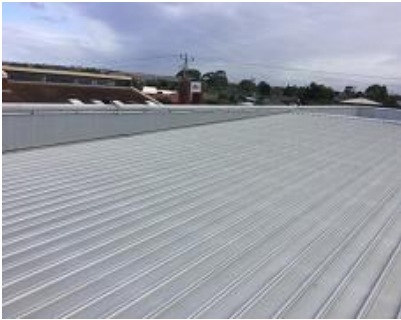
No height safety system installed	Trips, Slips and Falls	Awareness induction	High	Fall arrest anchors to be installed	Low	Client advised	Outstanding	OH&S REGULATIONS 3.55
04	Building: General Stores Location Reference: L06 Task: Access to the A/c units

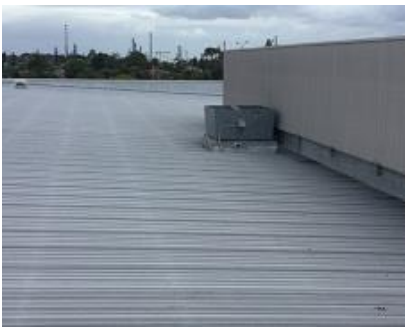
No safe access to the A/c units	Trips, Slips and Falls	N/A	Low	Supply walkway to the A/c units	Low	Client advised	Outstanding	-
06	Building: General Stores Location Reference: L06 Task: Access to the plant deck

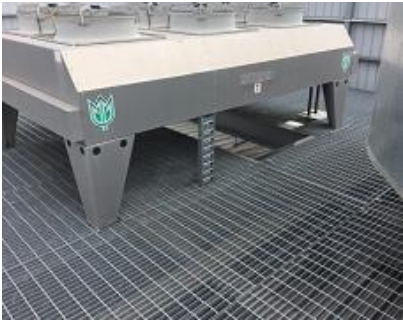
Variation in height between plant deck and unit is greater than required maximum	Trips, Slips and Falls	Awareness induction	Med	Mid rail to be installed	Low	Client advised	Outstanding	OH&S REGULATIONS 3.7 AS/NZS 1657-2013 6.2.1.2
08	Building: General Stores Location Reference: L08 Task: Access to the A/c units

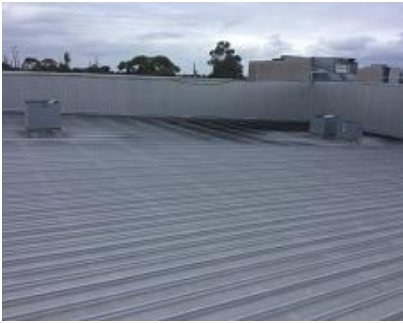
No safe access to the A/c units	Trips, Slips and Falls	N/A	Low	Supply walkway and step over to the A/c units	Low	Client advised	Outstanding	-
10	Building: General Stores Location Reference: L10 Task: Access to the plant deck

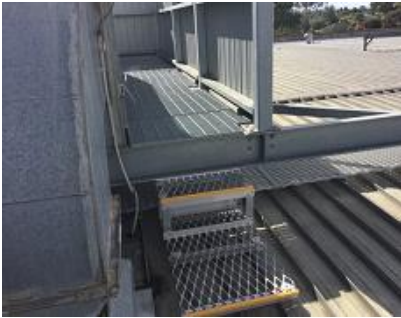
No safe access to the ladder	Trips, Slips and Falls	N/A	Low	Supply walkway to the ladder	Low	Client advised	Outstanding	-
12	Building: General Stores Location Reference: L12 Task: Access to the roof

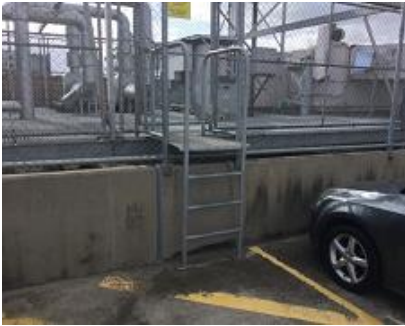
No slip resistance on ladder rungs	Trips, Slips and Falls	Awareness induction	Med	Non-slip safety yellow rung caps to be installed	Low	Client advised	Outstanding	OH&S REGULATIONS 3.7 AS/NZS 1657-2013 7.4.3.1
14	Building: General Stores Location Reference: L14 Task: Restrict access to the roof

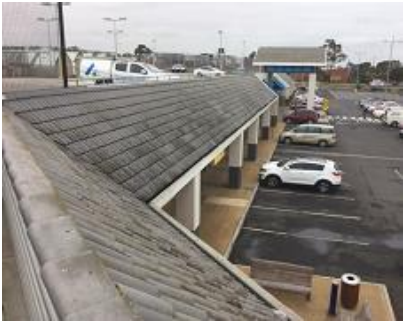
No height safety system installed	Trips, Slips and Falls	Restrict Access	High	"EWP Access Only" signs to be installed	Low	Client advised	Outstanding	OH&S REGULATIONS 3.55 & 3.11
16	Building: General Stores Location Reference: L16 Task: Access to the roof

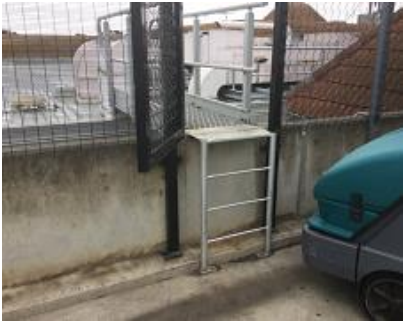
No slip resistance on ladder rungs	Trips, Slips and Falls	Awareness induction	Med	Existing ladder to be removed and new ladder to be installed	Low	Client advised	Outstanding	OH&S REGULATIONS 3.7 AS/NZS 1657-2013 7.4.3.1
18	Building: General Stores Location Reference: L16 Task: Access to the A/c units

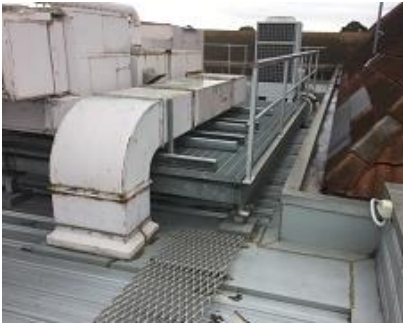
Variation in height between plant deck and roof is greater than required maximum	Trips, Slips and Falls	Awareness induction	Med	Step and handrail post to be installed	Low	Client advised	Outstanding	OH&S REGULATIONS 3.7 AS/NZS 1657-2013 3.1.4 & 4.4
20	Building: General Stores Location Reference: L17 Task: Access to the plant deck

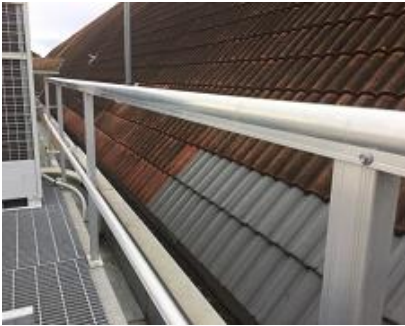
Sharp edges on handrails	Trips, Slips and Falls	Awareness induction	Med	Tek screws to be replaced with rivets	Low	Client advised	Outstanding	OH&S REGULATIONS 3.7 AS/NZS 1657-2013 5.6
22	Building: General Stores Location Reference: L17 Task: Access to the A/c units

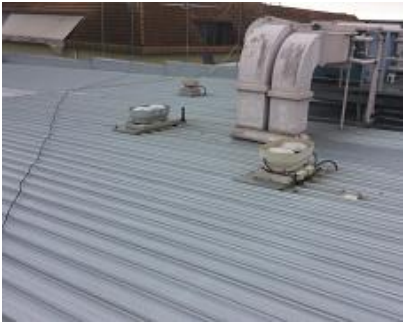
No safe access to the A/c units	Trips, Slips and Falls	N/A	Low	Supply walkway to the A/c units	Low	Client advised	Outstanding	-

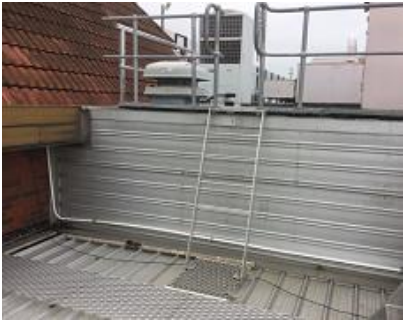
Bottom rung height is greater than required maximum, No slip resistance on ladder rungs and handrail projecting towards the user	Trips, Slips and Falls	Awareness induction	Med	Existing ladder to be removed and new ladder to be installed	Low	Client advised	Outstanding	OH&S REGULATIONS 3.7 AS/NZS 1657-2013 7.4.3.4, 7.4.3.1 & 7.4.8.5
24	Building: General Stores Location Reference: L17 Task: Access to the roof

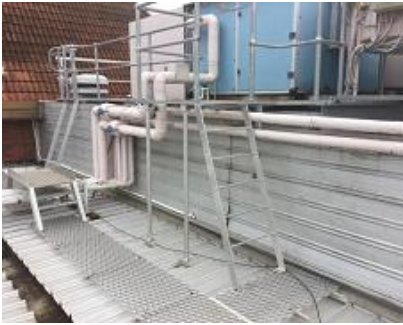
Bottom rung height is greater than required maximum, No slip resistance on ladder rungs and handrail projecting towards the user	Trips, Slips and Falls	Awareness induction	Med	Existing ladder to be removed and new ladder to be installed	Low	Client advised	Outstanding	OH&S REGULATIONS 3.7 AS/NZS 1657-2013 7.4.3.4, 7.4.3.1 & 7.4.8.5
26	Building: General Stores Location Reference: L18 Task: Access to the roof

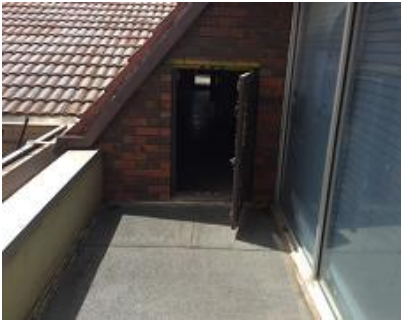
Headroom is less than required minimum	Trips, Slips and Falls	Awareness induction	Med	"Caution - Low Headroom" signs to be installed	Low	Client advised	Outstanding	OH&S REGULATIONS 3.7 AS/NZS 1657-2013 3.1.5
28	Building: General Stores Location Reference: L18 Task: Access to the roof

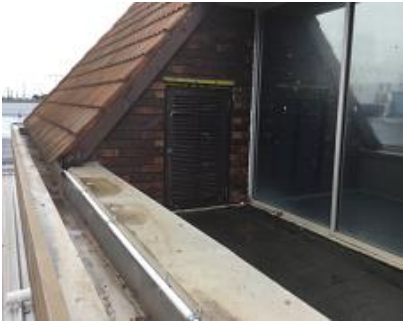
Headroom is less than required minimum	Trips, Slips and Falls	Awareness induction	Med	"Caution - Low Headroom" signs to be installed	Low	Client advised	Outstanding	OH&S REGULATIONS 3.7 AS/NZS 1657-2013 3.1.5
30	Building: General Stores Location Reference: L19 Task: Access to the roof

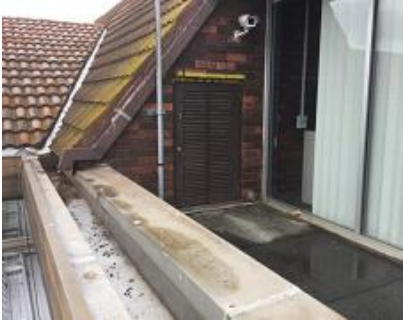
Headroom is less than required minimum	Trips, Slips and Falls	Awareness induction	Med	"Caution - Low Headroom" signs to be installed	Low	Client advised	Outstanding	OH&S REGULATIONS 3.7 AS/NZS 1657-2013 3.1.5
32	Building: General Stores Location Reference: L20 Task: Restrict access to the roof

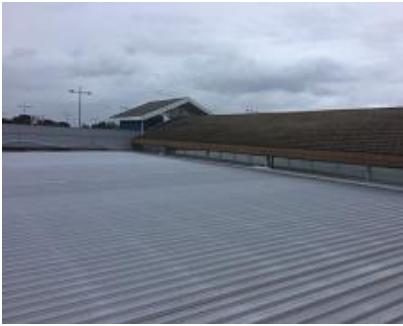
No height safety system installed	Trips, Slips and Falls	Restrict Access	High	"EWP Access Only" signs to be installed	Low	Client advised	Outstanding	OH&S REGULATIONS 3.55 & 3.11
34	Building: General Stores Location Reference: L22 Task: Access to the roof

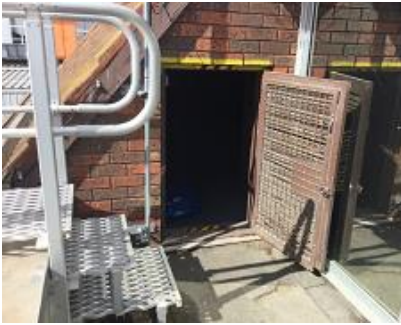
Headroom is less than required minimum	Trips, Slips and Falls	Awareness induction	Med	"Caution - Low Headroom" signs to be installed	Low	Client advised	Outstanding	OH&S REGULATIONS 3.7 AS/NZS 1657-2013 3.1.5
36	Building: General Stores Location Reference: L23 Task: Access to the roof

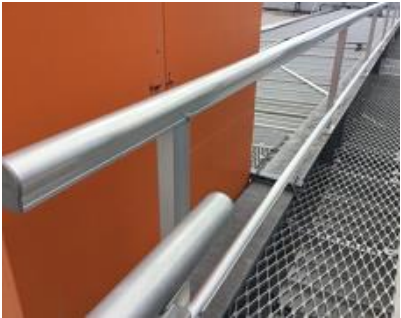
Sharp edges on handrails	Trips, Slips and Falls	Awareness induction	Med	Tek screws to be replaced with rivets	Low	Client advised	Outstanding	OH&S REGULATIONS 3.7 AS/NZS 1657-2013 5.6

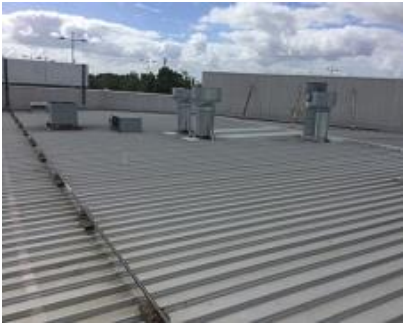
No safe access to the A/c units	Trips, Slips and Falls	N/A	Low	Supply walkway and step over to the A/c units	Low	Client advised	Outstanding	-
38	Building: General Stores Location Reference: L24 Task: Restrict access to the roof

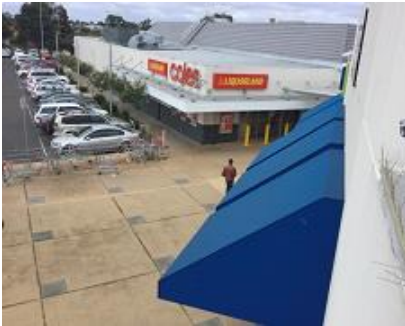
No height safety system installed	Trips, Slips and Falls	Restrict Access	High	"EWP Access to Roof" Signs to be installed	Low	Client advised	Outstanding	OH&S REGULATIONS 3.55 & 3.11
40	Building: General Stores Location Reference: L25 Task: Restrict access to the roof

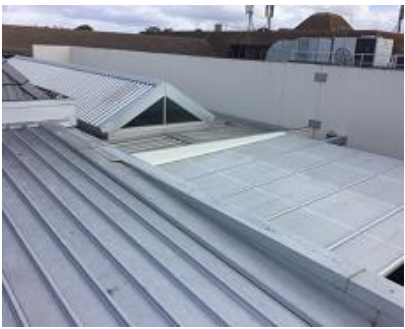
No height safety system installed	Trips, Slips and Falls	Awareness induction	High	Fall arrest anchor to be installed	Low	Client advised	Outstanding	OH&S REGULATIONS 3.55
42	Building: General Stores Location Reference: L26 Task: Access to the roof

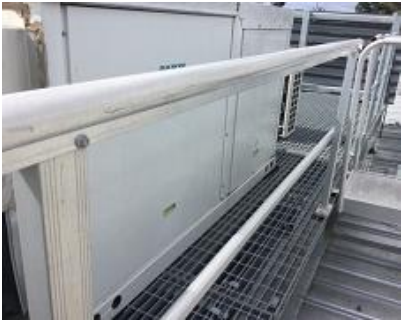
Sharp edges on handrails	Trips, Slips and Falls	Awareness induction	Med	Tek screws to be replaced with rivets	Low	Client advised	Outstanding	OH&S REGULATIONS 3.7 AS/NZS 1657-2013 5.6
44	Building: General Stores Location Reference: L27 Task: Access to the roof

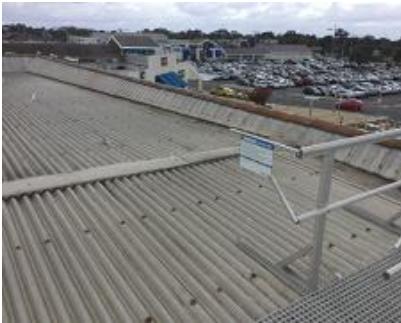
No height safety system installed	Trips, Slips and Falls	Awareness induction	High	Fall arrest anchor to be installed	Low	Client advised	Outstanding	OH&S REGULATIONS 3.55

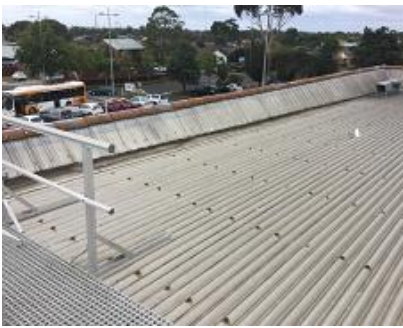
No height safety system installed	Trips, Slips and Falls	Awareness induction	High	Fall arrest anchor to be installed	Low	Client advised	Outstanding	OH&S REGULATIONS 3.55
46	Building: General Stores Location Reference: L28 Task: Access to the plant deck

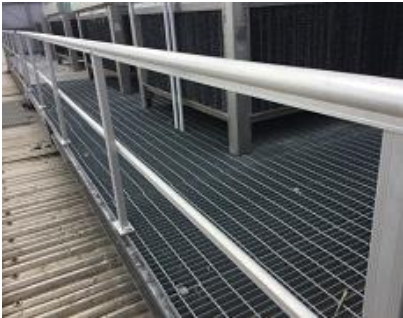
Sharp edges on handrails	Trips, Slips and Falls	Awareness induction	Med	Tek screws to be replaced with rivets	Low	Client advised	Outstanding	OH&S REGULATIONS 3.7 AS/NZS 1657-2013 5.6

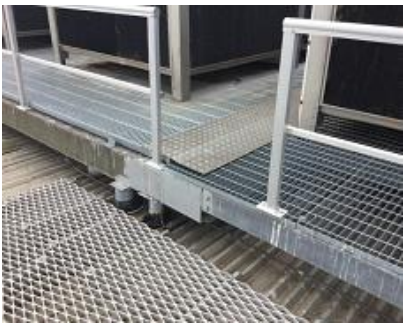
Variation in height between plant deck and roof is greater than required maximum	Trips, Slips and Falls	Awareness induction	Med	Step to be installed	Low	Client advised	Outstanding	OH&S REGULATIONS 3.7 AS/NZS 1657-2013 3.1.4
48	Building: General Stores Location Reference: L28 Task: Access to the roof

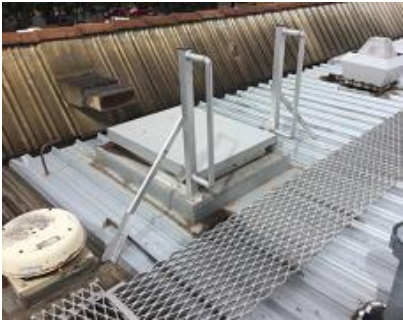
Non-complaint hatch grab rail is present	Trips, Slips and Falls	Awareness induction	Med	Existing hatch grab rail to be removed new hatch grab rail to be installed	Low	Client advised	Outstanding	OH&S REGULATIONS 3.7 AS/NZS 1657-2013 4.4
50	Building: General Stores Location Reference: L29 Task: Restrict access to the roof

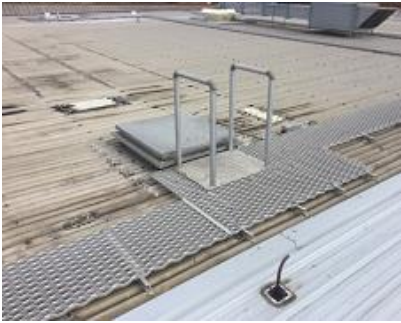
Non-complaint hatch grab rail is present	Trips, Slips and Falls	Awareness induction	Med	Existing hatch grab rail to be removed new hatch grab rail to be installed	Low	Client advised	Outstanding	OH&S REGULATIONS 3.7 AS/NZS 1657-2013 4.4
52	Building: General Stores Location Reference: L30 Task: Access to the A/c units

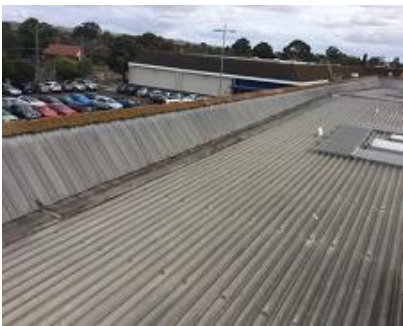
No height safety system installed	Trips, Slips and Falls	Awareness induction	High	Fall arrest anchors to be installed	Low	Client advised	Outstanding	OH&S REGULATIONS 3.55
54	Building: General Stores Location Reference: L31 Task: Access to the roof

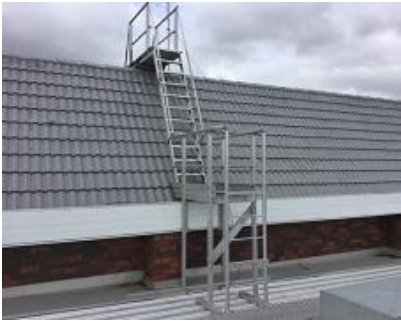
Bottom rung height is greater than required maximum and no slip resistance on ladder rungs	Trips, Slips and Falls	Awareness induction	Med	Existing ladder to be removed and new ladder to be installed	Low	Client advised	Outstanding	OH&S REGULATIONS 3.7 AS/NZS 1657-2013 7.4.3.4 & 7.4.3.1
56	Building: General Stores Location Reference: L32 Task: Access to the roof

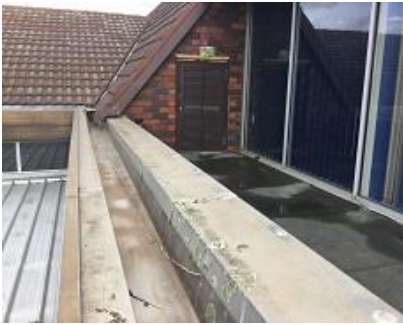
Headroom is less than required minimum	Trips, Slips and Falls	Awareness induction	Med	"Caution - Low Headroom" signs to be installed	Low	Client advised	Outstanding	OH&S REGULATIONS 3.7 AS/NZS 1657-2013 3.1.5
58	Building: General Stores Location Reference: L33 Task: Access to the A/c units

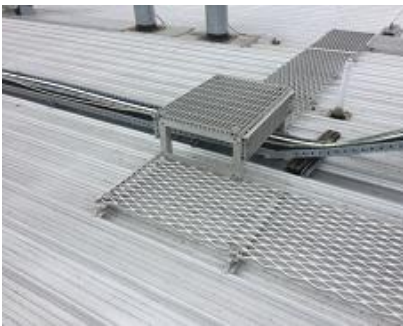
Variation in height between landing and roof is greater than required maximum	Trips, Slips and Falls	Awareness induction	Med	Handrail to be installed	Low	Client advised	Outstanding	OH&S REGULATIONS 3.7 AS/NZS 1657-2013 4.4
60	Building: General Stores Location Reference: L33 Task: Access to the A/c units

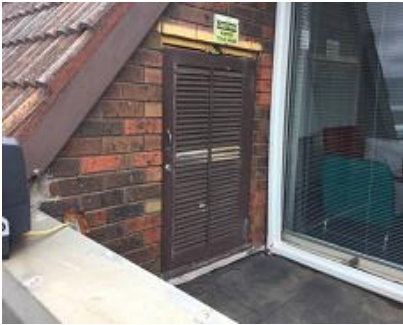
Headroom is less than required minimum	Trips, Slips and Falls	Awareness induction	Med	"Caution - Low Headroom" signs to be installed	Low	Client advised	Outstanding	OH&S REGULATIONS 3.7 AS/NZS 1657-2013 3.1.5
62	Building: General Stores Location Reference: L34 Task: Access to the roof

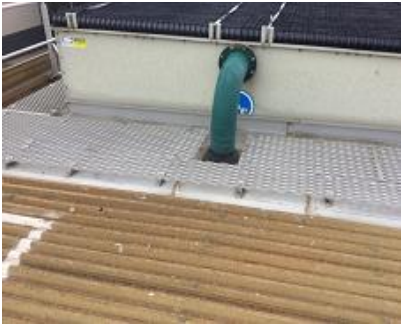
Walkway width is less than required minimum	Trips, Slips and Falls	Awareness induction	Med	Additional walkway section to be installed	Low	Client advised	Outstanding	OH&S REGULATIONS 3.7 AS/NZS 1657-2013 5.1.3
64	Building: General Stores Location Reference: L35 Task: Access to the roof

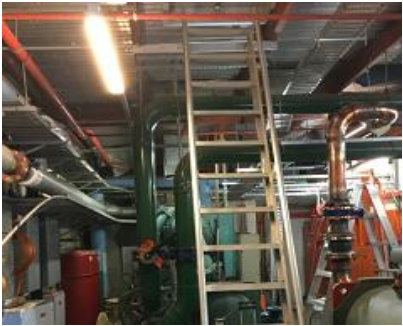
Top tread not levelled with landing	Trips, Slips and Falls	Awareness induction	Med	Existing ladder to be removed and new ladder to be installed	Low	Client advised	Outstanding	OH&S REGULATIONS 3.7 AS/NZS 1657-2013 7.4.3.3
66	Building: General Stores Location Reference: L35 Task: Access to the roof

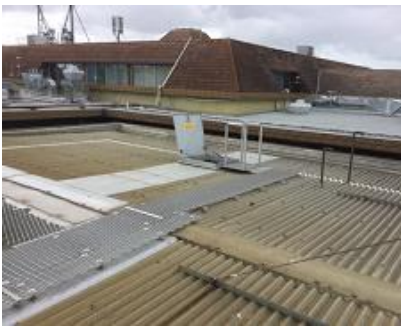
No height safety system installed	Trips, Slips and Falls	Awareness induction	High	Fall arrest anchors to be installed	Low	Client advised	Outstanding	OH&S REGULATIONS 3.55
68	Building: General Stores Location Reference: L36 Task: Restrict access to the roof

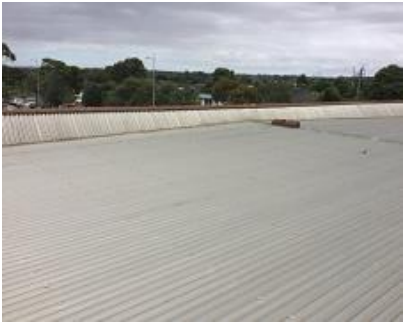
No height safety system installed	Trips, Slips and Falls	Awareness induction	High	Fall arrest anchors to be installed	Low	Client advised	Outstanding	OH&S REGULATIONS 3.55
70	Building: General Stores Location Reference: L36 Task: Access to the roof

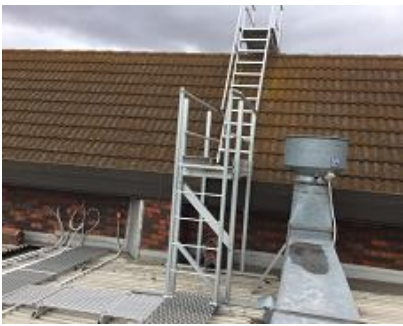
Bottom rung height is greater than required maximum and no slip resistance on ladder rungs	Trips, Slips and Falls	Awareness induction	Med	Existing ladder to be removed and new ladder to be installed	Low	Client advised	Outstanding	OH&S REGULATIONS 3.7 AS/NZS 1657-2013 7.4.3.4 & 7.4.3.1
72	Building: General Stores Location Reference: L37 Task: Access to the roof

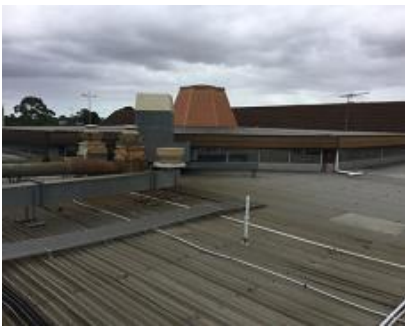
Variation in height between roofs are greater than required maximum	Trips, Slips and Falls	Awareness induction	Med	Access ladder including walkway to be installed	Low	Client advised	Outstanding	OH&S REGULATIONS 3.7 AS/NZS 1657-2013 3.1.4
74	Building: General Stores Location Reference: L39 Task: Access to the roof

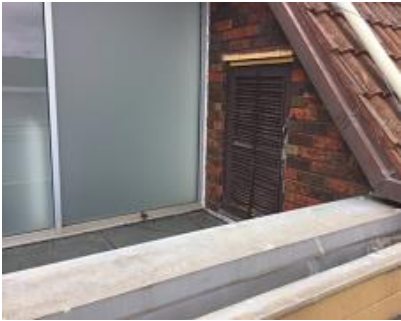
Headroom is less than required minimum	Trips, Slips and Falls	Awareness induction	Med	"Caution - Low Headroom" signs to be installed	Low	Client advised	Outstanding	OH&S REGULATIONS 3.7 AS/NZS 1657-2013 3.1.5
76	Building: General Stores Location Reference: L39 Task: Access to the roof

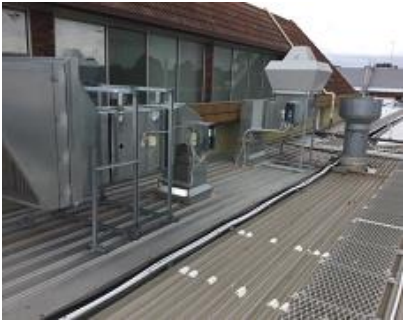
No safe access to the A/c units	Trips, Slips and Falls	N/A	Low	Supply walkway to the A/c units	Low	Client advised	Outstanding	-
78	Building: General Stores Location Reference: L40 Task: Access to the roof

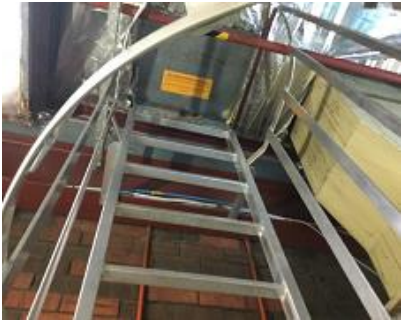
Top rung not levelled with landing and headroom is less than required minimum (Pipe in the way)	Trips, Slips and Falls	Awareness induction	Med	Existing ladder to be removed and new ladder including "Low Headroom" signs to be installed	Low	Client advised	Outstanding	OH&S REGULATIONS 3.7 AS/NZS 1657-2013 7.4.3.3 & 3.1.5
80	Building: General Stores Location Reference: L40 Task: Access to the A/c units

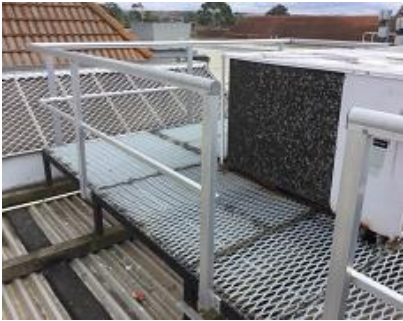
Sharp edges on handrails	Trips, Slips and Falls	Awareness induction	Med	Tek screws to be replaced with rivets	Low	Client advised	Outstanding	OH&S REGULATIONS 3.7 AS/NZS 1657-2013 5.6
82	Building: General Stores Location Reference: L42 Task: Access to the roof

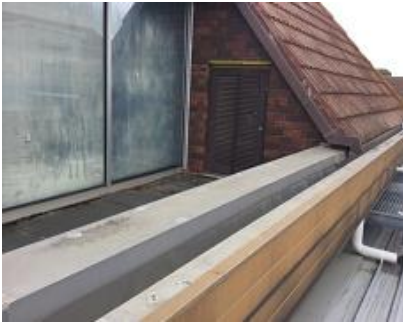
Headroom is less than required minimum	Trips, Slips and Falls	Awareness induction	Med	"Caution - Low Headroom" signs to be installed	Low	Client advised	Outstanding	OH&S REGULATIONS 3.7 AS/NZS 1657-2013 3.1.5

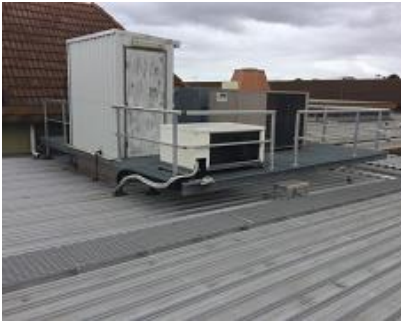
Sharp edges on handrails	Trips, Slips and Falls	Awareness induction	Med	Tek screws to be replaced with rivets	Low	Client advised	Outstanding	OH&S REGULATIONS 3.7 AS/NZS 1657-2013 5.6
84	Building: General Stores Location Reference: L43 Task: Access to the roof

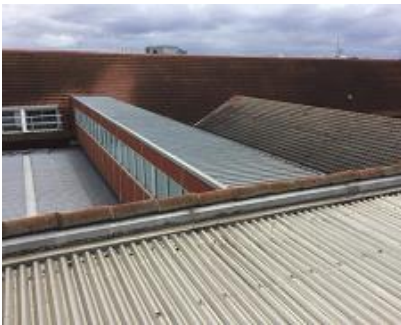
No height safety and safe access system installed	Trips, Slips and Falls	Awareness induction	High	Fall arrest static line, anchor strop, walkway and access ladder to be installed	Low	Client advised	Outstanding	OH&S REGULATIONS 3.7 & 3.55 AS/NZS 1657-2013 3.1.4

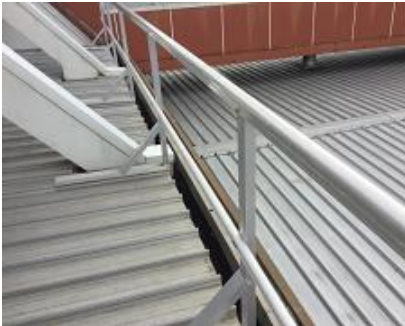
Sharp edges on handrails	Trips, Slips and Falls	Awareness induction	Med	Tek screws to be replaced with rivets	Low	Client advised	Outstanding	OH&S REGULATIONS 3.7 AS/NZS 1657-2013 5.6
86	Building: General Stores Location Reference: L44 Task: Access to the Ladder

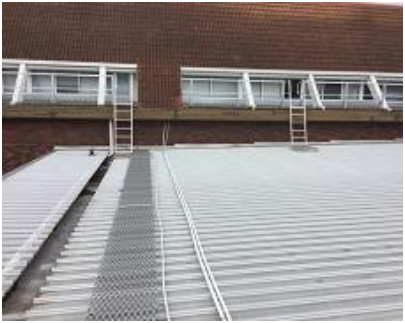
No safe access to the ladder	Trips, Slips and Falls	N/A	Low	Supply walkway to the ladder	Low	Client advised	Outstanding	-

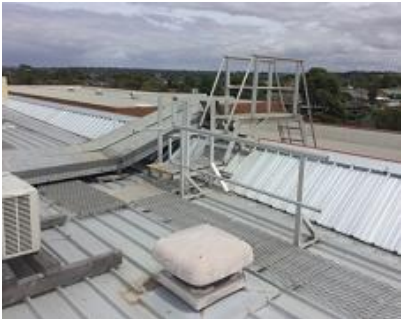
Sharp edges on handrails	Trips, Slips and Falls	Awareness induction	Med	Tek screws to be replaced with rivets	Low	Client advised	Outstanding	OH&S REGULATIONS 3.7 AS/NZS 1657-2013 5.6
