# Roof Safety Report

**DFO Homebush, NSW 2140**

Prepared By: Safemaster Safety Products  
Date: 24 May 2018

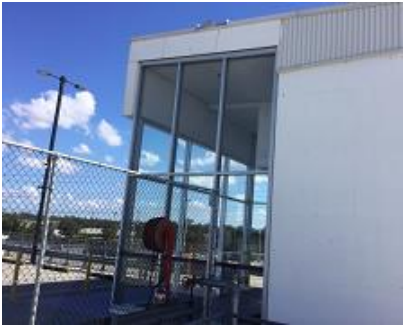
Fence in the way to access ladder bracket	Trips, Slips and Falls	Awareness induction	Med	Ladder access bracket to be re-located	Low	Client advised	Outstanding	OH&S REGULATIONS 3.7  AS/NZS 1657-2013 3.1.4
02	Building: General Stores Location Reference: <a href="#">L01</a> Task: Access to the roof

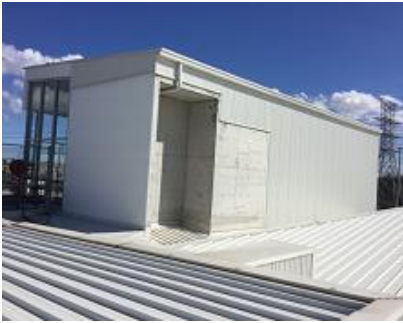
No height safety system installed	Trips, Slips and Falls	Awareness induction	High	Fall arrest anchors and anchor strop to be installed	Low	Client advised	Outstanding	OH&S REGULATIONS 3.55

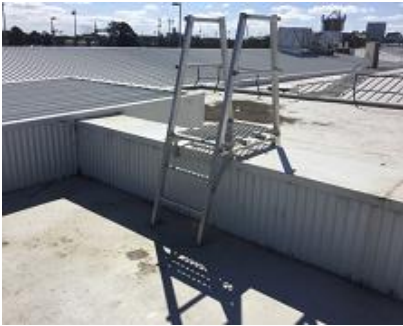
Non-complaint handrail is present	Trips, Slips and Falls	Awareness induction	Med	Existing handrail to be removed and new handrail to be installed	Low	Client advised	Outstanding	OH&S REGULATIONS 3.7  AS/NZS 1657-2013 4.4
04	Building: General Stores Location Reference: <a href="#">L03</a> Task: Access to the roof

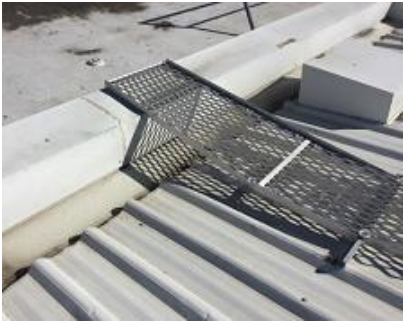
Variation in height between roofs are greater than required maximum	Trips, Slips and Falls	Awareness induction	Med	Access ladder and handrail to be installed	Low	Client advised	Outstanding	OH&S REGULATIONS 3.7  AS/NZS 1657-2013 3.1.4 & 4.4

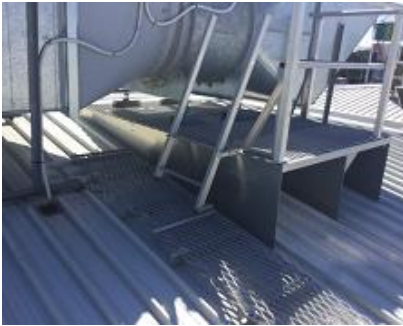
Bottom rung height is less than required minimum	Trips, Slips and Falls	Awareness induction	Med	Existing ladder to be removed and new ladder to be installed	Low	Client advised	Outstanding	OH&S REGULATIONS 3.7  AS/NZS 1657-2013 3.1.4
06	Building: General Stores Location Reference: <a href="#">L04</a> Task: Access to the roof

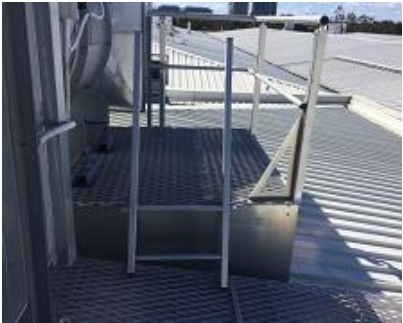
Gap between ladder and handrail is greater than required maximum	Trips, Slips and Falls	Awareness induction	Med	Handrail to be installed	Low	Client advised	Outstanding	OH&S REGULATIONS 3.7  AS/NZS 1657-2013 4.4

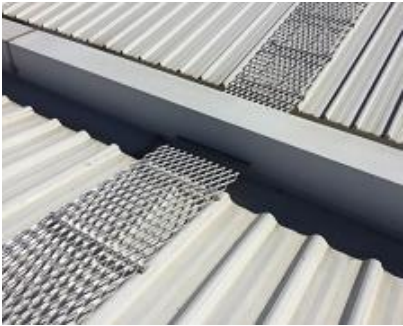
Variation in height between roofs are greater than required maximum	Trips, Slips and Falls	Awareness induction	Med	Access ladder to be installed	Low	Client advised	Outstanding	OH&S REGULATIONS 3.7  AS/NZS 1657-2013 3.1.4
08	Building: General Stores Location Reference: <a href="#">L04</a> Task: Access to the roof

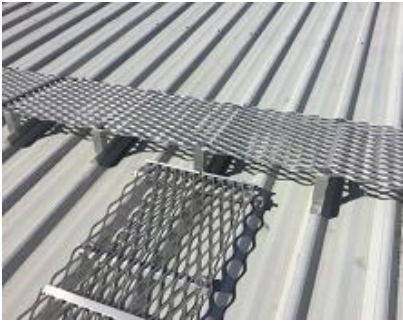
Variation in height between walkway panels are greater than required maximum	Trips, Slips and Falls	Awareness induction	Med	High visibility safety yellow nosing to be installed	Low	Client advised	Outstanding	OH&S REGULATIONS 3.7  AS/NZS 1657-2013 3.3.4

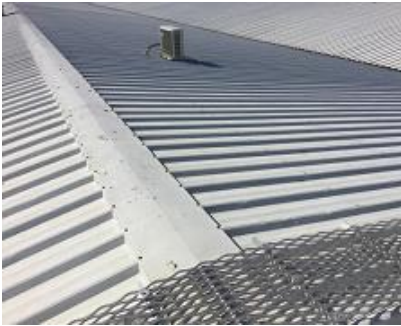
No safe access to the A/c units	Trips, Slips and Falls	N/A	Low	Supply walkway to the A/c units	Low	Client advised	Outstanding	-
10	Building: General Stores Location Reference: <a href="#">L05</a> Task: Access to the roof

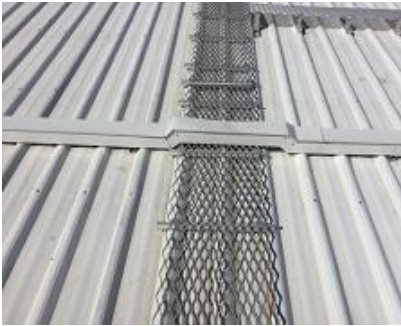
Cable installed over the walkway path	Trips, Slips and Falls	Awareness induction	Med	Step over to be installed	Low	Client advised	Outstanding	OH&S REGULATIONS 3.7  AS/NZS 1657-2013 3.1.4
12	Building: General Stores Location Reference: <a href="#">L05</a> Task: Access to the roof

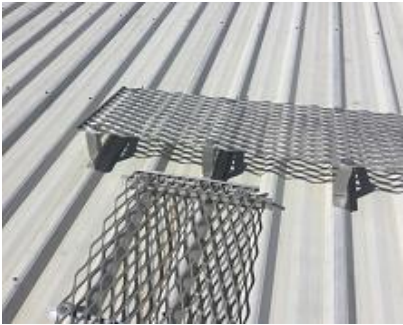
Variation in height between walkway panels are greater than required maximum	Trips, Slips and Falls	Awareness induction	Med	High visibility safety yellow nosing to be installed	Low	Client advised	Outstanding	OH&S REGULATIONS 3.7  AS/NZS 1657-2013 3.3.4
14	Building: General Stores Location Reference: <a href="#">L06</a> Task: Access to the roof

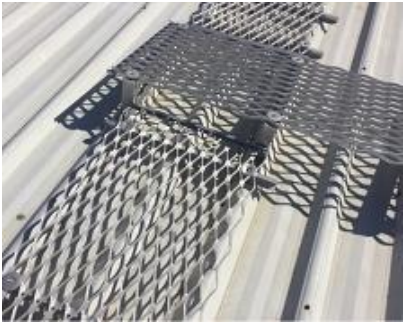
Variation in height between walkway panels are greater than required maximum	Trips, Slips and Falls	Awareness induction	Med	High visibility safety yellow nosing to be installed	Low	Client advised	Outstanding	OH&S REGULATIONS 3.7  AS/NZS 1657-2013 3.3.4

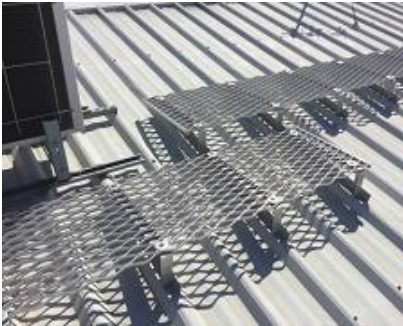
Variation in height between walkway panels are greater than required maximum	Trips, Slips and Falls	Awareness induction	Med	High visibility safety yellow nosing to be installed	Low	Client advised	Outstanding	OH&S REGULATIONS 3.7  AS/NZS 1657-2013 3.3.4
16	Building: General Stores Location Reference: <a href="#">L07</a> Task: Access to the roof

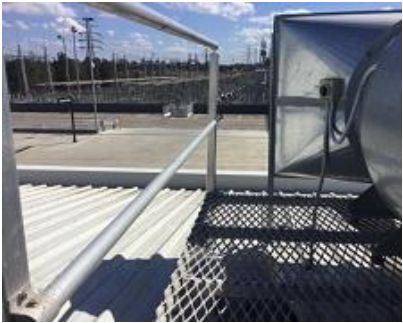
Handrail section is missing and sharp edges on handrails	Trips, Slips and Falls	Awareness induction	Med	Additional handrail section to be installed and tek screws to be replaced with rivets	Low	Client advised	Outstanding	OH&S REGULATIONS 3.7  AS/NZS 1657-2013 4.4 & 5.6

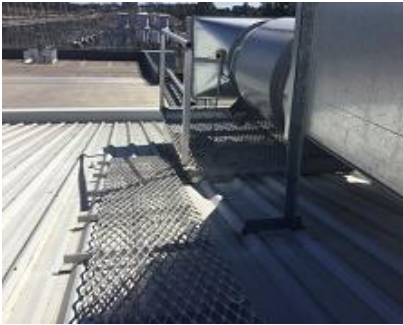
No safe access to the A/c units	Trips, Slips and Falls	N/A	Low	Supply walkway to the A/c units	Low	Client advised	Outstanding	-
18	Building: General Stores Location Reference: <a href="#">L07</a> Task: Access to the roof

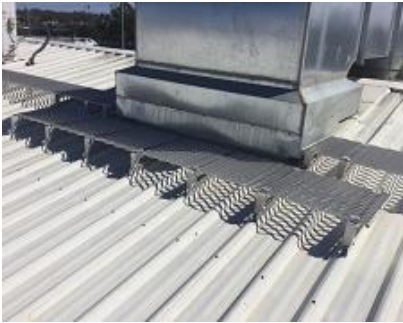
Variation in height between walkway panels are greater than required maximum	Trips, Slips and Falls	Awareness induction	Med	High visibility safety yellow nosing to be installed	Low	Client advised	Outstanding	OH&S REGULATIONS 3.7  AS/NZS 1657-2013 3.3.4

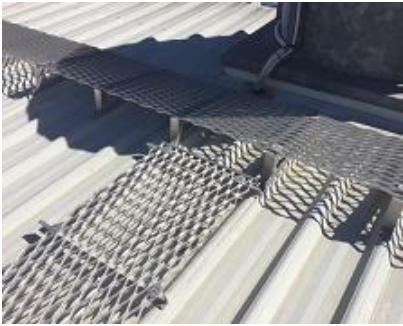
Variation in height between walkway panels are greater than required maximum	Trips, Slips and Falls	Awareness induction	Med	High visibility safety yellow nosing to be installed	Low	Client advised	Outstanding	OH&S REGULATIONS 3.7  AS/NZS 1657-2013 3.3.4
20	Building: General Stores Location Reference: <a href="#">L08</a> Task: Access to the roof

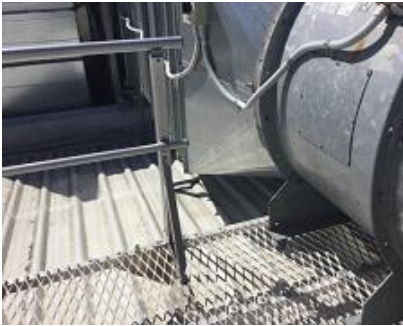
Handrail section is missing	Trips, Slips and Falls	Awareness induction	Med	Handrail to be installed	Low	Client advised	Outstanding	OH&S REGULATIONS 3.7  AS/NZS 1657-2013 4.4
22	Building: General Stores Location Reference: <a href="#">L09</a> Task: Access to the roof

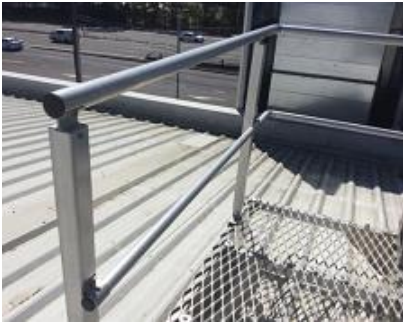
Sharp edges on handrails	Trips, Slips and Falls	Awareness induction	Med	Tek screws to be replaced with rivets	Low	Client advised	Outstanding	OH&S REGULATIONS 3.7  AS/NZS 1657-2013 5.6

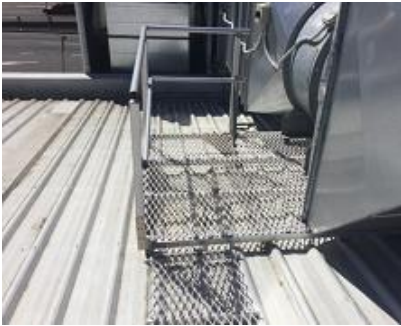
Variation in height between walkway panels are greater than required maximum	Trips, Slips and Falls	Awareness induction	Med	High visibility safety yellow nosing to be installed	Low	Client advised	Outstanding	OH&S REGULATIONS 3.7  AS/NZS 1657-2013 3.3.4
24	Building: General Stores Location Reference: <a href="#">L10</a> Task: Access to the roof

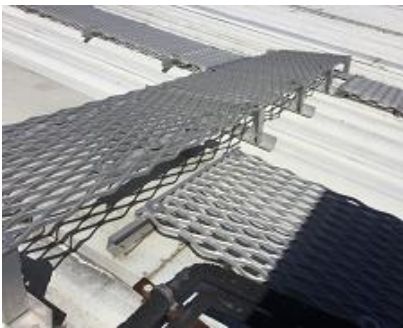
Variation in height between walkway panels are greater than required maximum	Trips, Slips and Falls	Awareness induction	Med	High visibility safety yellow nosing to be installed	Low	Client advised	Outstanding	OH&S REGULATIONS 3.7  AS/NZS 1657-2013 3.3.4
26	Building: General Stores Location Reference: <a href="#">L11</a> Task: Restrict access to the roof

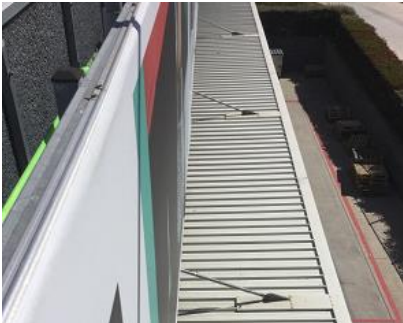
No height safety system installed	Trips, Slips and Falls	Restrict Access	High	"EWP Access only" signs to be installed	Low	Client advised	Outstanding	OH&S REGULATIONS 3.55 & 3.11

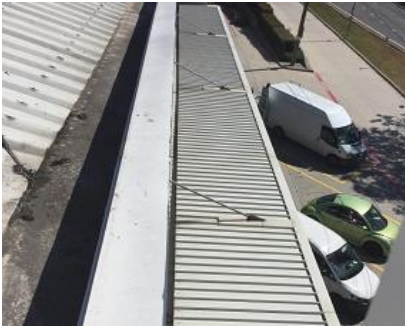
No height safety system installed	Trips, Slips and Falls	Restrict Access	High	"EWP Access only" signs to be installed	Low	Client advised	Outstanding	OH&S REGULATIONS 3.55 & 3.11
28	Building: General Stores Location Reference: <a href="#">L13</a> Task: Access to the roof

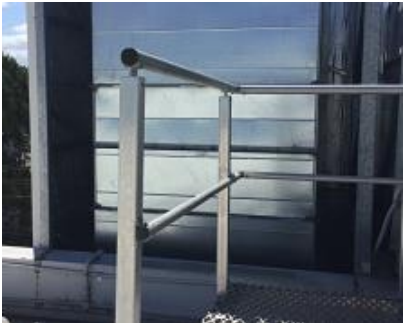
Sharp edges on handrails	Trips, Slips and Falls	Awareness induction	Med	Tek screws to be replaced with rivets	Low	Client advised	Outstanding	OH&S REGULATIONS 3.7  AS/NZS 1657-2013 5.6

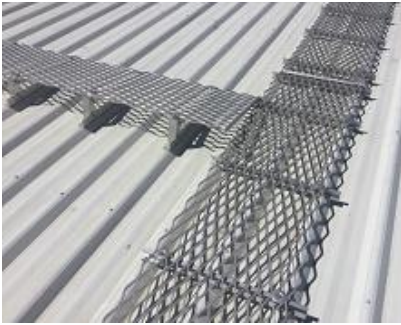
Variation in height between walkway panels are greater than required maximum	Trips, Slips and Falls	Awareness induction	Med	High visibility safety yellow nosing to be installed	Low	Client advised	Outstanding	OH&S REGULATIONS 3.7  AS/NZS 1657-2013 3.3.4
30	Building: General Stores Location Reference: <a href="#">L15</a> Task: Access to the roof

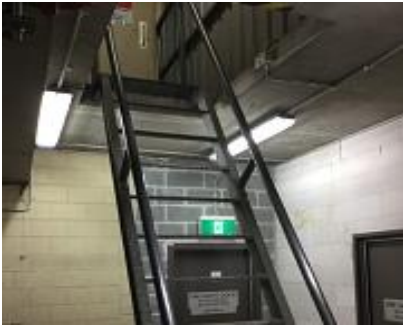
Gap between handrail and ladder is greater than required maximum	Trips, Slips and Falls	Awareness induction	Med	Existing handrail to be removed and new handrail to be installed	Low	Client advised	Outstanding	OH&S REGULATIONS 3.7  AS/NZS 1657-2013 7.3.5
32	Building: General Stores Location Reference: <a href="#">L16</a> Task: Access to the roof

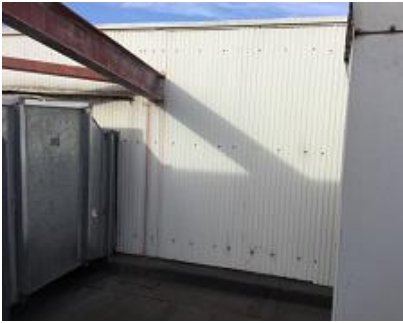
Variation in height between roofs are greater than required maximum	Trips, Slips and Falls	Awareness induction	Med	Access ladder to be installed	Low	Client advised	Outstanding	OH&S REGULATIONS 3.7  AS/NZS 1657-2013 3.1.4

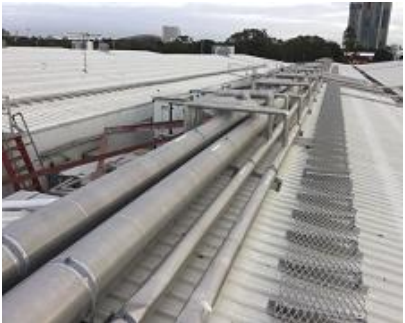
No height safety system installed	Trips, Slips and Falls	Awareness induction	High	Fall arrest anchors to be installed	Low	Client advised	Outstanding	OH&S REGULATIONS 3.55

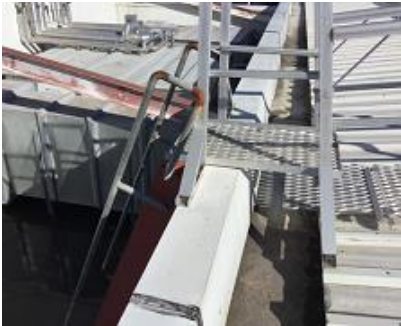
Existing walkway installed over the top tread	Trips, Slips and Falls	Awareness induction	Med	Existing walkway to be re-located	Low	Client advised	Outstanding	OH&S REGULATIONS 3.7  AS/NZS 1657-2013 7.3.6
36	Building: General Stores Location Reference: <a href="#">L18</a> Task: Access to the roof

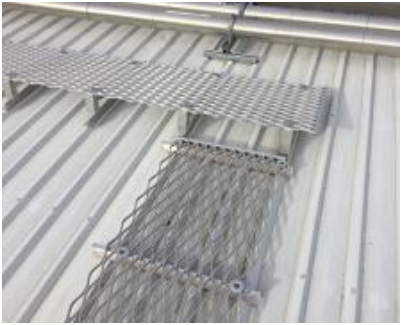
Variation in height between walkway panels are greater than required maximum	Trips, Slips and Falls	Awareness induction	Med	High visibility safety yellow nosing to be installed	Low	Client advised	Outstanding	OH&S REGULATIONS 3.7  AS/NZS 1657-2013 3.3.4
38	Building: General Stores Location Reference: <a href="#">L19</a> Task: Access to the roof

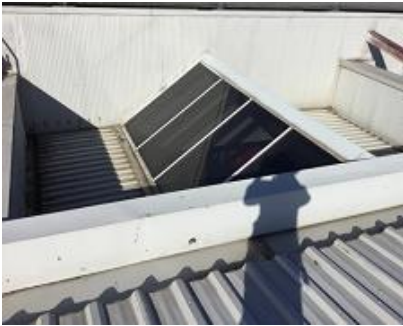
Brittle roof (Non-trafficable roof)	Trips, Slips and Falls	Restrict Access	High	"Warning-Keep Off-Brittle and Fragile Roof" signs to be installed	Low	Client advised	Outstanding	OH&S REGULATIONS 3.57
40	Building: General Stores Location Reference: <a href="#">L20</a> Task: Access to the roof

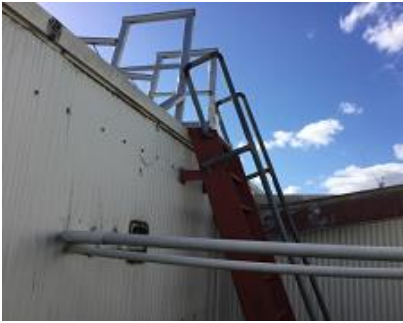
Existing walkway installed over the top tread	Trips, Slips and Falls	Awareness induction	Med	Existing walkway to be re-located	Low	Client advised	Outstanding	OH&S REGULATIONS 3.7  AS/NZS 1657-2013 7.3.6

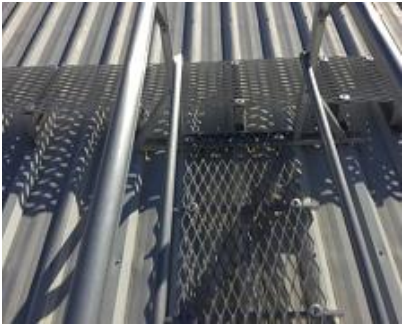
Variation in height between walkway panels are greater than required maximum	Trips, Slips and Falls	Awareness induction	Med	High visibility safety yellow nosing to be installed	Low	Client advised	Outstanding	OH&S REGULATIONS 3.7  AS/NZS 1657-2013 3.3.4
42	Building: General Stores Location Reference: <a href="#">L21</a> Task: Access to the roof

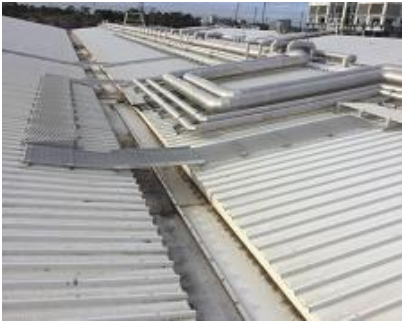
Variation in height between walkway panels are greater than required maximum	Trips, Slips and Falls	Awareness induction	Med	High visibility safety yellow nosing to be installed	Low	Client advised	Outstanding	OH&S REGULATIONS 3.7  AS/NZS 1657-2013 3.3.4

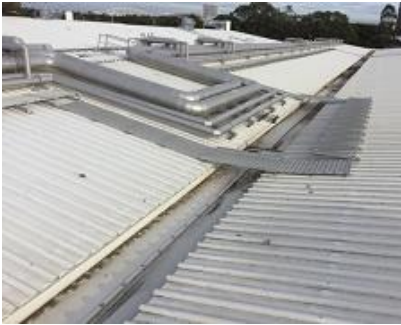
Variation in height between walkway panels are greater than required maximum	Trips, Slips and Falls	Awareness induction	Med	High visibility safety yellow nosing to be installed	Low	Client advised	Outstanding	OH&S REGULATIONS 3.7  AS/NZS 1657-2013 3.3.4
44	Building: General Stores Location Reference: <a href="#">L21</a> Task: Access to the roof

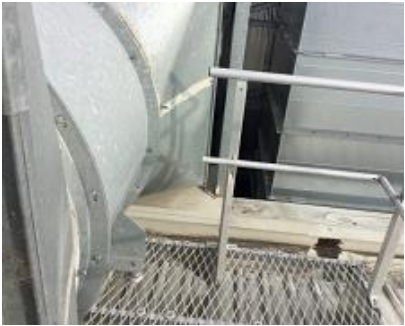
Handrail section is missing	Trips, Slips and Falls	Awareness induction	Med	Handrail to be installed	Low	Client advised	Outstanding	OH&S REGULATIONS 3.7  AS/NZS 1657-2013 4.4
46	Building: General Stores Location Reference: <a href="#">L22</a> Task: Access to the roof

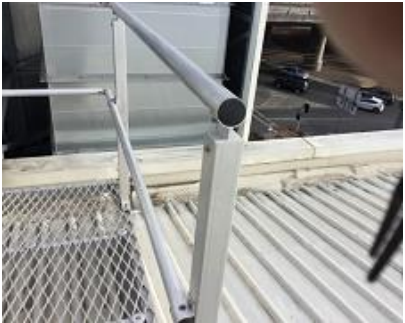
Sharp edges on handrails	Trips, Slips and Falls	Awareness induction	Med	Tek screws to be replaced with rivets	Low	Client advised	Outstanding	OH&S REGULATIONS 3.7  AS/NZS 1657-2013 5.6

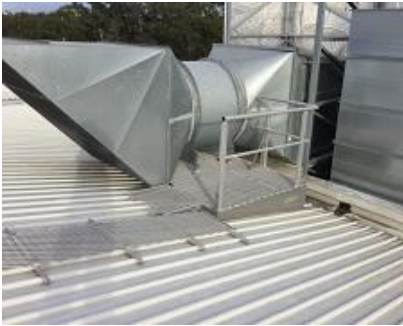
Variation in height between walkway panels are greater than required maximum	Trips, Slips and Falls	Awareness induction	Med	High visibility safety yellow nosing to be installed	Low	Client advised	Outstanding	OH&S REGULATIONS 3.7  AS/NZS 1657-2013 3.3.4
48	Building: General Stores Location Reference: <a href="#">L23</a> Task: Restrict access to the roof

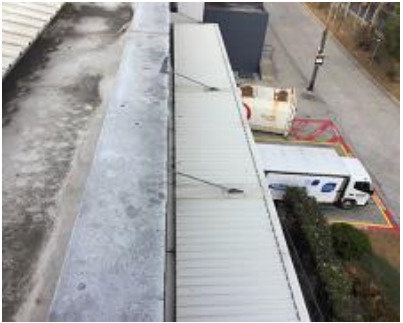
No height safety system installed	Trips, Slips and Falls	Restrict Access	High	"EWP Access only" signs to be installed	Low	Client advised	Outstanding	OH&S REGULATIONS 3.55 & 3.11

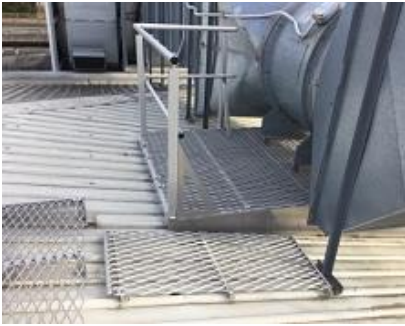
Sharp edges on handrails	Trips, Slips and Falls	Awareness induction	Med	Tek screws to be replaced with rivets	Low	Client advised	Outstanding	OH&S REGULATIONS 3.7  AS/NZS 1657-2013 5.6
50	Building: General Stores Location Reference: <a href="#">L24</a> Task: Access to the roof

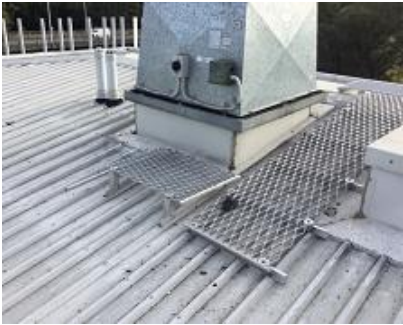
Variation in height between walkway panels are greater than required maximum	Trips, Slips and Falls	Awareness induction	Med	High visibility safety yellow nosing to be installed	Low	Client advised	Outstanding	OH&S REGULATIONS 3.7  AS/NZS 1657-2013 3.3.4
52	Building: General Stores Location Reference: <a href="#">L25</a> Task: Access to the roof

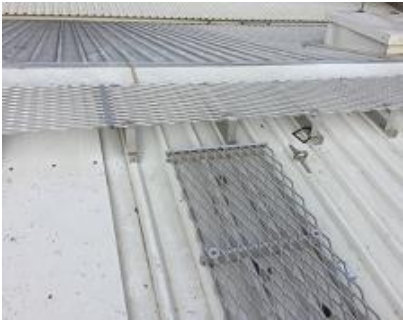
Variation in height between walkway panels are greater than required maximum	Trips, Slips and Falls	Awareness induction	Med	High visibility safety yellow nosing to be installed	Low	Client advised	Outstanding	OH&S REGULATIONS 3.7  AS/NZS 1657-2013 3.3.4

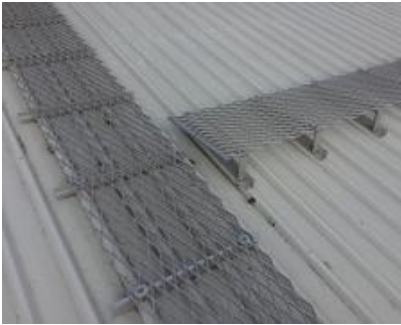
Variation in height between walkway panels are greater than required maximum	Trips, Slips and Falls	Awareness induction	Med	High visibility safety yellow nosing to be installed	Low	Client advised	Outstanding	OH&S REGULATIONS 3.7  AS/NZS 1657-2013 3.3.4
54	Building: General Stores Location Reference: <a href="#">L25</a> Task: Access to the roof

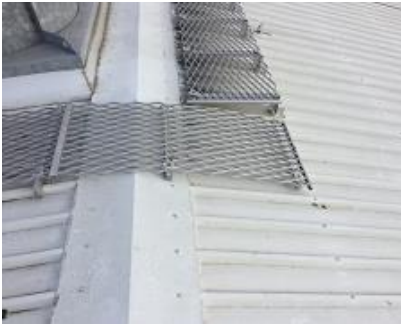
Variation in height between walkway panels are greater than required maximum	Trips, Slips and Falls	Awareness induction	Med	High visibility safety yellow nosing to be installed	Low	Client advised	Outstanding	OH&S REGULATIONS 3.7  AS/NZS 1657-2013 3.3.4
56	Building: General Stores Location Reference: <a href="#">L26</a> Task: Access to the A/c units

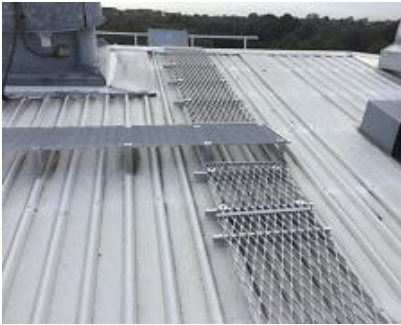
Variation in height between walkway panels are greater than required maximum	Trips, Slips and Falls	Awareness induction	Med	High visibility safety yellow nosing to be installed	Low	Client advised	Outstanding	OH&S REGULATIONS 3.7  AS/NZS 1657-2013 3.3.4
58	Building: General Stores Location Reference: <a href="#">L27</a> Task: Access to the roof

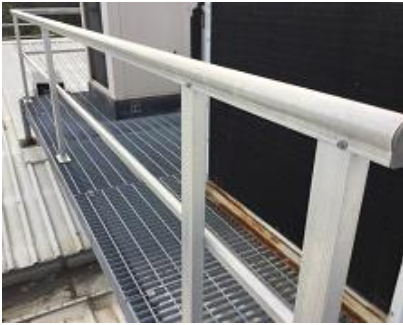
Sharp edges on handrails	Trips, Slips and Falls	Awareness induction	Med	Tek screws to be replaced with rivets	Low	Client advised	Outstanding	OH&S REGULATIONS 3.7  AS/NZS 1657-2013 5.6
60	Building: General Stores Location Reference: <a href="#">L27</a> Task: Access to the roof

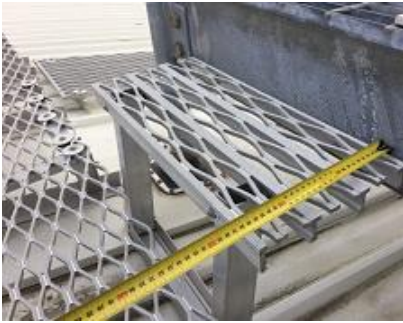
Non-complaint step is present	Trips, Slips and Falls	Awareness induction	Med	Existing step to be removed and new step to be installed	Low	Client advised	Outstanding	OH&S REGULATIONS 3.7  AS/NZS 1657-2013 3.1.4

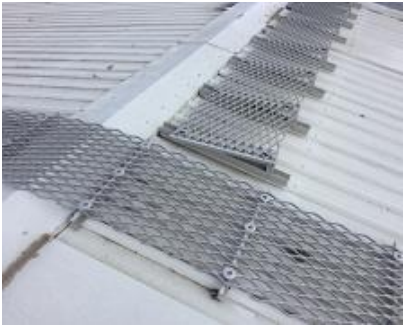
Variation in height between walkway panels are greater than required maximum	Trips, Slips and Falls	Awareness induction	Med	High visibility safety yellow nosing to be installed	Low	Client advised	Outstanding	OH&S REGULATIONS 3.7  AS/NZS 1657-2013 3.3.4
62	Building: General Stores Location Reference: <a href="#">L28</a> Task: Access to the roof

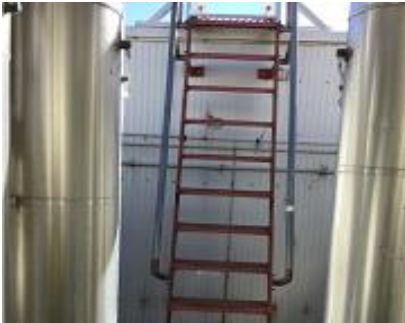
Gap between handrail and ladder is greater than required maximum and walkway installed over the top tread	Trips, Slips and Falls	Awareness induction	Med	Existing handrail to be removed and new handrail to be installed. Walkway to be re-located.	Low	Client advised	Outstanding	OH&S REGULATIONS 3.7  AS/NZS 1657-2013 7.4.3.3 & 7.3.5
68	Building: General Stores Location Reference: <a href="#">L31</a> Task: Access to the roof

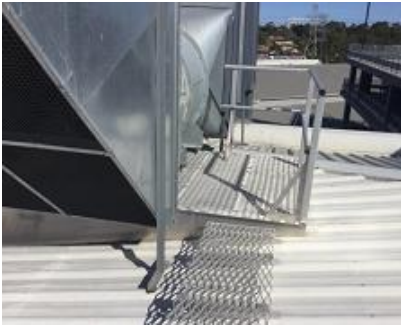
Sharp edges on handrails	Trips, Slips and Falls	Awareness induction	Med	Tek screws to be replaced with rivets	Low	Client advised	Outstanding	OH&S REGULATIONS 3.7  AS/NZS 1657-2013 5.6
