Roof Safety Report

DFO Homebush, NSW 2140

Prepared By: Safemaster Safety Products
Date: 27-11-2020

Roof Safety Report for
DFO Homebush, NSW 2140

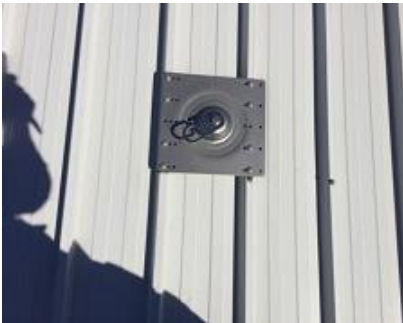
No	Photo of Hazard	Details of Hazard	Details of Risk	Existing/ Immediate Control Measure	Current Risk Level	Proposed Permanent Solution	Residual Risk Assessment	Details of Action Taken	Status	Reference
88	Building: General Stores Location Reference: L01 Task: Access to the roof

Not enough fixings installed (Anchors no longer required in this area)	Trips, Slips and Falls	Awareness induction	High	Existing anchors to be replaced	Low	Client advised	Outstanding	OH&S REGULATIONS 3.55
89	Building: General Stores Location Reference: L04 Task: Access to the roof

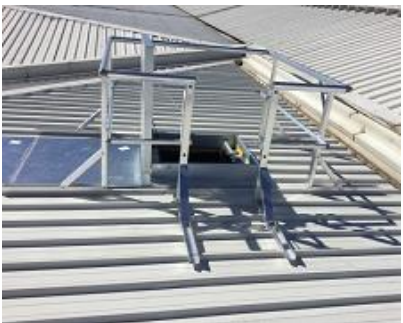
Headroom is less than required minimum and handrail is missing for ladder	Trips, Slips and Falls	Awareness induction	Med	"Caution-Low Headroom" signs and extendable stiles to be installed	Low	Client advised	Outstanding	OH&S REGULATIONS 3.7 AS/NZS 1657- 2013 3.1.5

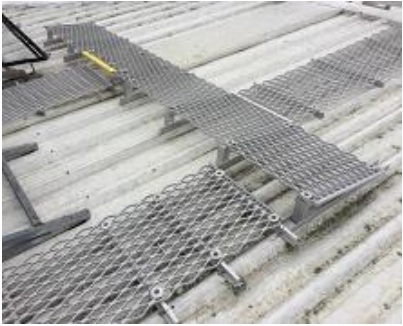
No	Photo of Hazard	Details of Hazard	Details of Risk	Existing/ Immediate Control Measure	Curren t Risk Level	Proposed Permanent Solution	Residu al Risk Assess ment	Details of Action Taken	Status	Reference
90	Building: General Stores Location Reference: L10 Task: Access to the roof

Variation in height between walkway panels are greater than required maximum	Trips, Slips and Falls	Awareness induction	Med	High visibility safety yellow nosing to be installed	Low	Client advised	Outstanding	OH&S REGULATIONS 3.7 AS/NZS 1657-2018 3.3.4
91	Building: General Stores Location Reference: L26 Task: Access to the roof

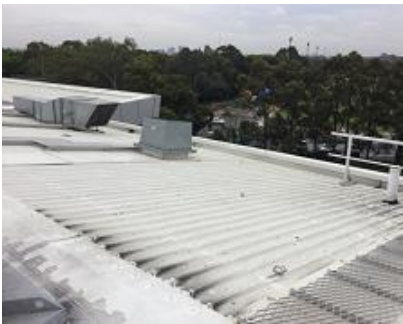
No safe access to the unit	Trips, Slips and Falls	Awareness induction	Med	Existing handrail to be extended for safe access	Low	Client advised	Outstanding	OH&S REGULATIONS 3.7 & 3.55

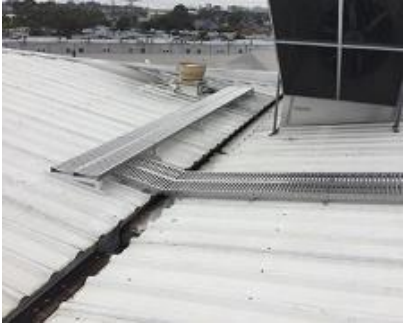
No	Photo of Hazard	Details of Hazard	Details of Risk	Existing/ Immediate Control Measure	Curren t Risk Level	Proposed Permanent Solution	Residu al Risk Assess ment	Details of Action Taken	Status	Reference
92	Building: General Stores Location Reference: L36 Task: Access to the roof

No safe access to the unit	Trips, Slips and Falls	Awareness induction	Med	Handrail to be installed for safe access	Low	Client advised	Outstanding	OH&S REGULATIONS 3.7 & 3.55

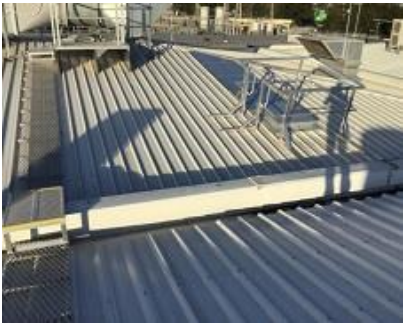
No	Photo of Hazard	Details of Hazard	Details of Risk	Existing/ Immediate Control Measure	Curren t Risk Level	Proposed Permanent Solution	Residu al Risk Assess ment	Details of Action Taken	Status	Reference
93	Building: General Stores Location Reference: L04 Task: Access to the roof

Levelled landing is missing at access point	Trips, Slips and Falls	Awareness induction	Med	Levelled landing including handrails to be installed at access point	Low	Client advised	Outstanding	OH&S REGULATIONS 3.7
94	Building: General Stores Location Reference: L10 Task: Access to the roof

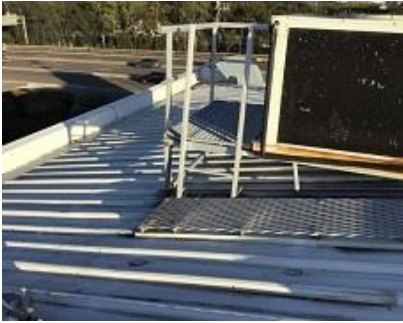
Landing at base is less than required minimum	Trips, Slips and Falls	Awareness induction	Med	Landing/walkway to be installed at base	Low	Client advised	Outstanding	OH&S REGULATIONS 3.7 AS/NZS 1657-2013 7.3.6

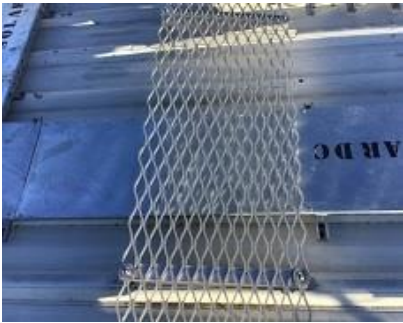
No	Photo of Hazard	Details of Hazard	Details of Risk	Existing/ Immediate Control Measure	Curren t Risk Level	Proposed Permanent Solution	Residu al Risk Assess ment	Details of Action Taken	Status	Reference
95	Building: General Stores Location Reference: L13 Task: Access to the roof

Walkway not fully secured to roof	Trips, Slips and Falls	Awareness induction	Med	Walkway to be secured with additional levelled brackets	Low	Client advised	Outstanding	OH&S REGULATIONS 3.7
96	Building: General Stores Location Reference: L16 Task: Access to the roof

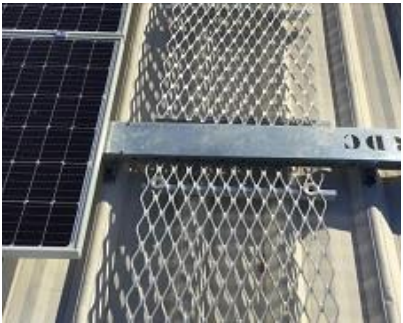
Cable tray installed over the walkway path	Trips, Slips and Falls	Awareness induction	Med	High visibility safety yellow tape to be installed	Low	Client advised	Outstanding	OH&S REGULATIONS 3.7

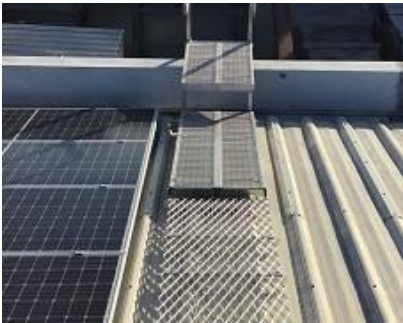
No	Photo of Hazard	Details of Hazard	Details of Risk	Existing/ Immediate Control Measure	Curren t Risk Level	Proposed Permanent Solution	Residu al Risk Assess ment	Details of Action Taken	Status	Reference
97	Building: General Stores Location Reference: L16 Task: Access to the roof

Variation in height between walkway panels are greater than required maximum	Trips, Slips and Falls	Awareness induction	Med	High visibility safety yellow nosings to be installed	Low	Client advised	Outstanding	OH&S REGULATIONS 3.7 AS/NZS 1657-2013 3.3.4
98	Building: General Stores Location Reference: L18 Task: Access to the roof

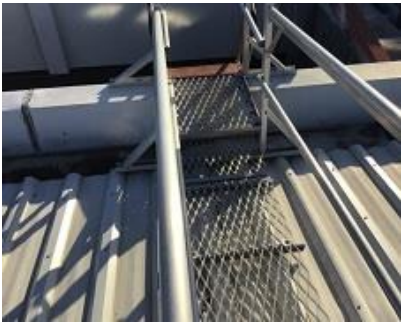
Variation in height between walkway panels are greater than required maximum	Trips, Slips and Falls	Awareness induction	Med	High visibility safety yellow nosings to be installed	Low	Client advised	Outstanding	OH&S REGULATIONS 3.7 AS/NZS 1657-2013 3.3.4

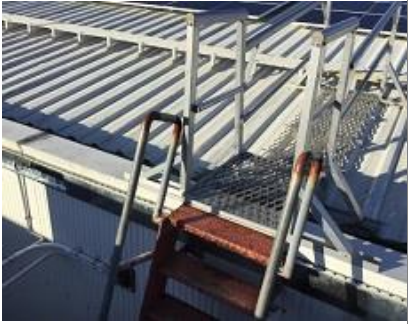
No	Photo of Hazard	Details of Hazard	Details of Risk	Existing/ Immediate Control Measure	Curren t Risk Level	Proposed Permanent Solution	Residu al Risk Assess ment	Details of Action Taken	Status	Reference
99	Building: General Stores Location Reference: L20 Task: Access to the roof

Variation in height between walkway panels are greater than required maximum	Trips, Slips and Falls	Awareness induction	Med	High visibility safety yellow nosings to be installed	Low	Client advised	Outstanding	OH&S REGULATIONS 3.7 AS/NZS 1657-2013 3.3.4
