Roof Safety Report

**DFO Homebush,
NSW 2140**

Prepared By: Safemaster Safety Products
Date: 06-11-2019

06-11-2019

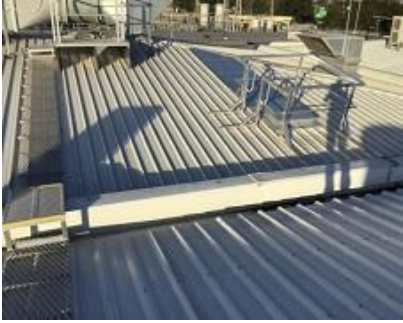
Levelled landing is missing at access point	Trips, Slips and Falls	Awareness induction	Med	Levelled landing including handrails to be installed at access point	Low	Client advised	Outstanding	OH&S REGULATIONS 3.7
94	Building: General Stores Location Reference: L10 Task: Access to the roof

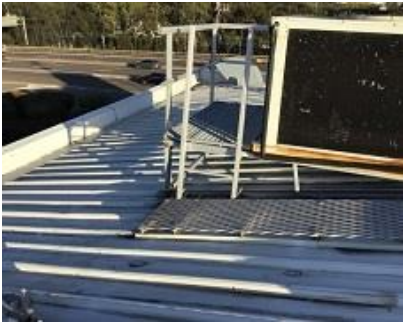
Landing at base is less than required minimum	Trips, Slips and Falls	Awareness induction	Med	Landing/walkway to be installed at base	Low	Client advised	Outstanding	OH&S REGULATIONS 3.7 AS/NZS 1657-2013 7.3.6

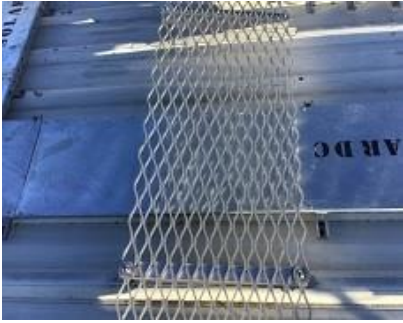
Walkway not fully secured to roof	Trips, Slips and Falls	Awareness induction	Med	Walkway to be secured with additional levelled brackets	Low	Client advised	Outstanding	OH&S REGULATIONS 3.7
96	Building: General Stores Location Reference: L16 Task: Access to the roof

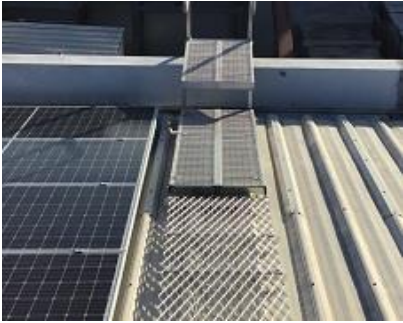
Variation in height between walkway panels are greater than required maximum	Trips, Slips and Falls	Awareness induction	Med	High visibility safety yellow nosings to be installed	Low	Client advised	Outstanding	OH&S REGULATIONS 3.7 AS/NZS 1657-2013 3.3.4
98	Building: General Stores Location Reference: L18 Task: Access to the roof
