Roof Safety Report

Dianella Plaza, WA 6059

Prepared By: Safemaster Safety Products
Date: 08 August 2018

31-07-2018

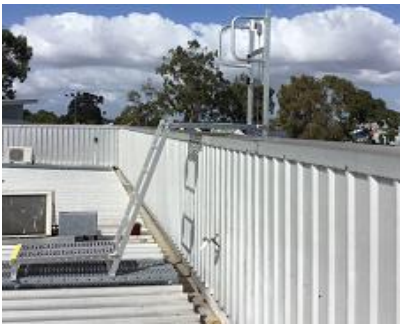
Inadequate fall protection at ladder landing platform	Trips, Slips and Falls	Awareness induction	Med	Existing ladder section to be removed and new ladder section including handrails to be installed	Low	Client advised	Outstanding	OH&S REGULATIONS 3.7 AS/NZS 1657-2018 4.4
81	Building: General Stores Location Reference: L01 Task: Access to the ladder

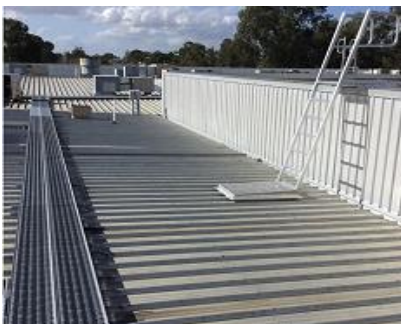
No safe access to the ladder	Trips, Slips and Falls	N/A	Low	Supply walkway to the ladder	Low	Client advised	Outstanding	-

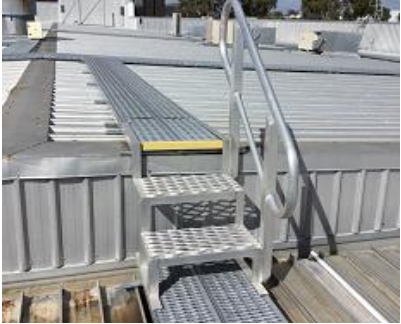
Tread risers are greater than required maximum	Trips, Slips and Falls	Awareness induction	Med	Existing stair to be removed and new ladder to be installed	Low	Client advised	Outstanding	OH&S REGULATIONS 3.7 AS/NZS 1657-2018 7.2.3.2
83	Building: General Stores Location Reference: L09 Task: Access to the roof

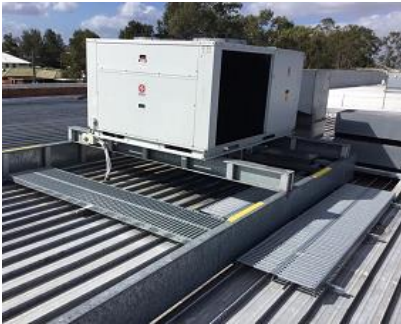
Trip hazards are present	Trips, Slips and Falls	Awareness induction	Med	"Trip Hazard" signs to be installed	Low	Client advised	Outstanding	OH&S REGULATIONS 3.7 & 3.11

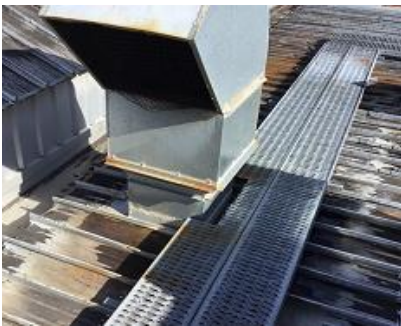
Walkway width is less than required minimum	Trips, Slips and Falls	Awareness induction	Med	Additional walkway section to be installed	Low	Client advised	Outstanding	OH&S REGULATIONS 3.7 AS/NZS 1657-2018 5.1.3
85	Building: General Stores Location Reference: L16 Task: Access to the A/c units

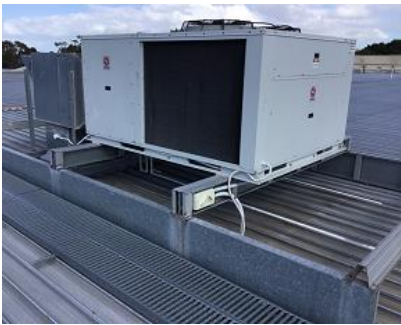
No safe access to the A/c units	Trips, Slips and Falls	N/A	Low	Supply walkway to the A/c units including trip hazard signs and safety yellow tape on bracings	Low	Client advised	Outstanding	-

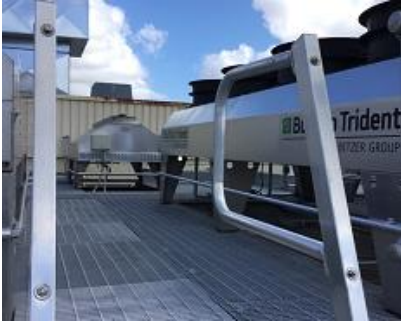
Sharp edges on ladder stiles	Trips, Slips and Falls	Awareness induction	Med	Bolt caps to be installed	Low	Client advised	Outsta nding	OH&S REGULATIONS 3.7 AS/NZS 1657- 2018 5.6
87	Building: General Stores Location Reference: L22 Task: Access to the roof

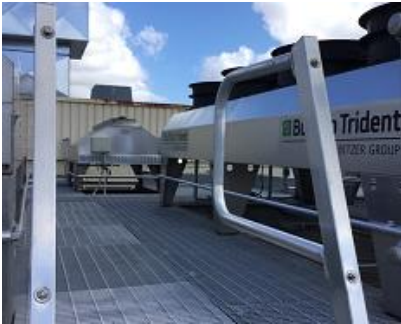
Sharp edges on ladder stiles	Trips, Slips and Falls	Awareness induction	Med	Bolt caps to be installed	Low	Client advised	Outsta nding	OH&S REGULATIONS 3.7 AS/NZS 1657- 2018 5.6

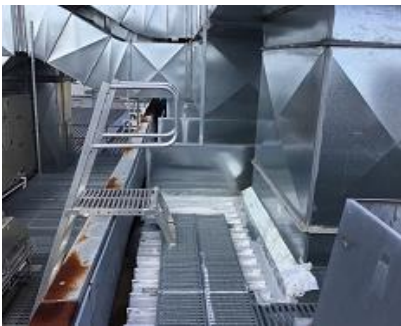
Walkway installed too close to fall edge and duct installed in front of ladder	Trips, Slips and Falls	Awareness induction	Med	Existing ladder to be re-located with landing platform, additional walkway sections, step bridge, handrails and low headroom signs	Low	Client advised	Outstanding	OH&S REGULATIONS 3.7 AS/NZS 1657-2018 5.4.1, 7.3.6 & 3.1.5
89	Building: General Stores Location Reference: L28 Task: Access to the roof

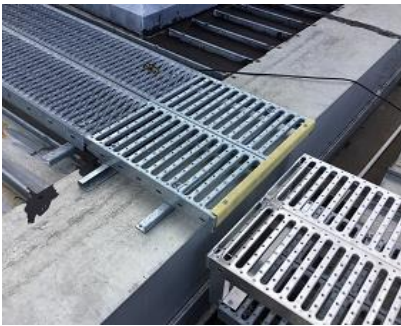
Roof walkway section not fully secured	Trips, Slips and Falls	Awareness induction	Med	Roof walkway section to be secured	Low	Client advised	Outstanding	OH&S REGULATIONS 3.7

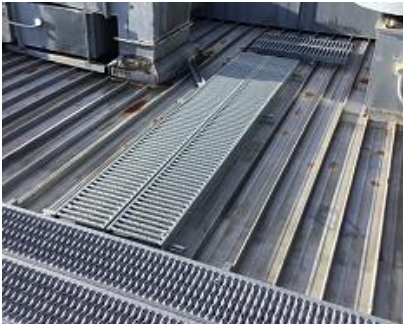
Roof walkway section not fully secured	Trips, Slips and Falls	Awareness induction	Med	Roof walkway section to be secured	Low	Client advised	Outstanding	OH&S REGULATIONS 3.7
91	Building: General Stores Location Reference: L37 Task: Access to the roof

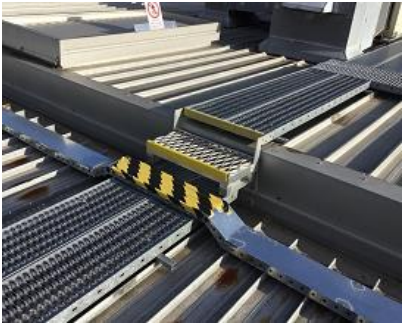
Cable tray installed over the walkway path	Trips, Slips and Falls	Awareness induction	Med	New landing platform to be installed to level with existing step	Low	Client advised	Outstanding	OH&S REGULATIONS 3.7

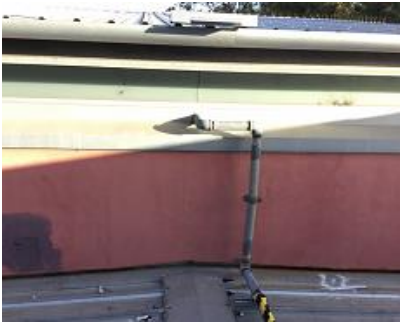
Not able to use ladder bracket safely	Trips, Slips and Falls	Awareness induction	Med	Levelled landing platform to be installed	Low	Client advised	Outstanding	OH&S REGULATIONS 3.7
93	Building: General Stores Location Reference: L38 Task: Restrict access to the roof

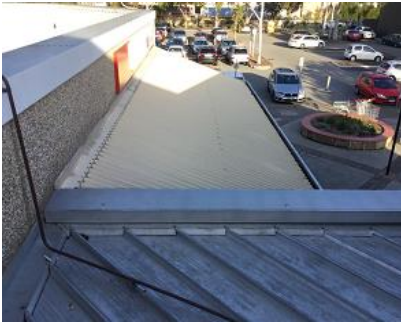
No height safety system installed	Trips, Slips and Falls	Restrict Access	High	"No Roof Access" sign to be installed	Low	Client advised	Outstanding	94

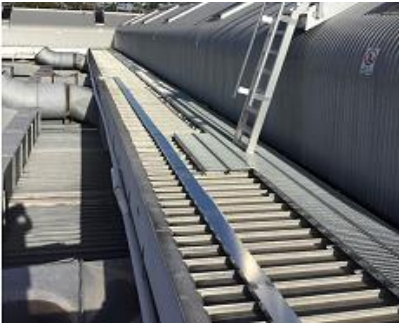
Gap between walkway and fall edge is less than required minimum	Trips, Slips and Falls	Awareness induction	Med	Handrail to be installed	Low	Client advised	Outstanding	OH&S REGULATIONS 3.7 AS/NZS 1657-2018 5.4.1
95	Building: General Stores Location Reference: L42 Task: Access to the roof

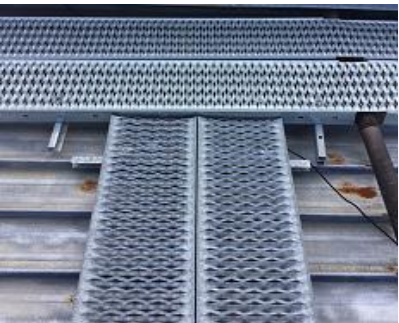
Variation in height between walkway panels are greater than required maximum	Trips, Slips and Falls	Awareness induction	Med	High visibility safety yellow nosing to be installed	Low	Client advised	Outstanding	OH&S REGULATIONS 3.7 AS/NZS 1657-2018 3.3.4

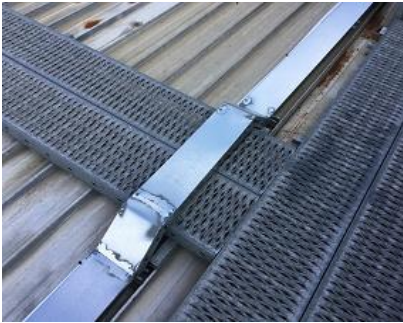
Cable tray installed over the walkway path	Trips, Slips and Falls	Awareness induction	Med	Step over to be installed	Low	Client advised	Outstanding	OH&S REGULATIONS 3.7 AS/NZS 1657-2018 3.1.4
97	Building: General Stores Location Reference: L44 Task: Access to the roof

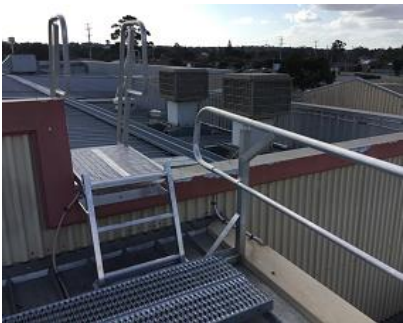
Ladder is too close to the fall edge	Trips, Slips and Falls	Awareness induction	Med	Existing ladder to be removed and new ladder to be installed in a new location	Low	Client advised	Outstanding	OH&S REGULATIONS 3.7 AS/NZS 1657-2018 3.1.4

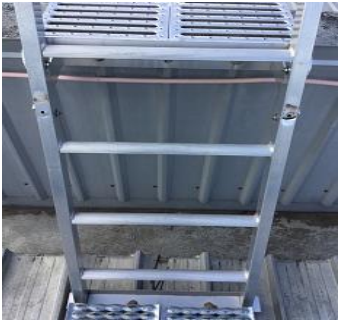
Existing ladder stiles damaged and bottom rung heights are less than required minimum	Trips, Slips and Falls	Awareness induction	Med	Existing ladder to be removed and new ladder to be installed	Low	Client advised	Outstanding	OH&S REGULATIONS 3.7 AS/NZS 1657-2018 7.4.3.4
99	Building: General Stores Location Reference: L48 Task: Access to the roof

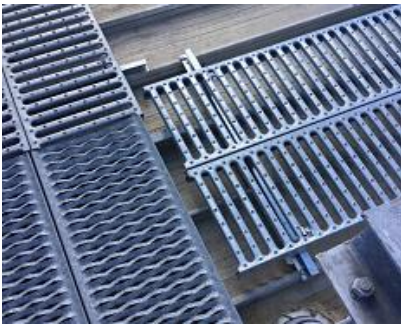
Gap between walkway panels are greater than required maximum	Trips, Slips and Falls	Awareness induction	Med	Checker plate to be installed to close the gap including high visibility safety yellow nosing's	Low	Client advised	Outstanding	OH&S REGULATIONS 3.7 AS/NZS 1657-2018 3.3.4

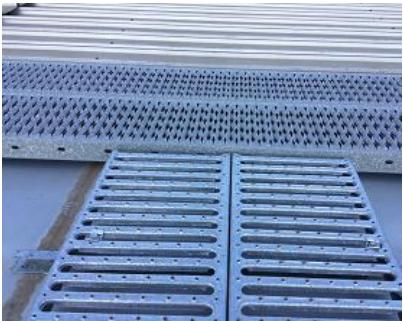
Variation in height between walkway panels are greater than required maximum	Trips, Slips and Falls	Awareness induction	Med	High visibility safety yellow nosing to be installed	Low	Client advised	Outstanding	OH&S REGULATIONS 3.7 AS/NZS 1657-2018 3.3.4
