# Roof Safety Report

**Eastlands, TAS 7018**

Prepared By: Safemaster Safety Products  
Date: 31-08-2020

CLIENT	BUILDINGS INSPECTED	SYSTEMS INSPECTED
Eastlands Shopping Centre	26 Bligh Street, Rosny Park TAS 7018	Anchor Points Signage Handrail Ladder Stair Mechanical Platform Roof Walkway

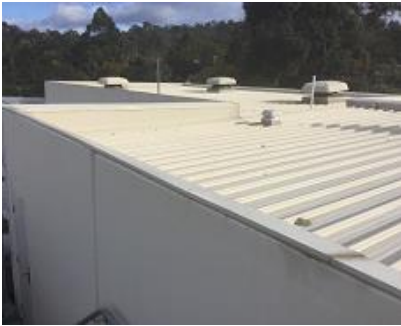
No height safety system installed	Trips, Slips and Falls	Awareness induction	High	Fall arrest anchors to be installed	Low	Client advised	Outstanding	OH&S REGULATIONS 3.55
02	Building: General Stores Location Reference: <a href="#">L01</a> Task: Access to the roof

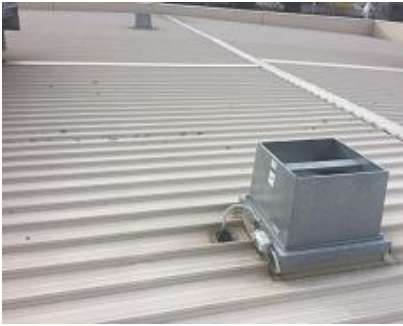
No safe access to the A/c units	Trips, Slips and Falls	N/A	Low	Supply walkway to the A/c units	Low	Client advised	Outstanding	-
04	Building: General Stores Location Reference: <a href="#">L03</a> Task: Access to the roof

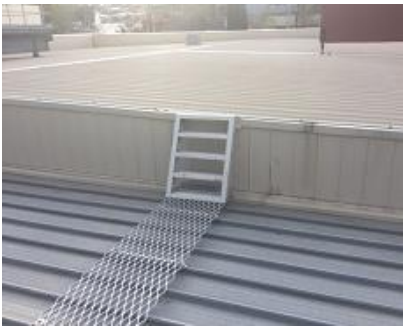
Non-complaint ladder is present	Trips, Slips and Falls	Awareness induction	Med	Existing ladder to be removed and new ladder to be installed	Low	Client advised	Outstanding	OH&S REGULATIONS 3.7  AS/NZS 1657-2013 7.3
06	Building: General Stores Location Reference: <a href="#">L05</a> Task: Access to the A/c units

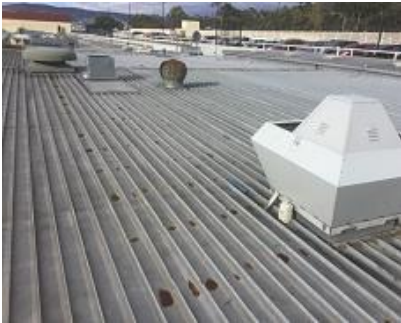
No safe access to the A/c units	Trips, Slips and Falls	N/A	Low	Supply walkway to the A/c units	Low	Client advised	Outstanding	-
08	Building: General Stores Location Reference: <a href="#">L05</a> Task: Access to the A/c units

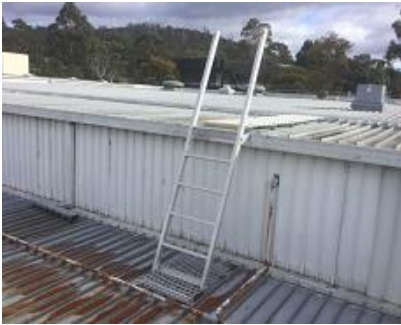
Non-complaint ladder is present	Trips, Slips and Falls	Awareness induction	Med	Existing ladder to be removed and new ladder to be installed	Low	Client advised	Outstanding	OH&S REGULATIONS 3.7  AS/NZS 1657-2013 7.3
10	Building: General Stores Location Reference: <a href="#">L07</a> Task: Access to the roof

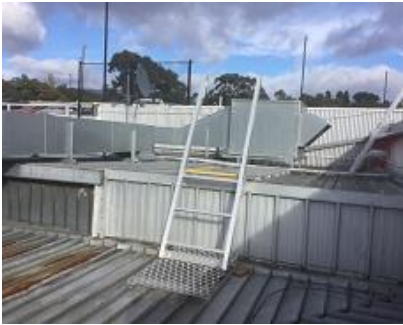
Non-complaint ladder is present	Trips, Slips and Falls	Awareness induction	Med	Existing ladder to be removed and new ladder to be installed	Low	Client advised	Outstanding	OH&S REGULATIONS 3.7  AS/NZS 1657-2013 7.3
12	Building: General Stores Location Reference: <a href="#">L08</a> Task: Access to the A/c units

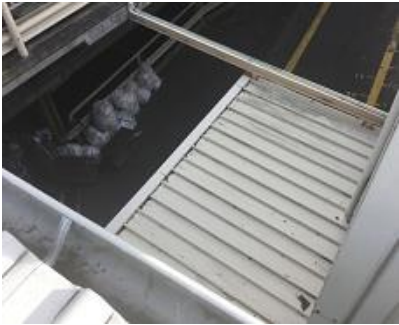
No height safety system installed	Trips, Slips and Falls	Restrict Access	High	"EWP Access Only" sign to be installed	Low	Client advised	Outstanding	OH&S REGULATIONS 3.55 & 3.11
14	Building: General Stores Location Reference: <a href="#">L09</a> Task: Access to the roof

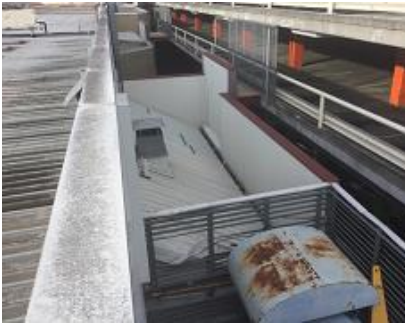
No safe access to the roof	Trips, Slips and Falls	Awareness induction	Med	Access ladder to be installed	Low	Client advised	Outsta nding	OH&S REGULATIONS 3.7  AS/NZS 1657- 2013 3.1.4
16	Building: General Stores Location Reference: <a href="#">L10</a> Task: Access to the A/c units

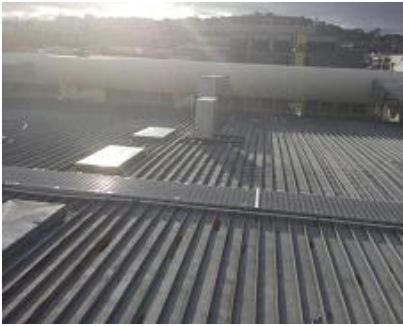
No safe access to the A/c units	Trips, Slips and Falls	N/A	Low	Supply walkway to the A/c units	Low	Client advised	Outstanding	-
18	Building: General Stores Location Reference: <a href="#">L10</a> Task: Access to the A/c units

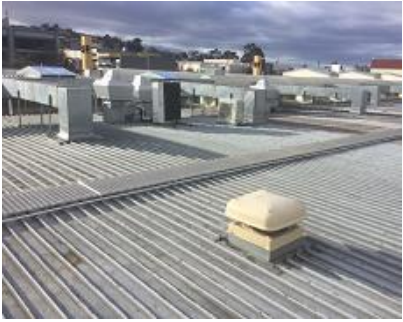
No safe access to the A/c units	Trips, Slips and Falls	N/A	Low	Supply walkway to the A/c units	Low	Client advised	Outstanding	-

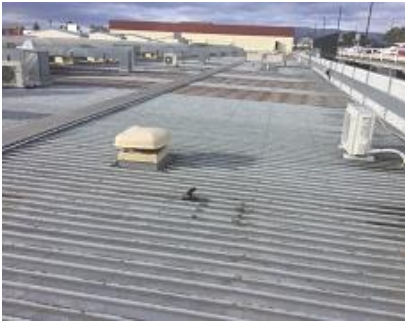
No safe access to the A/c units	Trips, Slips and Falls	N/A	Low	Supply walkway to the A/c units	Low	Client advised	Outstanding	-
20	Building: General Stores Location Reference: <a href="#">L11</a> Task: Access to the roof

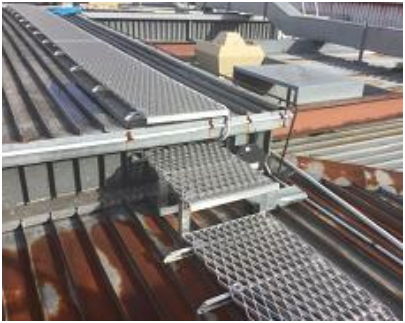
Non-complaint step is present	Trips, Slips and Falls	Awareness induction	Med	Existing step to be removed and new ladder to be installed	Low	Client advised	Outstanding	OH&S REGULATIONS 3.7  AS/NZS 1657-2013 3.1.4

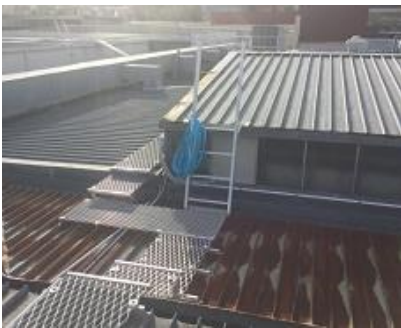
Non-complaint ladder is present	Trips, Slips and Falls	Awareness induction	Med	Existing ladder to be removed and new ladder to be installed	Low	Client advised	Outstanding	OH&S REGULATIONS 3.7  AS/NZS 1657-2013 7.3
22	Building: General Stores Location Reference: <a href="#">L1</a> Task: Access to the roof

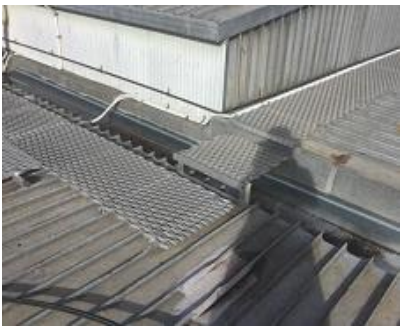
Non-complaint step is present	Trips, Slips and Falls	Awareness induction	Med	Existing step to be removed and new ladder to be installed	Low	Client advised	Outsta nding	OH&S REGULATIONS 3.7  AS/NZS 1657- 2013 3.1.4
24	Building: General Stores Location Reference: <a href="#">L12</a> Task: Access to the roof

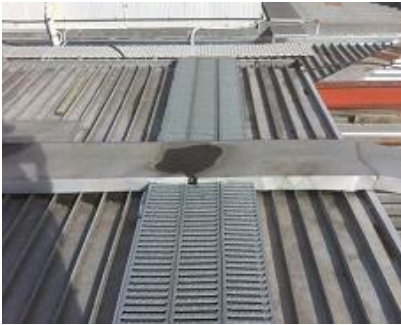
Cable tray installed over the walkway path	Trips, Slips and Falls	Awareness induction	Med	Step bridge to be installed	Low	Client advised	Outstanding	OH&S REGULATIONS 3.7  AS/NZS 1657-2013 3.1.4
26	Building: General Stores Location Reference: <a href="#">L13</a> Task: Access to the roof

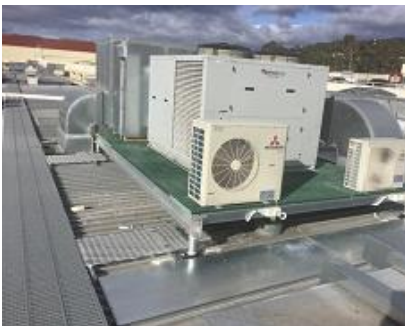
Variation in height between plant deck and roof is greater than required maximum	Trips, Slips and Falls	Awareness induction	Med	Handrail to be installed	Low	Client advised	Outstanding	OH&S REGULATIONS 3.7  AS/NZS 1657-2013 4.4
30	Building: General Stores Location Reference: <a href="#">L16</a> Task: Access to the plant deck

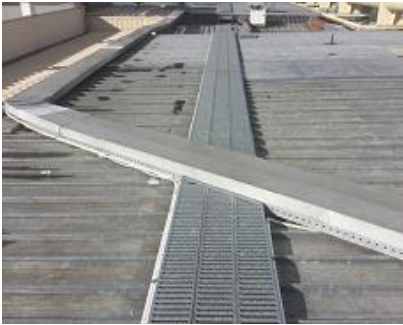
Cable tray installed over the walkway path	Trips, Slips and Falls	Awareness induction	Med	Step bridge to be installed	Low	Client advised	Outstanding	OH&S REGULATIONS 3.7  AS/NZS 1657-2013 3.1.4
32	Building: General Stores Location Reference: <a href="#">L17</a> Task: Access to the A/c units

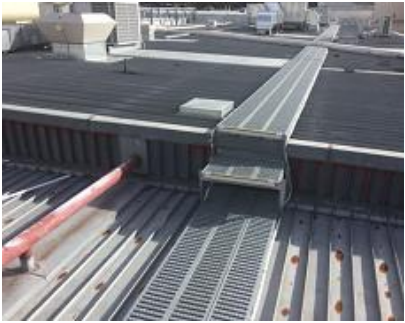
Non-complaint step is present	Trips, Slips and Falls	Awareness induction	Med	Existing step to be removed and new ladder to be installed	Low	Client advised	Outsta nding	OH&S REGULATIONS 3.7  AS/NZS 1657- 2013 3.1.4
34	Building: General Stores Location Reference: <a href="#">L18</a> Task: Access to the roof

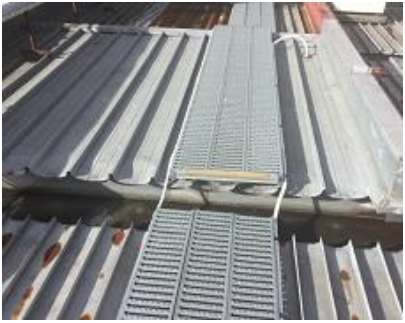
Gap between walkway panels are greater than required maximum	Trips, Slips and Falls	Awareness induction	Med	Additional walkway section to be installed	Low	Client advised	Outsta nding	OH&S REGULATIONS 3.7  AS/NZS 1657- 2013 3.2.3.4

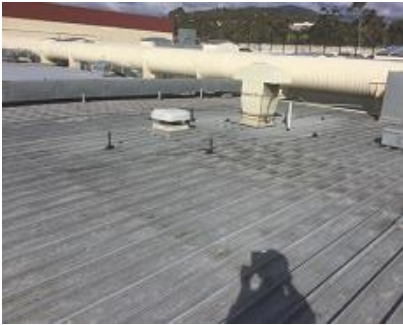
No safe access to the A/c units	Trips, Slips and Falls	N/A	Low	Supply walkway to the A/c units	Low	Client advised	Outstanding	-
38	Building: General Stores Location Reference: <a href="#">L18</a> Task: Access to the roof

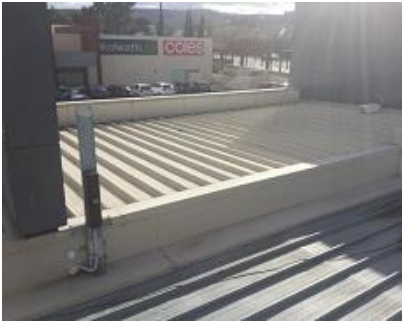
No height safety system installed	Trips, Slips and Falls	Awareness induction	High	Fall arrest anchors to be installed	Low	Client advised	Outstanding	OH&S REGULATIONS 3.55

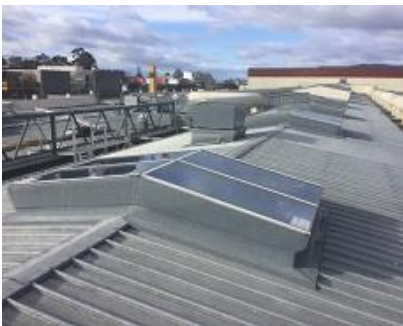
Brittle roof (Non-trafficable roof)	Trips, Slips and Falls	Restrict Access	High	"Warning-Keep Off-Brittle and Fragile Roof" signs to be installed	Low	Client advised	Outstanding	OH&S REGULATIONS 3.57
40	Building: General Stores Location Reference: <a href="#">L20</a> Task: Access to the A/c units

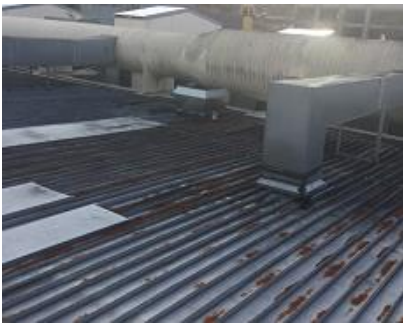
No safe access to the A/c units	Trips, Slips and Falls	N/A	Low	Supply walkway to the A/c units	Low	Client advised	Outstanding	-

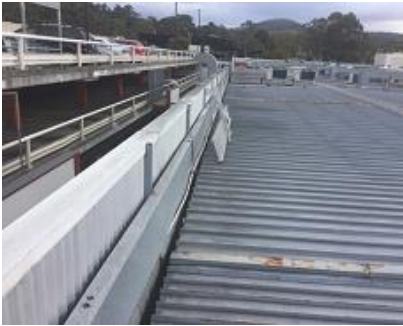
Non-complaint ladder is present	Trips, Slips and Falls	Awareness induction	Med	Existing ladder to be removed and new ladder to be installed	Low	Client advised	Outstanding	OH&S REGULATIONS 3.7  AS/NZS 1657-2013 7.4
42	Building: General Stores Location Reference: <a href="#">L21</a> Task: Access to the roof

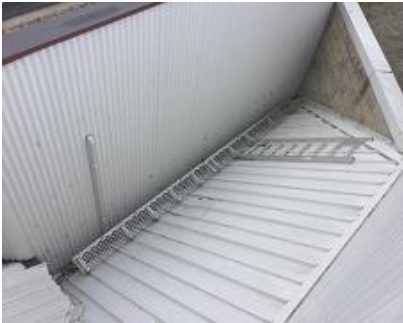
Non-complaint ladder is present, Walkway width is less than required minimum	Trips, Slips and Falls	Awareness induction	Med	Existing ladder to be removed. New cleats on steep roof and 600mm wide walkway to be installed	Low	Client advised	Outstanding	OH&S REGULATIONS 3.7  AS/NZS 1657-2013 7.3 & 5.1.3

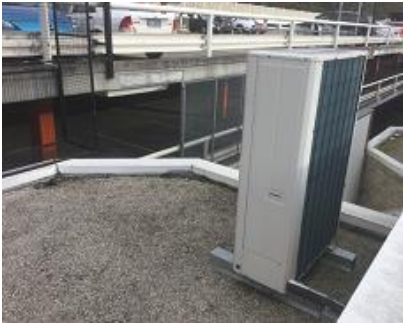
No height safety system installed	Trips, Slips and Falls	Awareness induction	High	Handrails to be installed	Low	Client advised	Outstanding	OH&S REGULATIONS 3.55
44	Building: General Stores Location Reference: <a href="#">L23</a> Task: Access to the roof

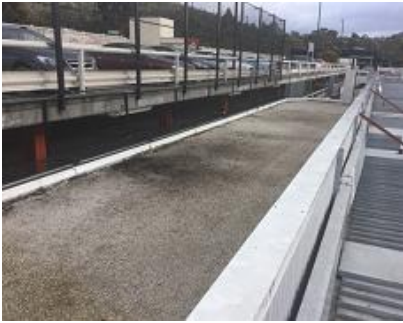
Variation in height between roofs are greater than required maximum	Trips, Slips and Falls	Awareness induction	Med	Access ladder to be installed	Low	Client advised	Outstanding	OH&S REGULATIONS 3.7  AS/NZS 1657-2013 3.1.4

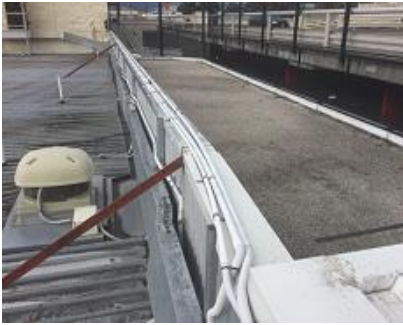
Variation in height between roofs are greater than required maximum	Trips, Slips and Falls	Awareness induction	Med	Access ladder to be installed	Low	Client advised	Outstanding	OH&S REGULATIONS 3.7  AS/NZS 1657-2013 3.1.4
46	Building: General Stores Location Reference: <a href="#">L23</a> Task: Access to the A/c units

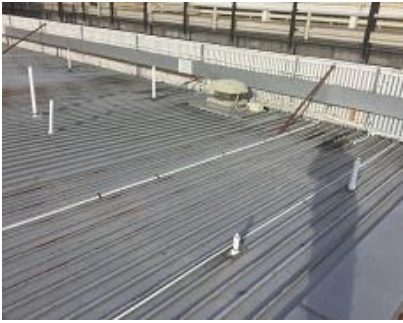
No safe access to the A/c units	Trips, Slips and Falls	N/A	Low	Supply walkway to the A/c units	Low	Client advised	Outstanding	-

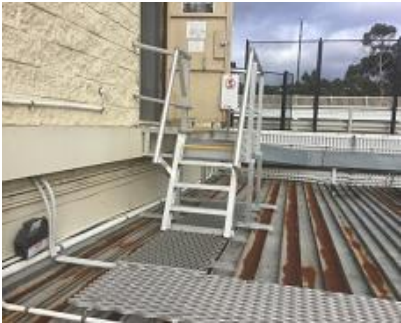
Uneven tread heights are present	Trips, Slips and Falls	Awareness induction	Med	Existing ladder to be removed and new ladder to be installed	Low	Client advised	Outstanding	OH&S REGULATIONS 3.7  AS/NZS 1657-2013 7.3
48	Building: General Stores Location Reference: <a href="#">L24</a> Task: Access to the roof

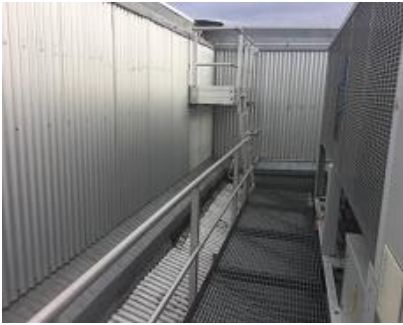
Bottom rung height is less than required minimum	Trips, Slips and Falls	Awareness induction	Med	Landing platform to be installed	Low	Client advised	Outstanding	OH&S REGULATIONS 3.7  AS/NZS 1657-2013 7.4.3.4
50	Building: General Stores Location Reference: <a href="#">L24</a> Task: Access to the plant deck

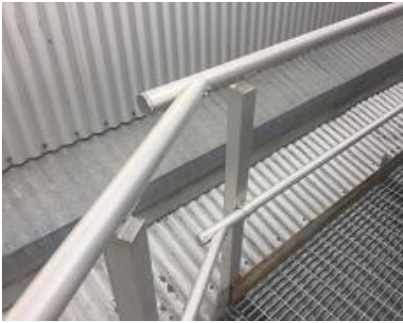
Sharp edges on handrails	Trips, Slips and Falls	Awareness induction	Med	Tek screws to be replaced with rivets and elbow to be installed	Low	Client advised	Outstanding	OH&S REGULATIONS 3.7  AS/NZS 1657-2013 5.6

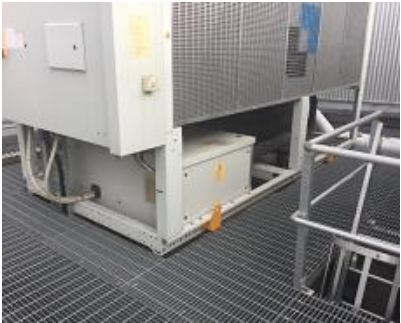
Variation in height between plant deck and unit is greater than required maximum	Trips, Slips and Falls	Awareness induction	Med	Handrails to be installed	Low	Client advised	Outstanding	OH&S REGULATIONS 3.7  AS/NZS 1657-2013 4.4
52	Building: General Stores Location Reference: <a href="#">L25</a> Task: Access to the plant deck

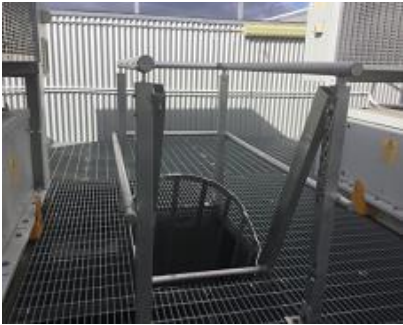
Gap between ladder stiles and handrail posts is less than required minimum	Trips, Slips and Falls	Awareness induction	Med	Existing handrails to be re-installed	Low	Client advised	Outstanding	OH&S REGULATIONS 3.7  AS/NZS 1657-2013 7.4.5
54	Building: General Stores Location Reference: <a href="#">L26</a> Task: Access to the roof

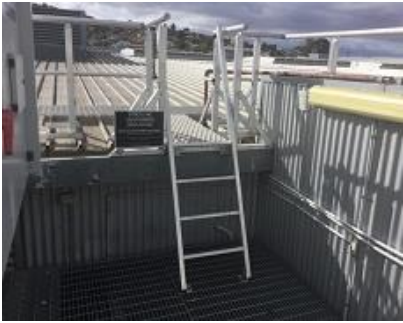
Top rung not levelled with landing and bottom rung height is greater than required maximum	Trips, Slips and Falls	Awareness induction	Med	Existing ladder to be re-installed with landing platform and brackets	Low	Client advised	Outstanding	OH&S REGULATIONS 3.7  AS/NZS 1657-2013 7.4.3.3 & 7.4.3.4

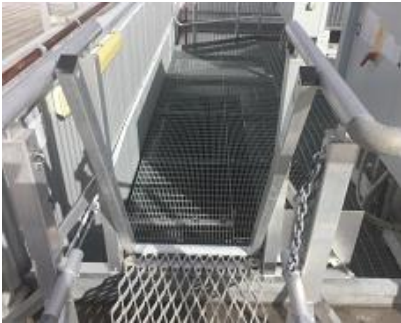
Gap between ladder stiles and handrail posts is less than required minimum	Trips, Slips and Falls	Awareness induction	Med	Existing handrails to be re-installed	Low	Client advised	Outstanding	OH&S REGULATIONS 3.7  AS/NZS 1657-2013 7.4.5
56	Building: General Stores Location Reference: <a href="#">L27</a> Task: Restrict access to the roof

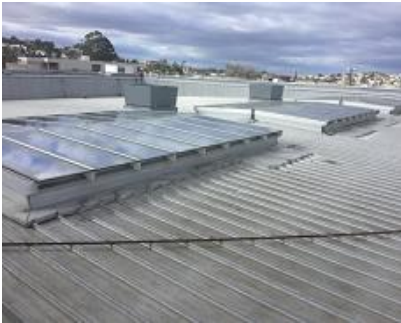
Brittle roof (Non-trafficable roof)	Trips, Slips and Falls	Restrict Access	High	"Warning-Keep Off-Brittle and Fragile Roof" signs to be installed	Low	Client advised	Outstanding	OH&S REGULATIONS 3.57

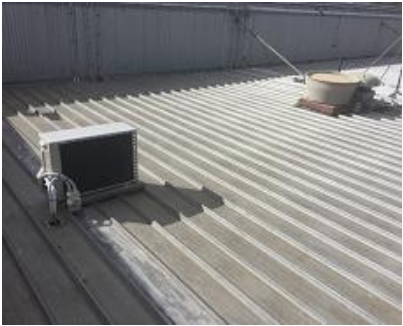
No safe access to the A/c units	Trips, Slips and Falls	N/A	Low	Supply walkway to the A/c units	Low	Client advised	Outstanding	-
58	Building: General Stores Location Reference: <a href="#">L28</a> Task: Access to the roof

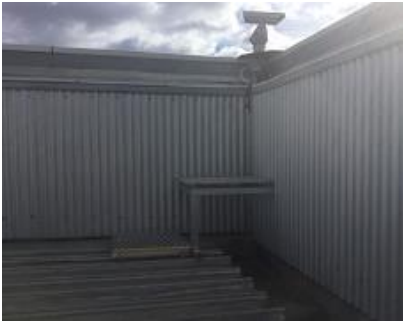
Non-complaint step is present	Trips, Slips and Falls	Awareness induction	Med	Existing step to be removed and new ladder to be installed	Low	Client advised	Outstanding	OH&S REGULATIONS 3.7  AS/NZS 1657-2013 3.1.4

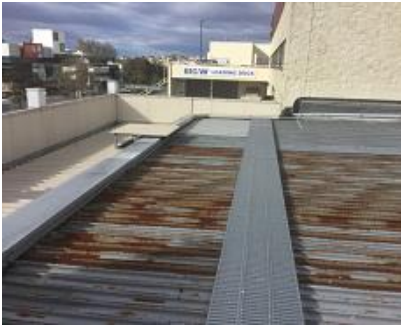
No height safety system installed	Trips, Slips and Falls	Awareness induction	High	Fall arrest anchor to be installed	Low	Client advised	Outstanding	OH&S REGULATIONS 3.55
60	Building: General Stores Location Reference: <a href="#">L29</a> Task: Access to the roof

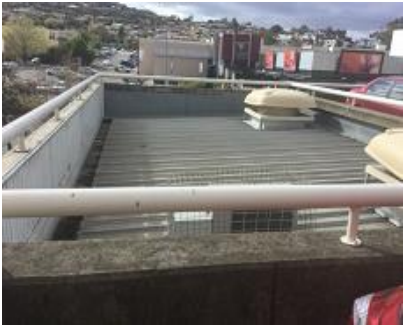
No safe access to the roof and A/c units	Trips, Slips and Falls	Awareness induction	Med	Ladder access bracket, permanent ladder and walkway to be installed	Low	Client advised	Outsta nding	OH&S REGULATIONS 3.7  AS/NZS 1657- 2013 3.1.4
62	Building: General Stores Location Reference: <a href="#">L30</a> Task: Access to the roof

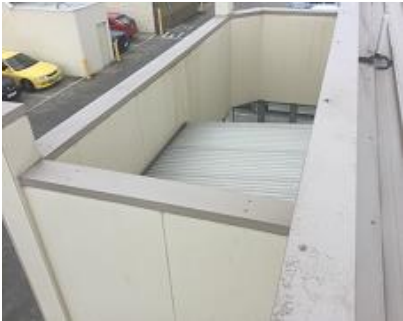
No height safety system installed	Trips, Slips and Falls	Restrict Access	High	"EWP Access Only" sign to be installed	Low	Client advised	Outstanding	OH&S REGULATIONS 3.55 & 3.11
64	Building: General Stores Location Reference: <a href="#">L30</a> Task: Access to the roof

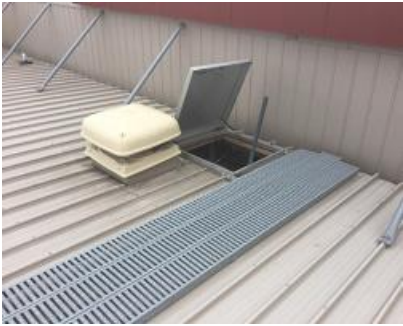
No safe access to the roof	Trips, Slips and Falls	Awareness induction	High	Handrails and access anchor to be installed	Low	Client advised	Outstanding	OH&S REGULATIONS 3.55
66	Building: General Stores Location Reference: <a href="#">L31</a> Task: Restrict access to the roof

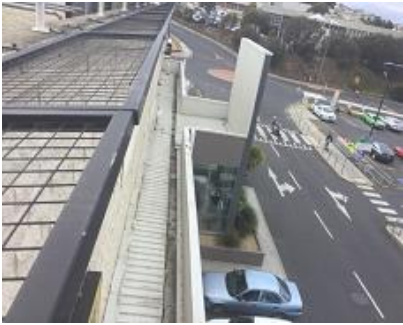
No height safety system installed	Trips, Slips and Falls	Restrict Access	High	"EWP Access Only" signs to be installed	Low	Client advised	Outstanding	OH&S REGULATIONS 3.55 & 3.11
68	Building: General Stores Location Reference: <a href="#">L32</a> Task: Access to the roof

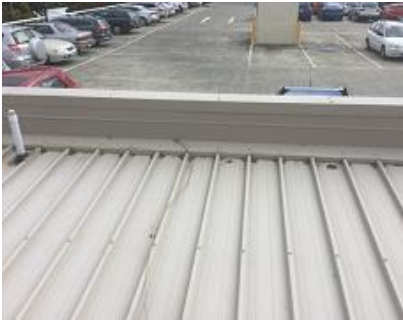
No safe access to the roof	Trips, Slips and Falls	Awareness induction	Med	Access ladder and ladder access bracket to be installed	Low	Client advised	Outstanding	OH&S REGULATIONS 3.7  AS/NZS 1657-2013 3.1.4

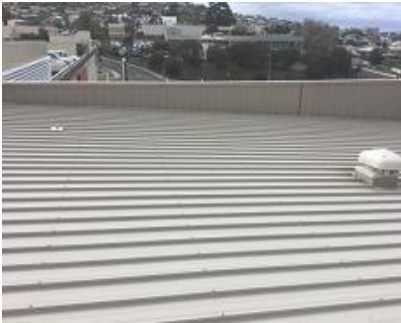
No height safety system installed	Trips, Slips and Falls	Awareness induction	High	Fall arrest anchors to be installed	Low	Client advised	Outstanding	OH&S REGULATIONS 3.55
70	Building: General Stores Location Reference: <a href="#">L33</a> Task: Access to the roof

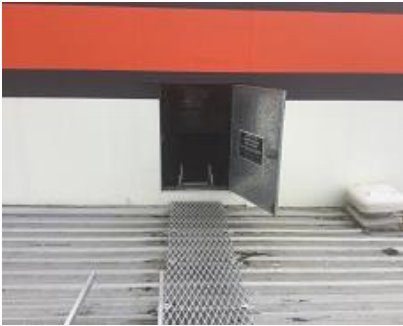
Headroom is less than required minimum	Trips, Slips and Falls	Awareness induction	Med	"Caution-Low Headroom" signs to be installed	Low	Client advised	Outstanding	OH&S REGULATIONS 3.7  AS/NZS 1657-2013 3.1.5
72	Building: General Stores Location Reference: <a href="#">L33</a> Task: Access to the roof

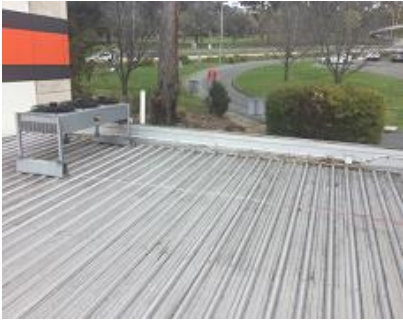
No height safety system installed	Trips, Slips and Falls	Awareness induction	High	Fall arrest anchors to be installed	Low	Client advised	Outstanding	OH&S REGULATIONS 3.55

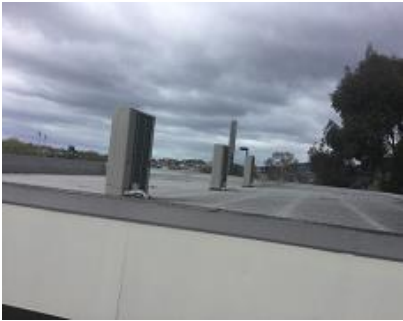
No height safety system installed	Trips, Slips and Falls	Awareness induction	High	Fall arrest anchors and access ladder to be installed	Low	Client advised	Outstanding	OH&S REGULATIONS 3.55  AS/NZS 1657-2013 3.1.4
74	Building: General Stores Location Reference: <a href="#">L34</a> Task: Access to the roof

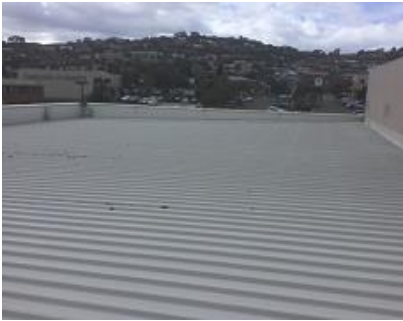
No height safety system installed	Trips, Slips and Falls	Awareness induction	High	Fall arrest anchors to be installed	Low	Client advised	Outstanding	OH&S REGULATIONS 3.55

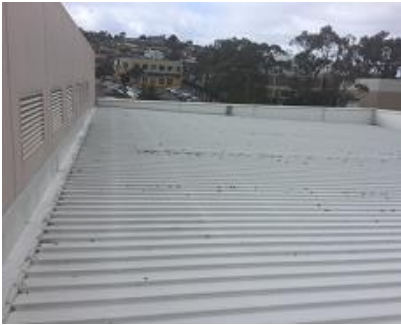
No height safety system installed	Trips, Slips and Falls	Awareness induction	High	Fall arrest anchors to be installed	Low	Client advised	Outstanding	OH&S REGULATIONS 3.55
76	Building: General Stores Location Reference: <a href="#">L34</a> Task: Access to the roof
