Roof Safety Report

Galleria, WA 6062

Prepared By: Safemaster Safety Products
Date: 08-09-2020

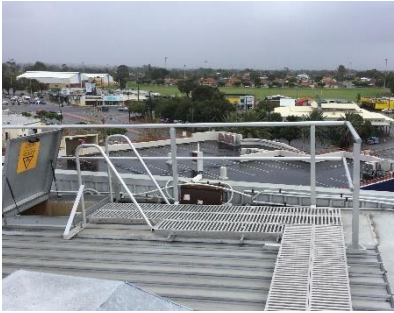
Handrail extension from fall edge is less than required minimum	Trips, Slips and Falls	Awareness induction	Med	Handrail to be installed	Low	Client advised	Outstanding	AS/NZS 1657-2013 6.2.1.1
04	Building: General Stores Location Reference: L2 Task: Access to the roof

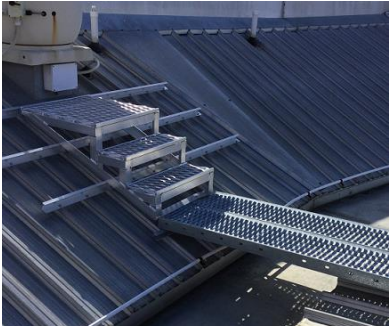
Walkway and steps height are greater than required maximum from the adjacent area	Trips, Slips and Falls	Awareness induction	Med	Handrail to be installed	Low	Client advised	Outstanding	OH&S REGULATIONS 3.7 AS/NZS 1657-2013 5.4.1
06	Building: General Stores Location Reference: L5 Task: Access to the roof

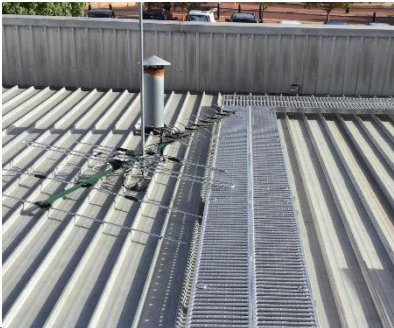
Antenna installed over walkway	Trips, Slips and Falls	Awareness induction	Med	Walkway to be re-routed with additional sections if required or Re-locate antenna	Low	Client advised	Outstanding	OH&S REGULATIONS 3.6
26	Building: General Stores Location Reference: L25 Task: Access to the A/c unit

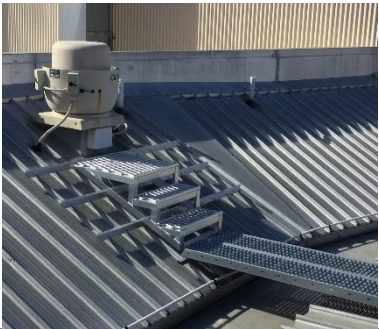
Walkway height is greater than required maximum from the adjacent area	Trips, Slips and Falls	Awareness induction	Med	Handrails to be installed	Low	Client advised	Outstanding	OH&S REGULATIONS 3.6 AS/NZS 1657-2013 5.4.1
34	Building: General Stores Location Reference: L31 Task: Access to the A/c unit

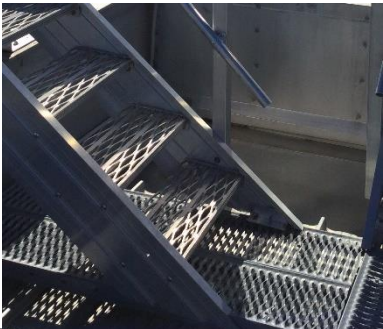
Bottom tread not uniformly spaced as remaining treads and Handrail is missing on one side	Trips, Slips and Falls	Awareness induction	Med	New landing platform to level with the bottom tread including high visibility safety yellow nosings to be installed and walkway to be re-routed with additional sections	Low	Client advised	Outstanding	OH&S REGULATIONS 3.7 AS/NZS 1657-2013 7.2.3.2
36	Building: General Stores Location Reference: L32 Task: Access to the A/c unit

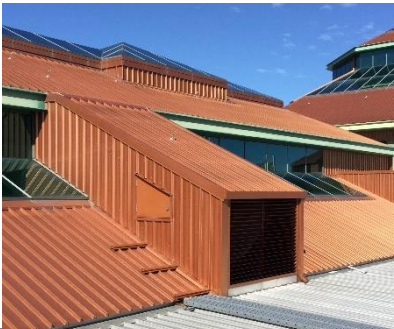
Roof pitch higher than the required minimum for a work area	Trips, Slips and Falls	Awareness induction	Med	Access platform and steps with handrail one side to be installed	Low	Client advised	Outstanding	OH&S REGULATIONS 3.6 AS/NZS 1657-2013 2.2
40	Building: General Stores Location Reference: L36 Task: Access to the A/c unit

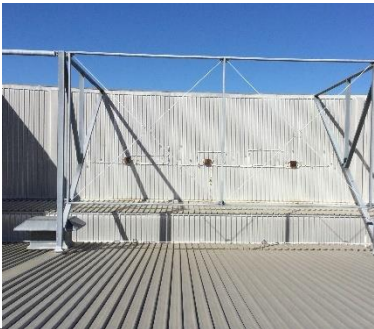
Variation in height between two roofs are greater than required maximum	Trips, Slips and Falls	Awareness induction	Med	Steps to be installed	Low	Client advised	Outstanding	OH&S REGULATIONS 3.7 AS/NZS 16572013 3.1.4
56	Building: General Stores Location Reference: L53 Task: Access to the A/c unit

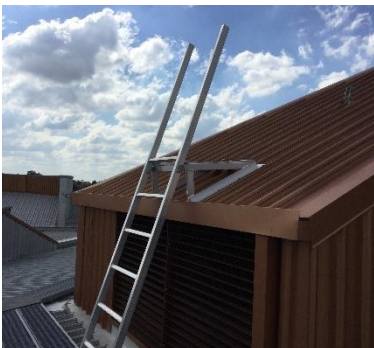
Top rung not levelled with landing platform	Trips, Slips and Falls	Awareness induction	Med	Existing ladder to be re-installed with new fixings brackets and landing platforms	Low	Client advised	Outstanding	OH&S REGULATIONS 3.7 AS/NZS 16572013 7.4.3.3

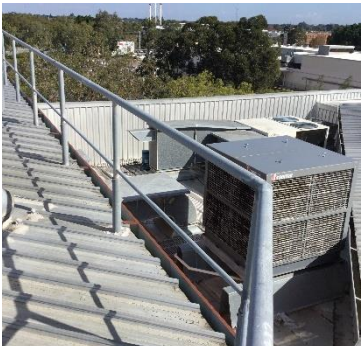
Toeboard is missing on handrail sections and gap between midrail and handrail is greater than required maximum and handrail not permitting unrestricted movement of the user's hand	Trips, Slips and Falls	Awareness induction	Med	Toeboard and midrail to be installed on existing steel handrail posts and New handrail and midrail section to be installed on corners	Low	Client advised	Outstanding	AS/NZS 16572013 5.6.3 & 5.6.6 & 6.2.1.2

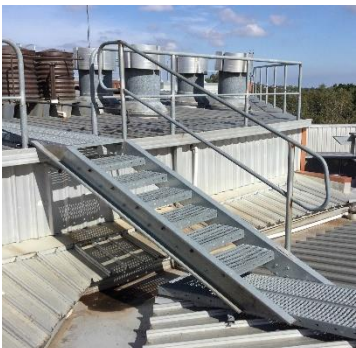
Risers and Goings varies greater than acceptable tolerance and Handrail is missing on one side	Trips, Slips and Falls	Awareness induction	Med	Existing stair to be removed and New stair to be installed	Low	Client advised	Outstanding	OH&S REGULATIONS 3.7 AS/NZS 16572013 7.2.3.2

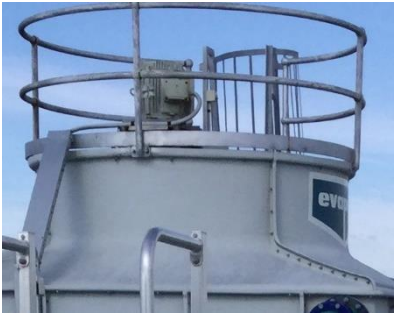
Gap between guardrail and ladder is greater than required maximum	Trips, Slips and Falls	Awareness induction	Med	New handrail and midrail sections to be installed on existing handrail posts to close the gap within the tolerance	Low	Client advised	Outstanding	AS/NZS 16572013 6.2.1.1
94	Building: General Stores Location Reference: L87 Task: Access to the A/c unit

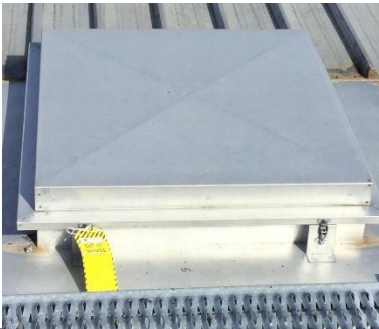
In-correct installation ladder and hatch size is less than required minimum	Trips, Slips and Falls	Awareness induction	Med	"OUT OF SERVICE" signs to be installed	Low	Client advised	Outstanding	OH&S REGULATIONS 3.5 & 3.7 & 3.11
100	Building: General Stores Location Reference: L93 Task: Access to the A/c unit

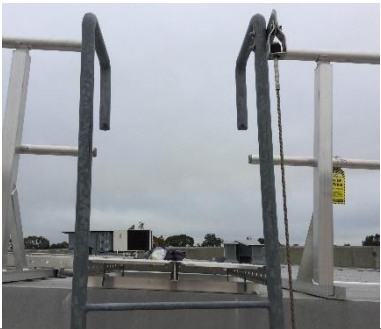
No slip resistance on ladder rungs, Top rung not levelled with landing & extension above landing is less than required minimum	Trips, Slips and Falls	Awareness induction	Med	Existing ladder to be removed and new ladder to be installed with landing platforms	Low	Client advised	Outstanding	OH&S REGULATIONS 3.7 AS/NZS 16572013 3.1.3 & 7.4.3.3 & 7.4.8.1
116	Building: General Stores Location Reference: L108 Task: Access to the A/c unit

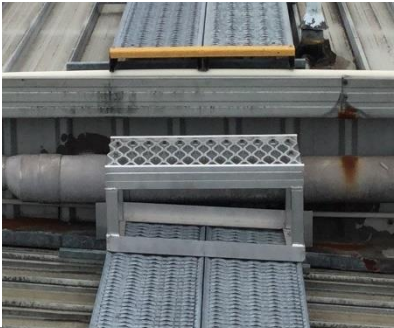
Variation in height between landings is greater than required maximum and existing step not compliant	Trips, Slips and Falls	Awareness induction	Med	Existing step to be removed and new mini stair to be installed	Low	Client advised	Outstanding	OH&S REGULATIONS 3.7 AS/NZS 16572013 3.1.4
124	Building: General Stores Location Reference: L112 Task: Access to the A/c unit

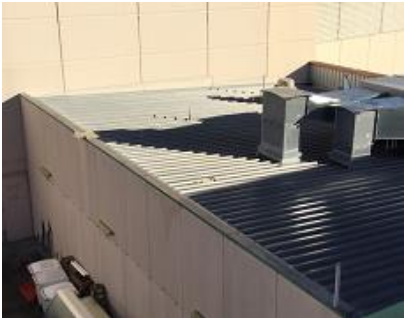
No safe access to the A/c units	Trips, Slips and Falls	N/A	Low	Supply walkway and handrails	Low	Client advised	Outstanding	-

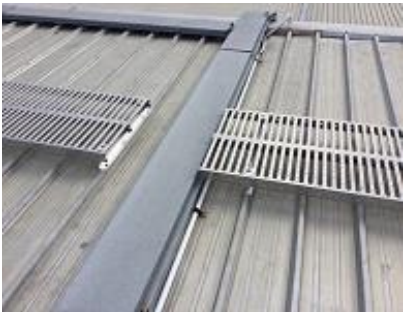
Gap between the walkway panels are greater than required maximum	Trips, Slips and Falls	Awareness induction	Med	Bridging platform to be installed between two walkway sections including high visibility safety yellow nosing's	Low	Client advised	Outstanding	OH&S REGULATIONS 3.7 AS/NZS 1657-2013 3.2.3.4

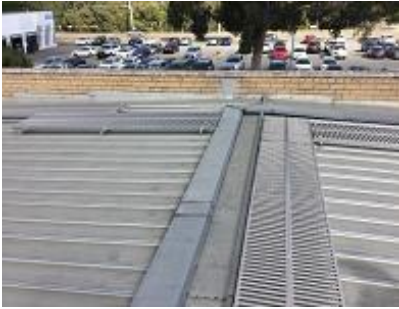
Gap between the walkway panels are greater than required maximum	Trips, Slips and Falls	Awareness induction	Med	Bridging platform to be installed between two walkway sections including high visibility safety yellow nosing's	Low	Client advised	Outstanding	OH&S REGULATIONS 3.7 AS/NZS 1657-2013 3.2.3.4

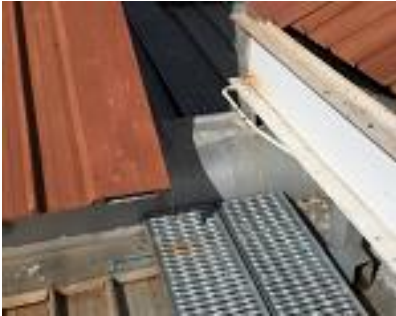
Variation in height between roof levels are greater than required maximum	Trips, Slips and Falls	Awareness induction	Med	Single step to be installed	Low	Client advised	Outstanding	OH&S REGULATIONS 3.7 AS/NZS 1657-2013 3.1.4

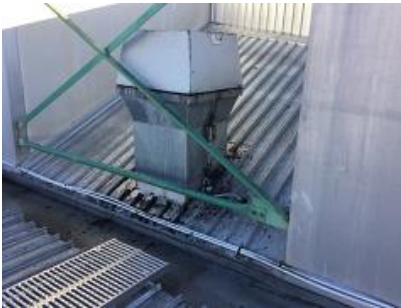
No safe access to the A/c unit	Trips, Slips and Falls	Awareness induction	Med	Additional walkway section, Low headroom sign. Step and landing platform to be installed	Low	Client advised	Outsta nding	OH&S REGULATIONS 3.7 AS/NZS 1657- 2013 3.1.4
142	Building: General Stores Location Reference: L32 Task: Access to the A/c unit

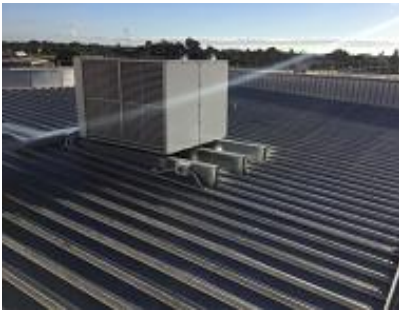
No safe access to the A/c unit	Trips, Slips and Falls	N/A	Low	Supply walkway to the A/c unit	Low	Client advised	Outstanding	-
144	Building: General Stores Location Reference: L32 Task: Access to the A/c unit

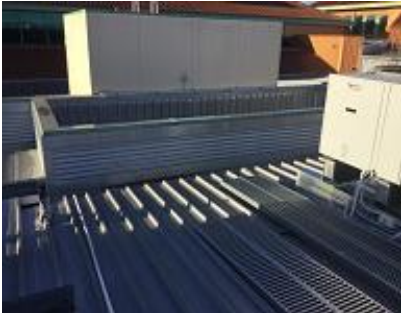
No safe access to the roof	Trips, Slips and Falls	Awareness induction	Med	Access ladder including handrails to be installed	Low	Client advised	Outstanding	OH&S REGULATIONS 3.7 AS/NZS 1657- 2013 3.1.4

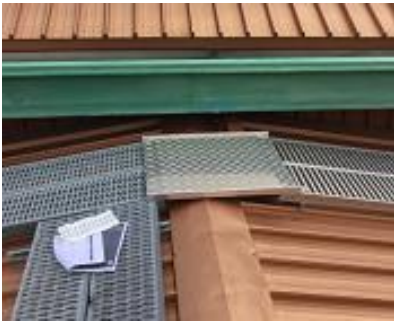
Variation in height between roofs are greater than required maximum	Trips, Slips and Falls	Awareness induction	Med	Access ladder including handrails and anchor strop to be installed	Low	Client advised	Outstanding	OH&S REGULATIONS 3.7 AS/NZS 1657-2013 3.1.4

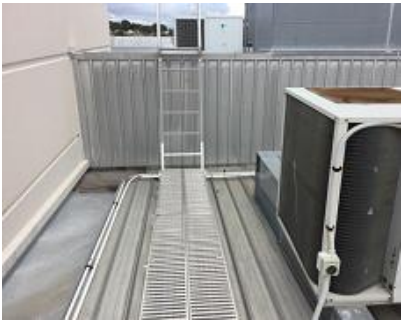
Bottom rung height is less than required minimum and handrails projecting towards the user	Trips, Slips and Falls	Awareness induction	Med	Existing handrails to be removed. Landing platform and preformed handrails to be installed.	Low	Client advised	Outstanding	OH&S REGULATIONS 3.7 AS/NZS 1657- 2013 7.3.6 & 7.4.8.5

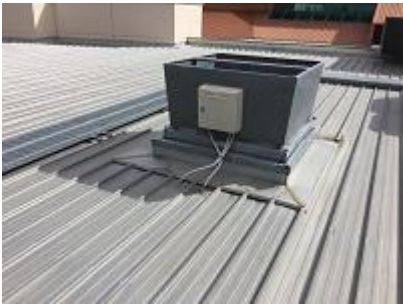
No safe access to the A/c unit	Trips, Slips and Falls	N/A	Low	Supply walkway to the A/c unit	Low	Client advised	Outstanding	-
158	Building: General Stores Location Reference: L44 Task: Access to the A/c unit

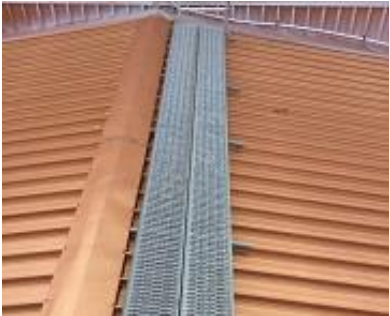
Walkway slope is greater than required maximum	Trips, Slips and Falls	Awareness induction	Med	Walkway to re-installed with levelled brackets and landing platforms	Low	Client advised	Outstanding	OH&S REGULATIONS 3.7 AS/NZS 1657-2013 5.1.1

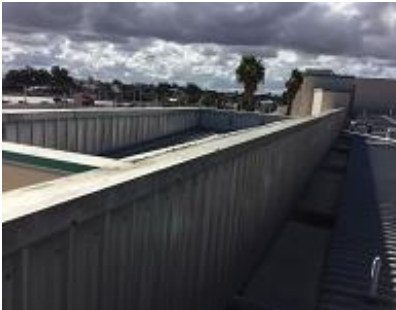
Variation in height between roofs are greater than required maximum	Trips, Slips and Falls	Awareness induction	Med	Access ladder including landing platforms, preformed handrails to be installed	Low	Client advised	Outstanding	OH&S REGULATIONS 3.7 AS/NZS 1657-2013 3.1.4

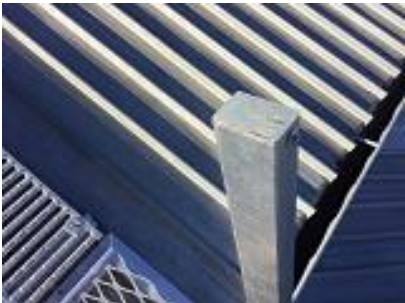
Sharp edges on ladder stiles	Trips, Slips and Falls	Awareness induction	Med	Tek screws to be replaced with rivets	Low	Client advised	Outstanding	OH&S REGULATIONS 3.7 AS/NZS 1657- 2013 7.4.3.1

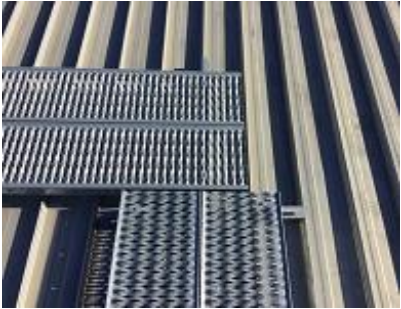
Missing walkway section at corner	Trips, Slips and Falls	Awareness induction	Med	Supply walkway to the A/c unit	Low	Client advised	Outstanding	OH&S REGULATIONS 3.7

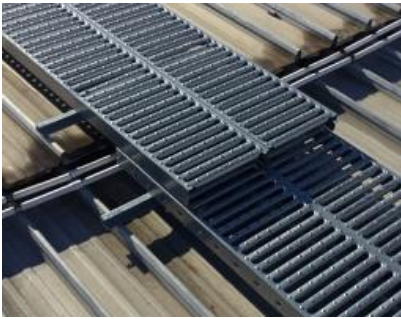
Variation in height between walkway panels are greater than required maximum	Trips, Slips and Falls	Awareness induction	Med	High visibility safety yellow nosing to be installed	Low	Client advised	Outstanding	OH&S REGULATIONS 3.7 AS/NZS 1657-2013 3.3.4
182	Building: General Stores Location Reference: L110 Task: Access to the plant deck

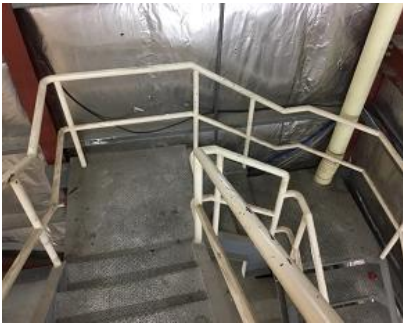
Toe board is missing for stair landings	Trips, Slips and Falls	Awareness induction	Med	Toe board to be installed	Low	Client advised	Outstanding	OH&S REGULATIONS 3.7 AS/NZS 1657-2018 7.2.5
185	Building: General Stores Location Reference: L02 Task: Access to the roof

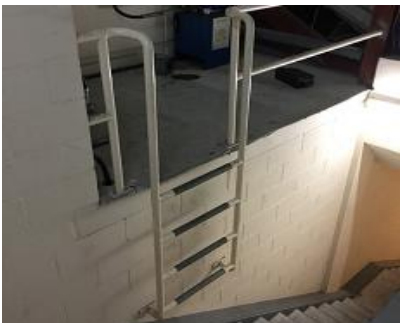
Clearance between ladder and wall is less than required minimum and no slip resistance on ladder rungs and no landing at base	Trips, Slips and Falls	Awareness induction	Med	Non-slip rung caps and warning sign to be installed	Low	Client advised	Outstanding	OH&S REGULATIONS 3.7 AS/NZS 1657-2018 7.4.5, 7.4.3.1 & 7.3.6

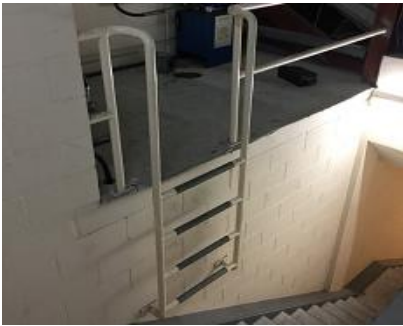
Toe board is missing for guardrail	Trips, Slips and Falls	Awareness induction	Med	Toe board and self-closing gate to be installed	Low	Client advised	Outstanding	OH&S REGULATIONS 3.7 AS/NZS 1657-2018 4.6
187	Building: General Stores Location Reference: L05 Task: Access to the A/c units

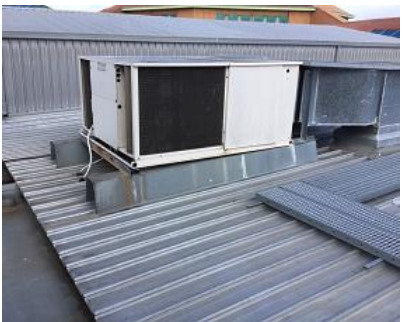
No safe access to the A/c units	Trips, Slips and Falls	N/A	Low	Supply walkway to the A/c units	Low	Client advised	Outstanding	-

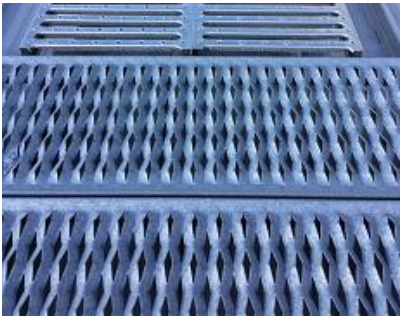
Variation in height between walkway panels are greater than required maximum	Trips, Slips and Falls	Awareness induction	Med	High visibility safety yellow nosing's to be installed	Low	Client advised	Outstanding	OH&S REGULATIONS 3.7 AS/NZS 1657-2018 3.3.4
189	Building: General Stores Location Reference: L12 Task: Access to the roof

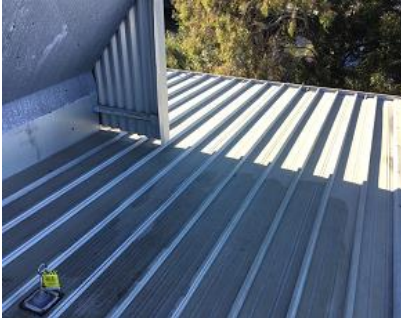
Anchor point is bent	Trips, Slips and Falls	Awareness induction	Med	Existing anchor to be replaced	Low	Client advised	Outstanding	OH&S REGULATIONS 3.55

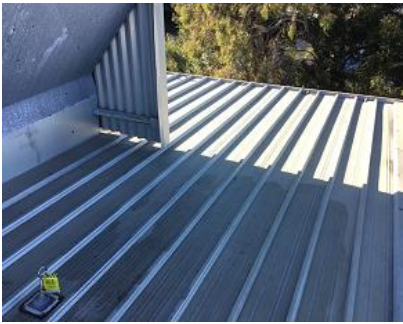
Not enough anchors installed	Trips, Slips and Falls	Awareness induction	High	Anchors to be installed	Low	Client advised	Outstanding	OH&S REGULATIONS 3.55
191	Building: General Stores Location Reference: L13 Task: Access to the roof

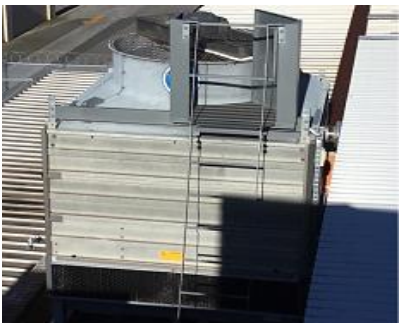
Fall arrest static line is missing and landing is less than required minimum and no slip resistance on ladder rungs	Trips, Slips and Falls	Awareness induction	Med	Fall arrest static line and warning sign for in-adequate landing and non-slip rung caps to be installed	Low	Client advised	Outstanding	OH&S REGULATIONS 3.7 & 3.11 AS/NZS 1657-2018 7.4.7 & 7.3.6

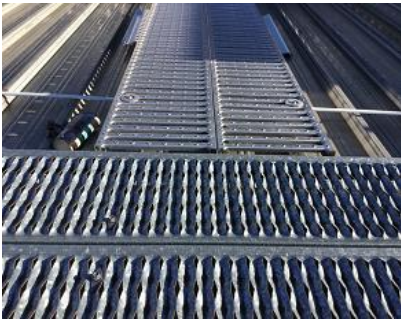
Variation in height between walkway panels are greater than required maximum	Trips, Slips and Falls	Awareness induction	Med	High visibility safety yellow nosing's to be installed	Low	Client advised	Outstanding	OH&S REGULATIONS 3.7 AS/NZS 1657-2018 3.3.4
193	Building: General Stores Location Reference: L15 Task: Access to the roof

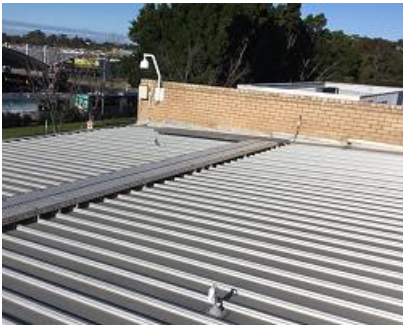
Gap between walkway and fall edge is less than required minimum	Trips, Slips and Falls	Awareness induction	Med	"Safety harness to be attached to anchor point" sign to be installed	Low	Client advised	Outstanding	OH&S REGULATIONS 3.7 AS/NZS 1657-2018 5.4.1
195	Building: General Stores Location Reference: L17 Task: Access to the roof

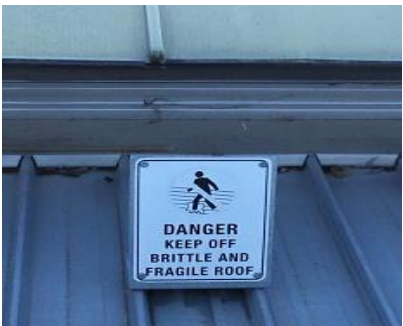
Non-complaint signs are present	Trips, Slips and Falls	Awareness induction	Med	Existing signs to be replaced	Low	Client advised	Outstanding	OH&S REGULATIONS 3.55 & 3.11

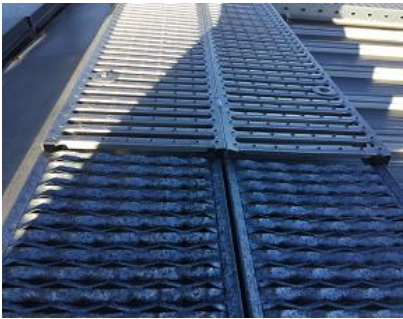
Variation in height between walkway panels are greater than required maximum	Trips, Slips and Falls	Awareness induction	Med	High visibility safety yellow nosing's to be installed	Low	Client advised	Outstanding	OH&S REGULATIONS 3.7 AS/NZS 1657-2018 3.3.4
197	Building: General Stores Location Reference: L17 Task: Access to the A/c units

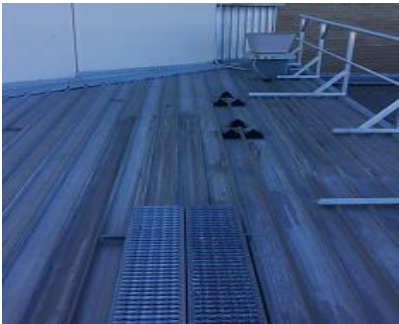
No safe access to the A/c units	Trips, Slips and Falls	N/A	Low	Supply walkway to the A/c units	Low	Client advised	Outstanding	-
199	Building: General Stores Location Reference: L21 Task: Access to the roof

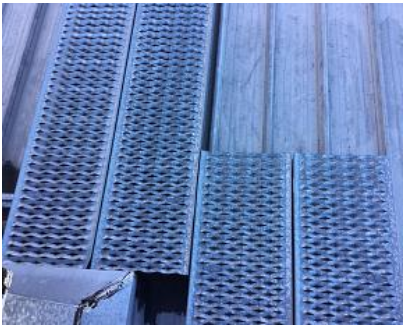
Walkway width is less than required minimum	Trips, Slips and Falls	Awareness induction	Med	Additional walkway section to be installed	Low	Client advised	Outstanding	OH&S REGULATIONS 3.7 AS/NZS 1657-2018 5.1.3
201	Building: General Stores Location Reference: L24 Task: Access to the roof

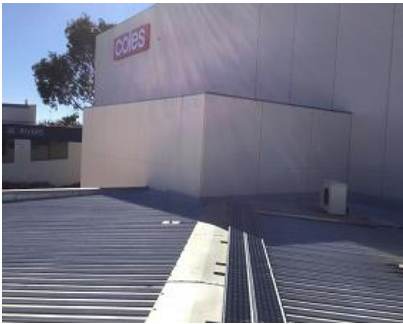
No height safety system installed	Trips, Slips and Falls	Awareness induction	High	Ladder access bracket, ladder support platform and fall arrest anchors to be installed	Low	Client advised	Outstanding	OH&S REGULATIONS 3.55
20 3	Building: General Stores Location Reference: L29 Task: Access to the roof

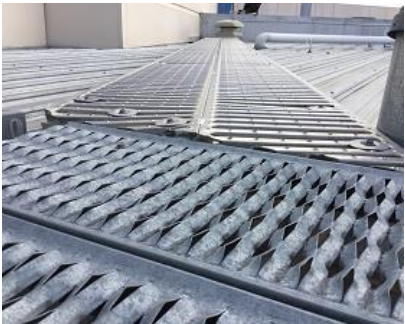
Variation in height between walkway panels are greater than required maximum	Trips, Slips and Falls	Awareness induction	Med	High visibility safety yellow nosing's to be installed	Low	Client advised	Outstanding	OH&S REGULATIONS 3.7 AS/NZS 1657-2018 3.3.4
20 5	Building: General Stores Location Reference: L66 Task: Access to the roof

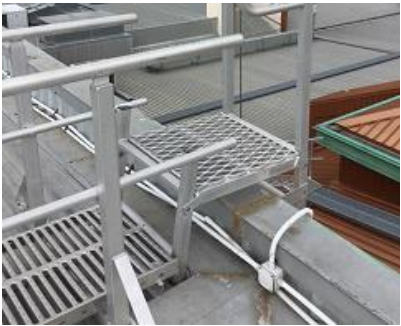
Landing is less than required minimum	Trips, Slips and Falls	Awareness induction	Med	Existing landing to be extended including handrails	Low	Client advised	Outstanding	OH&S REGULATIONS 3.7 AS/NZS 1657-2018 7.3.6
20 7	Building: General Stores Location Reference: L51 Task: Access to the roof

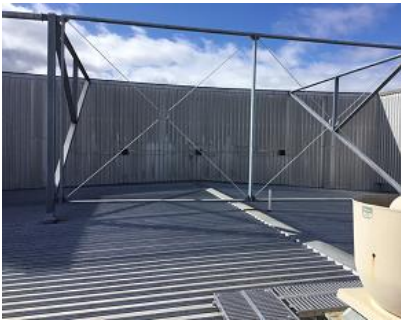
No safe access to the A/c units	Trips, Slips and Falls	N/A	Low	Supply walkway to the A/c units	Low	Client advised	Outstanding	-
209	Building: General Stores Location Reference: L52 Task: Access to the roof

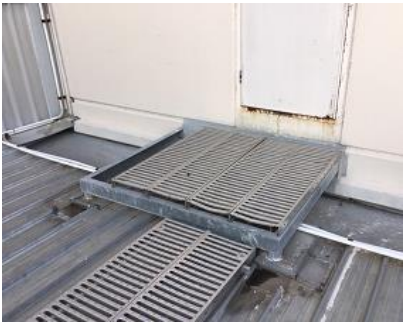
Existing landing is damaged	Trips, Slips and Falls	Awareness induction	Med	Landing to be replaced	Low	Client advised	Outsta nding	OH&S REGULATIONS 3.7
211	Building: General Stores Location Reference: L46 Task: Access to the roof

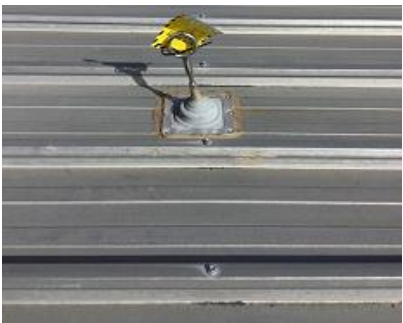
Anchor is bent	Trips, Slips and Falls	Awareness induction	Med	Anchor to be replaced	Low	Client advised	Outsta nding	OH&S REGULATIONS 3.55

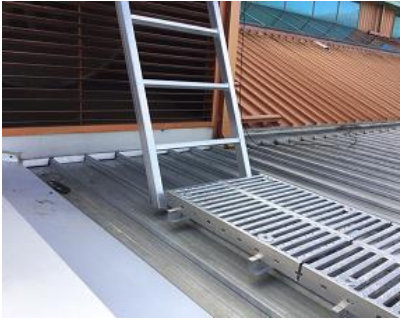
Bottom rung height is less than required minimum	Trips, Slips and Falls	Awareness induction	Med	Landing platform to be installed	Low	Client advised	Outstanding	OH&S REGULATIONS 3.7 AS/NZS 1657-2018 7.4.3.4

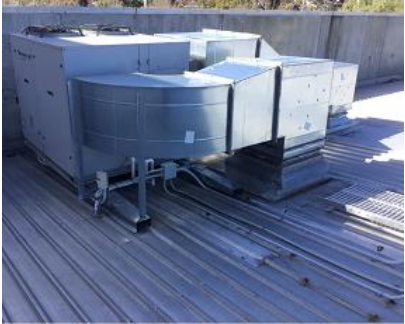
No safe access to the A/c units	Trips, Slips and Falls	N/A	Low	Supply walkway to the A/c units	Low	Client advised	Outstanding	-
22 9	Building: General Stores Location Reference: L104 Task: Access to the roof
