Roof Safety Report

Galleria, WA 6062

Prepared By: Safemaster Safety Products
Date: 20-August-2018

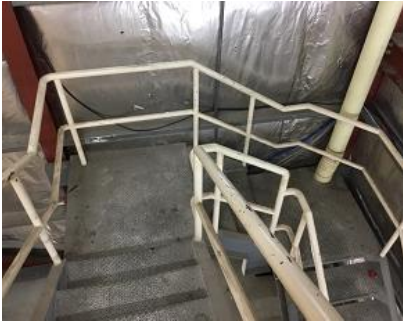
Toe board is missing for stair landings	Trips, Slips and Falls	Awareness induction	Med	Toe board to be installed	Low	Client advised	Outstanding	OH&S REGULATIONS 3.7 AS/NZS 1657-2018 7.2.5
185	Building: General Stores Location Reference: L02 Task: Access to the roof

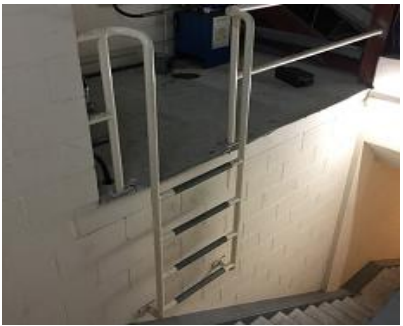
Clearance between ladder and wall is less than required minimum and no slip resistance on ladder rungs and no landing at base	Trips, Slips and Falls	Awareness induction	Med	Non-slip rung caps and warning sign to be installed	Low	Client advised	Outstanding	OH&S REGULATIONS 3.7 AS/NZS 1657-2018 7.4.5, 7.4.3.1 & 7.3.6

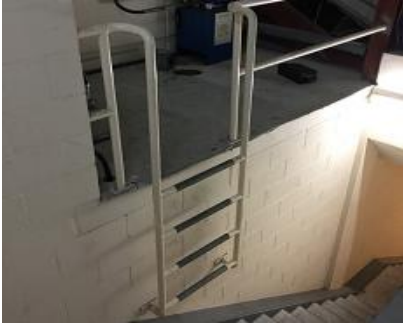
Toe board is missing for guardrail	Trips, Slips and Falls	Awareness induction	Med	Toe board and self-closing gate to be installed	Low	Client advised	Outstanding	OH&S REGULATIONS 3.7 AS/NZS 1657-2018 4.6
187	Building: General Stores Location Reference: L05 Task: Access to the A/c units

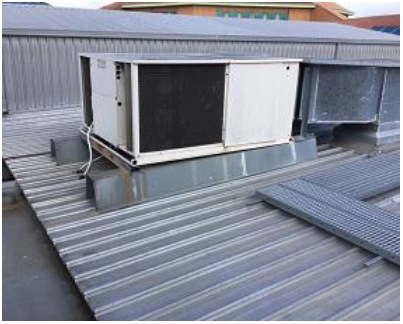
No safe access to the A/c units	Trips, Slips and Falls	N/A	Low	Supply walkway to the A/c units	Low	Client advised	Outstanding	-

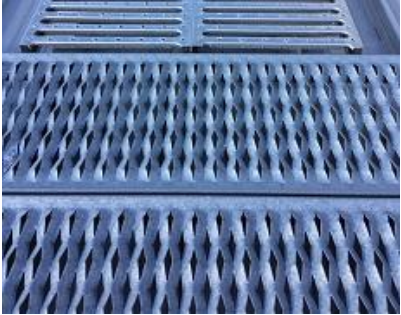
Variation in height between walkway panels are greater than required maximum	Trips, Slips and Falls	Awareness induction	Med	High visibility safety yellow nosing's to be installed	Low	Client advised	Outstanding	OH&S REGULATIONS 3.7 AS/NZS 1657-2018 3.3.4
189	Building: General Stores Location Reference: L12 Task: Access to the roof

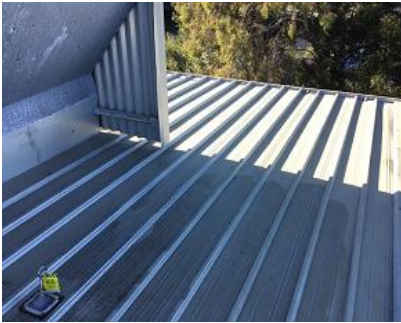
Anchor point is bent	Trips, Slips and Falls	Awareness induction	Med	Existing anchor to be replaced	Low	Client advised	Outstanding	OH&S REGULATIONS 3.55

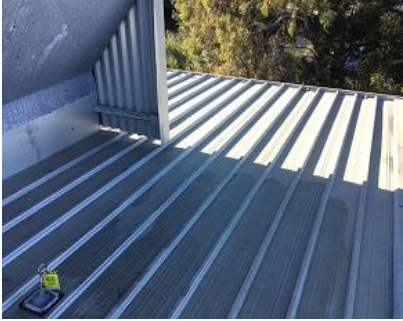
Not enough anchors installed	Trips, Slips and Falls	Awareness induction	High	Anchors to be installed	Low	Client advised	Outstanding	OH&S REGULATIONS 3.55
191	Building: General Stores Location Reference: L13 Task: Access to the roof

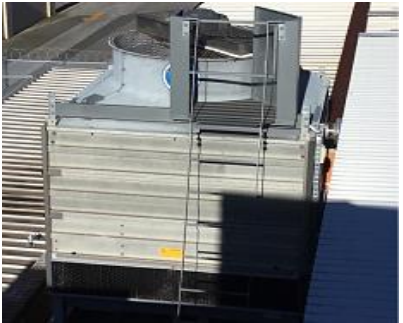
Fall arrest static line is missing and landing is less than required minimum and no slip resistance on ladder rungs	Trips, Slips and Falls	Awareness induction	Med	Fall arrest static line and warning sign for in-adequate landing and non-slip rung caps to be installed	Low	Client advised	Outstanding	OH&S REGULATIONS 3.7 & 3.11 AS/NZS 1657-2018 7.4.7 & 7.3.6

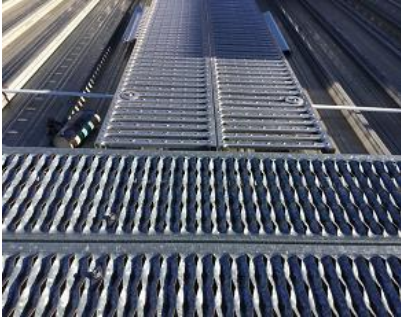
Variation in height between walkway panels are greater than required maximum	Trips, Slips and Falls	Awareness induction	Med	High visibility safety yellow nosing's to be installed	Low	Client advised	Outstanding	OH&S REGULATIONS 3.7 AS/NZS 1657-2018 3.3.4
193	Building: General Stores Location Reference: L15 Task: Access to the roof

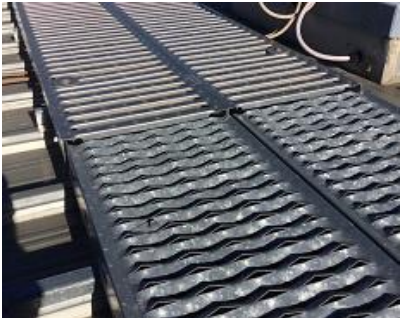
Variation in height between walkway panels are greater than required maximum	Trips, Slips and Falls	Awareness induction	Med	High visibility safety yellow nosing's to be installed	Low	Client advised	Outstanding	OH&S REGULATIONS 3.7 AS/NZS 1657-2018 3.3.4

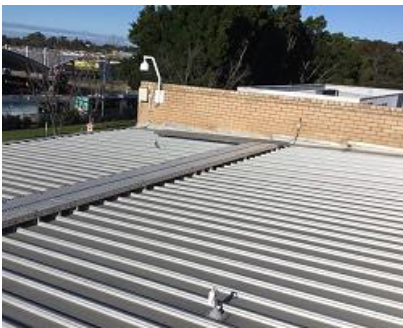
Gap between walkway and fall edge is less than required minimum	Trips, Slips and Falls	Awareness induction	Med	"Safety harness to be attached to anchor point" sign to be installed	Low	Client advised	Outstanding	OH&S REGULATIONS 3.7 AS/NZS 1657-2018 5.4.1
195	Building: General Stores Location Reference: L17 Task: Access to the roof

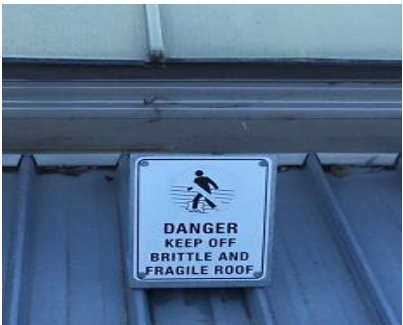
Non-complaint signs are present	Trips, Slips and Falls	Awareness induction	Med	Existing signs to be replaced	Low	Client advised	Outstanding	OH&S REGULATIONS 3.55 & 3.11

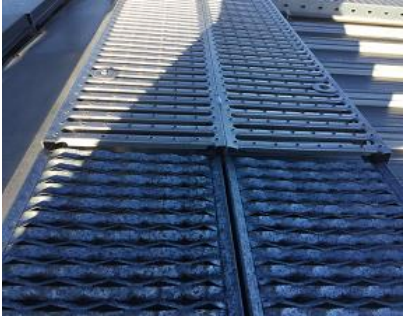
Variation in height between walkway panels are greater than required maximum	Trips, Slips and Falls	Awareness induction	Med	High visibility safety yellow nosing's to be installed	Low	Client advised	Outstanding	OH&S REGULATIONS 3.7 AS/NZS 1657-2018 3.3.4
197	Building: General Stores Location Reference: L17 Task: Access to the A/c units

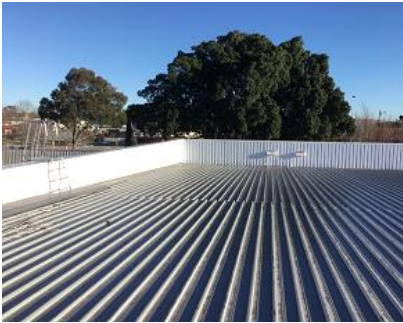
No safe access to the A/c units	Trips, Slips and Falls	N/A	Low	Supply walkway to the A/c units	Low	Client advised	Outstanding	-

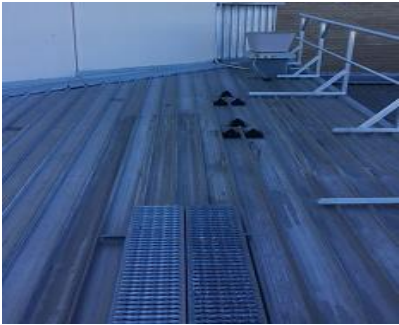
No safe access to the A/c units	Trips, Slips and Falls	N/A	Low	Supply walkway to the A/c units	Low	Client advised	Outstanding	-
199	Building: General Stores Location Reference: L21 Task: Access to the roof

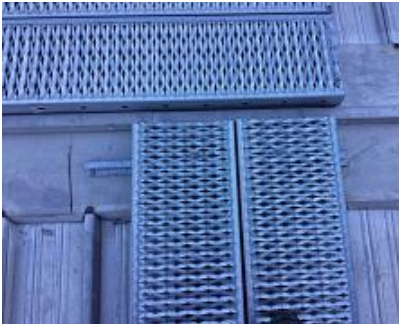
Gap between walkway panels are greater than required maximum	Trips, Slips and Falls	Awareness induction	Med	Walkway bridge and high visibility safety yellow nosing's to be installed	Low	Client advised	Outstanding	OH&S REGULATIONS 3.7 AS/NZS 1657-2018 3.2.3.4

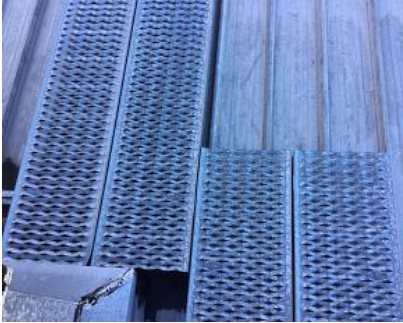
Walkway width is less than required minimum	Trips, Slips and Falls	Awareness induction	Med	Additional walkway section to be installed	Low	Client advised	Outstanding	OH&S REGULATIONS 3.7 AS/NZS 1657-2018 5.1.3
201	Building: General Stores Location Reference: L24 Task: Access to the roof

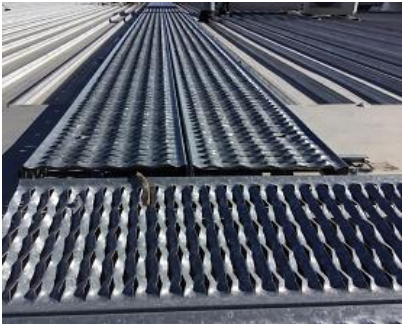
Variation in height between walkway panels are greater than required maximum	Trips, Slips and Falls	Awareness induction	Med	High visibility safety yellow nosing's to be installed	Low	Client advised	Outstanding	OH&S REGULATIONS 3.7 AS/NZS 1657-2018 3.3.4

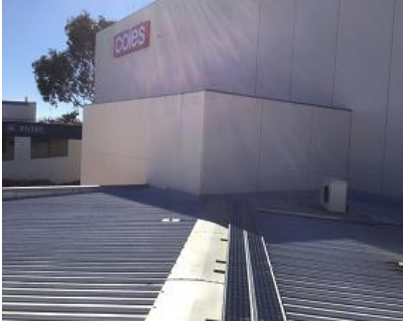
No height safety system installed	Trips, Slips and Falls	Awareness induction	High	Ladder access bracket, ladder support platform and fall arrest anchors to be installed	Low	Client advised	Outstanding	OH&S REGULATIONS 3.55
20 3	Building: General Stores Location Reference: L29 Task: Access to the roof

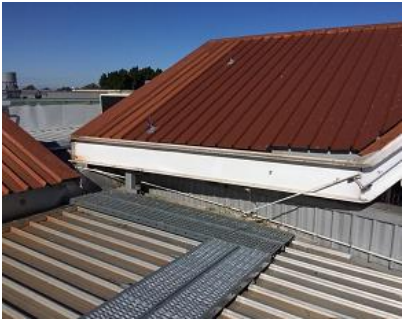
Variation in height between roofs are greater than required maximum	Trips, Slips and Falls	Awareness induction	Med	Access ladder to be installed	Low	Client advised	Outstanding	OH&S REGULATIONS 3.7 AS/NZS 1657-2018 3.1.4

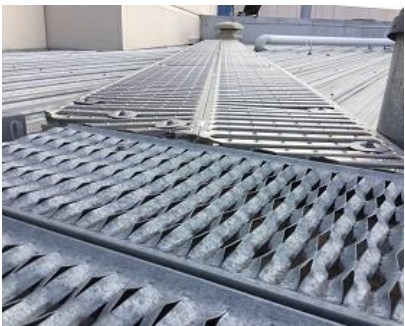
Variation in height between walkway panels are greater than required maximum	Trips, Slips and Falls	Awareness induction	Med	High visibility safety yellow nosing's to be installed	Low	Client advised	Outstanding	OH&S REGULATIONS 3.7 AS/NZS 1657-2018 3.3.4
20 5	Building: General Stores Location Reference: L66 Task: Access to the roof

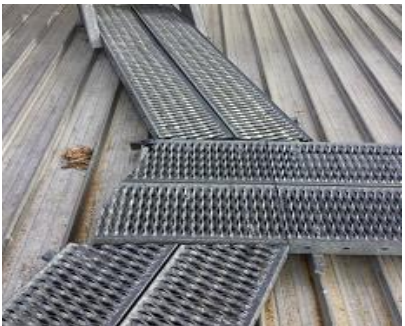
Variation in height between walkway panels are greater than required maximum	Trips, Slips and Falls	Awareness induction	Med	High visibility safety yellow nosing's to be installed	Low	Client advised	Outstanding	OH&S REGULATIONS 3.7 AS/NZS 1657-2018 3.3.4

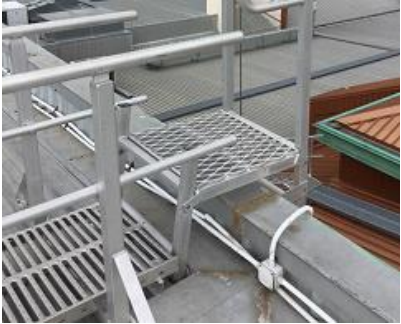
Landing is less than required minimum	Trips, Slips and Falls	Awareness induction	Med	Existing landing to be extended including handrails	Low	Client advised	Outstanding	OH&S REGULATIONS 3.7 AS/NZS 1657-2018 7.3.6
20 7	Building: General Stores Location Reference: L51 Task: Access to the roof

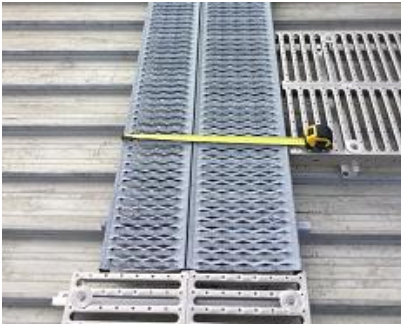
Walkway width is less than required minimum	Trips, Slips and Falls	Awareness induction	Med	Existing walkway to be removed and new walkway to be installed	Low	Client advised	Outstanding	OH&S REGULATIONS 3.7 AS/NZS 1657-2018 5.1.3

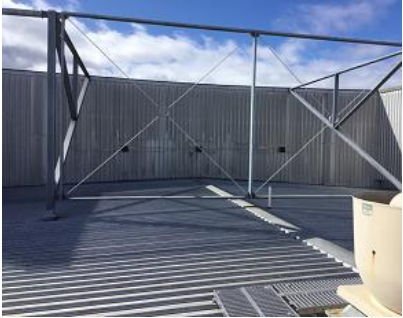
No safe access to the A/c units	Trips, Slips and Falls	N/A	Low	Supply walkway to the A/c units	Low	Client advised	Outstanding	-
20 9	Building: General Stores Location Reference: L52 Task: Access to the roof

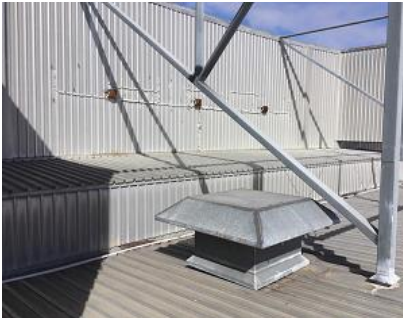
No safe access to the A/c units	Trips, Slips and Falls	N/A	Low	Supply walkway to the A/c units	Low	Client advised	Outstanding	-

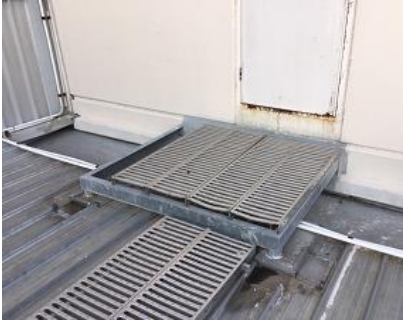
Existing landing is damaged	Trips, Slips and Falls	Awareness induction	Med	Landing to be replaced	Low	Client advised	Outsta nding	OH&S REGULATIONS 3.7
211	Building: General Stores Location Reference: L46 Task: Access to the roof

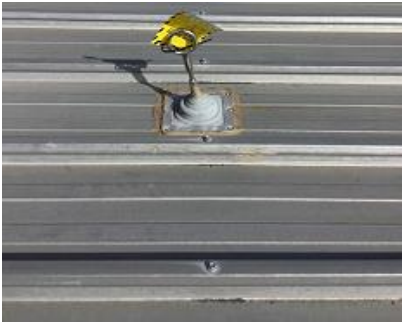
Anchor is bent	Trips, Slips and Falls	Awareness induction	Med	Anchor to be replaced	Low	Client advised	Outsta nding	OH&S REGULATIONS 3.55

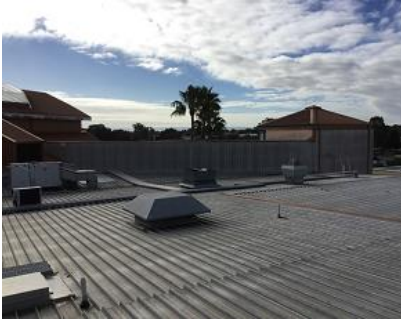
No height safety system installed	Trips, Slips and Falls	Awareness induction	High	EWP Access Only signs to be installed	Low	Client advised	Outstanding	OH&S REGULATIONS 3.55 & 3.11
213	Building: General Stores Location Reference: L63 Task: Access to the roof

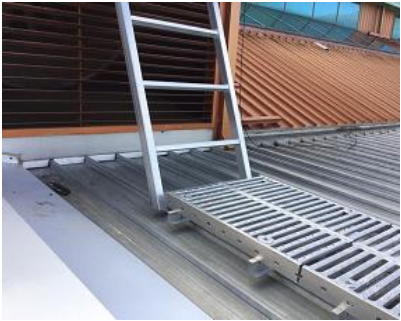
Bottom rung height is less than required minimum	Trips, Slips and Falls	Awareness induction	Med	Landing platform to be installed	Low	Client advised	Outstanding	OH&S REGULATIONS 3.7 AS/NZS 1657-2018 7.4.3.4

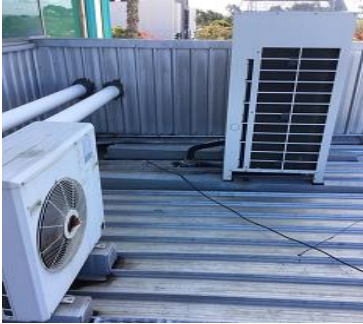
No safe access to the A/c units	Trips, Slips and Falls	N/A	Low	Supply walkway to the A/c units	Low	Client advised	Outstanding	-
215	Building: General Stores Location Reference: L92 Task: Access to the roof

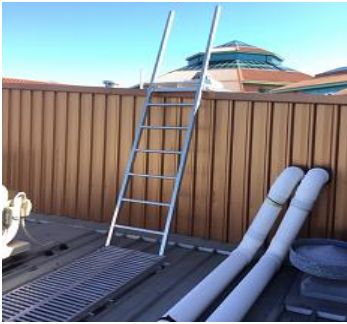
Bottom rung height is less than required minimum and top rung not levelled with landing	Trips, Slips and Falls	Awareness induction	Med	Existing ladder to be re-installed with landing platforms and brackets	Low	Client advised	Outstanding	OH&S REGULATIONS 3.7 AS/NZS 1657-2018 7.4.3.4 & 7.4.3.3

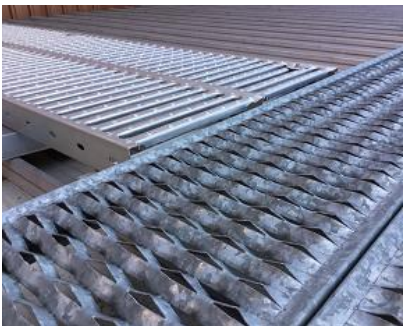
Variation in height between walkway panels are greater than required maximum	Trips, Slips and Falls	Awareness induction	Med	High visibility safety yellow nosing's to be installed	Low	Client advised	Outstanding	OH&S REGULATIONS 3.7 AS/NZS 1657-2018 3.3.4
217	Building: General Stores Location Reference: L92 Task: Access to the roof

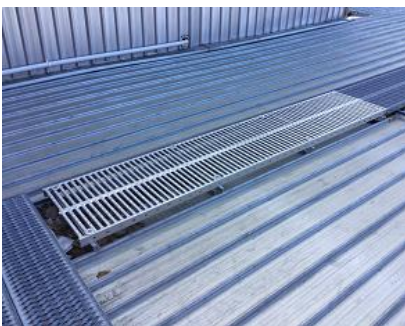
Gap between walkway panels are greater than required maximum	Trips, Slips and Falls	Awareness induction	Med	Checker plate to be installed	Low	Client advised	Outstanding	OH&S REGULATIONS 3.7 AS/NZS 1657-2018 3.2.3.4

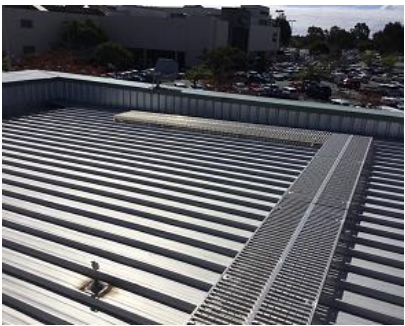
Gap between walkway and fall edge is less than required minimum	Trips, Slips and Falls	Awareness induction	Med	"Safety Harness to be attached to anchor point" sign to be installed	Low	Client advised	Outstanding	OH&S REGULATIONS 3.7 AS/NZS 1657-2018 5.4.1
219	Building: General Stores Location Reference: L94 Task: Access to the roof

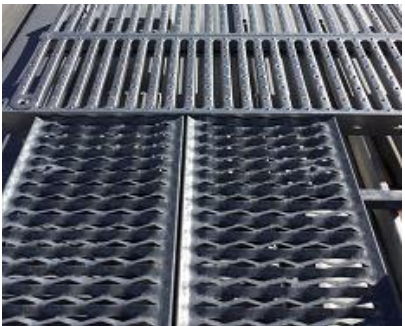
Variation in height between walkway panels are greater than required maximum	Trips, Slips and Falls	Awareness induction	Med	High visibility safety yellow nosing's to be installed	Low	Client advised	Outstanding	OH&S REGULATIONS 3.7 AS/NZS 1657-2018 3.3.4

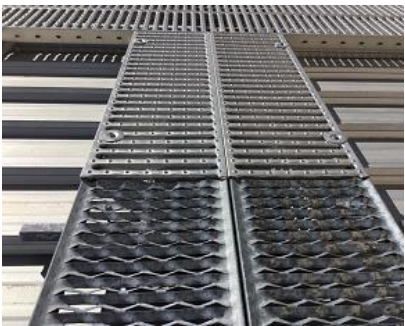
Variation in height between walkway panels are greater than required maximum	Trips, Slips and Falls	Awareness induction	Med	High visibility safety yellow nosing's to be installed	Low	Client advised	Outstanding	OH&S REGULATIONS 3.7 AS/NZS 1657-2018 3.3.4
221	Building: General Stores Location Reference: L96 Task: Access to the roof

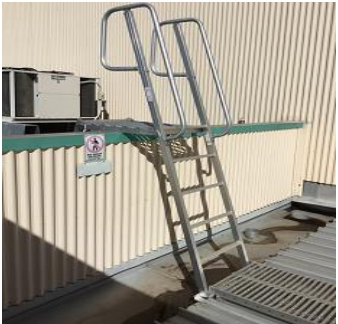
Bottom rung heights are less than required minimum, landing is less than required minimum and handrail projecting towards the user	Trips, Slips and Falls	Awareness induction	Med	Existing ladder to be removed and new ladder to be installed	Low	Client advised	Outstanding	OH&S REGULATIONS 3.7 AS/NZS 1657-2018 7.4.3.4, 7.3.6 & 7.4.8.5

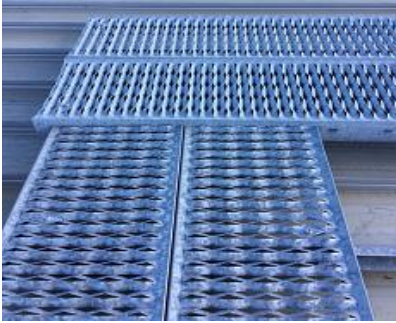
Variation in height between walkway panels are greater than required maximum	Trips, Slips and Falls	Awareness induction	Med	High visibility safety yellow nosing's to be installed	Low	Client advised	Outstanding	OH&S REGULATIONS 3.7 AS/NZS 1657-2018 3.3.4
22 3	Building: General Stores Location Reference: L98 Task: Access to the roof

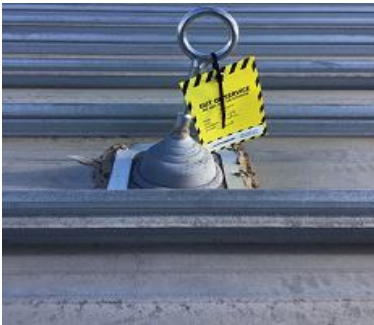
Damaged anchor points(x2) are present	Trips, Slips and Falls	Awareness induction	High	New anchor points to be installed	Low	Client advised	Outstanding	OH&S REGULATIONS 3.55

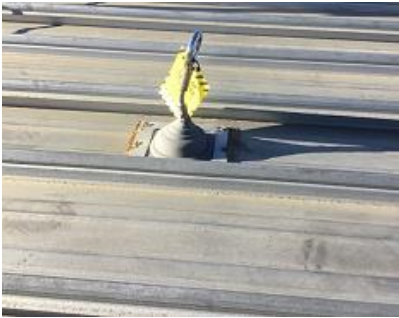
Damaged anchor points(x2) are present	Trips, Slips and Falls	Awareness induction	High	New anchor points to be installed	Low	Client advised	Outsta nding	OH&S REGULATIONS 3.55
22 5	Building: General Stores Location Reference: L100 Task: Access to the roof

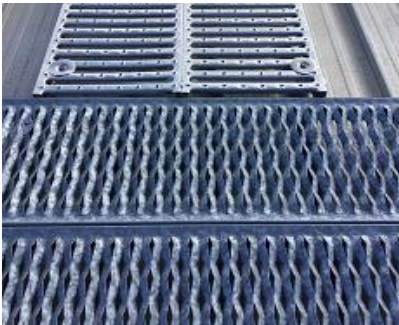
Variation in height between walkway panels are greater than required maximum	Trips, Slips and Falls	Awareness induction	Med	High visibility safety yellow nosing's to be installed	Low	Client advised	Outsta nding	OH&S REGULATIONS 3.7 AS/NZS 1657- 2018 3.3.4

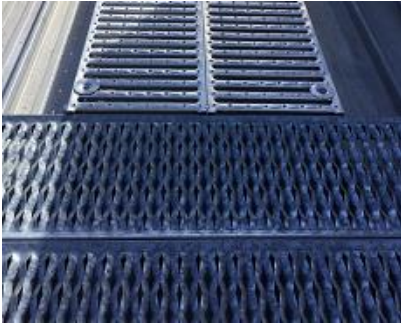
Variation in height between walkway panels are greater than required maximum	Trips, Slips and Falls	Awareness induction	Med	High visibility safety yellow nosing's to be installed	Low	Client advised	Outstanding	OH&S REGULATIONS 3.7 AS/NZS 1657-2018 3.3.4
22 7	Building: General Stores Location Reference: L100 Task: Access to the roof

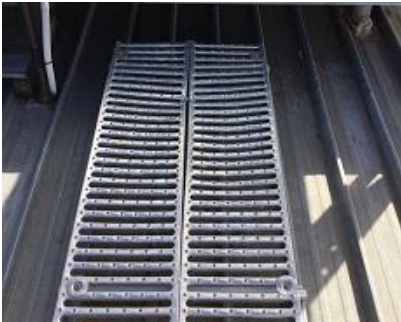
Damaged walkway is present	Trips, Slips and Falls	Awareness induction	Med	Damaged walkway section to be replaced	Low	Client advised	Outstanding	OH&S REGULATIONS 3.7

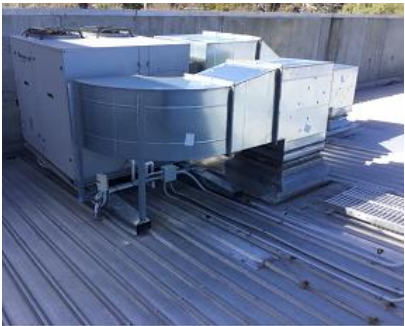
No safe access to the A/c units	Trips, Slips and Falls	N/A	Low	Supply walkway to the A/c units	Low	Client advised	Outstanding	-
22 9	Building: General Stores Location Reference: L104 Task: Access to the roof

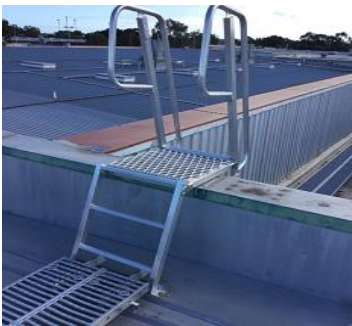
Bottom rung heights are less than required minimum, landing is less than required minimum and handrail projecting towards the user	Trips, Slips and Falls	Awareness induction	Med	Existing ladder to be removed and new ladder to be installed	Low	Client advised	Outstanding	OH&S REGULATIONS 3.7 AS/NZS 1657-2018 7.4.3.4, 7.3.6 & 7.4.8.5

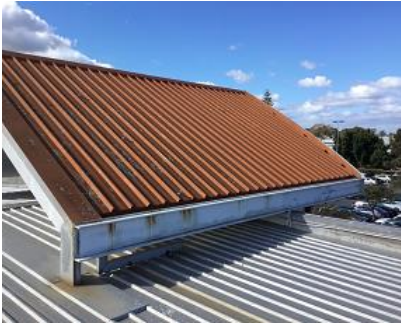
No safe access to the anchors	Trips, Slips and Falls	Awareness induction	Med	Access ladder to be installed	Low	Client advised	Outstanding	OH&S REGULATIONS 3.7 AS/NZS 1657-2018 3.1.4
231	Building: General Stores Location Reference: L109 Task: Access to the roof

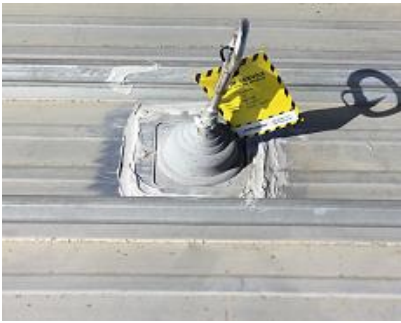
Damaged anchor point (x1) is present	Trips, Slips and Falls	Awareness induction	High	New anchor point to be installed	Low	Client advised	Outstanding	OH&S REGULATIONS 3.55

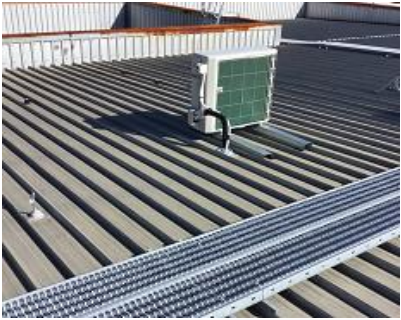
No safe access to the A/c units	Trips, Slips and Falls	N/A	Low	Supply walkway to the A/c units	Low	Client advised	Outstanding	-
23 3	Building: General Stores Location Reference: L110 Task: Access to the roof

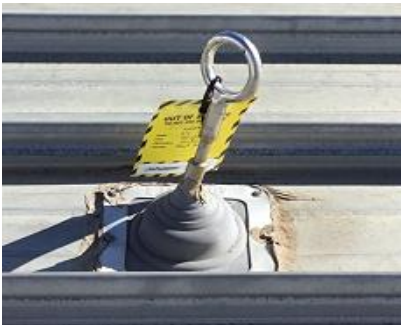
Damaged anchor point (x1) is present	Trips, Slips and Falls	Awareness induction	High	New anchor point to be installed	Low	Client advised	Outstanding	OH&S REGULATIONS 3.55

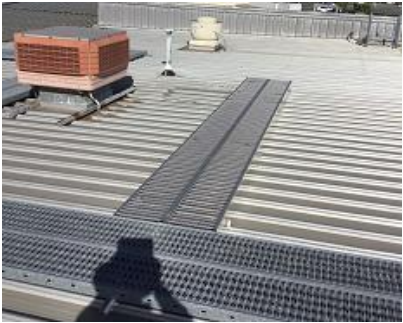
No safe access to the A/c units	Trips, Slips and Falls	N/A	Low	Supply walkway to the A/c units	Low	Client advised	Outstanding	-
23 5	Building: General Stores Location Reference: L114 Task: Access to the roof

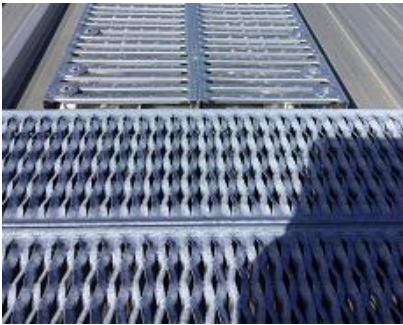
Variation in height between walkway panels are greater than required maximum	Trips, Slips and Falls	Awareness induction	Med	High visibility safety yellow nosing's to be installed	Low	Client advised	Outstanding	OH&S REGULATIONS 3.7 AS/NZS 1657-2018 3.3.4
