Roof Safety Report

**Gateway Plaza Leopold,
VIC 3224**

Prepared By: Safemaster Safety Products
Date: 26 February 2018

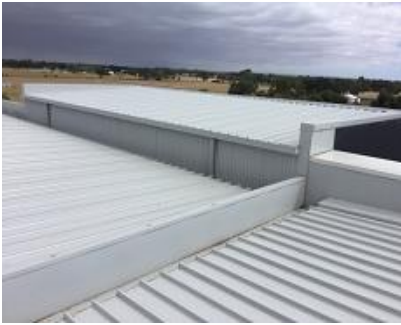
No height safety system installed	Trips, Slips and Falls	Awareness induction	High	Fall arrest anchors and access ladder to be installed	Low	Client advised	Outstanding	OH&S REGULATIONS 3.7 & 3.55 AS/NZS 1657-2013 3.1.4
02	Building: General Stores Location Reference: L01 Task: Access to the roof

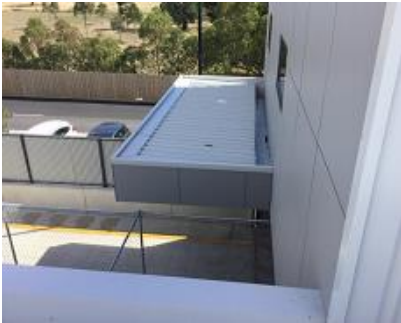
No height safety system installed (No serviceable items on roof)	Trips, Slips and Falls	Restrict Access	High	"EWP Access Only" sign to be installed	Low	Client advised	Outstanding	OH&S REGULATIONS 3.55 & 3.11
04	Building: General Stores Location Reference: L03 Task: Access to the A/c units

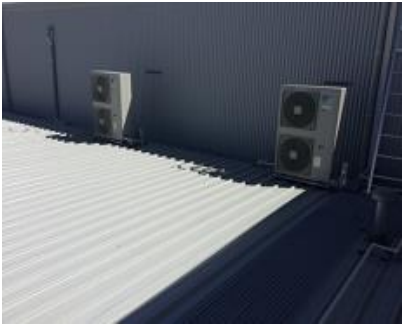
No safe access to the A/c units	Trips, Slips and Falls	N/A	Low	Supply walkway to the A/c units	Low	Client advised	Outstanding	-
06	Building: General Stores Location Reference: L04 Task: Access to the roof

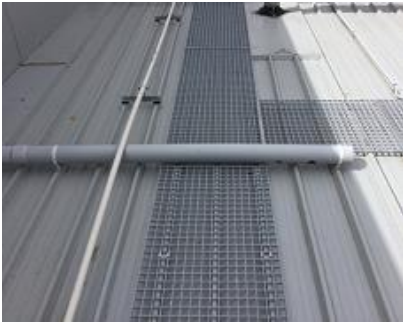
Pipe installed over the walkway path	Trips, Slips and Falls	Awareness induction	Med	Step bridge to be installed	Low	Client advised	Outstanding	OH&S REGULATIONS 3.7 AS/NZS 1657-2013 3.1.4

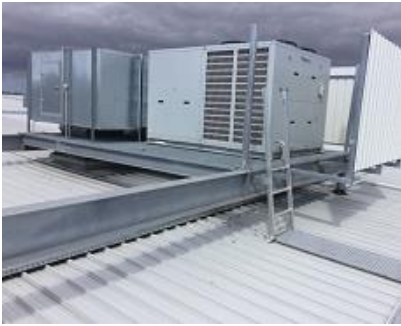
Gap between top rung and landing is greater than required maximum	Trips, Slips and Falls	Awareness induction	Med	Existing ladder to be re-installed with new brackets	Low	Client advised	Outstanding	OH&S REGULATIONS 3.7 AS/NZS 1657-2013 7.4.8.4
08	Building: General Stores Location Reference: L04 Task: Access to the plant deck

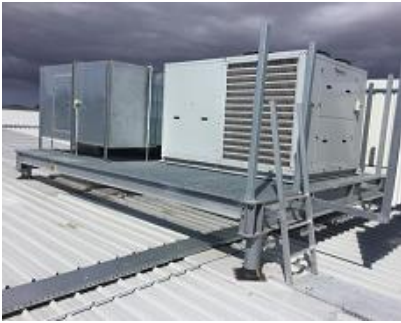
Gap between top rung and landing is greater than required maximum	Trips, Slips and Falls	Awareness induction	Med	Existing ladder to be re-installed with new brackets	Low	Client advised	Outstanding	OH&S REGULATIONS 3.7 AS/NZS 1657-2013 7.4.8.4
10	Building: General Stores Location Reference: L05 Task: Access to the plant deck

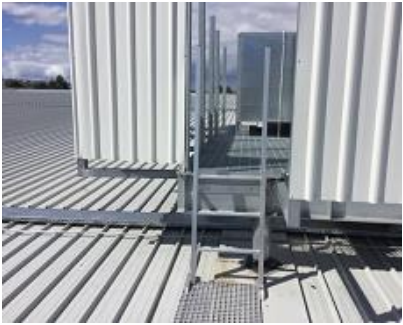
Gap between top rung and landing is greater than required maximum	Trips, Slips and Falls	Awareness induction	Med	Existing ladder to be re-installed with new brackets	Low	Client advised	Outstanding	OH&S REGULATIONS 3.7 AS/NZS 1657-2013 7.4.8.4
12	Building: General Stores Location Reference: L06 Task: Access to the plant deck

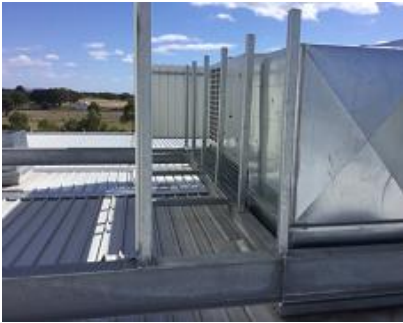
Variation in height between plant deck and roof is greater than required maximum	Trips, Slips and Falls	Awareness induction	Med	Handrails to be installed	Low	Client advised	Outstanding	OH&S REGULATIONS 3.7 AS/NZS 1657-2013 4.4

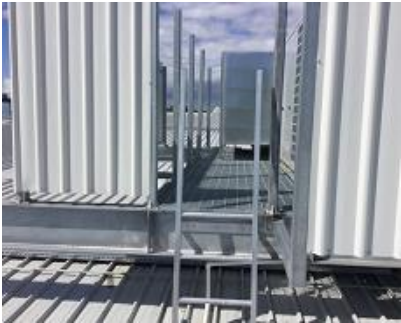
Gap between top rung and landing is greater than required maximum	Trips, Slips and Falls	Awareness induction	Med	Existing ladder to be re-installed with new brackets	Low	Client advised	Outstanding	OH&S REGULATIONS 3.7 AS/NZS 1657-2013 7.4.8.4
14	Building: General Stores Location Reference: L07 Task: Access to the plant deck

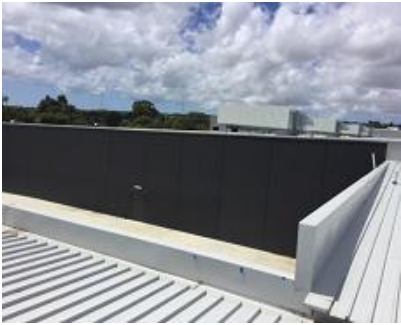
No height safety system installed	Trips, Slips and Falls	Awareness induction	High	Fall arrest anchors to be installed	Low	Client advised	Outstanding	OH&S REGULATIONS 3.55
16	Building: General Stores Location Reference: L08 Task: Access to the roof

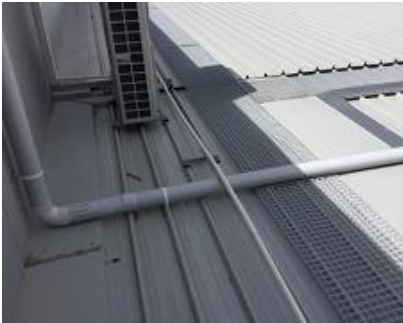
Pipe installed over the walkway path	Trips, Slips and Falls	Awareness induction	Med	Step bridge to be installed	Low	Client advised	Outstanding	OH&S REGULATIONS 3.7 AS/NZS 1657-2013 3.1.4
18	Building: General Stores Location Reference: L09 Task: Access to the A/c units

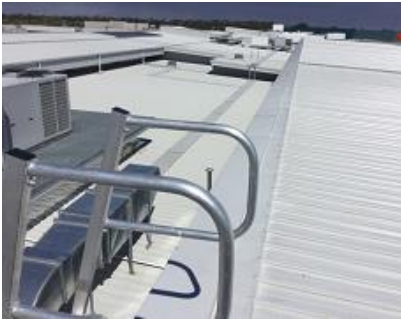
No height safety system installed	Trips, Slips and Falls	Awareness induction	High	Fall arrest anchors to be installed	Low	Client advised	Outstanding	OH&S REGULATIONS 3.55
20	Building: General Stores Location Reference: L10 Task: Access to the A/c units

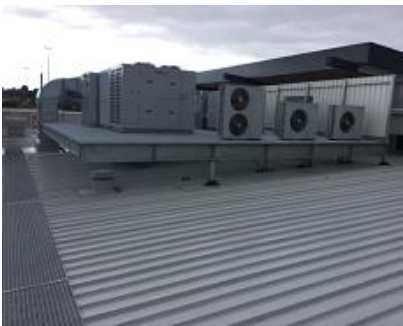
Variation in height between plant deck and roof is greater than required maximum	Trips, Slips and Falls	Awareness induction	Med	Access ladder and guardrails to be installed	Low	Client advised	Outstanding	OH&S REGULATIONS 3.7 AS/NZS 1657-2013 3.1.4 & 4.4
22	Building: General Stores Location Reference: L12 Task: Access to the roof

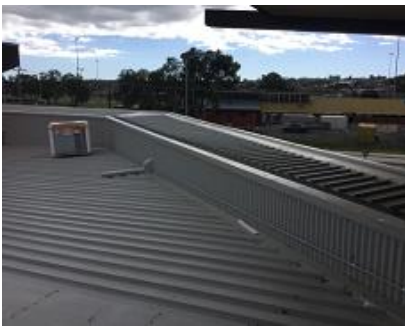
No height safety system installed	Trips, Slips and Falls	Awareness induction	High	Fall arrest static line and access ladder to be installed	Low	Client advised	Outstanding	OH&S REGULATIONS 3.7 & 3.55 AS/NZS 1657-2013 3.1.4
24	Building: General Stores Location Reference: L14 Task: Access to the roof

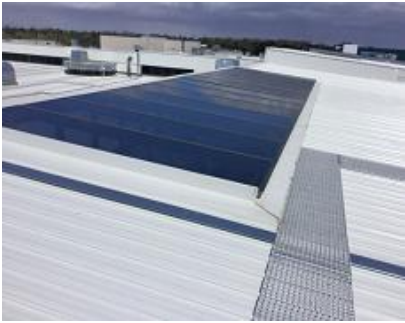
Brittle roof (Non-trafficable roof)	Trips, Slips and Falls	Restrict Access	High	"Warning-Keep Off-Brittle and Fragile Roof" signs to be installed	Low	Client advised	Outstanding	OH&S REGULATIONS 3.57
26	Building: General Stores Location Reference: L16 Task: Access to the roof

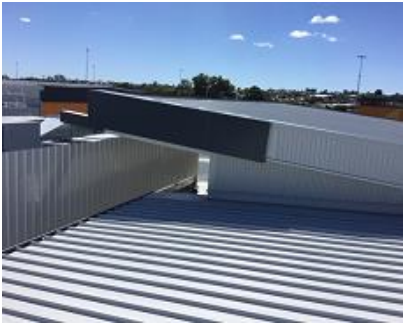
No height safety system installed	Trips, Slips and Falls	Awareness induction	High	Fall arrest anchors to be installed	Low	Client advised	Outstanding	OH&S REGULATIONS 3.55

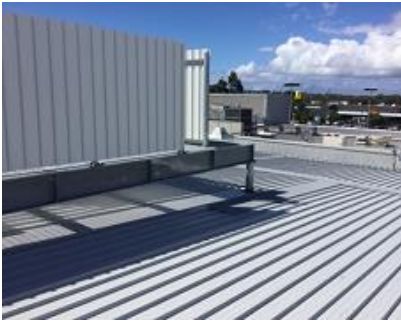
Variation in height between plant deck and roof is greater than required maximum	Trips, Slips and Falls	Awareness induction	Med	Access ladder to be installed	Low	Client advised	Outstanding	OH&S REGULATIONS 3.7 AS/NZS 1657-2013 3.1.4
28	Building: General Stores Location Reference: L18 Task: Access to the plant deck

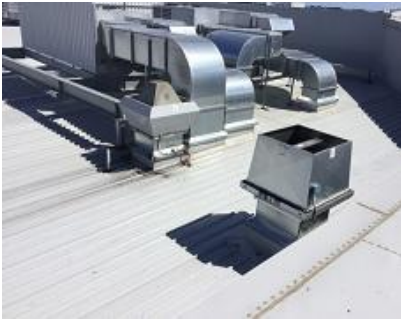
No safe access to the A/c units	Trips, Slips and Falls	N/A	Low	Supply walkway to the A/c units	Low	Client advised	Outstanding	-
30	Building: General Stores Location Reference: L19 Task: Access to the plant deck

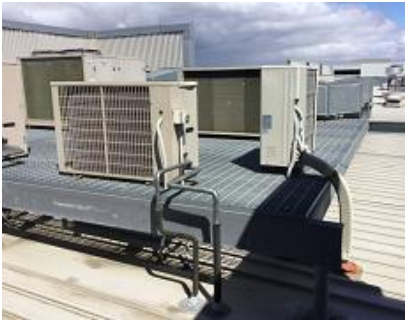
Variation in height between plant deck and roof is greater than required maximum	Trips, Slips and Falls	Awareness induction	Med	Handrails to be installed	Low	Client advised	Outstanding	OH&S REGULATIONS 3.7 AS/NZS 1657-2013 4.4
32	Building: General Stores Location Reference: L20 Task: Access to the A/c units

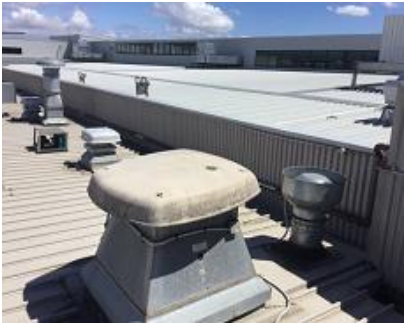
No safe access to the A/c units	Trips, Slips and Falls	N/A	Low	Supply walkway to the A/c units	Low	Client advised	Outstanding	-

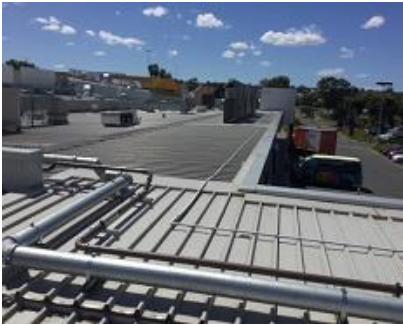
No height safety system installed	Trips, Slips and Falls	Awareness induction	High	Fall arrest anchors to be installed	Low	Client advised	Outstanding	OH&S REGULATIONS 3.55
34	Building: General Stores Location Reference: L21 Task: Access to the plant deck

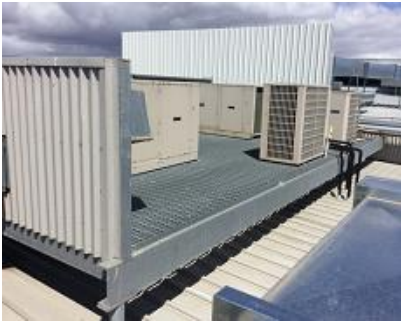
Variation in height between plant deck and roof is greater than required maximum	Trips, Slips and Falls	Awareness induction	Med	Handrails to be installed	Low	Client advised	Outstanding	OH&S REGULATIONS 3.7 AS/NZS 1657-2013 4.4
36	Building: General Stores Location Reference: L22 Task: Access to the plant deck

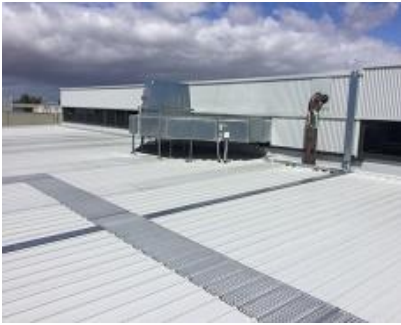
No safe access to the A/c units	Trips, Slips and Falls	N/A	Low	Supply walkway to the A/c units	Low	Client advised	Outstanding	-
38	Building: General Stores Location Reference: L23 Task: Access to the roof

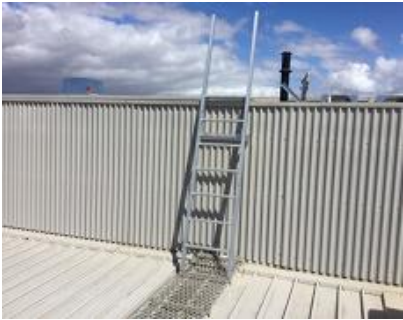
Gap between the ladder and permanent structure is less than required minimum	Trips, Slips and Falls	Awareness induction	Med	Existing ladder to be re-installed with new brackets and landing platforms	Low	Client advised	Outstanding	OH&S REGULATIONS 3.7 AS/NZS 1657-2013 7.4.5
40	Building: General Stores Location Reference: L23 Task: Access to the A/c units

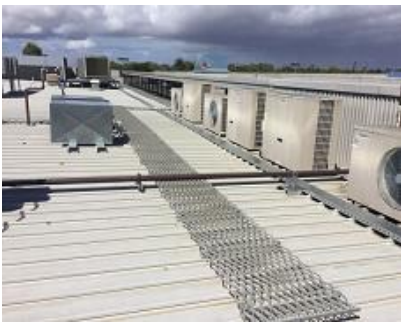
No safe access to the A/c units and pipe installed over the walkway path	Trips, Slips and Falls	N/A	Low	Supply walkway and step over to the A/c units	Low	Client advised	Outstanding	-
42	Building: General Stores Location Reference: L24 Task: Access to the roof

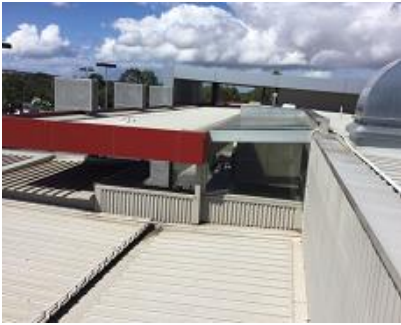
Brittle roof (Non-trafficable roof)	Trips, Slips and Falls	Restrict Access	High	"Warning-Keep Off-Brittle and Fragile Roof" signs to be installed	Low	Client advised	Outstanding	OH&S REGULATIONS 3.57
44	Building: General Stores Location Reference: L25 Task: Access to the roof

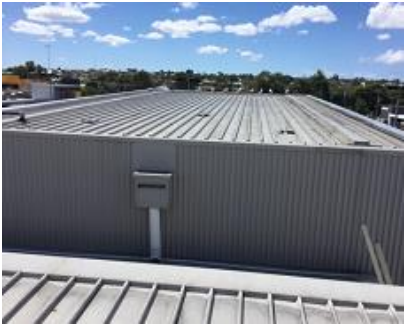
Variation in height between roofs are greater than required maximum	Trips, Slips and Falls	Awareness induction	Med	Access ladder and anchor strop to be installed	Low	Client advised	Outstanding	OH&S REGULATIONS 3.7 AS/NZS 1657-2013 3.1.4
46	Building: General Stores Location Reference: L26 Task: Access to the plant deck

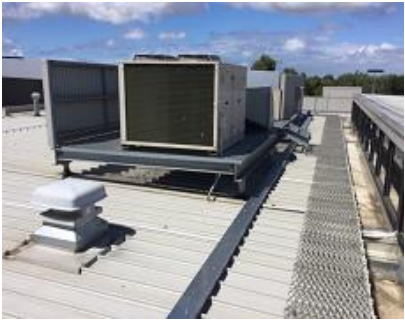
Non-complaint stair is present	Trips, Slips and Falls	Awareness induction	Med	Existing stair to be removed and new ladder to be installed	Low	Client advised	Outstanding	OH&S REGULATIONS 3.7 AS/NZS 1657-2013 7.2

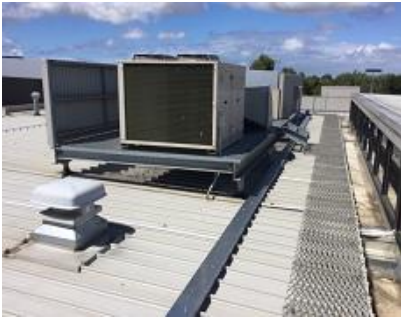
Variation in height between plant deck and roof is greater than required maximum	Trips, Slips and Falls	Awareness induction	Med	Handrails to be installed	Low	Client advised	Outstanding	OH&S REGULATIONS 3.7 AS/NZS 1657-2013 4.4
48	Building: General Stores Location Reference: L27 Task: Access to the roof

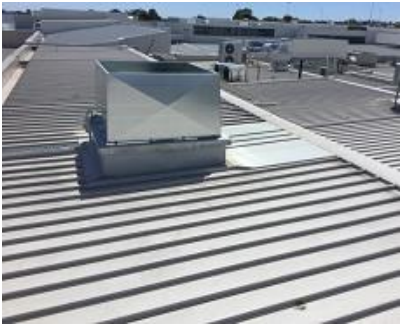
No safe access to the A/c units	Trips, Slips and Falls	N/A	Low	Supply walkway and handrail to the A/c units	Low	Client advised	Outstanding	-
50	Building: General Stores Location Reference: L28 Task: Access to the roof

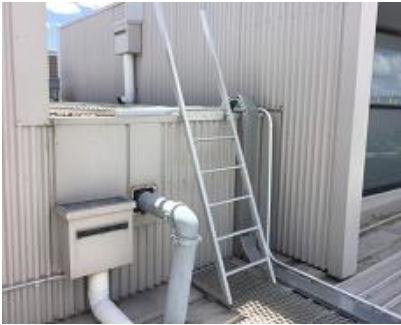
Bottom rung height is less than required minimum and clearance behind the ladder is less than required minimum	Trips, Slips and Falls	Awareness induction	Med	Existing ladder to be re-installed with landing platforms and brackets	Low	Client advised	Outstanding	OH&S REGULATIONS 3.7 AS/NZS 1657-2013 7.4.3.4 & 7.4.5
52	Building: General Stores Location Reference: L29 Task: Access to the roof

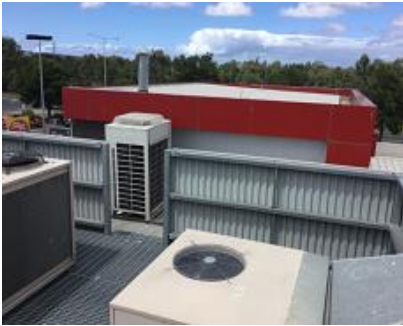
Variation in height between roofs are greater than required maximum	Trips, Slips and Falls	Awareness induction	Med	Access ladder and anchor strop to be installed	Low	Client advised	Outstanding	OH&S REGULATIONS 3.7 AS/NZS 1657-2013 3.1.4
54	Building: General Stores Location Reference: L31 Task: Access to the plant deck

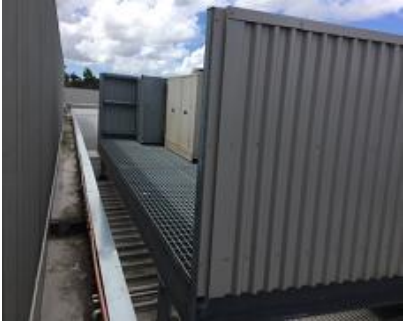
Variation in height between plant deck and roof is greater than required maximum	Trips, Slips and Falls	Awareness induction	Med	Handrails to be installed	Low	Client advised	Outstanding	OH&S REGULATIONS 3.7 AS/NZS 1657-2013 4.4
56	Building: General Stores Location Reference: L32 Task: Access to the roof

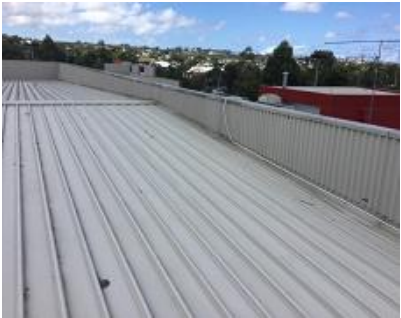
No height safety system installed	Trips, Slips and Falls	Awareness induction	High	Fall arrest anchors to be installed	Low	Client advised	Outstanding	OH&S REGULATIONS 3.55
58	Building: General Stores Location Reference: L34 Task: Access to the A/c units

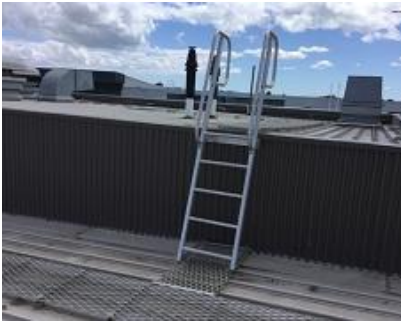
Top rung not levelled with landing, bottom rung height is less than required minimum and handrails projecting towards the user	Trips, Slips and Falls	Awareness induction	Med	Existing ladder to be removed and new ladder to be installed	Low	Client advised	Outstanding	OH&S REGULATIONS 3.7 AS/NZS 1657-2013 7.4.3.3, 7.4.3.4 & 7.4.8.4
60	Building: General Stores Location Reference: L36 Task: Access to the plant deck

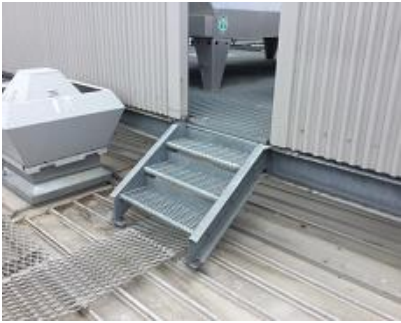
Non-complaint stair is present	Trips, Slips and Falls	Awareness induction	Med	Existing stair to be removed and new ladder to be installed	Low	Client advised	Outstanding	OH&S REGULATIONS 3.7 AS/NZS 1657-2013 7.2
62	Building: General Stores Location Reference: L36 Task: Access to the A/c units

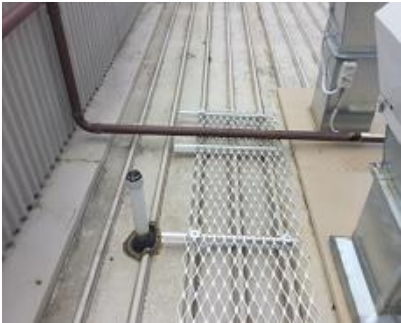
Pipe installed over the walkway path	Trips, Slips and Falls	Awareness induction	Med	Step over to be installed	Low	Client advised	Outstanding	OH&S REGULATIONS 3.7 AS/NZS 1657-2013 3.1.4
64	Building: General Stores Location Reference: L37 Task: Access to the roof

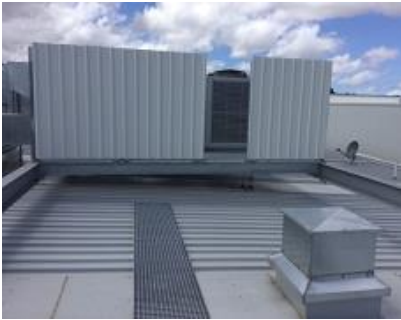
Variation in height between plant deck and roof is greater than required maximum	Trips, Slips and Falls	Awareness induction	Med	Access ladder including additional walkway sections to be installed	Low	Client advised	Outstanding	OH&S REGULATIONS 3.7 AS/NZS 1657-2013 3.1.4
66	Building: General Stores Location Reference: L38 Task: Access to the plant deck

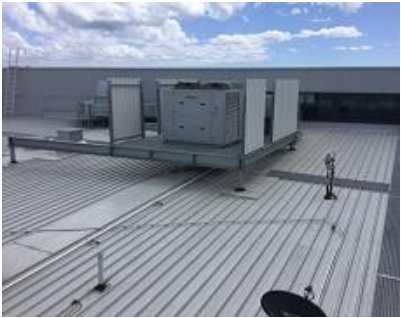
Variation in height between plant deck and roof is greater than required maximum	Trips, Slips and Falls	Awareness induction	Med	Handrails to be installed	Low	Client advised	Outstanding	OH&S REGULATIONS 3.7 AS/NZS 1657-2013 4.4
68	Building: General Stores Location Reference: L39 Task: Access to the plant deck

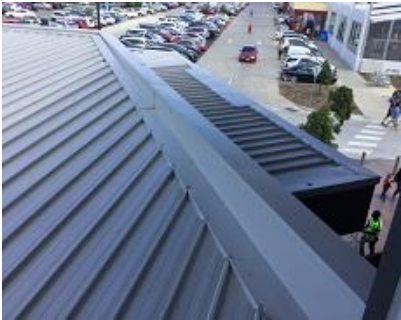
Variation in height between roofs are greater than required maximum	Trips, Slips and Falls	Awareness induction	Med	Access ladders including additional walkway sections to be installed	Low	Client advised	Outstanding	OH&S REGULATIONS 3.7 AS/NZS 1657-2013 3.1.4
70	Building: General Stores Location Reference: L40 Task: Access to the roof

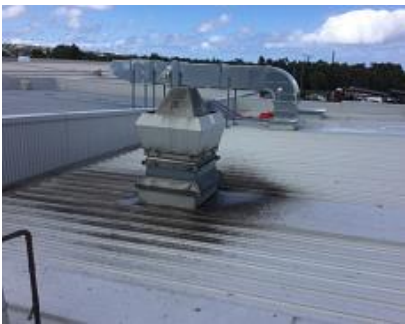
No safe access to the A/c units	Trips, Slips and Falls	N/A	Low	Supply walkway to the A/c units	Low	Client advised	Outstanding	-
72	Building: General Stores Location Reference: L40 Task: Access to the roof

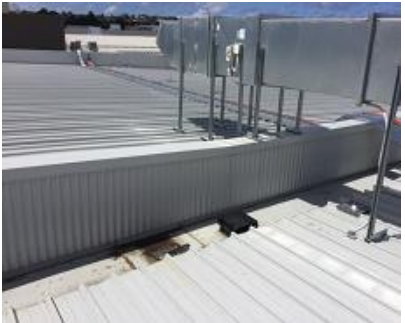
Variation in height between roofs are greater than required maximum	Trips, Slips and Falls	Awareness induction	Med	Access ladder to be installed	Low	Client advised	Outstanding	OH&S REGULATIONS 3.7 AS/NZS 1657-2013 3.1.4

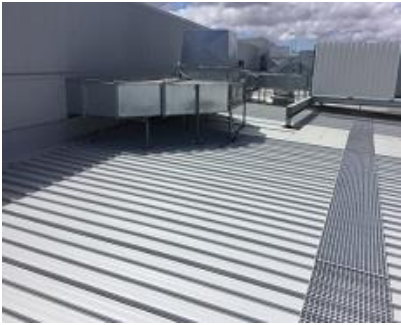
No safe access to the A/c units	Trips, Slips and Falls	N/A	Low	Supply walkway to the A/c units	Low	Client advised	Outstanding	-
74	Building: General Stores Location Reference: L41 Task: Restrict access to the roof

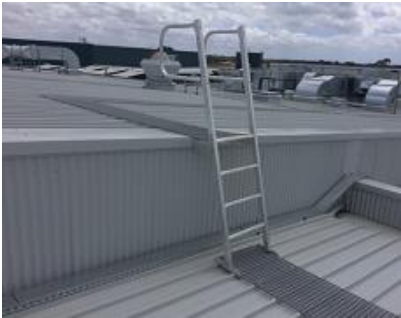
Top rung not levelled with landing	Trips, Slips and Falls	Awareness induction	Med	Existing ladder to be re-installed with landing platforms and brackets	Low	Client advised	Outstanding	OH&S REGULATIONS 3.7 AS/NZS 1657-2013 7.4.3.3
76	Building: General Stores Location Reference: L42 Task: Access to the roof

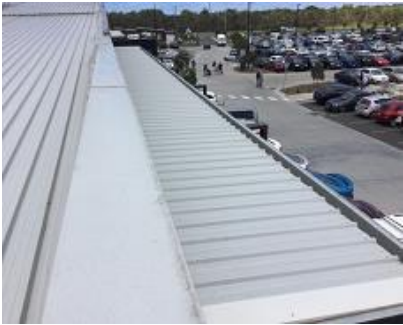
No height safety system installed	Trips, Slips and Falls	Awareness induction	High	Fall arrest static line, access ladder, anchor and anchor stop to be installed	Low	Client advised	Outstanding	OH&S REGULATIONS 3.7 & 3.55 AS/NZS 1657-2013 3.1.4
78	Building: General Stores Location Reference: L44 Task: Access to the plant deck

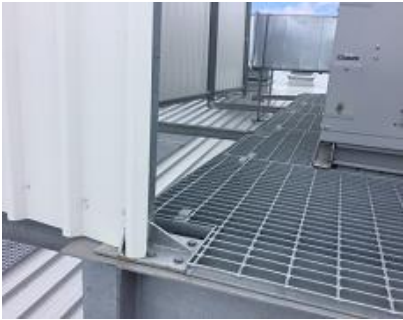
Variation in height between plant deck and roof is greater than required maximum	Trips, Slips and Falls	Awareness induction	Med	Handrails to be installed	Low	Client advised	Outstanding	OH&S REGULATIONS 3.7 AS/NZS 1657-2013 4.4
80	Building: General Stores Location Reference: L45 Task: Access to the plant deck

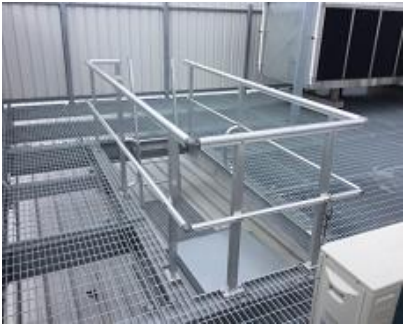
Sharp edges on handrails	Trips, Slips and Falls	Awareness induction	Med	Tek screws to be replaced with rivets	Low	Client advised	Outstanding	OH&S REGULATIONS 3.7 AS/NZS 1657-2013 5.6
82	Building: General Stores Location Reference: L45 Task: Access to the roof

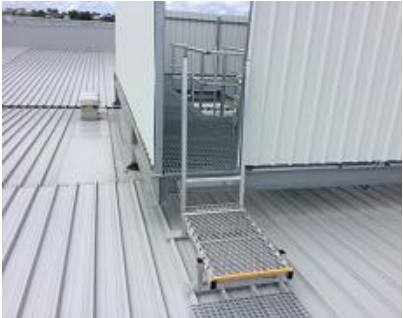
Gap between top rung and landing is greater than required maximum	Trips, Slips and Falls	Awareness induction	Med	Existing ladder to be re-installed with new brackets, landing platform and handrails	Low	Client advised	Outstanding	OH&S REGULATIONS 3.7 AS/NZS 1657-2013 7.4.8.4

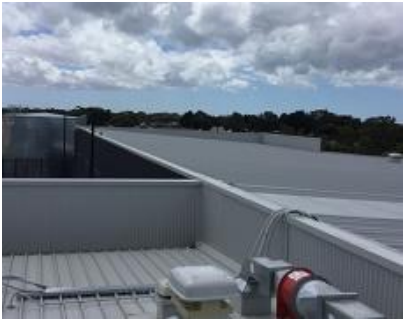
No height safety system installed	Trips, Slips and Falls	Awareness induction	High	Fall arrest anchors to be installed	Low	Client advised	Outstanding	OH&S REGULATIONS 3.55
84	Building: General Stores Location Reference: L47 Task: Access to the roof
