# Roof Safety Report

**Grand Plaza, QLD 4118**

Prepared By: Safemaster Safety Products  
Date: 31-01-2020

Roof Safety Report for  
**Grand Plaza, QLD 4118**

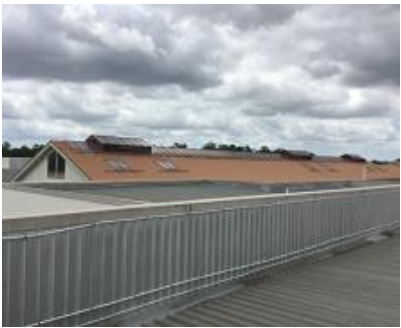
| No | Photo of Hazard | Details of Hazard | Details of Risk | Existing/<br>Immediate<br>Control<br>Measure | Current<br>Risk<br>Level | Proposed Permanent<br>Solution | Residual<br>Risk<br>Assessment | Details of<br>Action<br>Taken | Status | Reference |
|---|---|---|---|--|---|---|---|---|---|--|
| 155 | Building: General Stores<br>Location Reference: <a href="#">L10</a><br>Task: Access to the roof | | | | | | | | | |

| No | Photo of Hazard | Details of Hazard | Details of Risk | Existing/<br>Immediate<br>Control<br>Measure | Current<br>Risk<br>Level | Proposed Permanent<br>Solution | Residual<br>Risk<br>Assessment | Details of<br>Action<br>Taken | Status | Reference |
|---|---|---|---|--|---|---|---|---|---|--|
| | | No height safety system installed | Trips, Slips and Falls | Awareness induction | High | Anchors & Strop to be installed | Low | Client advised | Outstanding | OH&S REGULATIONS 3.55 |

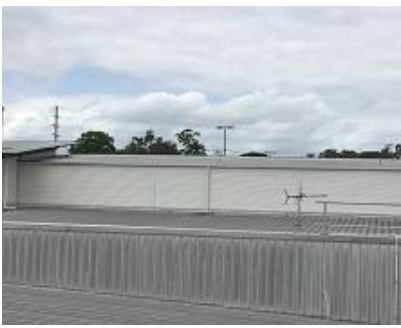
| No | Photo of Hazard | Details of Hazard | Details of Risk | Existing/<br>Immediate<br>Control<br>Measure | Current<br>Risk<br>Level | Proposed Permanent<br>Solution | Residual<br>Risk<br>Assessment | Details of<br>Action<br>Taken | Status | Reference |
|---|---|---|---|--|---|---|---|---|---|--|
| 156 | Building: General Stores<br>Location Reference: <a href="#">L28</a><br>Task: Access to the roof | | | | | | | | | |

| No | Photo of Hazard | Details of Hazard | Details of Risk | Existing/<br>Immediate<br>Control<br>Measure | Current<br>Risk<br>Level | Proposed Permanent<br>Solution | Residual<br>Risk<br>Assessment | Details of<br>Action<br>Taken | Status | Reference |
|---|---|---|---|--|---|---|---|---|---|--|
| | | Variation in height between roofs are greater than required maximum | Trips, Slips and Falls | Awareness induction | Med | Access ladder to be installed | Low | Client advised | Outstanding | OH&S REGULATIONS 3.7<br>AS/NZS 1657-2013 3.1.4 |

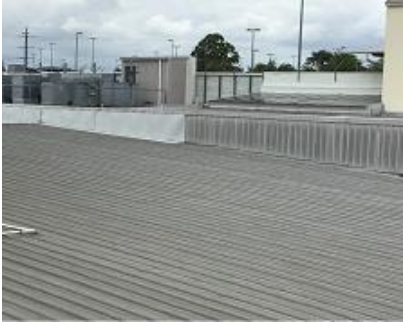
| No | Photo of Hazard | Details of Hazard | Details of Risk | Existing/<br>Immediate<br>Control<br>Measure | Curren<br>t Risk<br>Level | Proposed Permanent<br>Solution | Residu<br>al Risk<br>Assess<br>ment | Details of<br>Action<br>Taken | Status | Reference |
|---|--|---|---|--|---|---|---|---|---|--|
| 157 | Building: General Stores<br>Location Reference: <a href="#">L28</a><br>Task: Access to the roof | | | | | | | | | |

| No | Photo of Hazard | Details of Hazard | Details of Risk | Existing/<br>Immediate<br>Control<br>Measure | Curren<br>t Risk<br>Level | Proposed Permanent<br>Solution | Residu<br>al Risk<br>Assess<br>ment | Details of<br>Action<br>Taken | Status | Reference |
|---|--|---|---|--|---|---|---|---|---|--|
| | | Variation in height between roofs are greater than required maximum | Trips, Slips and Falls | Awareness induction | Med | Access ladder to be installed | Low | Client advised | Outstanding | OH&S REGULATIONS 3.7<br><br>AS/NZS 1657-2013 3.1.4 |

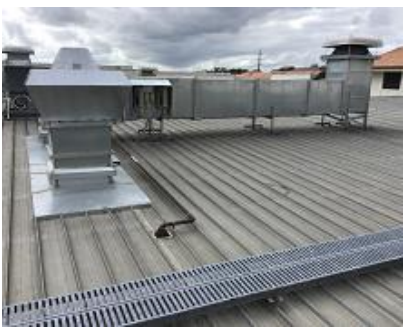
| No | Photo of Hazard | Details of Hazard | Details of Risk | Existing/<br>Immediate<br>Control<br>Measure | Curren<br>t Risk<br>Level | Proposed Permanent<br>Solution | Residu<br>al Risk<br>Assess<br>ment | Details of<br>Action<br>Taken | Status | Reference |
|---|--|---|---|--|---|---|---|---|---|--|
| 158 | Building: General Stores<br>Location Reference: <a href="#">L39</a><br>Task: Access to the A/c units | | | | | | | | | |

| No | Photo of Hazard | Details of Hazard | Details of Risk | Existing/<br>Immediate<br>Control<br>Measure | Curren<br>t Risk<br>Level | Proposed Permanent<br>Solution | Residu<br>al Risk<br>Assess<br>ment | Details of<br>Action<br>Taken | Status | Reference |
|---|--|---|---|--|---|---|---|---|---|--|
| | | No safe access to the A/c units | Trips, Slips and Falls | N/A | Low | Supply walkway to the A/c units | Low | Client advised | Outstanding | - |

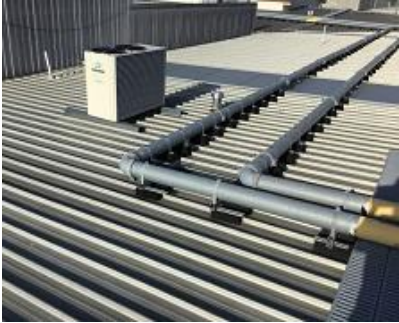
| No | Photo of Hazard | Details of Hazard | Details of Risk | Existing/<br>Immediate<br>Control<br>Measure | Curren<br>t Risk<br>Level | Proposed Permanent<br>Solution | Residu<br>al Risk<br>Assess<br>ment | Details of<br>Action<br>Taken | Status | Reference |
|---|--|---|---|--|---|---|---|---|---|---|
| | | No safe access to the A/c units | Trips, Slips and Falls | N/A | Low | Supply walkway to the A/c units | Low | Client advised | Outstanding | - |

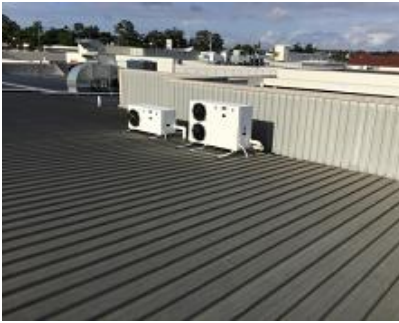
| No | Photo of Hazard | Details of Hazard | Details of Risk | Existing/<br>Immediate<br>Control<br>Measure | Curren<br>t Risk<br>Level | Proposed Permanent<br>Solution | Residu<br>al Risk<br>Assess<br>ment | Details of<br>Action<br>Taken | Status | Reference |
|---|--|---|---|--|---|---|---|---|---|---|
| | | No safe access to the A/c units | Trips, Slips and Falls | N/A | Low | Supply walkway to the A/c units | Low | Client advised | Outstanding | - |

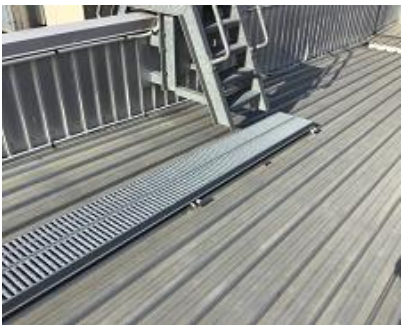
| No | Photo of Hazard | Details of Hazard | Details of Risk | Existing/<br>Immediate<br>Control<br>Measure | Curren<br>t Risk<br>Level | Proposed Permanent<br>Solution | Residu<br>al Risk<br>Assess<br>ment | Details of<br>Action<br>Taken | Status | Reference |
|---|---|--|---|--|---|--|---|---|---|--|
| 161 | Building: General Stores<br>Location Reference: <a href="#">L53</a><br>Task: Access to the roof | | | | | | | | | |

| No | Photo of Hazard | Details of Hazard | Details of Risk | Existing/<br>Immediate<br>Control<br>Measure | Curren<br>t Risk<br>Level | Proposed Permanent<br>Solution | Residu<br>al Risk<br>Assess<br>ment | Details of<br>Action<br>Taken | Status | Reference |
|---|---|--|---|--|---|--|---|---|---|--|
| | | Landing is less than required minimum | Trips, Slips and Falls | Awareness induction | Med | Landing to be installed | Low | Client advised | Outstanding | OH&S REGULATIONS 3.7<br><br>AS/NZS 1657-2018 7.3.6 |

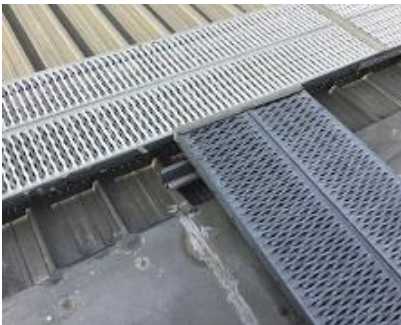
| No | Photo of Hazard | Details of Hazard | Details of Risk | Existing/<br>Immediate<br>Control<br>Measure | Curren<br>t Risk<br>Level | Proposed Permanent<br>Solution | Residu<br>al Risk<br>Assess<br>ment | Details of<br>Action<br>Taken | Status | Reference |
|---|---|--|---|--|---|--|---|---|---|--|
| 162 | Building: General Stores<br>Location Reference: <a href="#">L60</a><br>Task: Access to the roof | | | | | | | | | |

| No | Photo of Hazard | Details of Hazard | Details of Risk | Existing/<br>Immediate<br>Control<br>Measure | Curren<br>t Risk<br>Level | Proposed Permanent<br>Solution | Residu<br>al Risk<br>Assess<br>ment | Details of<br>Action<br>Taken | Status | Reference |
|---|---|--|---|--|---|--|---|---|---|--|
| | | Variation in height between walkway panels are greater than required maximum | Trips, Slips and Falls | Awareness induction | Med | High visibility safety yellow nosing to be installed | Low | Client advised | Outstanding | OH&S REGULATIONS 3.7<br><br>AS/NZS 1657-2013 3.3.4 |
