Roof Safety Report

**Gympie Central Shopping
Centre, QLD 4570**

Prepared By: Safemaster Safety Products
Date: 15 March 2019

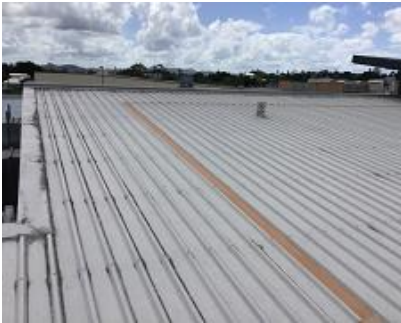
| No | Photo of Hazard | Details of Hazard | Details of Risk | Existing/ Immediate Control Measure | Curre nt Risk Level | Proposed Permanent Solution | Resid ual Risk Asse sme nt | Details of Action Taken | Status | Reference |
|---|---|--|---|--|---|---|---|---|---|--|
| 01 | Building: General Stores Location Reference: L03 Task: Access to the roof | | | | | | | | | |

| No | Photo of Hazard | Details of Hazard | Details of Risk | Existing/ Immediate Control Measure | Curre nt Risk Level | Proposed Permanent Solution | Resid ual Risk Asse sme nt | Details of Action Taken | Status | Reference |
|---|---|--|---|--|---|---|---|---|---|--|
| | | No height safety system installed | Trips, Slips and Falls | Awareness induction | High | Fall arrest anchors to be installed | Low | Client advised | Outstanding | OH&S REGULATIONS 3.55 |

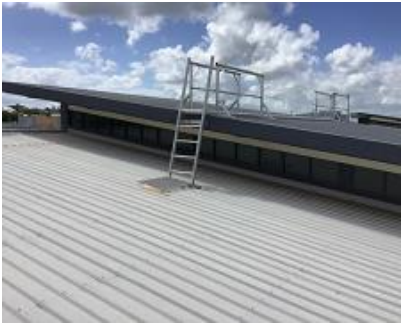
| No | Photo of Hazard | Details of Hazard | Details of Risk | Existing/ Immediate Control Measure | Curre nt Risk Level | Proposed Permanent Solution | Resid ual Risk Asse sme nt | Details of Action Taken | Status | Reference |
|---|---|--|---|--|---|---|---|---|---|--|
| 02 | Building: General Stores Location Reference: L05 Task: Access to the roof | | | | | | | | | |

| No | Photo of Hazard | Details of Hazard | Details of Risk | Existing/ Immediate Control Measure | Curre nt Risk Level | Proposed Permanent Solution | Resid ual Risk Asse sme nt | Details of Action Taken | Status | Reference |
|---|---|--|---|--|---|---|---|---|---|--|
| | | Bottom rung height is less than required minimum | Trips, Slips and Falls | Awareness induction | Med | Landing platform to be installed | Low | Client advised | Outstanding | OH&S REGULATIONS 3.7 AS/NZS 1657-2013 7.4.3.4 |

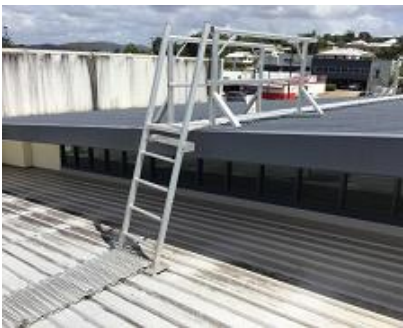
| No | Photo of Hazard | Details of Hazard | Details of Risk | Existing/ Immediate Control Measure | Curre nt Risk Level | Proposed Permanent Solution | Resid ual Risk Asse sme nt | Details of Action Taken | Status | Reference |
|---|---|--|---|--|---|---|---|---|---|--|
| 03 | Building: General Stores Location Reference: L05 Task: Access to the roof | | | | | | | | | |

| No | Photo of Hazard | Details of Hazard | Details of Risk | Existing/ Immediate Control Measure | Curre nt Risk Level | Proposed Permanent Solution | Resid ual Risk Asse sme nt | Details of Action Taken | Status | Reference |
|---|---|--|---|--|---|---|---|---|---|--|
| | | Bottom rung height is less than required minimum | Trips, Slips and Falls | Awareness induction | Med | Landing platform to be installed | Low | Client advised | Outstanding | OH&S REGULATIONS 3.7 AS/NZS 1657-2013 7.4.3.4 |

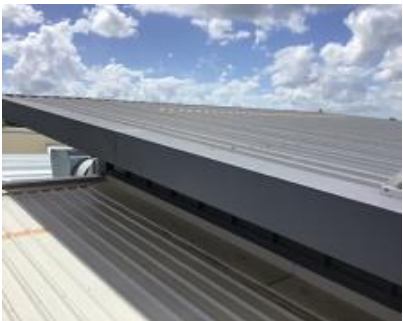
| No | Photo of Hazard | Details of Hazard | Details of Risk | Existing/ Immediate Control Measure | Curre nt Risk Level | Proposed Permanent Solution | Resid ual Risk Asse sme nt | Details of Action Taken | Status | Reference |
|---|---|--|---|--|---|---|---|---|---|--|
| 04 | Building: General Stores Location Reference: L05 Task: Access to the roof | | | | | | | | | |

| No | Photo of Hazard | Details of Hazard | Details of Risk | Existing/ Immediate Control Measure | Curre nt Risk Level | Proposed Permanent Solution | Resid ual Risk Asse sme nt | Details of Action Taken | Status | Reference |
|---|---|--|---|--|---|---|---|---|---|--|
| | | No height safety system installed | Trips, Slips and Falls | Awareness induction | High | Fall arrest anchors to be installed | Low | Client advised | Outstanding | OH&S REGULATIONS 3.55 |

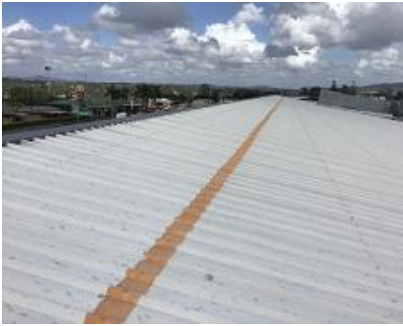
| No | Photo of Hazard | Details of Hazard | Details of Risk | Existing/ Immediate Control Measure | Curre nt Risk Level | Proposed Permanent Solution | Resid ual Risk Asse sme nt | Details of Action Taken | Status | Reference |
|---|--|---|---|--|---|---|---|---|---|---|
| 05 | Building: General Stores Location Reference: L11 Task: Access to the roof | | | | | | | | | |

| No | Photo of Hazard | Details of Hazard | Details of Risk | Existing/ Immediate Control Measure | Curre nt Risk Level | Proposed Permanent Solution | Resid ual Risk Asse sme nt | Details of Action Taken | Status | Reference |
|---|--|---|---|--|---|---|---|---|---|---|
| | | No height safety system installed | Trips, Slips and Falls | Awareness induction | High | Fall arrest anchors to be installed | Low | Client advised | Outstanding | OH&S REGULATIONS 3.55 |

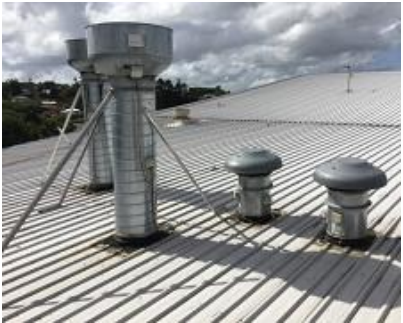
| No | Photo of Hazard | Details of Hazard | Details of Risk | Existing/ Immediate Control Measure | Curre nt Risk Level | Proposed Permanent Solution | Resid ual Risk Asse sme nt | Details of Action Taken | Status | Reference |
|---|--|---|---|--|---|---|---|---|---|---|
| 06 | Building: General Stores Location Reference: L12 Task: Access to the A/c units | | | | | | | | | |

| No | Photo of Hazard | Details of Hazard | Details of Risk | Existing/ Immediate Control Measure | Curre nt Risk Level | Proposed Permanent Solution | Resid ual Risk Asse sme nt | Details of Action Taken | Status | Reference |
|---|--|---|---|--|---|---|---|---|---|---|
| | | No safe access to the A/c units | Trips, Slips and Falls | N/A | Low | Supply walkway to the A/c units | Low | Client advised | Outstanding | - |

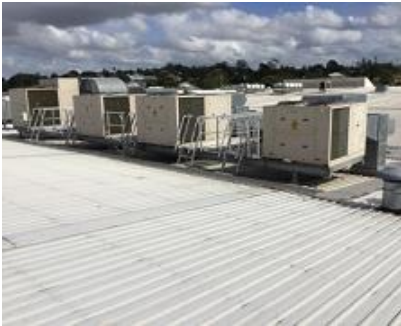
| No | Photo of Hazard | Details of Hazard | Details of Risk | Existing/ Immediate Control Measure | Curre nt Risk Level | Proposed Permanent Solution | Resid ual Risk Asse sme nt | Details of Action Taken | Status | Reference |
|---|---|--|---|--|---|--|---|---|---|--|
| 07 | Building: General Stores Location Reference: L13 Task: Access to the roof | | | | | | | | | |

| No | Photo of Hazard | Details of Hazard | Details of Risk | Existing/ Immediate Control Measure | Curre nt Risk Level | Proposed Permanent Solution | Resid ual Risk Asse sme nt | Details of Action Taken | Status | Reference |
|---|---|--|---|--|---|--|---|---|---|--|
| | | Landing is less than required minimum for ladders (x5) | Trips, Slips and Falls | Awareness induction | Med | Additional walkway sections at base to be installed for ladders (x5) | Low | Client advised | Outstanding | OH&S REGULATIONS 3.7 AS/NZS 1657-2013 7.3.6 |

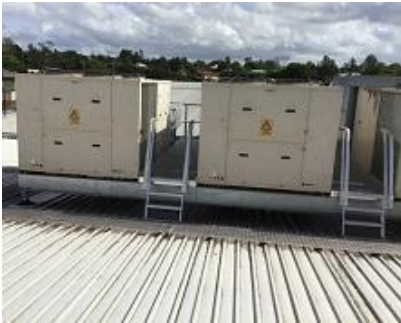
| No | Photo of Hazard | Details of Hazard | Details of Risk | Existing/ Immediate Control Measure | Curre nt Risk Level | Proposed Permanent Solution | Resid ual Risk Asse sme nt | Details of Action Taken | Status | Reference |
|---|---|--|---|--|---|--|---|---|---|--|
| 08 | Building: General Stores Location Reference: L14 Task: Access to the roof | | | | | | | | | |

| No | Photo of Hazard | Details of Hazard | Details of Risk | Existing/ Immediate Control Measure | Curre nt Risk Level | Proposed Permanent Solution | Resid ual Risk Asse sme nt | Details of Action Taken | Status | Reference |
|---|---|--|---|--|---|--|---|---|---|--|
| | | Landing is less than required minimum for ladders (x2) | Trips, Slips and Falls | Awareness induction | Med | Additional walkway sections at base to be installed for ladders (x2) | Low | Client advised | Outstanding | OH&S REGULATIONS 3.7 AS/NZS 1657-2013 7.3.6 |

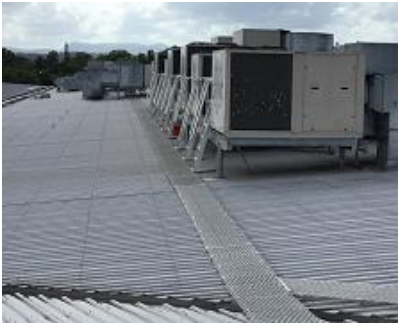
| No | Photo of Hazard | Details of Hazard | Details of Risk | Existing/ Immediate Control Measure | Curre nt Risk Level | Proposed Permanent Solution | Resid ual Risk Asse sme nt | Details of Action Taken | Status | Reference |
|---|---|--|---|--|---|--|---|---|---|--|
| 09 | Building: General Stores Location Reference: L15 Task: Access to the roof | | | | | | | | | |

| No | Photo of Hazard | Details of Hazard | Details of Risk | Existing/ Immediate Control Measure | Curre nt Risk Level | Proposed Permanent Solution | Resid ual Risk Asse sme nt | Details of Action Taken | Status | Reference |
|---|---|--|---|--|---|--|---|---|---|--|
| | | Landing is less than required minimum for ladders (x9) | Trips, Slips and Falls | Awareness induction | Med | Additional walkway sections at base to be installed for ladders (x9) | Low | Client advised | Outstanding | OH&S REGULATIONS 3.7 AS/NZS 1657-2013 7.3.6 |

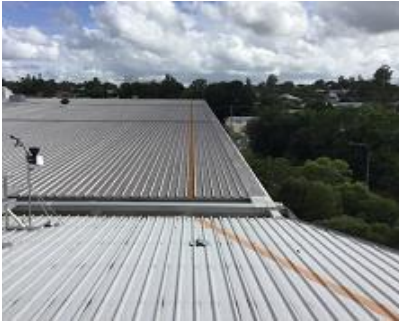
| No | Photo of Hazard | Details of Hazard | Details of Risk | Existing/ Immediate Control Measure | Curre nt Risk Level | Proposed Permanent Solution | Resid ual Risk Asse sme nt | Details of Action Taken | Status | Reference |
|---|---|--|---|--|---|--|---|---|---|--|
| 10 | Building: General Stores Location Reference: L16 Task: Access to the roof | | | | | | | | | |

| No | Photo of Hazard | Details of Hazard | Details of Risk | Existing/ Immediate Control Measure | Curre nt Risk Level | Proposed Permanent Solution | Resid ual Risk Asse sme nt | Details of Action Taken | Status | Reference |
|---|---|--|---|--|---|--|---|---|---|--|
| | | No height safety system installed | Trips, Slips and Falls | Awareness induction | High | Fall arrest anchors to be installed | Low | Client advised | Outstanding | OH&S REGULATIONS 3.55 |

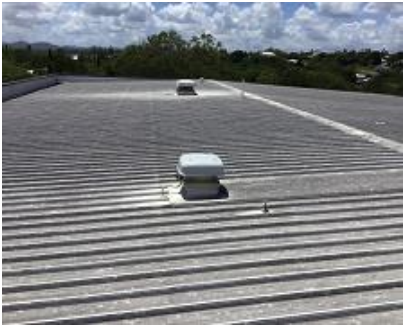
| No | Photo of Hazard | Details of Hazard | Details of Risk | Existing/ Immediate Control Measure | Curre nt Risk Level | Proposed Permanent Solution | Resid ual Risk Asse sme nt | Details of Action Taken | Status | Reference |
|---|--|---|---|--|---|--|---|---|---|--|
| 11 | Building: General Stores Location Reference: L17 Task: Access to the A/c units | | | | | | | | | |

| No | Photo of Hazard | Details of Hazard | Details of Risk | Existing/ Immediate Control Measure | Curre nt Risk Level | Proposed Permanent Solution | Resid ual Risk Asse sme nt | Details of Action Taken | Status | Reference |
|---|--|---|---|--|---|--|---|---|---|--|
| | | No safe access to the A/c units | Trips, Slips and Falls | N/A | Low | Supply walkway to the A/c units | Low | Client advised | Outstanding | - |

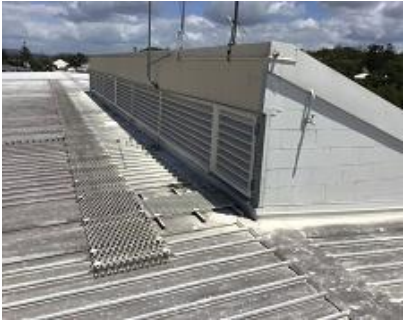
| No | Photo of Hazard | Details of Hazard | Details of Risk | Existing/ Immediate Control Measure | Curre nt Risk Level | Proposed Permanent Solution | Resid ual Risk Asse sme nt | Details of Action Taken | Status | Reference |
|---|--|---|---|--|---|--|---|---|---|--|
| 12 | Building: General Stores Location Reference: L17 Task: Access to the roof | | | | | | | | | |

| No | Photo of Hazard | Details of Hazard | Details of Risk | Existing/ Immediate Control Measure | Curre nt Risk Level | Proposed Permanent Solution | Resid ual Risk Asse sme nt | Details of Action Taken | Status | Reference |
|---|--|---|---|--|---|--|---|---|---|--|
| | | Head room is less than required minimum | Trips, Slips and Falls | Awareness induction | Med | "Caution-Low Headroom" signs to be installed | Low | Client advised | Outstanding | OH&S REGULATIONS 3.7 AS/NZS 1657-2013 3.1.5 |

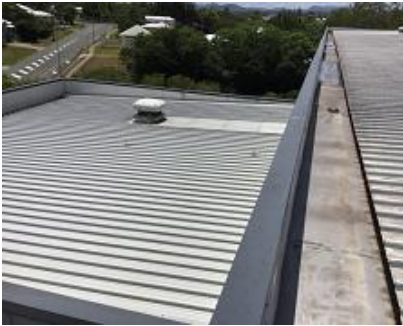
| No | Photo of Hazard | Details of Hazard | Details of Risk | Existing/ Immediate Control Measure | Curre nt Risk Level | Proposed Permanent Solution | Resid ual Risk Asse sme nt | Details of Action Taken | Status | Reference |
|---|--|---|---|--|---|---|---|---|---|--|
| 13 | Building: General Stores Location Reference: L18 Task: Access to the roof | | | | | | | | | |

| No | Photo of Hazard | Details of Hazard | Details of Risk | Existing/ Immediate Control Measure | Curre nt Risk Level | Proposed Permanent Solution | Resid ual Risk Asse sme nt | Details of Action Taken | Status | Reference |
|---|--|---|---|--|---|---|---|---|---|--|
| | | Variation in height between roof levels are greater than required maximum | Trips, Slips and Falls | Awareness induction | Med | Access ladder to be installed | Low | Client advised | Outstanding | OH&S REGULATIONS 3.7 AS/NZS 1657-2013 3.1.4 |

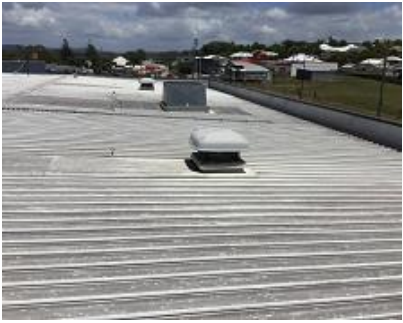
| No | Photo of Hazard | Details of Hazard | Details of Risk | Existing/ Immediate Control Measure | Curre nt Risk Level | Proposed Permanent Solution | Resid ual Risk Asse sme nt | Details of Action Taken | Status | Reference |
|---|--|---|---|--|---|---|---|---|---|--|
| 14 | Building: General Stores Location Reference: L18 Task: Access to the A/c units | | | | | | | | | |

| No | Photo of Hazard | Details of Hazard | Details of Risk | Existing/ Immediate Control Measure | Curre nt Risk Level | Proposed Permanent Solution | Resid ual Risk Asse sme nt | Details of Action Taken | Status | Reference |
|---|--|---|---|--|---|---|---|---|---|--|
| | | No safe access to the A/c units | Trips, Slips and Falls | N/A | Low | Supply walkway to the A/c units | Low | Client advised | Outstanding | - |

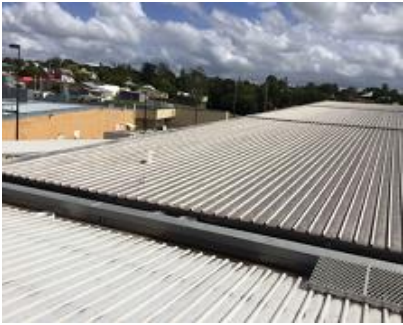
| No | Photo of Hazard | Details of Hazard | Details of Risk | Existing/ Immediate Control Measure | Curre nt Risk Level | Proposed Permanent Solution | Resid ual Risk Asse sme nt | Details of Action Taken | Status | Reference |
|---|---|---|---|--|---|--|---|---|---|---|
| 15 | Building: General Stores Location Reference: L19 Task: Access to the roof | | | | | | | | | |

| No | Photo of Hazard | Details of Hazard | Details of Risk | Existing/ Immediate Control Measure | Curre nt Risk Level | Proposed Permanent Solution | Resid ual Risk Asse sme nt | Details of Action Taken | Status | Reference |
|---|---|---|---|--|---|--|---|---|---|---|
| | | No height safety system installed | Trips, Slips and Falls | Awareness induction | High | Fall arrest anchors to be installed | Low | Client advised | Outstanding | OH&S REGULATIONS 3.55 |

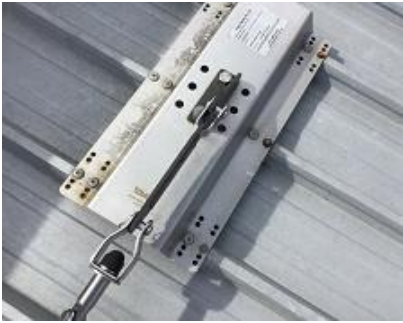
| No | Photo of Hazard | Details of Hazard | Details of Risk | Existing/ Immediate Control Measure | Curre nt Risk Level | Proposed Permanent Solution | Resid ual Risk Asse sme nt | Details of Action Taken | Status | Reference |
|---|---|---|---|--|---|--|---|---|---|---|
| 16 | Building: General Stores Location Reference: L20 Task: Access to the roof | | | | | | | | | |

| No | Photo of Hazard | Details of Hazard | Details of Risk | Existing/ Immediate Control Measure | Curre nt Risk Level | Proposed Permanent Solution | Resid ual Risk Asse sme nt | Details of Action Taken | Status | Reference |
|---|---|---|---|--|---|--|---|---|---|---|
| | | Static line installed incorrectly | Trips, Slips and Falls | Awareness induction | High | Existing static line screws to be replaced | Low | Client advised | Outstanding | OH&S REGULATIONS 3.55 |

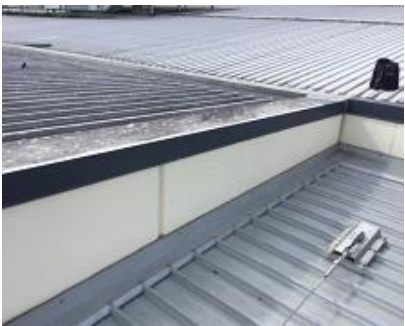
| No | Photo of Hazard | Details of Hazard | Details of Risk | Existing/ Immediate Control Measure | Curre nt Risk Level | Proposed Permanent Solution | Resid ual Risk Asse sme nt | Details of Action Taken | Status | Reference |
|---|--|---|---|--|---|--|---|---|---|--|
| 17 | Building: General Stores Location Reference: L20 Task: Access to the roof | | | | | | | | | |

| No | Photo of Hazard | Details of Hazard | Details of Risk | Existing/ Immediate Control Measure | Curre nt Risk Level | Proposed Permanent Solution | Resid ual Risk Asse sme nt | Details of Action Taken | Status | Reference |
|---|--|---|---|--|---|--|---|---|---|--|
| | | Variation in height between roof levels are greater than required maximum | Trips, Slips and Falls | Awareness induction | Med | Access ladder to be installed | Low | Client advised | Outstanding | OH&S REGULATIONS 3.7 AS/NZS 1657-2013 3.1.4 |

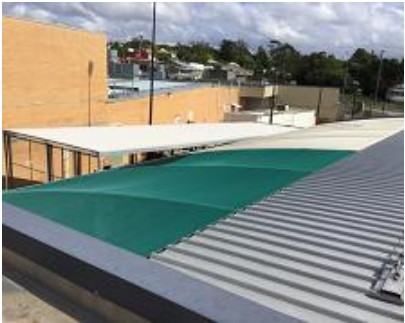
| No | Photo of Hazard | Details of Hazard | Details of Risk | Existing/ Immediate Control Measure | Curre nt Risk Level | Proposed Permanent Solution | Resid ual Risk Asse sme nt | Details of Action Taken | Status | Reference |
|---|--|---|---|--|---|--|---|---|---|--|
| 18 | Building: General Stores Location Reference: L20 Task: Restrict access to the roof | | | | | | | | | |

| No | Photo of Hazard | Details of Hazard | Details of Risk | Existing/ Immediate Control Measure | Curre nt Risk Level | Proposed Permanent Solution | Resid ual Risk Asse sme nt | Details of Action Taken | Status | Reference |
|---|--|---|---|--|---|--|---|---|---|--|
| | | Non-trafficable roof sections are present | Trips, Slips and Falls | Restrict Access | High | "Brittle and Fragile Roof" signs to be installed | Low | Client advised | Outstanding | OH&S REGULATIONS 3.57 |

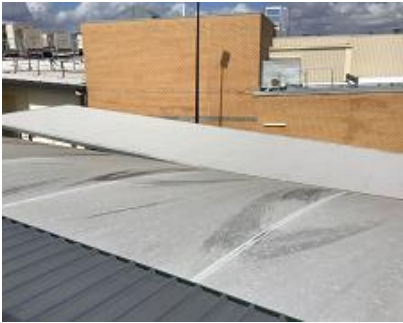
| No | Photo of Hazard | Details of Hazard | Details of Risk | Existing/ Immediate Control Measure | Curre nt Risk Level | Proposed Permanent Solution | Resid ual Risk Asse sme nt | Details of Action Taken | Status | Reference |
|---|---|--|---|--|---|---|---|---|---|--|
| 19 | Building: General Stores Location Reference: L21 Task: Access to the roof | | | | | | | | | |

| No | Photo of Hazard | Details of Hazard | Details of Risk | Existing/ Immediate Control Measure | Curre nt Risk Level | Proposed Permanent Solution | Resid ual Risk Asse sme nt | Details of Action Taken | Status | Reference |
|---|---|--|---|--|---|---|---|---|---|--|
| | | No height safety system installed | Trips, Slips and Falls | Awareness induction | High | Fall arrest anchors to be installed | Low | Client advised | Outstanding | OH&S REGULATIONS 3.55 |

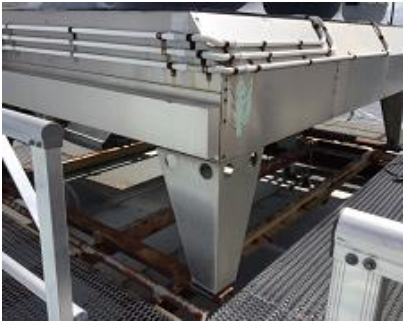
| No | Photo of Hazard | Details of Hazard | Details of Risk | Existing/ Immediate Control Measure | Curre nt Risk Level | Proposed Permanent Solution | Resid ual Risk Asse sme nt | Details of Action Taken | Status | Reference |
|---|---|--|---|--|---|---|---|---|---|--|
| 20 | Building: General Stores Location Reference: L23 Task: Access to the roof | | | | | | | | | |

| No | Photo of Hazard | Details of Hazard | Details of Risk | Existing/ Immediate Control Measure | Curre nt Risk Level | Proposed Permanent Solution | Resid ual Risk Asse sme nt | Details of Action Taken | Status | Reference |
|---|---|--|---|--|---|---|---|---|---|--|
| | | Variation in height between plant deck and unit is greater than required maximum | Trips, Slips and Falls | Awareness induction | Med | Mid rail to be installed | Low | Client advised | Outstanding | OH&S REGULATIONS 3.7 AS/NZS 1657-2013 4.4 |

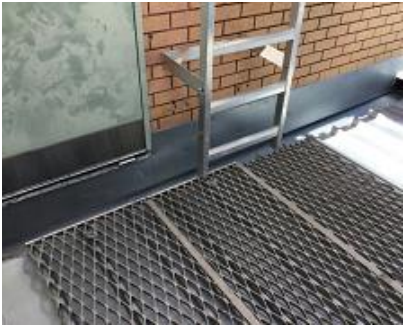
| No | Photo of Hazard | Details of Hazard | Details of Risk | Existing/ Immediate Control Measure | Curre nt Risk Level | Proposed Permanent Solution | Resid ual Risk Asse sme nt | Details of Action Taken | Status | Reference |
|---|---|--|---|--|---|---|---|---|---|--|
| 21 | Building: General Stores Location Reference: L24 Task: Access to the roof | | | | | | | | | |

| No | Photo of Hazard | Details of Hazard | Details of Risk | Existing/ Immediate Control Measure | Curre nt Risk Level | Proposed Permanent Solution | Resid ual Risk Asse sme nt | Details of Action Taken | Status | Reference |
|---|---|--|---|--|---|---|---|---|---|--|
| | | Bottom rung height is less than required minimum | Trips, Slips and Falls | Awareness induction | Med | Landing platform to be installed | Low | Client advised | Outstanding | OH&S REGULATIONS 3.7 AS/NZS 1657-2013 7.4.3.4 |

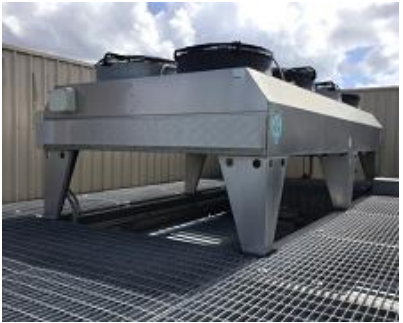
| No | Photo of Hazard | Details of Hazard | Details of Risk | Existing/ Immediate Control Measure | Curre nt Risk Level | Proposed Permanent Solution | Resid ual Risk Asse sme nt | Details of Action Taken | Status | Reference |
|---|---|--|---|--|---|---|---|---|---|--|
| 22 | Building: General Stores Location Reference: L25 Task: Access to the roof | | | | | | | | | |

| No | Photo of Hazard | Details of Hazard | Details of Risk | Existing/ Immediate Control Measure | Curre nt Risk Level | Proposed Permanent Solution | Resid ual Risk Asse sme nt | Details of Action Taken | Status | Reference |
|---|---|--|---|--|---|---|---|---|---|--|
| | | Variation in height between plant deck and unit is greater than required maximum | Trips, Slips and Falls | Awareness induction | Med | Mid rail to be installed | Low | Client advised | Outstanding | OH&S REGULATIONS 3.7 AS/NZS 1657-2013 4.4 |

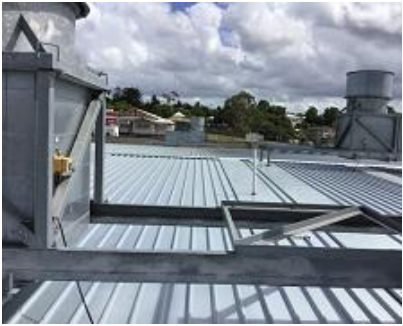
| No | Photo of Hazard | Details of Hazard | Details of Risk | Existing/ Immediate Control Measure | Curre nt Risk Level | Proposed Permanent Solution | Resid ual Risk Asse sme nt | Details of Action Taken | Status | Reference |
|---|--|---|---|--|---|---|---|---|---|---|
| 23 | Building: General Stores Location Reference: L26 Task: Access to the A/c units | | | | | | | | | |

| No | Photo of Hazard | Details of Hazard | Details of Risk | Existing/ Immediate Control Measure | Curre nt Risk Level | Proposed Permanent Solution | Resid ual Risk Asse sme nt | Details of Action Taken | Status | Reference |
|---|--|---|---|--|---|---|---|---|---|---|
| | | No safe access to the A/c units | Trips, Slips and Falls | N/A | Low | Supply walkway to the A/c units | Low | Client advised | Outstanding | - |

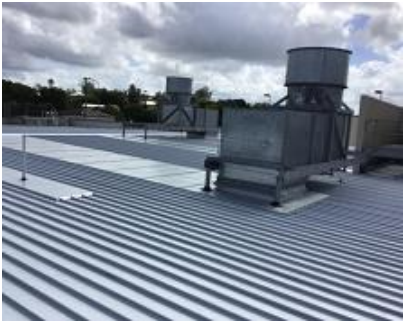
| No | Photo of Hazard | Details of Hazard | Details of Risk | Existing/ Immediate Control Measure | Curre nt Risk Level | Proposed Permanent Solution | Resid ual Risk Asse sme nt | Details of Action Taken | Status | Reference |
|---|--|---|---|--|---|---|---|---|---|---|
| 24 | Building: General Stores Location Reference: L26 Task: Access to the A/c units | | | | | | | | | |

| No | Photo of Hazard | Details of Hazard | Details of Risk | Existing/ Immediate Control Measure | Curre nt Risk Level | Proposed Permanent Solution | Resid ual Risk Asse sme nt | Details of Action Taken | Status | Reference |
|---|--|---|---|--|---|---|---|---|---|---|
| | | No safe access to the A/c units | Trips, Slips and Falls | N/A | Low | Supply walkway to the A/c units | Low | Client advised | Outstanding | - |

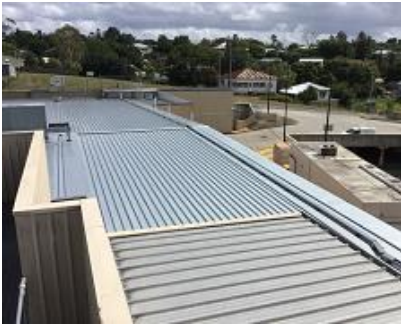
| No | Photo of Hazard | Details of Hazard | Details of Risk | Existing/ Immediate Control Measure | Curre nt Risk Level | Proposed Permanent Solution | Resid ual Risk Asse sme nt | Details of Action Taken | Status | Reference |
|---|--|---|---|--|---|---|---|---|---|---|
| 25 | Building: General Stores Location Reference: L26 Task: Access to the roof | | | | | | | | | |

| No | Photo of Hazard | Details of Hazard | Details of Risk | Existing/ Immediate Control Measure | Curre nt Risk Level | Proposed Permanent Solution | Resid ual Risk Asse sme nt | Details of Action Taken | Status | Reference |
|---|--|---|---|--|---|---|---|---|---|---|
| | | No height safety system installed | Trips, Slips and Falls | Awareness induction | High | Fall arrest anchors to be installed | Low | Client advised | Outstanding | OH&S REGULATIONS 3.55 |

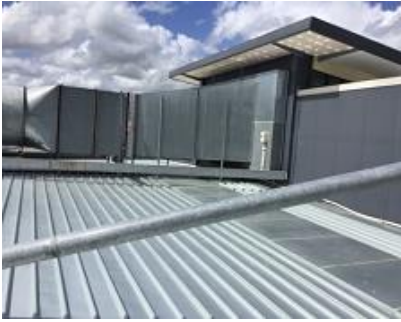
| No | Photo of Hazard | Details of Hazard | Details of Risk | Existing/ Immediate Control Measure | Curre nt Risk Level | Proposed Permanent Solution | Resid ual Risk Asse sme nt | Details of Action Taken | Status | Reference |
|---|--|---|---|--|---|---|---|---|---|---|
| 26 | Building: General Stores Location Reference: L27 Task: Access to the A/c units | | | | | | | | | |

| No | Photo of Hazard | Details of Hazard | Details of Risk | Existing/ Immediate Control Measure | Curre nt Risk Level | Proposed Permanent Solution | Resid ual Risk Asse sme nt | Details of Action Taken | Status | Reference |
|---|--|---|---|--|---|---|---|---|---|---|
| | | No safe access to the A/c units | Trips, Slips and Falls | N/A | Low | Supply walkway to the A/c units | Low | Client advised | Outstanding | - |

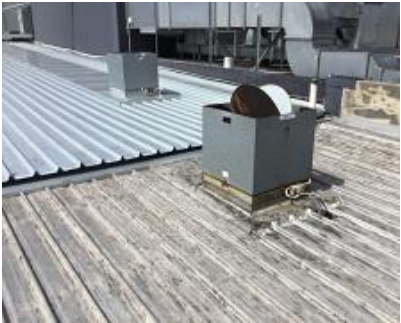
| No | Photo of Hazard | Details of Hazard | Details of Risk | Existing/ Immediate Control Measure | Curre nt Risk Level | Proposed Permanent Solution | Resid ual Risk Asse sme nt | Details of Action Taken | Status | Reference |
|---|--|---|---|--|---|---|---|---|---|---|
| 27 | Building: General Stores Location Reference: L28 Task: Access to the A/c units | | | | | | | | | |

| No | Photo of Hazard | Details of Hazard | Details of Risk | Existing/ Immediate Control Measure | Curre nt Risk Level | Proposed Permanent Solution | Resid ual Risk Asse sme nt | Details of Action Taken | Status | Reference |
|---|--|---|---|--|---|---|---|---|---|---|
| | | No safe access to the A/c units | Trips, Slips and Falls | N/A | Low | Supply walkway to the A/c units | Low | Client advised | Outstanding | - |

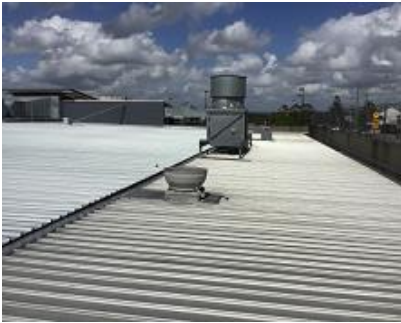
| No | Photo of Hazard | Details of Hazard | Details of Risk | Existing/ Immediate Control Measure | Curre nt Risk Level | Proposed Permanent Solution | Resid ual Risk Asse sme nt | Details of Action Taken | Status | Reference |
|---|--|---|---|--|---|---|---|---|---|---|
| 28 | Building: General Stores Location Reference: L28 Task: Access to the A/c units | | | | | | | | | |

| No | Photo of Hazard | Details of Hazard | Details of Risk | Existing/ Immediate Control Measure | Curre nt Risk Level | Proposed Permanent Solution | Resid ual Risk Asse sme nt | Details of Action Taken | Status | Reference |
|---|--|---|---|--|---|---|---|---|---|---|
| | | No safe access to the A/c units | Trips, Slips and Falls | N/A | Low | Supply walkway to the A/c units | Low | Client advised | Outstanding | - |

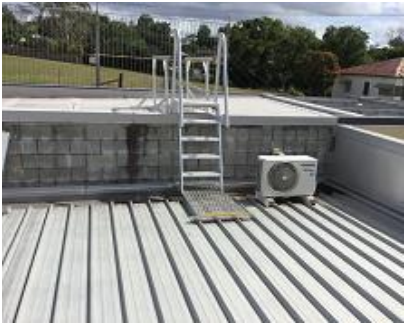
| No | Photo of Hazard | Details of Hazard | Details of Risk | Existing/ Immediate Control Measure | Curre nt Risk Level | Proposed Permanent Solution | Resid ual Risk Asse sme nt | Details of Action Taken | Status | Reference |
|---|--|---|---|--|---|---|---|---|---|---|
| 29 | Building: General Stores Location Reference: L29 Task: Access to the A/c units | | | | | | | | | |

| No | Photo of Hazard | Details of Hazard | Details of Risk | Existing/ Immediate Control Measure | Curre nt Risk Level | Proposed Permanent Solution | Resid ual Risk Asse sme nt | Details of Action Taken | Status | Reference |
|---|--|---|---|--|---|---|---|---|---|---|
| | | No safe access to the A/c units | Trips, Slips and Falls | N/A | Low | Supply walkway to the A/c units | Low | Client advised | Outstanding | - |
