Roof Safety Report

**Halls Head Central,
WA 6210**

Prepared By: Safemaster Safety Products
Date: 21-08-2018

Roof Safety Report for
Halls Head Central, WA 6210

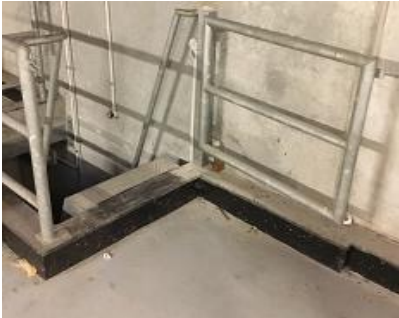
No	Photo of Hazard	Details of Hazard	Details of Risk	Existing/ Immediate Control Measure	Curren t Risk Level	Proposed Permanent Solution	Residu al Risk Assess ment	Details of Action Taken	Status	Reference
82	Building: General Stores Location Reference: L01 Task: Access to the roof

Top tread not levelled with landing	Trips, Slips and Falls	Awareness induction	Med	Landing platform to be installed. Existing self-closing gate to be replaced including additional handrail sections	Low	Client advised	Outstanding	OH&S REGULATIONS 3.7 AS/NZS 1657-2018 7.4.3.3
83	Building: General Stores Location Reference: L01 Task: Access to the roof

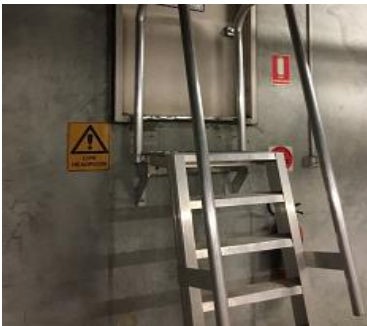
Top tread not levelled with landing and bottom tread height is less than required minimum	Trips, Slips and Falls	Awareness induction	Med	Existing ladder to be removed and new ladder including landing at door level and base to be installed	Low	Client advised	Outstanding	OH&S REGULATIONS 3.7 AS/NZS 1657-2018 7.4.3.3 & 7.4.3.4

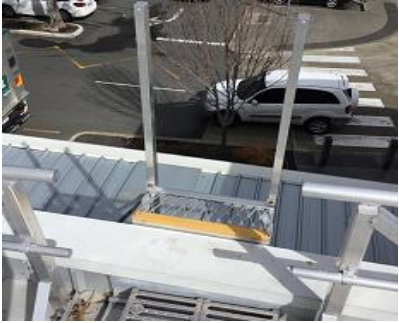
No	Photo of Hazard	Details of Hazard	Details of Risk	Existing/ Immediate Control Measure	Curren t Risk Level	Proposed Permanent Solution	Residu al Risk Assess ment	Details of Action Taken	Status	Reference
84	Building: General Stores Location Reference: L08 Task: Access to the roof

Landing at top is less than required minimum, handrail is missing for landing and trip hazard at base of ladder	Trips, Slips and Falls	Awareness induction	Med	Access anchor at top of ladder, Landing platforms, handrail at top and base to be installed	Low	Client advised	Outstanding	OH&S REGULATIONS 3.7 AS/NZS 1657-2018 7.3.6, 5.4.1 & 7.4.3.4
85	Building: General Stores Location Reference: L17 Task: Access to the roof

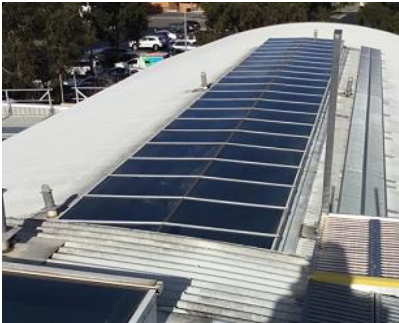
Walkway slope perpendicular to the direction of travel is greater than required maximum	Trips, Slips and Falls	Awareness induction	Med	Walkway to be re-installed with levelled brackets	Low	Client advised	Outstanding	OH&S REGULATIONS 3.7 AS/NZS 1657-2018 5.1.1

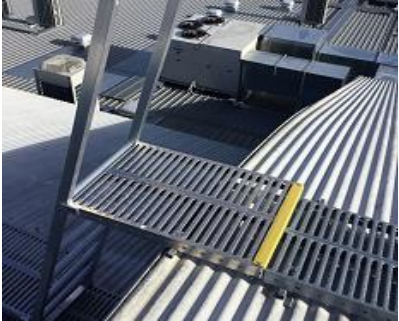
No	Photo of Hazard	Details of Hazard	Details of Risk	Existing/ Immediate Control Measure	Curren t Risk Level	Proposed Permanent Solution	Residu al Risk Assess ment	Details of Action Taken	Status	Reference
86	Building: General Stores Location Reference: L17 Task: Access to the roof

Handrail is missing for landing	Trips, Slips and Falls	Awareness induction	Med	Handrail to be installed at access point	Low	Client advised	Outstanding	OH&S REGULATIONS 3.7 AS/NZS 1657-2018 5.4.1
87	Building: General Stores Location Reference: L17 Task: Access to the roof

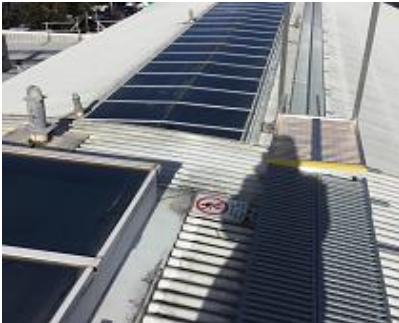
No safe transition provided between static lines	Trips, Slips and Falls	Awareness induction	High	Anchor points to be installed	Low	Client advised	Outstanding	OH&S REGULATIONS 3.55

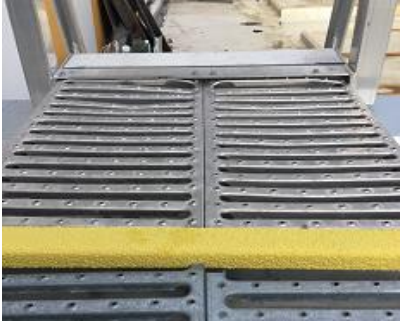
No	Photo of Hazard	Details of Hazard	Details of Risk	Existing/ Immediate Control Measure	Curren t Risk Level	Proposed Permanent Solution	Residu al Risk Assess ment	Details of Action Taken	Status	Reference
88	Building: General Stores Location Reference: L20 Task: Access to the roof

Top tread not levelled with landing	Trips, Slips and Falls	Awareness induction	Med	Existing landing platform to be replaced	Low	Client advised	Outstanding	OH&S REGULATIONS 3.7 AS/NZS 1657-2018 7.4.3.3
89	Building: General Stores Location Reference: L21 Task: Access to the roof

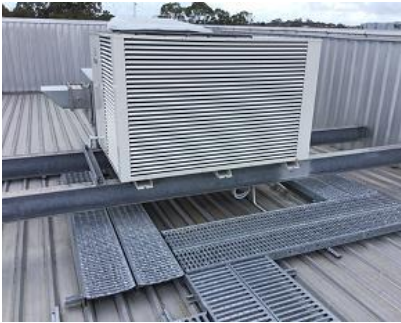
No safe access to the A/c units	Trips, Slips and Falls	Awareness induction	Med	Bridging platform including steps and handrails to be installed	Low	Client advised	Outstanding	OH&S REGULATIONS 3.7 AS/NZS 1657-2018 3.1.4

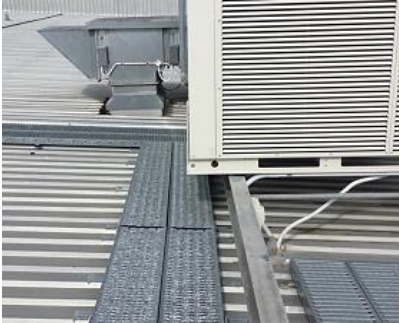
No	Photo of Hazard	Details of Hazard	Details of Risk	Existing/ Immediate Control Measure	Curren t Risk Level	Proposed Permanent Solution	Residu al Risk Assess ment	Details of Action Taken	Status	Reference
90	Building: General Stores Location Reference: L24 Task: Access to the roof

A/c unit protruding over the walkway path and required walkway width not achieved	Trips, Slips and Falls	Awareness induction	Med	Existing walkway to be re-located	Low	Client advised	Outstanding	OH&S REGULATIONS 3.7 AS/NZS 1657-2018 5.1.3
91	Building: General Stores Location Reference: L25 Task: Access to the roof

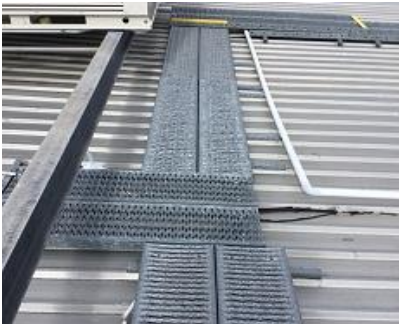
A/c unit protruding over the walkway path and walkway not fully secured	Trips, Slips and Falls	Awareness induction	Med	Existing walkway to re-located including additional fixings	Low	Client advised	Outstanding	OH&S REGULATIONS 3.7 AS/NZS 1657-2018 5.1.3

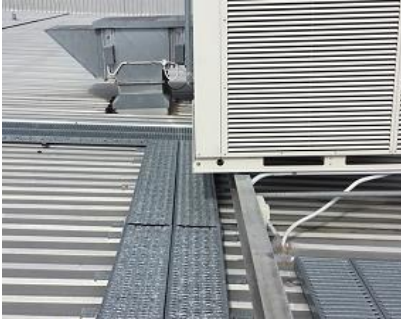
No	Photo of Hazard	Details of Hazard	Details of Risk	Existing/ Immediate Control Measure	Curren t Risk Level	Proposed Permanent Solution	Residu al Risk Assess ment	Details of Action Taken	Status	Reference
92	Building: General Stores Location Reference: L26 Task: Access to the roof

A/c unit protruding over the walkway path and required walkway width not achieved	Trips, Slips and Falls	Awareness induction	Med	Existing walkway to be re-located	Low	Client advised	Outstanding	OH&S REGULATIONS 3.7 AS/NZS 1657-2018 5.1.3
93	Building: General Stores Location Reference: L23 Task: Access to the roof

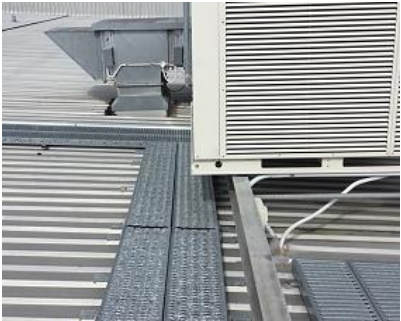
A/c unit protruding over the walkway path and required walkway width not achieved	Trips, Slips and Falls	Awareness induction	Med	Existing walkway to be re-located	Low	Client advised	Outstanding	OH&S REGULATIONS 3.7 AS/NZS 1657-2018 5.1.3

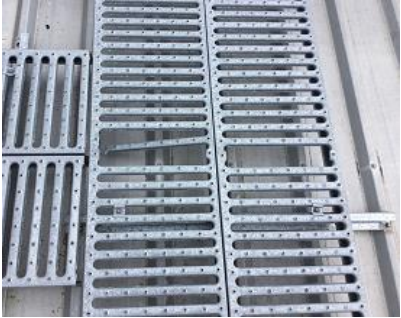
No	Photo of Hazard	Details of Hazard	Details of Risk	Existing/ Immediate Control Measure	Curren t Risk Level	Proposed Permanent Solution	Residu al Risk Assess ment	Details of Action Taken	Status	Reference
94	Building: General Stores Location Reference: L31 Task: Access to the roof

Damaged walkway section is present	Trips, Slips and Falls	Awareness induction	Med	Walkway section to be replaced	Low	Client advised	Outstanding	OH&S REGULATIONS 3.7
95	Building: General Stores Location Reference: L32 Task: Access to the roof

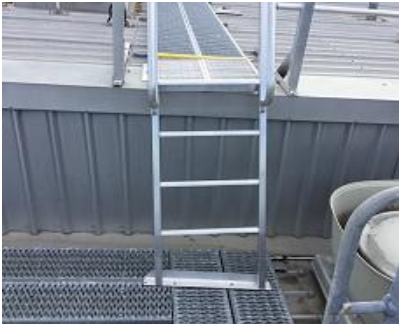
Bottom rung height is greater than required maximum and top landing is less than required minimum	Trips, Slips and Falls	Awareness induction	Med	Landing platforms to be installed	Low	Client advised	Outstanding	OH&S REGULATIONS 3.7 AS/NZS 1657-2018 7.4.3.4 & 7.3.6

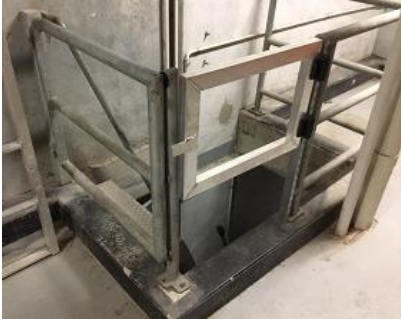
No	Photo of Hazard	Details of Hazard	Details of Risk	Existing/ Immediate Control Measure	Curren t Risk Level	Proposed Permanent Solution	Residu al Risk Assess ment	Details of Action Taken	Status	Reference
96	Building: General Stores Location Reference: L35 Task: Access to the roof

No safe side access to the ladder	Trips, Slips and Falls	Awareness induction	Med	Sign to be installed	Low	Client advised	Outstanding	OH&S REGULATIONS 3.7 & 3.11
97	Building: General Stores Location Reference: L35 Task: Access to the roof

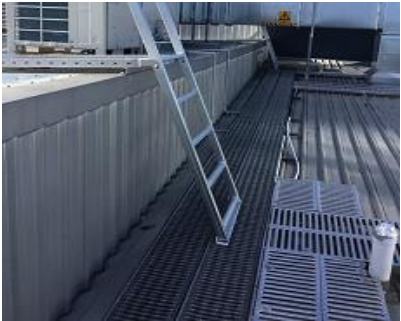
Bottom rung height is less than required minimum	Trips, Slips and Falls	Awareness induction	Med	Landing platform to be installed	Low	Client advised	Outstanding	OH&S REGULATIONS 3.7 AS/NZS 1657-2018 7.4.3.4

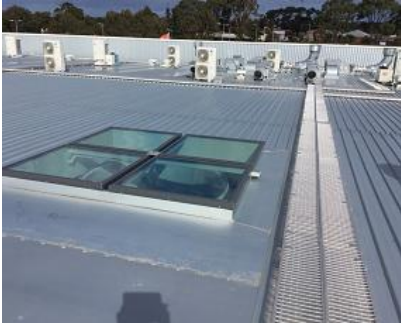
No	Photo of Hazard	Details of Hazard	Details of Risk	Existing/ Immediate Control Measure	Curren t Risk Level	Proposed Permanent Solution	Residu al Risk Assess ment	Details of Action Taken	Status	Reference
98	Building: General Stores Location Reference: L41 Task: Access to the roof

Gap between walkway and brittle roof section is less than required minimum	Trips, Slips and Falls	Awareness induction	Med	Handrail to be installed	Low	Client advised	Outstanding	OH&S REGULATIONS 3.7 AS/NZS 1657-2018 5.4.1
99	Building: General Stores Location Reference: L55 Task: Access to the A/c units

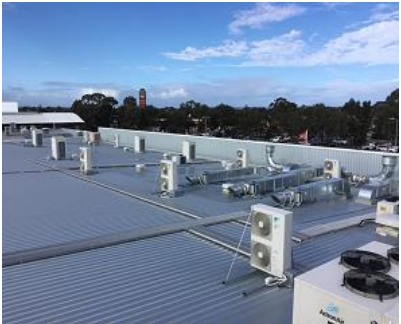
No safe access to the A/c units	Trips, Slips and Falls	N/A	Low	Supply walkway to the A/c units	Low	Client advised	Outstanding	-

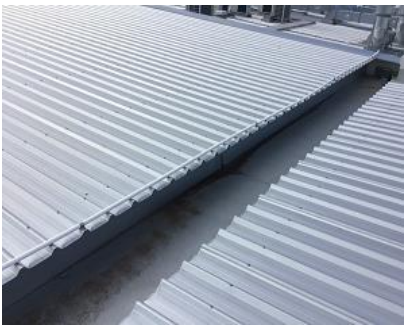
No	Photo of Hazard	Details of Hazard	Details of Risk	Existing/ Immediate Control Measure	Curren t Risk Level	Proposed Permanent Solution	Residu al Risk Assess ment	Details of Action Taken	Status	Reference
100	Building: General Stores Location Reference: L11 Task: Access to the roof

Variation in height between roofs are greater than required maximum	Trips, Slips and Falls	Awareness induction	Med	Step bridge including handrail and step to be installed	Low	Client advised	Outstanding	OH&S REGULATIONS 3.7 AS/NZS 1657-2018 3.1.4
101	Building: General Stores Location Reference: L60 Task: Access to the roof

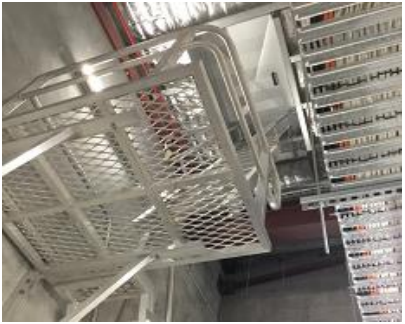
Cage is not installed for ladder at upper level	Trips, Slips and Falls	Awareness induction	Med	Cage to be installed	Low	Client advised	Outstanding	OH&S REGULATIONS 3.7 AS/NZS 1657-2018 7.4.7

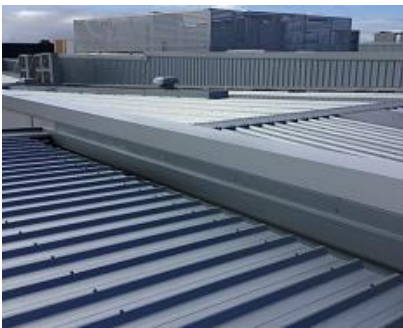
No	Photo of Hazard	Details of Hazard	Details of Risk	Existing/ Immediate Control Measure	Curren t Risk Level	Proposed Permanent Solution	Residu al Risk Assess ment	Details of Action Taken	Status	Reference
102	Building: General Stores Location Reference: L60 Task: Access to the roof

Variation in height between roofs are greater than required maximum	Trips, Slips and Falls	Awareness induction	Med	Step bridge to be installed	Low	Client advised	Outstanding	OH&S REGULATIONS 3.7 AS/NZS 1657-2018 3.1.4
103	Building: General Stores Location Reference: L60 Task: Access to the roof

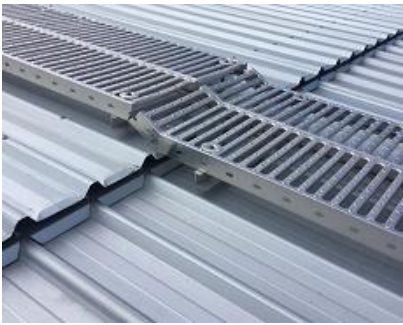
Variation in height between walkway panels are greater than required maximum	Trips, Slips and Falls	Awareness induction	Med	Existing bent walkway to be removed and high visibility safety yellow nosing to be installed	Low	Client advised	Outstanding	OH&S REGULATIONS 3.7 AS/NZS 1657-2018 3.3.4

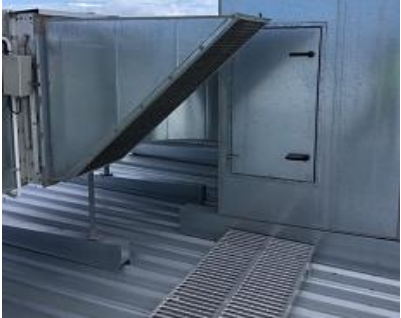
No	Photo of Hazard	Details of Hazard	Details of Risk	Existing/ Immediate Control Measure	Curren t Risk Level	Proposed Permanent Solution	Residu al Risk Assess ment	Details of Action Taken	Status	Reference
104	Building: General Stores Location Reference: L48 Task: Access to the roof

Duct protruding over the walkway path	Trips, Slips and Falls	Awareness induction	Med	Existing walkway to be relocated with additional walkway sections	Low	Client advised	Outstanding	OH&S REGULATIONS 3.7 AS/NZS 1657-2018 3.3.4
105	Building: General Stores Location Reference: L49 Task: Access to the roof

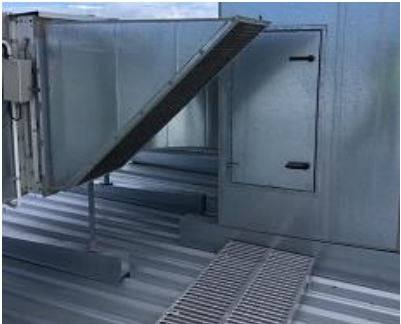
Duct protruding over the walkway path	Trips, Slips and Falls	Awareness induction	Med	Existing walkway to be relocated with additional walkway sections	Low	Client advised	Outstanding	OH&S REGULATIONS 3.7 AS/NZS 1657-2018 3.3.4

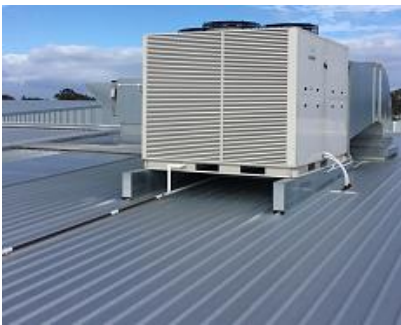
No	Photo of Hazard	Details of Hazard	Details of Risk	Existing/ Immediate Control Measure	Curren t Risk Level	Proposed Permanent Solution	Residu al Risk Assess ment	Details of Action Taken	Status	Reference
106	Building: General Stores Location Reference: L48 Task: Access to the A/c units

No safe access to the A/c units	Trips, Slips and Falls	N/A	Low	Supply walkway to the A/c units	Low	Client advised	Outstanding	-
107	Building: General Stores Location Reference: L53 Task: Access to the roof

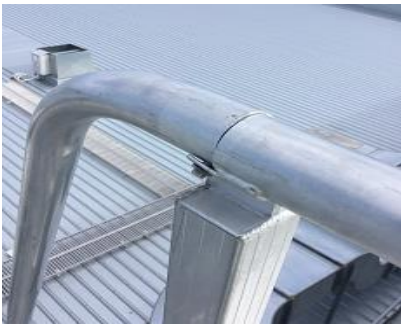
Sharp edges on handrail and tread spacing is greater than required maximum	Trips, Slips and Falls	Awareness induction	Med	Existing ladder to be removed and new ladder to be installed	Low	Client advised	Outstanding	OH&S REGULATIONS 3.7 AS/NZS 1657-2018 5.6 & 7.3
