Roof Safety Report

Halls Head Central, WA 6210

Prepared By: Safemaster Safety Products
Date: 09-09-2020

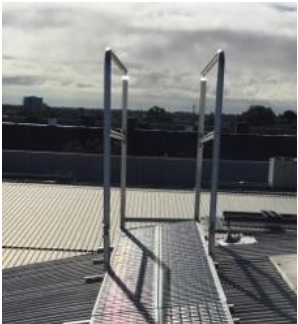
No	Photo of Hazard	Details of Hazard	Details of Risk	Existing/ Immediate Control Measure	Curren t Risk Level	Proposed Permanent Solution	Residu al Risk Assess ment	Details of Action Taken	Status	Reference
21	Building: General Stores Location Reference: L16 Task: Access to the roof

Landing not levelled	Trips, Slips and Falls	Awareness induction	Med	Levelled landing platform to be installed	Low	Client advised	Outsta nding	OH&S REGULATIONS 3.7 AS1657-2018 7.3.6
40	Building: General Stores Location Reference: L33 Task: Access to the roof

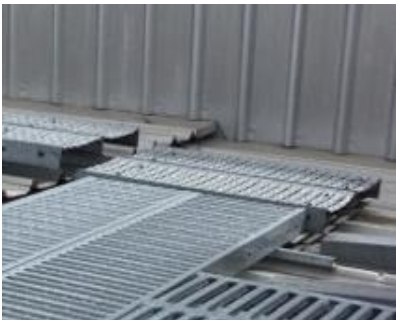
Variation in height between the adjacent levels are greater than required maximum	Trips, Slips and Falls	Awareness induction	Med	High visibility safety yellow nosing to be installed	Low	Client advised	Outsta nding	OH&S REGULATIONS 3.7 AS1657-2018 3.3.4

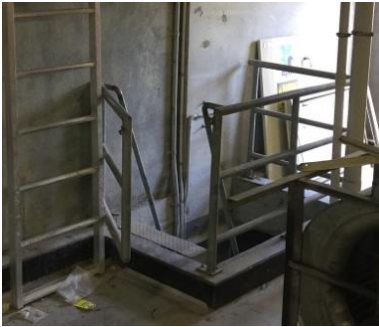
No	Photo of Hazard	Details of Hazard	Details of Risk	Existing/ Immediate Control Measure	Curren t Risk Level	Proposed Permanent Solution	Residu al Risk Assess ment	Details of Action Taken	Status	Reference
47	Building: General Stores Location Reference: L35 Task: Access to the roof

Self-closing gate not fully operable as ladder in the way	Trips, Slips and Falls	Awareness induction	Med	Ladder to be removed as this access point is no longer used	Low	Client advised	Outstanding	OH&S REGULATIONS 3.7 AS1657-2018 6.2.1.1
48	Building: General Stores Location Reference: L35 Task: Access to the roof

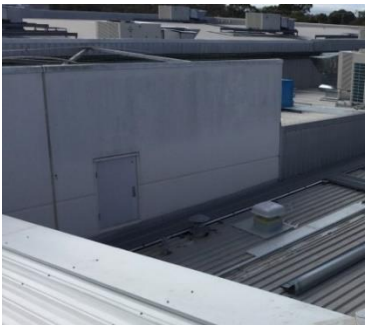
Headroom is less than required minimum	Trips, Slips and Falls	Awareness induction	Med	"WARNING LOW HEADROOM" sign to be installed including high visibility safety yellow tape	Low	Client advised	Outstanding	OH&S REGULATIONS 3.7 AS1657-2018 3.1.5

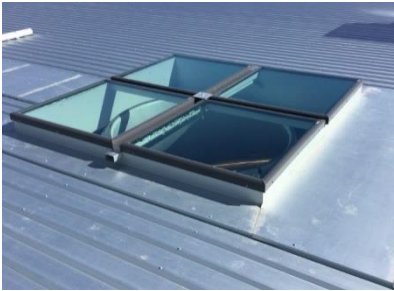
No	Photo of Hazard	Details of Hazard	Details of Risk	Existing/ Immediate Control Measure	Curren t Risk Level	Proposed Permanent Solution	Residu al Risk Assess ment	Details of Action Taken	Status	Reference
49	Building: General Stores Location Reference: L36 to L43 Task: Access to the roof

Brittle roof (Non-traffiicable)	Trips, Slips and Falls	Awareness induction	High	"KEEP OFF BRITTLE AND FRAGILE ROOF" signs to be installed	Low	Client advised	Outstanding	OH&S REGULATIONS 3.57

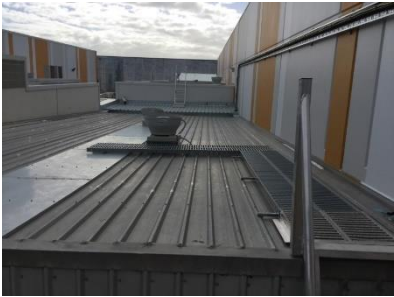
No	Photo of Hazard	Details of Hazard	Details of Risk	Existing/ Immediate Control Measure	Curren t Risk Level	Proposed Permanent Solution	Residu al Risk Assess ment	Details of Action Taken	Status	Reference
60	Building: General Stores Location Reference: L20 & L21 Task: Access to the roof

Roof walkway not installed for safe access and egress to the A/C units	Trips, Slips and Falls	Awareness induction	Low	Supply walkway to A/C units	Low	Client advised	Outstanding	-
61	Building: General Stores Location Reference: L23 Task: Access to the roof

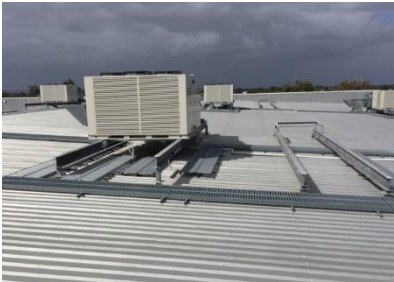
Walkway sections missing to provide continuous access path	Trips, Slips and Falls	Awareness induction	Low	Supply walkway to fill the gaps	Low	Client advised	Outstanding	-

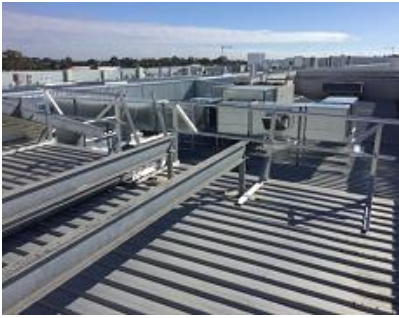
No	Photo of Hazard	Details of Hazard	Details of Risk	Existing/ Immediate Control Measure	Curren t Risk Level	Proposed Permanent Solution	Residu al Risk Assess ment	Details of Action Taken	Status	Reference
64	Building: General Stores Location Reference: L15 Task: Access to the roof

Gap between rails is greater than required maximum	Trips, Slips and Falls	Awareness induction	Med	Midrail to be re-positioned	Low	Client advised	Outstanding	OH&S REGULATIONS 3.7 AS/NZS 1657-2013 4.4
65	Building: General Stores Location Reference: L16 Task: Access to the roof

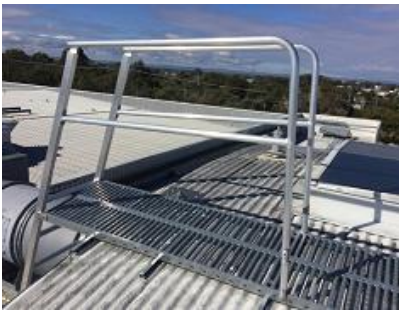
Gap between rails is greater than required maximum	Trips, Slips and Falls	Awareness induction	Med	Existing handrail to be removed and new handrail to be installed	Low	Client advised	Outstanding	OH&S REGULATIONS 3.7 AS/NZS 1657-2013 4.4

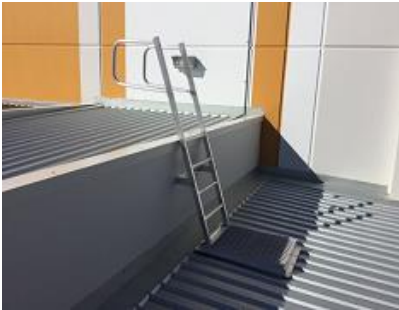
No	Photo of Hazard	Details of Hazard	Details of Risk	Existing/ Immediate Control Measure	Curren t Risk Level	Proposed Permanent Solution	Residu al Risk Assess ment	Details of Action Taken	Status	Reference
66	Building: General Stores Location Reference: L21 Task: Access to the roof

Gap between ladder and permanent structure is less than required minimum	Trips, Slips and Falls	Awareness induction	Med	Existing ladder to be re-installed with new landing platform and fixings bracket	Low	Client advised	Outstanding	OH&S REGULATIONS 3.7 AS/NZS 1657-2013 7.4.5
67	Building: General Stores Location Reference: L32 Task: Access to the roof

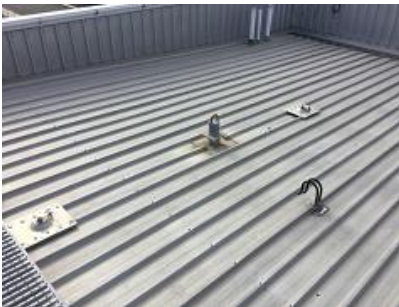
Non-compliant stanchion is present	Trips, Slips and Falls	Awareness induction	Med	Existing stanchion to be removed/out of service sign to be installed	Low	Client advised	Outstanding	OH&S REGULATIONS 3.55

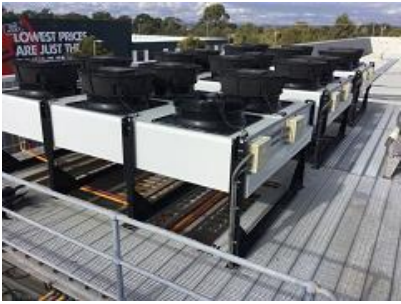
No	Photo of Hazard	Details of Hazard	Details of Risk	Existing/ Immediate Control Measure	Curren t Risk Level	Proposed Permanent Solution	Residu al Risk Assess ment	Details of Action Taken	Status	Reference
68	Building: General Stores Location Reference: L32 Task: Access to the plant deck

Variation in height between plant deck and unit is greater than required maximum	Trips, Slips and Falls	Awareness induction	Med	Midrail to units to be installed	Low	Client advised	Outstanding	OH&S REGULATIONS 3.7 AS/NZS 1657-2013 4.4
69	Building: General Stores Location Reference: L35 Task: Access to the roof

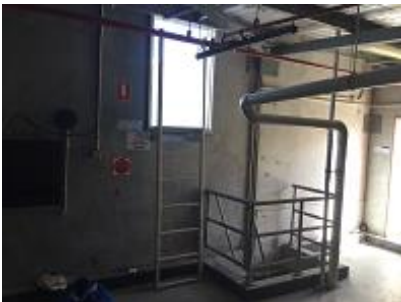
Roof opening is too close the fall edge	Trips, Slips and Falls	Awareness induction	High	Protecting screen/guardrail to be installed	Low	Client advised	Outstanding	OH&S REGULATIONS 3.55

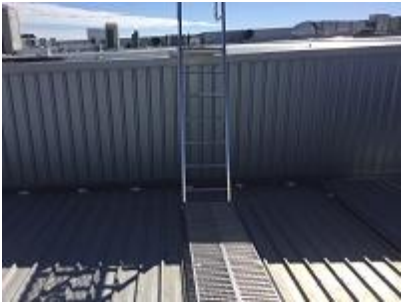
No	Photo of Hazard	Details of Hazard	Details of Risk	Existing/ Immediate Control Measure	Curren t Risk Level	Proposed Permanent Solution	Residu al Risk Assess ment	Details of Action Taken	Status	Reference
71	Building: General Stores Location Reference: L55 Task: Access to the roof

Bottom rung height is less than required minimum	Trips, Slips and Falls	Awareness induction	Med	Landing platform to be installed	Low	Client advised	Outstanding	OH&S REGULATIONS 3.7 AS/NZS 1657-2013 7.4.3.4

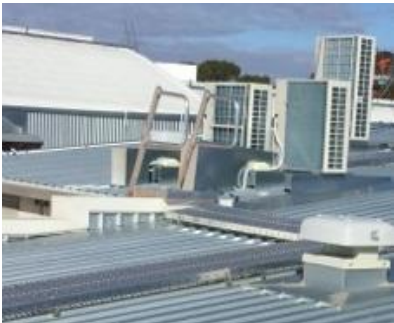
No	Photo of Hazard	Details of Hazard	Details of Risk	Existing/ Immediate Control Measure	Curre nt Risk Level	Proposed Permanent Solution	Resid ual Risk Asse sme nt	Details of Action Taken	Status	Reference
72	Building: General Stores Location Reference: L56 Task: Access to the roof

Landing platform slope at top is greater than required maximum and anchors missing	Trips, Slips and Falls	Awareness induction	Med	Levelled landing platform to be installed and anchor to be installed	Low	Client advised	Outstanding	OH&S REGULATIONS 3.7 & 3.55 AS/NZS 1657-2013 7.4.8.4
73	Building: General Stores Location Reference: L56 Task: Access to the roof

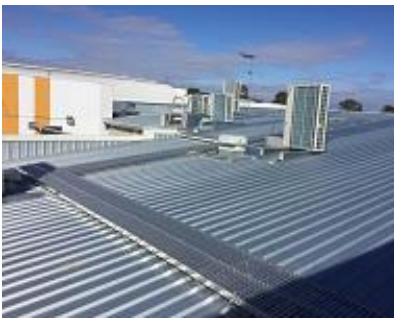
Walkway slope across the walkway path is greater than required maximum	Trips, Slips and Falls	Awareness induction	Med	Existing walkway to be re-installed with levelled brackets	Low	Client advised	Outstanding	OH&S REGULATIONS 3.7 AS/NZS 1657-2013 5.1.1

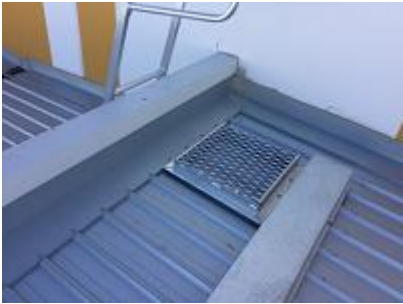
No	Photo of Hazard	Details of Hazard	Details of Risk	Existing/ Immediate Control Measure	Curren t Risk Level	Proposed Permanent Solution	Residu al Risk Assess ment	Details of Action Taken	Status	Reference
74	Building: General Stores Location Reference: L57 Task: Access to the roof

Bottom rung height is less than required minimum and landing at top is less than required minimum	Trips, Slips and Falls	Awareness induction	Med	Landing platforms to be installed	Low	Client advised	Outstanding	OH&S REGULATIONS 3.7 AS/NZS 1657-2013 7.4.3.4 & 7.3.6
75	Building: General Stores Location Reference: L58 Task: Access to the roof

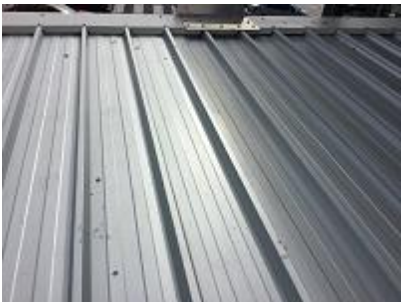
No safe access to the roof and signage is missing	Trips, Slips and Falls	Awareness induction	High	Anchor stop and signage to be installed	Low	Client advised	Outstanding	OH&S REGULATIONS 3.55 & 3.11

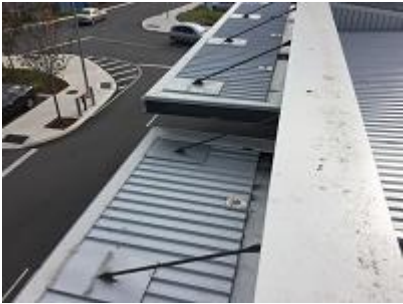
No	Photo of Hazard	Details of Hazard	Details of Risk	Existing/ Immediate Control Measure	Curren t Risk Level	Proposed Permanent Solution	Residu al Risk Assess ment	Details of Action Taken	Status	Reference
76	Building: General Stores Location Reference: L58 Task: Access to the roof

Variation in height between roofs are greater than required maximum	Trips, Slips and Falls	Awareness induction	Med	Access ladder including handrails to be installed	Low	Client advised	Outstanding	OH&S REGULATIONS 3.7 AS/NZS 1657-2013 3.1.4
77	Building: General Stores Location Reference: L58 Task: Access to the roof

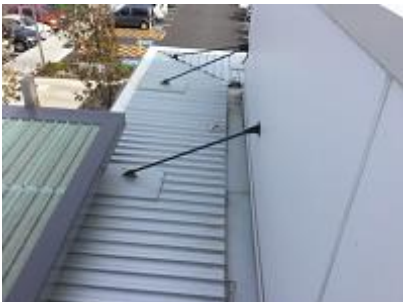
Not enough anchors installed	Trips, Slips and Falls	Awareness induction	High	Fall arrest anchors to be installed	Low	Client advised	Outstanding	OH&S REGULATIONS 3.55

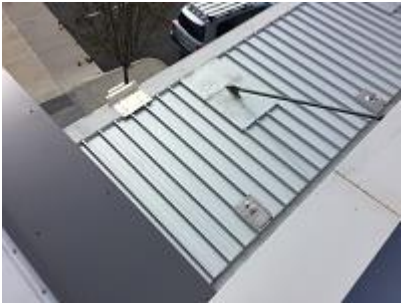
No	Photo of Hazard	Details of Hazard	Details of Risk	Existing/ Immediate Control Measure	Curren t Risk Level	Proposed Permanent Solution	Residu al Risk Assess ment	Details of Action Taken	Status	Reference
78	Building: General Stores Location Reference: L59 Task: Access to the roof

No safe access to the roof and signage is missing	Trips, Slips and Falls	Awareness induction	High	Anchor strop and signage to be installed	Low	Client advised	Outstanding	OH&S REGULATIONS 3.55 & 3.11
79	Building: General Stores Location Reference: L38 Task: Access to the A/c units

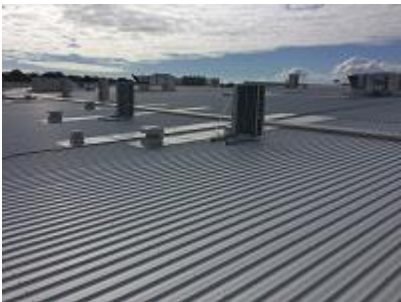
No safe access to the A/c units	Trips, Slips and Falls	N/A	Low	Supply walkway to the A/c units	Low	Client advised	Outstanding	-

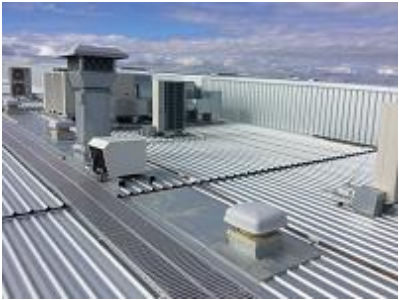
No	Photo of Hazard	Details of Hazard	Details of Risk	Existing/ Immediate Control Measure	Curren t Risk Level	Proposed Permanent Solution	Residu al Risk Assess ment	Details of Action Taken	Status	Reference
80	Building: General Stores Location Reference: L38 Task: Access to the A/c units

No safe access to the A/c units	Trips, Slips and Falls	N/A	Low	Supply walkway to the A/c units	Low	Client advised	Outstanding	-
81	Building: General Stores Location Reference: L38 Task: Access to the A/c unit

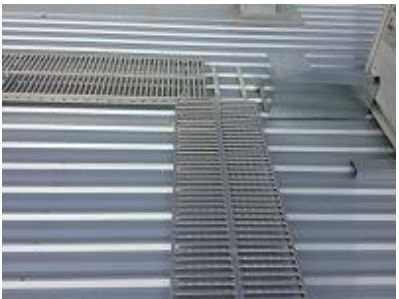
Walkway width is less than required minimum	Trips, Slips and Falls	Awareness induction	Med	Additional walkway section to be installed	Low	Client advised	Outstanding	OH&S REGULATIONS 3.7 AS/NZS 1657-2013 5.1.3

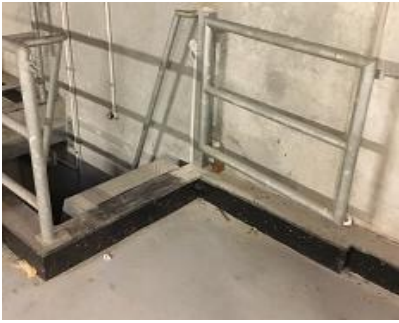
No	Photo of Hazard	Details of Hazard	Details of Risk	Existing/ Immediate Control Measure	Current Risk Level	Proposed Permanent Solution	Residual Risk Assessment	Details of Action Taken	Status	Reference
82	Building: General Stores Location Reference: L01 Task: Access to the roof

Top tread not levelled with landing	Trips, Slips and Falls	Awareness induction	Med	Landing platform to be installed. Existing self-closing gate to be replaced including additional handrail sections	Low	Client advised	Outstanding	OH&S REGULATIONS 3.7 AS1657-2018 7.4.3.3
83	Building: General Stores Location Reference: L01 Task: Access to the roof

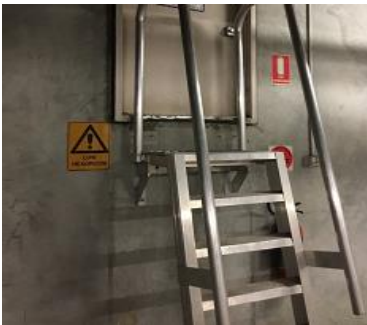
Top tread not levelled with landing and bottom tread height is less than required minimum	Trips, Slips and Falls	Awareness induction	Med	Existing ladder to be removed and new ladder including landing at door level and base to be installed	Low	Client advised	Outstanding	OH&S REGULATIONS 3.7 AS1657-2018 7.4.3.3 & 7.4.3.4

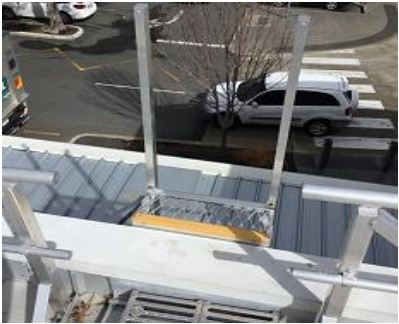
No	Photo of Hazard	Details of Hazard	Details of Risk	Existing/ Immediate Control Measure	Curren t Risk Level	Proposed Permanent Solution	Residu al Risk Assess ment	Details of Action Taken	Status	Reference
84	Building: General Stores Location Reference: L08 Task: Access to the roof

Landing at top is less than required minimum, handrail is missing for landing and trip hazard at base of ladder	Trips, Slips and Falls	Awareness induction	Med	Access anchor at top of ladder, Landing platforms, handrail at top and base to be installed	Low	Client advised	Outstanding	OH&S REGULATIONS 3.7 AS1657-2018 7.3.6, 5.4.1 & 7.4.3.4
85	Building: General Stores Location Reference: L17 Task: Access to the roof

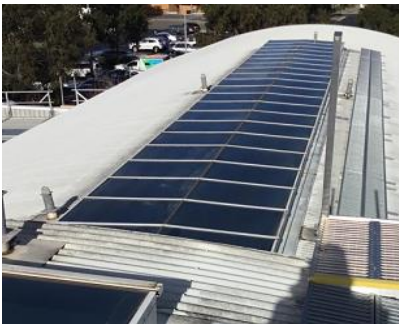
Walkway slope perpendicular to the direction of travel is greater than required maximum	Trips, Slips and Falls	Awareness induction	Med	Walkway to be re-installed with levelled brackets	Low	Client advised	Outstanding	OH&S REGULATIONS 3.7 AS1657-2018 5.1.1

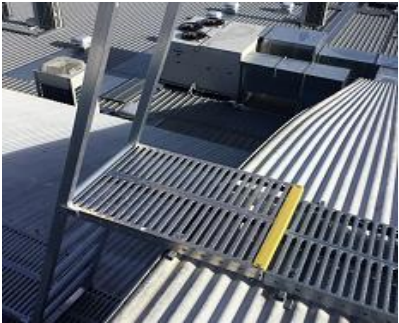
No	Photo of Hazard	Details of Hazard	Details of Risk	Existing/ Immediate Control Measure	Curren t Risk Level	Proposed Permanent Solution	Residu al Risk Assess ment	Details of Action Taken	Status	Reference
86	Building: General Stores Location Reference: L17 Task: Access to the roof

Handrail is missing for landing	Trips, Slips and Falls	Awareness induction	Med	Handrail to be installed at access point	Low	Client advised	Outstanding	OH&S REGULATIONS 3.7 AS1657-2018 5.4.1
87	Building: General Stores Location Reference: L17 Task: Access to the roof

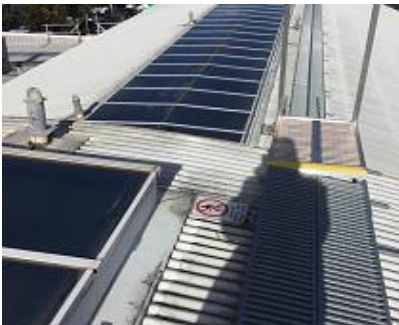
No safe transition provided between static lines	Trips, Slips and Falls	Awareness induction	High	Anchor points to be installed	Low	Client advised	Outstanding	OH&S REGULATIONS 3.55

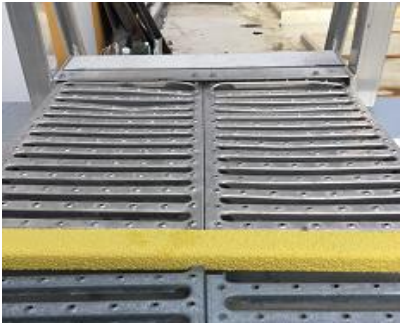
No	Photo of Hazard	Details of Hazard	Details of Risk	Existing/ Immediate Control Measure	Curren t Risk Level	Proposed Permanent Solution	Residu al Risk Assess ment	Details of Action Taken	Status	Reference
88	Building: General Stores Location Reference: L20 Task: Access to the roof

Top tread not levelled with landing	Trips, Slips and Falls	Awareness induction	Med	Existing landing platform to be replaced	Low	Client advised	Outstanding	OH&S REGULATIONS 3.7 AS1657-2018 7.4.3.3
89	Building: General Stores Location Reference: L21 Task: Access to the roof

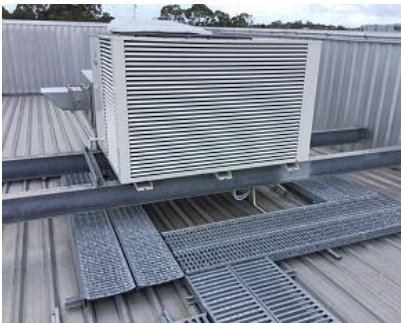
No safe access to the A/c units	Trips, Slips and Falls	Awareness induction	Med	Bridging platform including steps and handrails to be installed	Low	Client advised	Outstanding	OH&S REGULATIONS 3.7 AS1657-2018 3.1.4

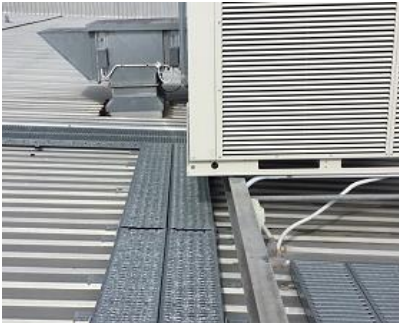
No	Photo of Hazard	Details of Hazard	Details of Risk	Existing/ Immediate Control Measure	Curren t Risk Level	Proposed Permanent Solution	Residu al Risk Assess ment	Details of Action Taken	Status	Reference
90	Building: General Stores Location Reference: L24 Task: Access to the roof

A/c unit protruding over the walkway path and required walkway width not achieved	Trips, Slips and Falls	Awareness induction	Med	Existing walkway to be re-located	Low	Client advised	Outstanding	OH&S REGULATIONS 3.7 AS1657-2018 5.1.3
91	Building: General Stores Location Reference: L25 Task: Access to the roof

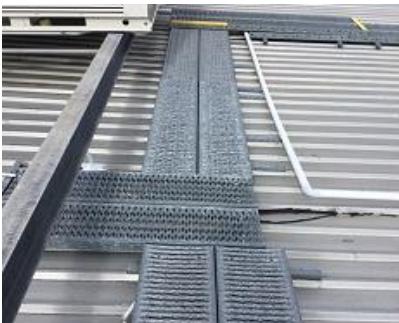
A/c unit protruding over the walkway path and walkway not fully secured	Trips, Slips and Falls	Awareness induction	Med	Existing walkway to re-located including additional fixings	Low	Client advised	Outstanding	OH&S REGULATIONS 3.7 AS1657-2018 5.1.3

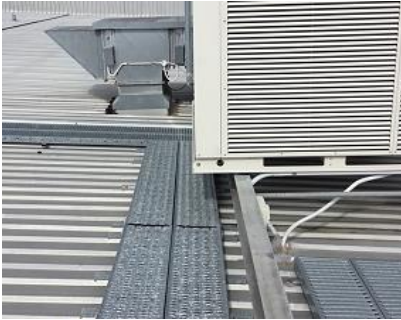
No	Photo of Hazard	Details of Hazard	Details of Risk	Existing/ Immediate Control Measure	Curren t Risk Level	Proposed Permanent Solution	Residu al Risk Assess ment	Details of Action Taken	Status	Reference
92	Building: General Stores Location Reference: L26 Task: Access to the roof

A/c unit protruding over the walkway path and required walkway width not achieved	Trips, Slips and Falls	Awareness induction	Med	Existing walkway to be re-located	Low	Client advised	Outstanding	OH&S REGULATIONS 3.7 AS1657-2018 5.1.3
93	Building: General Stores Location Reference: L23 Task: Access to the roof

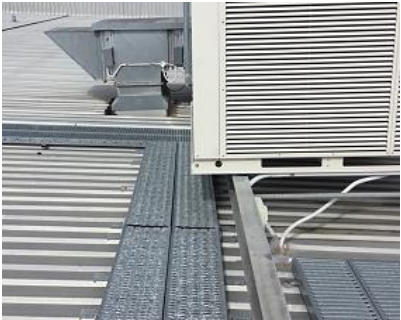
A/c unit protruding over the walkway path and required walkway width not achieved	Trips, Slips and Falls	Awareness induction	Med	Existing walkway to be re-located	Low	Client advised	Outstanding	OH&S REGULATIONS 3.7 AS1657-2018 5.1.3

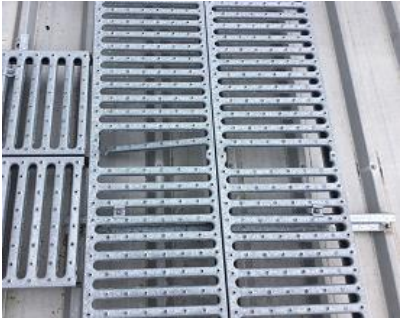
No	Photo of Hazard	Details of Hazard	Details of Risk	Existing/ Immediate Control Measure	Curren t Risk Level	Proposed Permanent Solution	Residu al Risk Assess ment	Details of Action Taken	Status	Reference
94	Building: General Stores Location Reference: L31 Task: Access to the roof

Damaged walkway section is present	Trips, Slips and Falls	Awareness induction	Med	Walkway section to be replaced	Low	Client advised	Outstanding	OH&S REGULATIONS 3.7
95	Building: General Stores Location Reference: L32 Task: Access to the roof

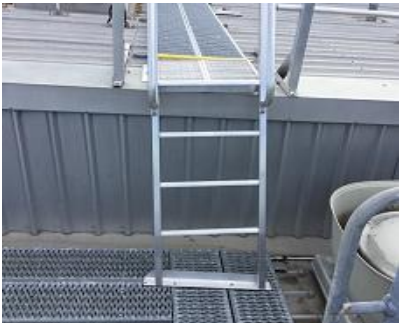
Bottom rung height is greater than required maximum and top landing is less than required minimum	Trips, Slips and Falls	Awareness induction	Med	Landing platforms to be installed	Low	Client advised	Outstanding	OH&S REGULATIONS 3.7 AS1657-2018 7.4.3.4 & 7.3.6

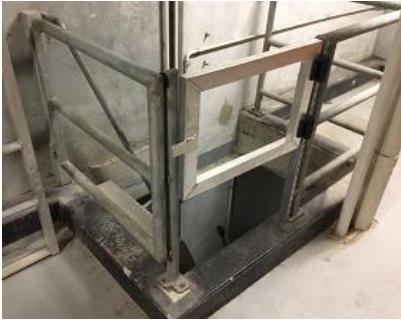
No	Photo of Hazard	Details of Hazard	Details of Risk	Existing/ Immediate Control Measure	Curren t Risk Level	Proposed Permanent Solution	Residu al Risk Assess ment	Details of Action Taken	Status	Reference
96	Building: General Stores Location Reference: L35 Task: Access to the roof

No safe side access to the ladder	Trips, Slips and Falls	Awareness induction	Med	Sign to be installed	Low	Client advised	Outstanding	OH&S REGULATIONS 3.7 & 3.11
97	Building: General Stores Location Reference: L35 Task: Access to the roof

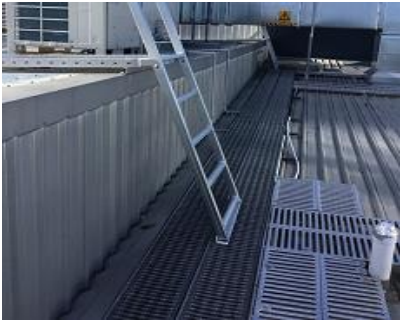
Bottom rung height is less than required minimum	Trips, Slips and Falls	Awareness induction	Med	Landing platform to be installed	Low	Client advised	Outstanding	OH&S REGULATIONS 3.7 AS1657-2018 7.4.3.4

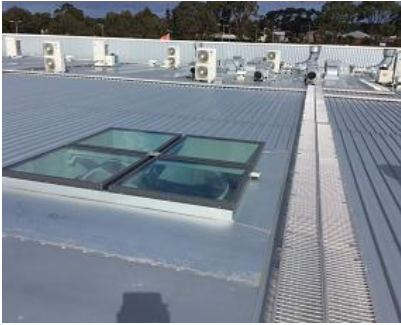
No	Photo of Hazard	Details of Hazard	Details of Risk	Existing/ Immediate Control Measure	Curren t Risk Level	Proposed Permanent Solution	Residu al Risk Assess ment	Details of Action Taken	Status	Reference
98	Building: General Stores Location Reference: L41 Task: Access to the roof

Gap between walkway and brittle roof section is less than required minimum	Trips, Slips and Falls	Awareness induction	Med	Handrail to be installed	Low	Client advised	Outstanding	OH&S REGULATIONS 3.7 AS1657-2018 5.4.1
99	Building: General Stores Location Reference: L55 Task: Access to the A/c units

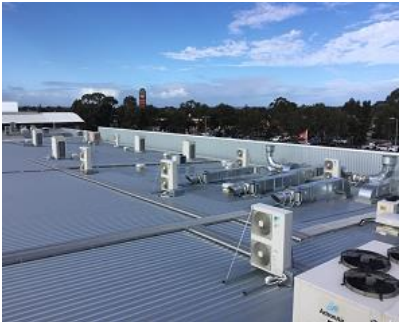
No safe access to the A/c units	Trips, Slips and Falls	N/A	Low	Supply walkway to the A/c units	Low	Client advised	Outstanding	-

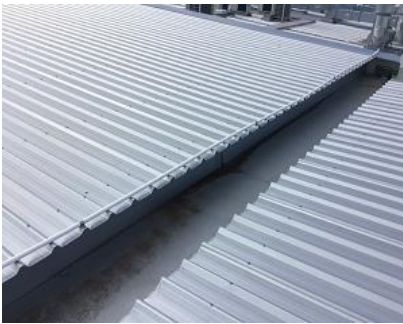
No	Photo of Hazard	Details of Hazard	Details of Risk	Existing/ Immediate Control Measure	Curren t Risk Level	Proposed Permanent Solution	Residu al Risk Assess ment	Details of Action Taken	Status	Reference
100	Building: General Stores Location Reference: L11 Task: Access to the roof

Variation in height between roofs are greater than required maximum	Trips, Slips and Falls	Awareness induction	Med	Step bridge including handrail and step to be installed	Low	Client advised	Outstanding	OH&S REGULATIONS 3.7 AS1657-2018 3.1.4
101	Building: General Stores Location Reference: L60 Task: Access to the roof

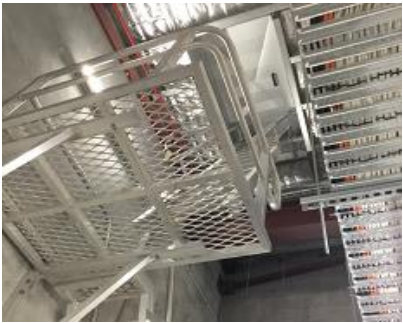
Cage is not installed for ladder at upper level	Trips, Slips and Falls	Awareness induction	Med	Cage to be installed	Low	Client advised	Outstanding	OH&S REGULATIONS 3.7 AS1657-2018 7.4.7

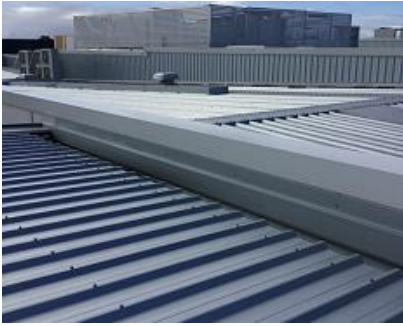
Variation in height between roofs are greater than required maximum	Trips, Slips and Falls	Awareness induction	Med	Step bridge to be installed	Low	Client advised	Outstanding	OH&S REGULATIONS 3.7 AS1657-2018 3.1.4
103	Building: General Stores Location Reference: L60 Task: Access to the roof

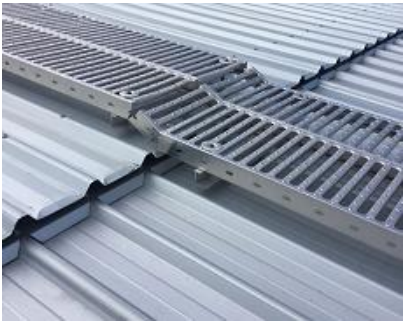
Variation in height between walkway panels are greater than required maximum	Trips, Slips and Falls	Awareness induction	Med	Existing bent walkway to be removed and high visibility safety yellow nosing to be installed	Low	Client advised	Outstanding	OH&S REGULATIONS 3.7 AS1657-2018 3.3.4

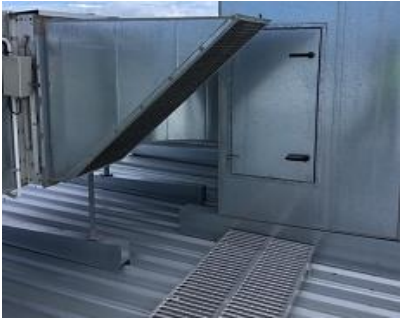
Duct protruding over the walkway path	Trips, Slips and Falls	Awareness induction	Med	Existing walkway to be relocated with additional walkway sections	Low	Client advised	Outstanding	OH&S REGULATIONS 3.7 AS1657-2018 3.3.4
105	Building: General Stores Location Reference: L49 Task: Access to the roof

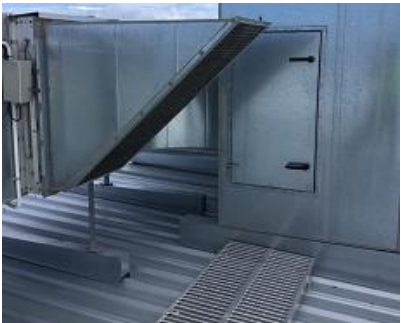
Duct protruding over the walkway path	Trips, Slips and Falls	Awareness induction	Med	Existing walkway to be relocated with additional walkway sections	Low	Client advised	Outstanding	OH&S REGULATIONS 3.7 AS1657-2018 3.3.4

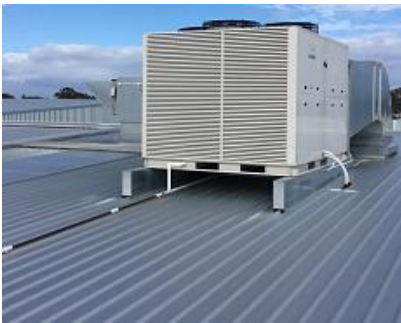
No safe access to the A/c units	Trips, Slips and Falls	N/A	Low	Supply walkway to the A/c units	Low	Client advised	Outstanding	-
107	Building: General Stores Location Reference: L53 Task: Access to the roof

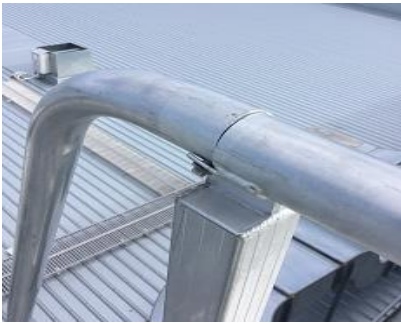
Sharp edges on handrail and tread spacing is greater than required maximum	Trips, Slips and Falls	Awareness induction	Med	Existing ladder to be removed and new ladder to be installed	Low	Client advised	Outstanding	OH&S REGULATIONS 3.7 AS1657-2018 5.6 & 7.3

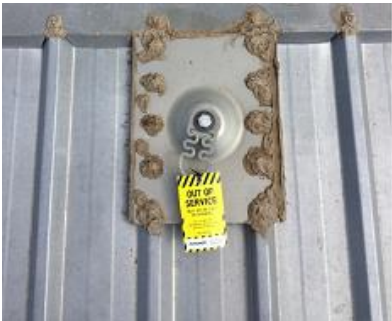
Unknown anchor is present	Trips, Slips and Falls	Awareness induction	High	Anchor to be replaced	Low	Client advised	Outstanding	OH&S REGULATIONS 3.55
110	Building: General Stores Location Reference: L27 Task: Access to the roof
