Roof Safety Report

**Kalamunda Central,
WA 6076**

Prepared By: Safemaster Safety Products
Date: 22-Aug-2018

30-07-2018

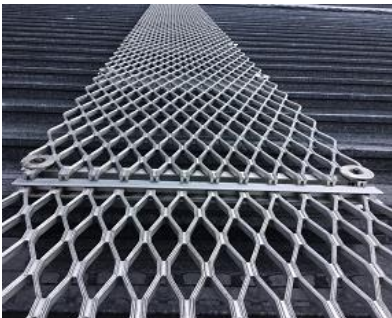
Variation in height between walkway panels are greater than required maximum and walkway junctions are loose	Trips, Slips and Falls	Awareness induction	Med	Walkway junction to be secured and high visibility safety yellow nosing's to be installed	Low	Client advised	Outstanding	OH&S REGULATIONS 3.7 AS/NZS 1657-2018 3.3.4
35	Building: General Stores Location Reference: L04 Task: Access to the roof

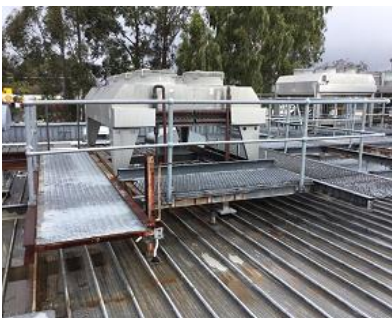
Gratings are rusty and wobbly	Trips, Slips and Falls	Awareness induction	Med	Existing grating to be removed and new series 13 aluminium grating to be installed	Low	Client advised	Outstanding	OH&S REGULATIONS 3.7

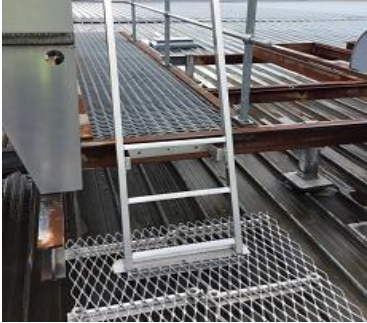
Top rung not levelled with landing and bottom rung height is less than required minimum	Trips, Slips and Falls	Awareness induction	Med	Existing ladder to be removed and new ladder to be installed	Low	Client advised	Outstanding	OH&S REGULATIONS 3.7 AS/NZS 1657-2018 7.4.3.3 & 7.4.3.4
37	Building: General Stores Location Reference: L06 Task: Access to the roof

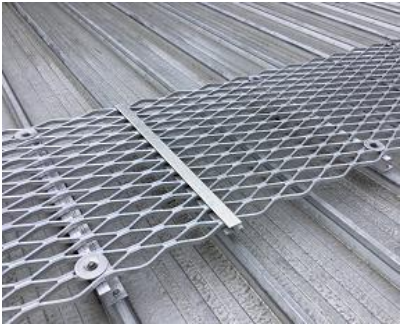
Variation in height between walkway panels are greater than required maximum and walkway junctions are loose	Trips, Slips and Falls	Awareness induction	Med	Walkway junction to be secured and high visibility safety yellow nosing's to be installed	Low	Client advised	Outstanding	OH&S REGULATIONS 3.7 AS/NZS 1657-2018 3.3.4

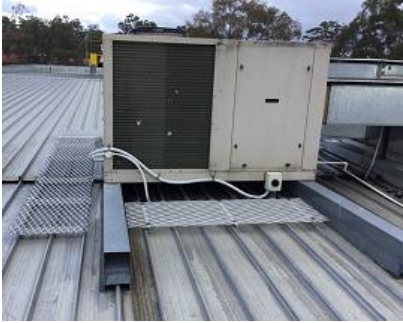
No safe access to the A/c units	Trips, Slips and Falls	N/A	Low	Supply walkway to the A/c units	Low	Client advised	Outstanding	-
39	Building: General Stores Location Reference: L07 Task: Access to the A/c units

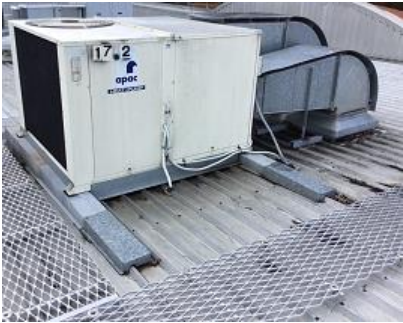
No safe access to the A/c units	Trips, Slips and Falls	N/A	Low	Supply walkway to the A/c units	Low	Client advised	Outstanding	-

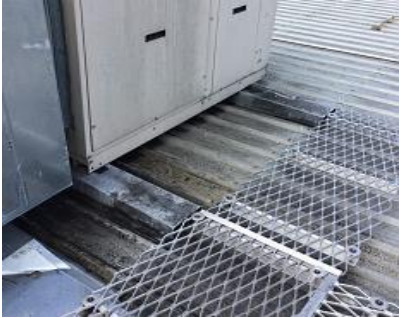
No safe access to the A/c units	Trips, Slips and Falls	N/A	Low	Supply walkway to the A/c units	Low	Client advised	Outstanding	-
41	Building: General Stores Location Reference: L08 Task: Access to the A/c units

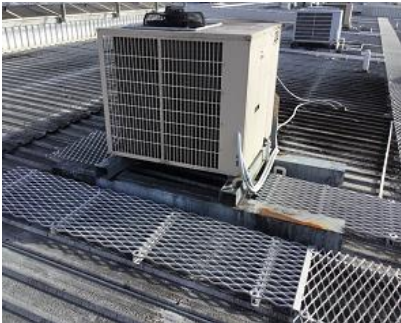
No safe access to the A/c units	Trips, Slips and Falls	N/A	Low	Walkway and high visibility safety yellow tape to supports to be installed	Low	Client advised	Outstanding	-

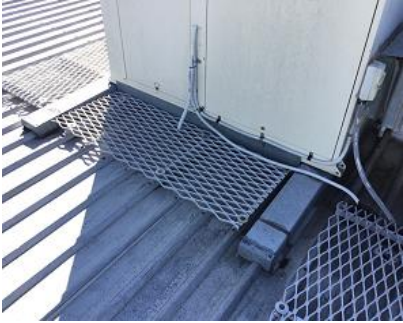
Bracings protruding over the walkway path	Trips, Slips and Falls	Awareness induction	Med	Step bridge including high visibility safety yellow nosing's to be installed	Low	Client advised	Outstanding	OH&S REGULATIONS 3.7
43	Building: General Stores Location Reference: L10 Task: Access to the A/c units

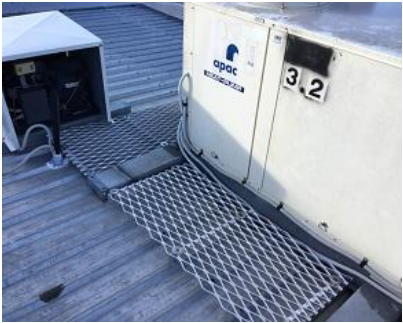
Bracings protruding over the walkway path	Trips, Slips and Falls	Awareness induction	Med	Step bridge including high visibility safety yellow nosing's to be installed	Low	Client advised	Outstanding	OH&S REGULATIONS 3.7

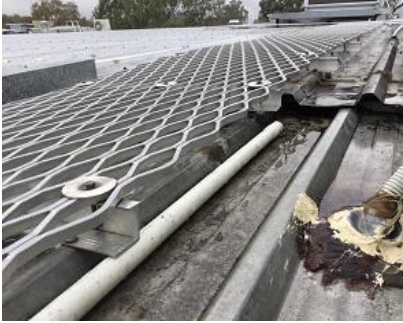
Walkway sections been pulled out	Trips, Slips and Falls	Awareness induction	Med	Walkway to be re-installed with high visibility safety yellow nosing's	Low	Client advised	Outstanding	OH&S REGULATIONS 3.7 AS/NZS 1657-2018 3.3.4
45	Building: General Stores Location Reference: L1 Task: Access to the A/c units

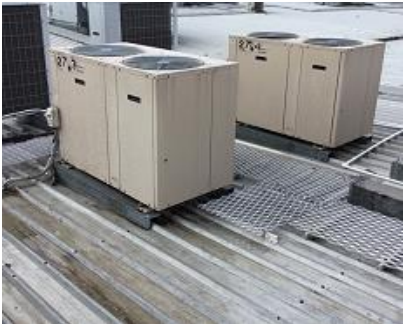
No safe access to the A/c units and existing walkway not fully secured	Trips, Slips and Falls	N/A	Low	Supply walkway to the A/c units and existing walkway to be secured	Low	Client advised	Outstanding	-

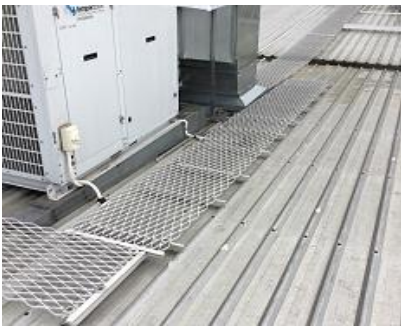
Walkway width is less than required minimum	Trips, Slips and Falls	Awareness induction	Med	Additional walkway sections to be installed	Low	Client advised	Outstanding	OH&S REGULATIONS 3.7 AS/NZS 1657-2018 5.1.3
47	Building: General Stores Location Reference: L1 Task: Access to the roof

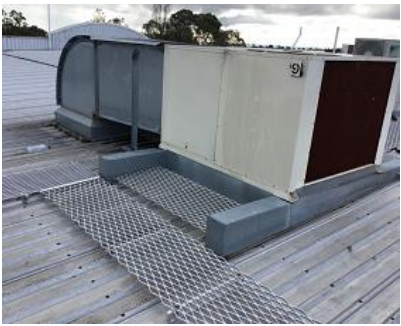
Gap between walkway panels are greater than required maximum	Trips, Slips and Falls	Awareness induction	Med	Walkway to be re-installed to close the gap	Low	Client advised	Outstanding	OH&S REGULATIONS 3.7 AS/NZS 1657-2013 3.2.3.4

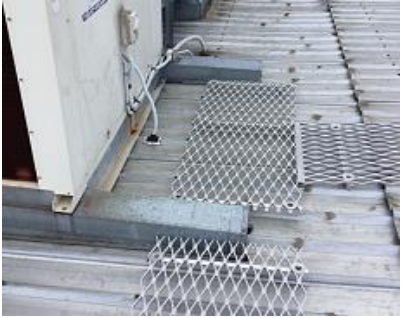
Bracings protruding over the walkway path	Trips, Slips and Falls	Awareness induction	Med	Additional walkway section including high visibility safety yellow tape to be installed	Low	Client advised	Outstanding	OH&S REGULATIONS 3.7 AS/NZS 1657-2018 5.1.3
49	Building: General Stores Location Reference: L20 Task: Access to the roof

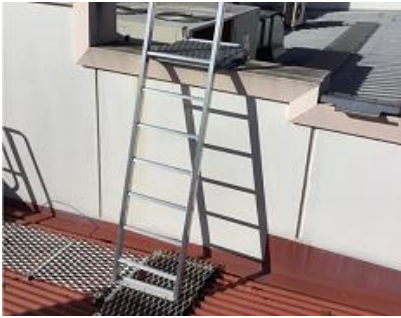
Top landing is less than required minimum, Top rung not levelled with landing, bottom rung height is less than required minimum and landing at base is less than required minimum	Trips, Slips and Falls	Awareness induction	Med	Existing ladder to be removed and new ladder to be installed	Low	Client advised	Outstanding	OH&S REGULATIONS 3.7 AS/NZS 1657-2013 7.3.6, 7.4.3.3, 7.4.3.4 & 7.3.6

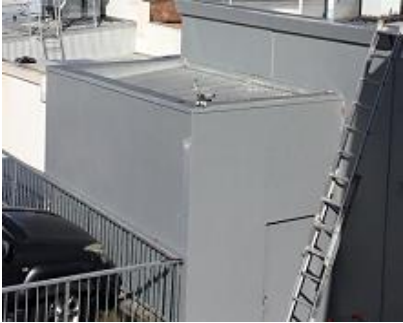
No safe access to the roof	Trips, Slips and Falls	Awareness induction	Med	Access ladder and anchor stop to be installed	Low	Client advised	Outsta nding	OH&S REGULATIONS 3.7 AS/NZS 1657- 2018 3.1.4
51	Building: General Stores Location Reference: L27 Task: Access to the roof

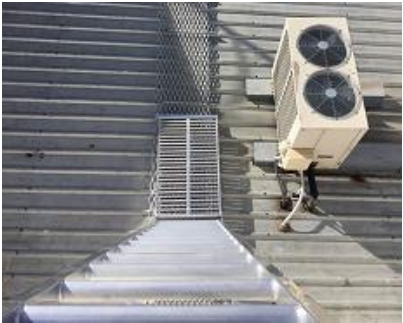
Walkway width at base of ladder is less than required minimum	Trips, Slips and Falls	Awareness induction	Med	Additional walkway section to be installed	Low	Client advised	Outsta nding	OH&S REGULATIONS 3.7 AS/NZS 1657- 2013 5.1.3

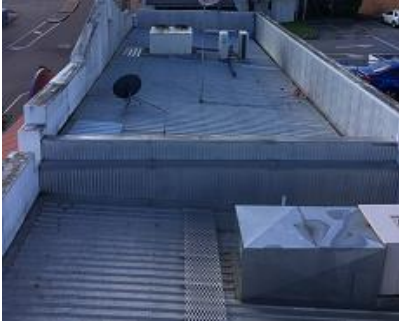
Variation in height between roof levels are greater than required maximum	Trips, Slips and Falls	Awareness induction	Med	Access ladder to be installed	Low	Client advised	Outstanding	OH&S REGULATIONS 3.7 AS/NZS 1657-2018 3.1.4
53	Building: General Stores Location Reference: L14 Task: Access to the roof

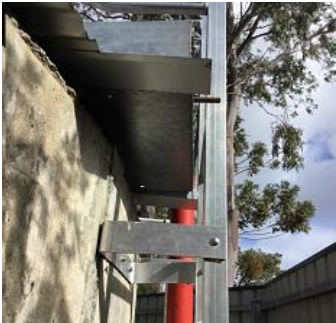
Hand clearance is less than required minimum	Trips, Slips and Falls	Awareness induction	Med	Existing ladders to be re-installed with new brackets	Low	Client advised	Outstanding	OH&S REGULATIONS 3.7 AS/NZS 1657-2013 7.4.8.4
