Addendum Report-1

Karratha City, WA 6714

Prepared By: Safemaster Safety Products
Date: 27 Jun 2017

This report has been prepared for the benefit of Vicinity Centres to provide a consolidation of the roof safety systems audit and consulting for the Karratha City.

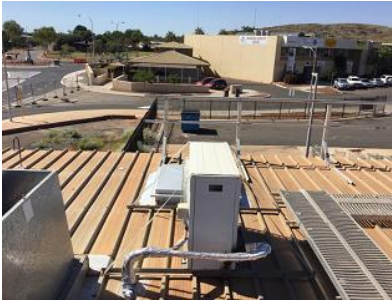
No safe access to the hatch	Trips, Slips and Falls	N/A	Low	Supply walkway to hatch	Low	Client advised	Outstanding	-
60	Building: General Stores Location Reference: L01 Task: Access to the roof

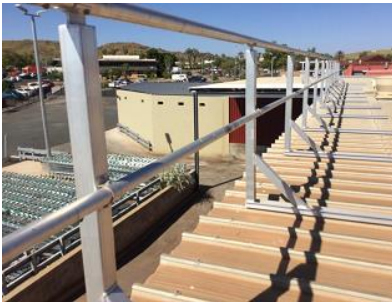
Sharp edges on handrails	Hand Injury	Awareness induction	Med	Tek screws to be replaced with rivets	Low	Client advised	Outstanding	OH&S REGULATIONS 3.7 AS/NZS 1657-2013 5.6

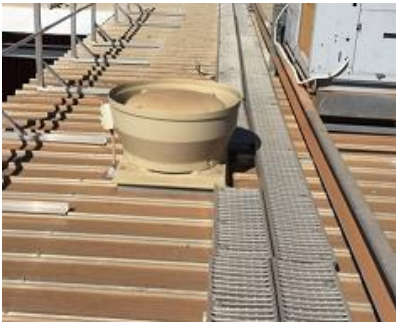
Walkway width is less than required minimum	Trips, Slips and Falls	Awareness induction	Med	Additional walkway section to be installed	Low	Client advised	Outstanding	OH&S REGULATIONS 3.7 AS/NZS 1657-2013 5.1.3
62	Building: General Stores Location Reference: L03 Task: Access to the roof

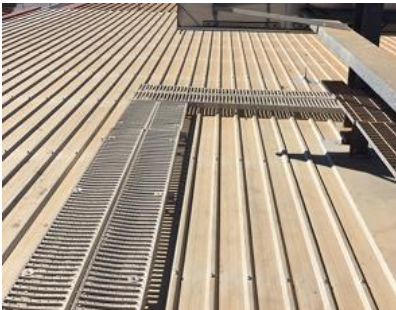
Sign protrudes over the walkway	Trips, Slips and Falls	Awareness induction	Med	Additional walkway section to be installed	Low	Client advised	Outstanding	OH&S REGULATIONS 3.7

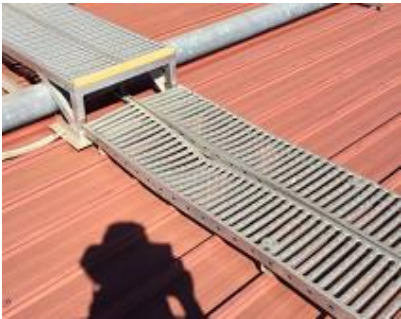
Damaged walkway	Trips, Slips and Falls	Awareness induction	Med	Existing damaged walkway to be replaced	Low	Client advised	Outstanding	OH&S REGULATIONS 3.7
64	Building: General Stores Location Reference: L12 Task: Access to the roof

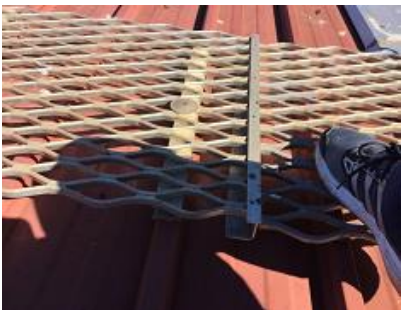
Walkway installed incorrectly	Trips, Slips and Falls	Awareness induction	Med	Walkway sections to be joined with additional channels	Low	Client advised	Outstanding	OH&S REGULATIONS 3.7

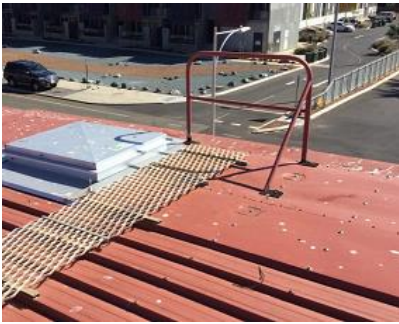
Non-complaint handrails is present	Trips, Slips and Falls	Awareness induction	Med	Existing handrail to be removed and new handrail section to be installed	Low	Client advised	Outstanding	OH&S REGULATIONS 3.7 AS/NZS 1657-2013 4.4
66	Building: General Stores Location Reference: L12 Task: Access to the A/c unit

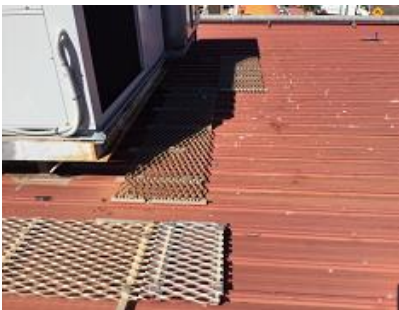
Missing walkway sections to access A/c unit safely	Trips, Slips and Falls	Awareness induction	Med	Additional walkway sections to be installed	Low	Client advised	Outstanding	OH&S REGULATIONS 3.7

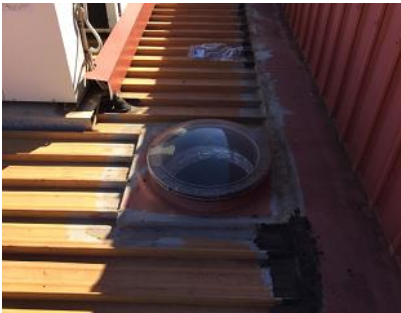
Brittle roof (Non trafficable roof)	Trips, Slips and Falls	Restrict Access	High	"Keep Off Brittle and Fragile Roof" sign to be installed	Low	Client advised	Outstanding	OH&S REGULATIONS 3.57
68	Building: General Stores Location Reference: L13 Task: Restrict access to the roof

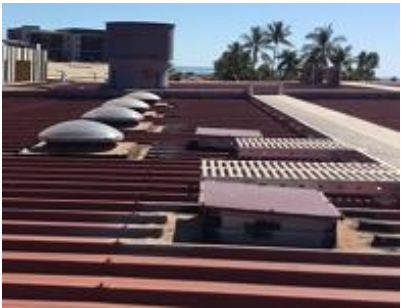
Brittle roof (Non trafficable roof)	Trips, Slips and Falls	Restrict Access	High	"Keep Off Brittle and Fragile Roof" sign to be installed	Low	Client advised	Outstanding	OH&S REGULATIONS 3.57

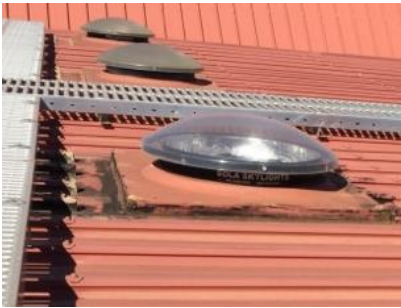
Brittle roof (Non trafficable roof)	Trips, Slips and Falls	Restrict Access	High	"Keep Off Brittle and Fragile Roof" sign to be installed	Low	Client advised	Outstanding	OH&S REGULATIONS 3.57
70	Building: General Stores Location Reference: L25 Task: Access to the A/c units

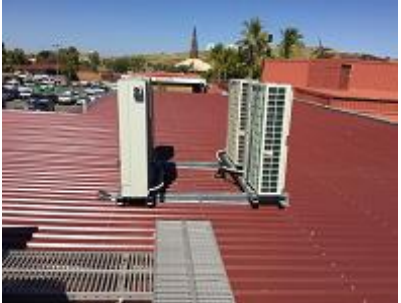
No safe access to the A/c units	Trips, Slips and Falls	N/A	Low	Supply Walkway to the A/c units	Low	Client advised	Outstanding	-

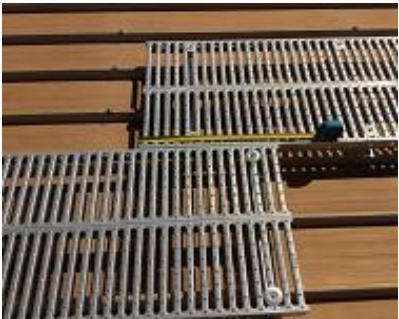
Walkway width is less than required minimum	Trips, Slips and Falls	Awareness induction	Med	Additional walkway section to be installed	Low	Client advised	Outstanding	OH&S REGULATIONS 3.7 AS/NZS 1657-2013 5.1.3
72	Building: General Stores Location Reference: L52 Task: Access to the roof

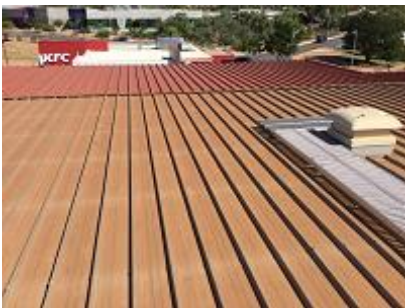
Missing anchor point	Trips, Slips and Falls	Awareness induction	High	Fall arrest anchor to be installed	Low	Client advised	Outstanding	OH&S REGULATIONS 3.55

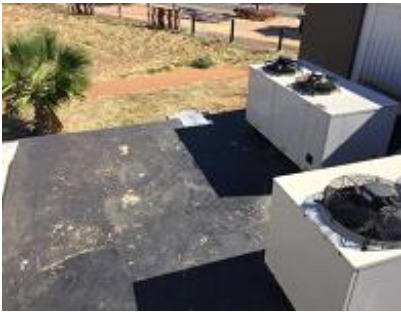
Anchor point is missing at access point	Trips, Slips and Falls	Awareness induction	High	Fall arrest anchor and anchor stop to be installed	Low	Client advised	Outstanding	OH&S REGULATIONS 3.55
74	Building: General Stores Location Reference: L56 Task: Access to the roof

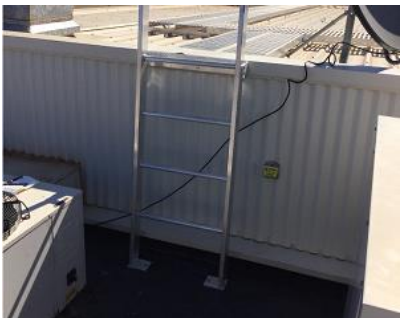
Gap between ladder and permanent structure is less than required minimum	Trips, Slips and Falls	Awareness induction	Med	Existing ladder to be re-installed with new brackets and fixings	Low	Client advised	Outstanding	OH&S REGULATIONS 3.7 AS/NZS 1657-2013 7.4.5

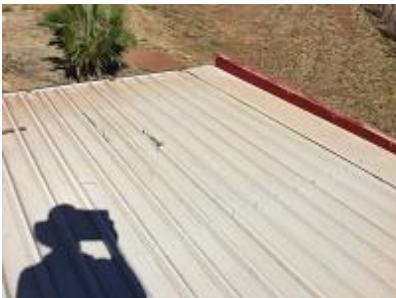
Anchor point too close to the edge	Trips, Slips and Falls	Awareness induction	High	Existing anchor point to be re-located	Low	Client advised	Outstanding	OH&S REGULATIONS 3.55
76	Building: General Stores Location Reference: L57 Task: Access to the roof

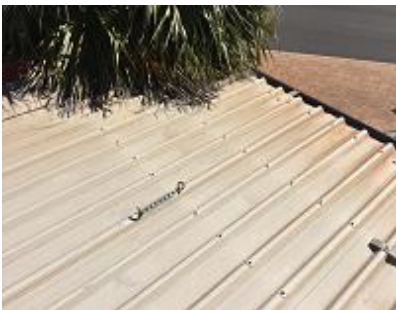
Anchor point too close to the edge	Trips, Slips and Falls	Awareness induction	High	Existing anchor point to be re-located	Low	Client advised	Outstanding	OH&S REGULATIONS 3.55

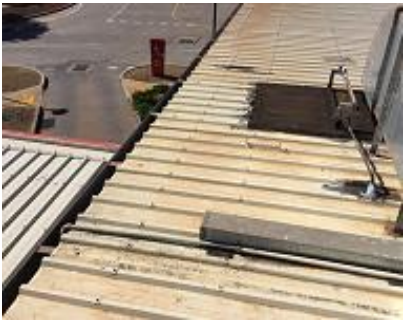
Anchor point too close to the edge	Trips, Slips and Falls	Awareness induction	High	Existing anchor point to be re-located	Low	Client advised	Outstanding	OH&S REGULATIONS 3.55
78	Building: General Stores Location Reference: L57 Task: Access to the roof

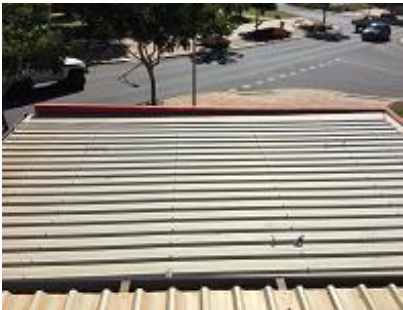
Anchor point too close to the edge	Trips, Slips and Falls	Awareness induction	High	Existing anchor points to be re-located	Low	Client advised	Outstanding	OH&S REGULATIONS 3.55

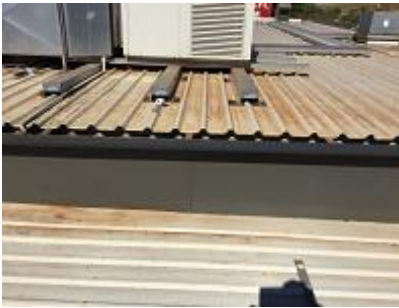
Variation in height between roofs are greater than required maximum	Trips, Slips and Falls	Awareness induction	Med	Access ladder including handrails to be installed	Low	Client advised	Outstanding	OH&S REGULATIONS 3.7 AS/NZS 1657-2013 3.1.4
80	Building: General Stores Location Reference: L24 Task: Access to the roof

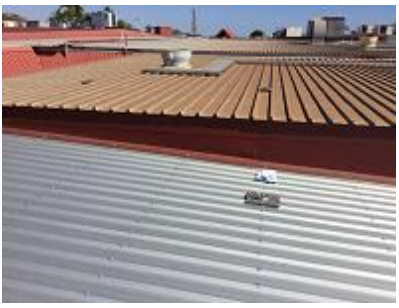
Variation in height between roofs are greater than required maximum	Trips, Slips and Falls	Awareness induction	Med	Single step to be installed	Low	Client advised	Outstanding	OH&S REGULATIONS 3.7 AS/NZS 1657-2013 3.1.4
