# Roof Safety Report

**Lake Haven Centre, NSW 2263**

Prepared By: Safemaster Safety Products  
Date: 01-11-2019

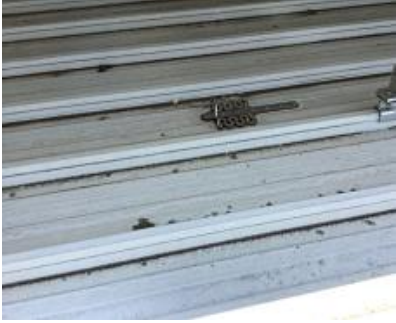
Anchors (x5) covered by solar panels	Trips, Slips and Falls	Awareness induction	High	New anchors to be installed	Low	Client advised	Outstanding	OH&S REGULATIONS 3.55
22 9	Building: General Roof Location Reference: <a href="#">L03</a> Task: Access to the roof

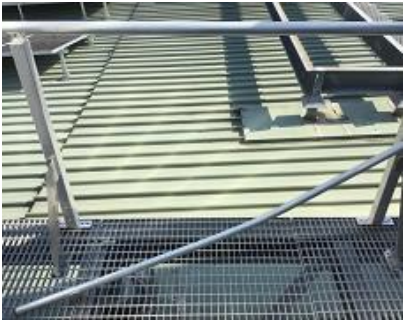
Midrail damaged	Trips, Slips and Falls	Awareness induction	Med	Midrail to be replaced	Low	Client advised	Outstanding	OH&S REGULATIONS 3.7  AS/NZS 1657-2013 4.4

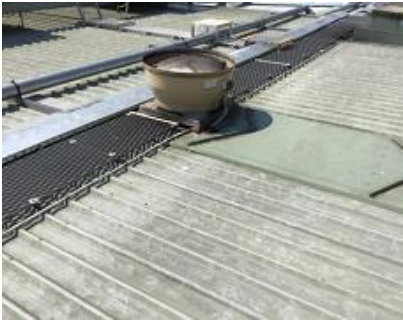
Gap between the walkway sections is greater than required maximum	Trips, Slips and Falls	Awareness induction	Med	Additional walkway section to be installed	Low	Client advised	Outstanding	OH&S REGULATIONS 3.7  AS/NZS 1657-2013 3.2.3.4
231	Building: General Roof Location Reference: <a href="#">L22</a> Task: Access to the roof

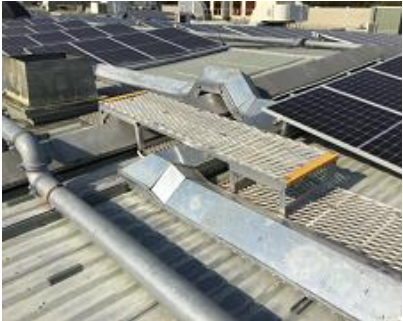
Step bridge not fully secured and handrail is missing	Trips, Slips and Falls	Awareness induction	Med	Platform to be fully secured and handrail to be installed	Low	Client advised	Outstanding	OH&S REGULATIONS 3.7  AS/NZS 1657-2013 4.4

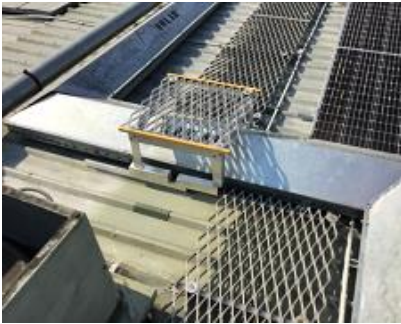
Step bridge not fully secured and handrail is missing	Trips, Slips and Falls	Awareness induction	Med	Platform to be fully secured and handrail to be installed	Low	Client advised	Outstanding	OH&S REGULATIONS 3.7  AS/NZS 1657-2013 4.4
23 3	Building: General Roof Location Reference: <a href="#">L22</a> Task: Access to the roof

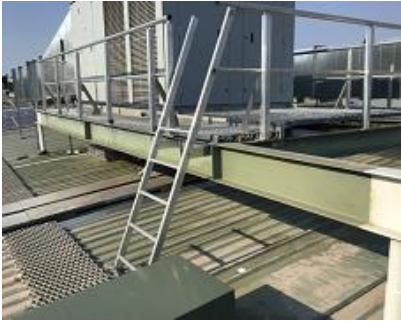
Bottom rung height is less than required minimum and top rung not levelled with landing	Trips, Slips and Falls	Awareness induction	Med	Landing platforms to be installed	Low	Client advised	Outstanding	OH&S REGULATIONS 3.7  AS/NZS 1657-2013 7.4.3.4 & 7.4.3.3

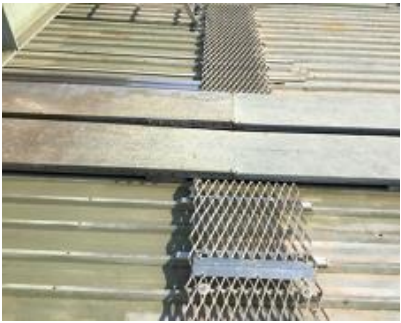
Cable tray installed over the walkway path	Trips, Slips and Falls	Awareness induction	Med	Step bridge to be installed	Low	Client advised	Outstanding	OH&S REGULATIONS 3.7  AS/NZS 1657-2013 3.1.4
23 5	Building: General Roof Location Reference: <a href="#">L26</a> Task: Access to the roof

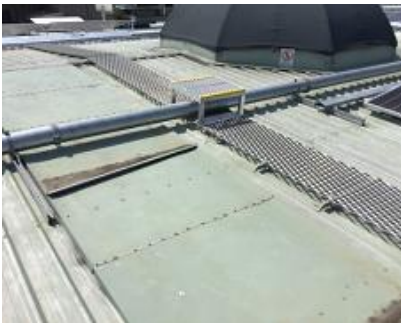
Non-complaint step bridge is installed	Trips, Slips and Falls	Awareness induction	Med	Step bridge to be modified and re-installed	Low	Client advised	Outstanding	OH&S REGULATIONS 3.7  AS/NZS 1657-2013 3.1.4

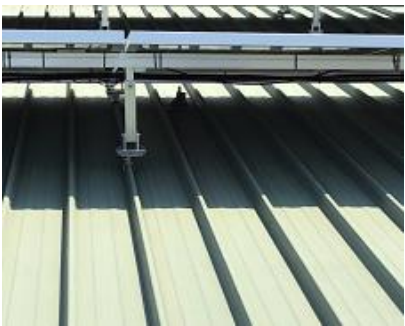
Anchor covered by solar panel	Trips, Slips and Falls	Awareness induction	High	New anchors to be installed	Low	Client advised	Outstanding	OH&S REGULATIONS 3.55
23 7	Building: General Roof Location Reference: <a href="#">L32</a> Task: Access to the roof

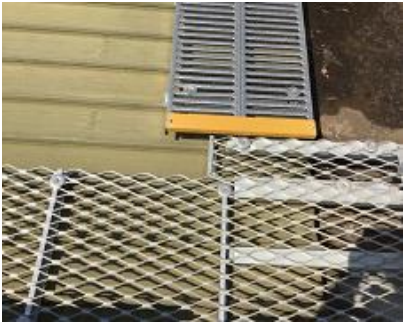
Gap between walkway panels are greater than required maximum	Trips, Slips and Falls	Awareness induction	Med	Walkway section to be installed	Low	Client advised	Outstanding	OH&S REGULATIONS 3.7  AS/NZS 1657-2013 3.2.3.4

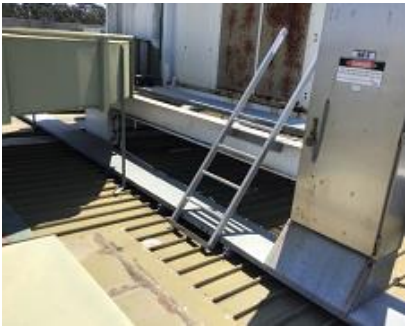
Non-complaint ladder is present	Trips, Slips and Falls	Awareness induction	Med	Existing ladder to be replaced	Low	Client advised	Outstanding	OH&S REGULATIONS 3.7  AS/NZS 1657-2013 7.4
23 9	Building: General Roof Location Reference: <a href="#">L40</a> Task: Access to the roof

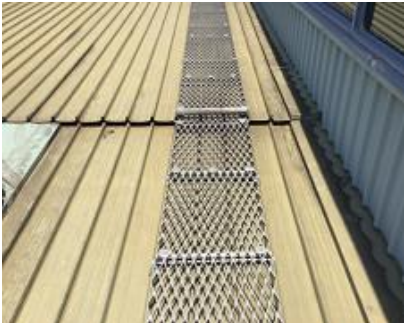
Variation in height between walkway panels are greater than required maximum	Trips, Slips and Falls	Awareness induction	Med	High visibility safety yellow nosing to be installed	Low	Client advised	Outstanding	OH&S REGULATIONS 3.7  AS/NZS 1657-2013 3.3.4

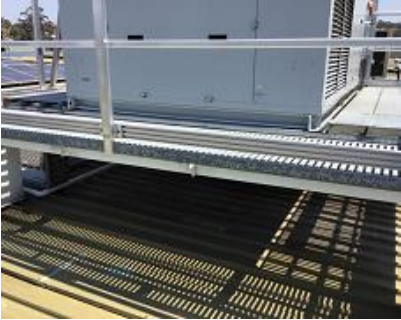
Variation in height between walkway panels are greater than required maximum	Trips, Slips and Falls	Awareness induction	Med	High visibility safety yellow nosing to be installed	Low	Client advised	Outstanding	OH&S REGULATIONS 3.7  AS/NZS 1657-2013 3.3.4
241	Building: General Roof Location Reference: <a href="#">L40</a> Task: Access to the roof

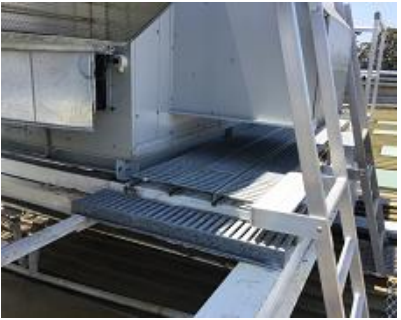
No safe access to the plant deck	Trips, Slips and Falls	Awareness induction	Med	Mesh and handrail to be installed	Low	Client advised	Outstanding	OH&S REGULATIONS 3.7  AS/NZS 1657-2013 3.1.4

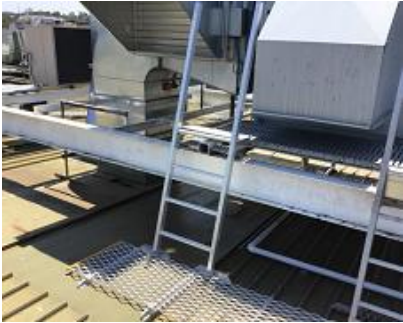
Bottom rung height is less than required minimum and top rung not levelled with landing	Trips, Slips and Falls	Awareness induction	Med	Landing platforms to be installed	Low	Client advised	Outstanding	OH&S REGULATIONS 3.7  AS/NZS 1657-2013 7.4.3.4 & 7.4.3.3
24 3	Building: General Roof Location Reference: <a href="#">L41</a> Task: Access to the A/c units

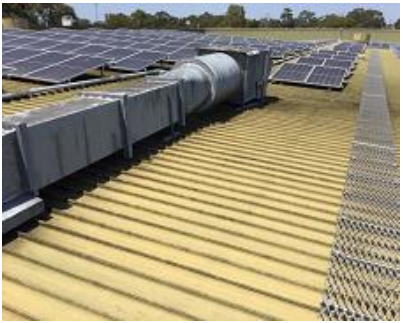
No safe access to the A/c units	Trips, Slips and Falls	N/A	Low	Supply walkway to the A/c units	Low	Client advised	Outstanding	-

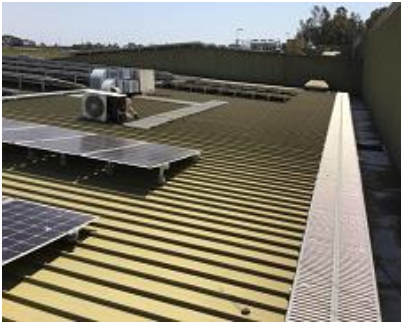
No safe access to the A/c units	Trips, Slips and Falls	N/A	Low	Supply walkway to the A/c units	Low	Client advised	Outstanding	-
24 5	Building: General Roof Location Reference: <a href="#">L47</a> Task: Access to the roof

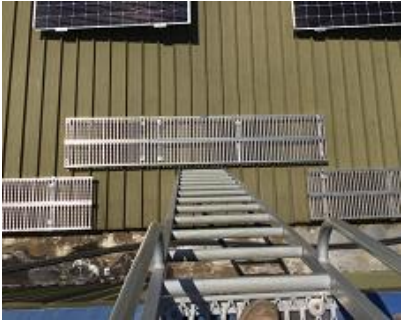
Gap between walkway panels are greater than required maximum	Trips, Slips and Falls	Awareness induction	Med	Walkway section to be installed	Low	Client advised	Outstanding	OH&S REGULATIONS 3.7  AS/NZS 1657-2013 3.2.3.4

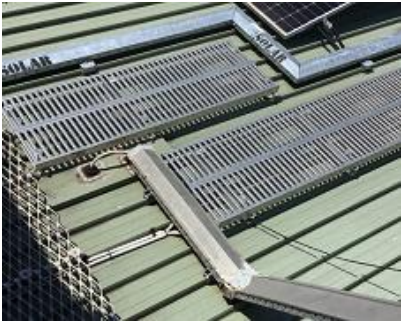
Gap between walkway panels are greater than required maximum	Trips, Slips and Falls	Awareness induction	Med	Walkway section to be installed	Low	Client advised	Outstanding	OH&S REGULATIONS 3.7  AS/NZS 1657-2013 3.2.3.4
24 7	Building: General Roof Location Reference: <a href="#">L51</a> Task: Access to the roof

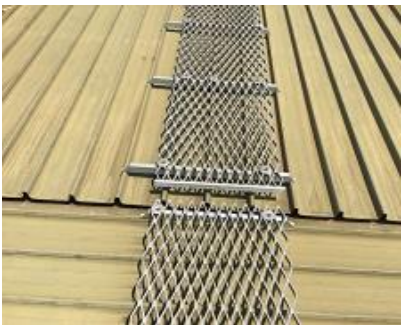
Variation in height between walkway panels are greater than required maximum	Trips, Slips and Falls	Awareness induction	Med	High visibility safety yellow nosing's to be installed	Low	Client advised	Outstanding	OH&S REGULATIONS 3.7  AS/NZS 1657-2013 3.3.4

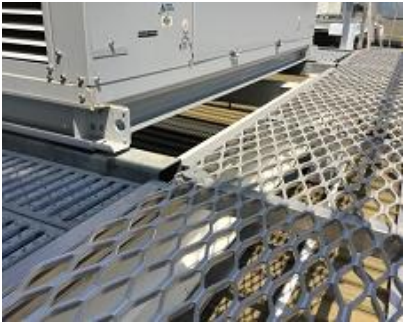
Gap between grating and unit is greater than required maximum	Trips, Slips and Falls	Awareness induction	Med	Gap to be filled	Low	Client advised	Outstanding	OH&S REGULATIONS 3.7  AS/NZS 1657-2013 3.2.3.4
24 9	Building: General Roof Location Reference: <a href="#">L58</a> Task: Access to the roof

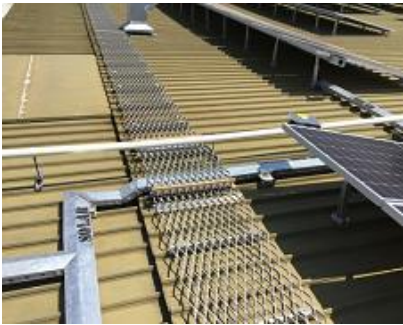
Pipe installed over the walkway path	Trips, Slips and Falls	Awareness induction	Med	Step bridge to be installed	Low	Client advised	Outstanding	OH&S REGULATIONS 3.7  AS/NZS 1657-2013 3.1.4

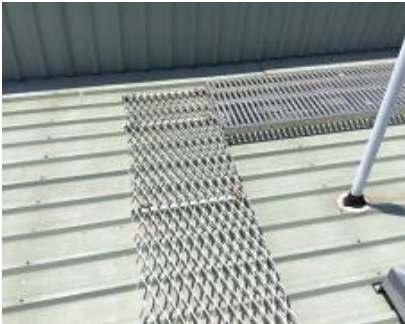
Variation in height between walkway panels are greater than required maximum	Trips, Slips and Falls	Awareness induction	Med	High visibility safety yellow nosing's to be installed	Low	Client advised	Outstanding	OH&S REGULATIONS 3.7  AS/NZS 1657-2013 3.3.4
251	Building: General Roof Location Reference: <a href="#">L58</a> Task: Access to the roof

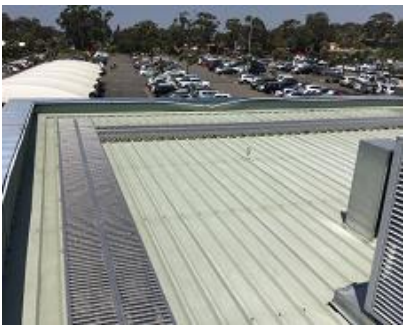
Gap between walkway and fall edge is less than required minimum	Trips, Slips and Falls	Awareness induction	Med	Handrail to be installed	Low	Client advised	Outstanding	OH&S REGULATIONS 3.7  AS/NZS 1657-2013 4.4

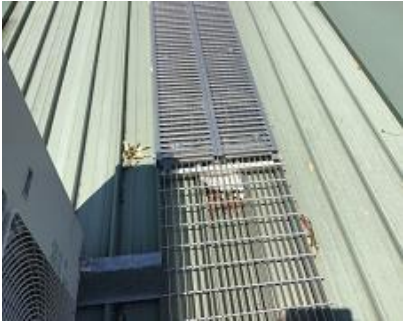
Variation in height between walkway panels are greater than required maximum	Trips, Slips and Falls	Awareness induction	Med	High visibility safety yellow nosing's to be installed	Low	Client advised	Outstanding	OH&S REGULATIONS 3.7  AS/NZS 1657-2013 3.3.4
