Roof Safety Report

**Livingston Market Place,
WA 6155**

Prepared By: Safemaster Safety Products
Date: 23-Aug-2018

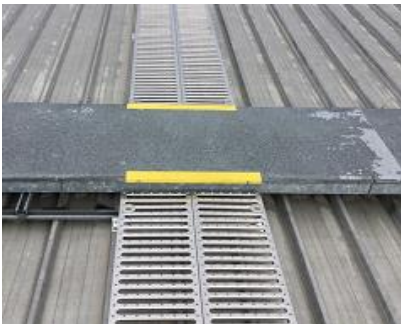
Cable tray installed over the walkway path	Trips, Slips and Falls	Awareness induction	Med	Step bridge including handrail to be installed	Low	Client advised	Outstanding	OH&S REGULATIONS 3.7 AS/NZS 1657-2018 3.1.4
55	Building: General Stores Location Reference: L08 Task: Access to the roof

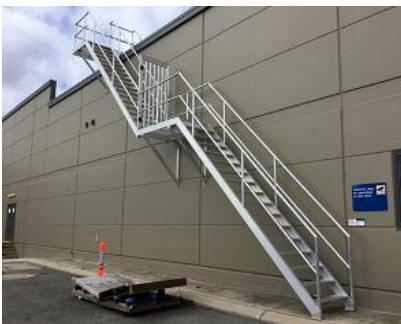
Toe board is missing for mid landing	Trips, Slips and Falls	Awareness induction	Med	Toe board to mid landing to be installed	Low	Client advised	Outstanding	OH&S REGULATIONS 3.7 AS/NZS 1657-2013 4.6

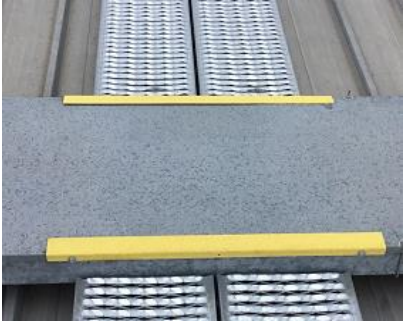
Cable tray installed over the walkway path	Trips, Slips and Falls	Awareness induction	Med	Step bridge including handrail to be installed	Low	Client advised	Outstanding	OH&S REGULATIONS 3.7 AS/NZS 1657-2018 3.1.4
57	Building: General Stores Location Reference: L09 Task: Access to the roof

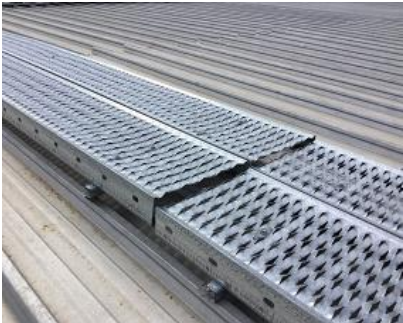
Variation in height between walkway panels are greater than required maximum and walkway not fully secured	Trips, Slips and Falls	Awareness induction	Med	Walkway to be secured with high visibility safety yellow nosing	Low	Client advised	Outstanding	OH&S REGULATIONS 3.7 AS/NZS 1657-2013 3.3.4

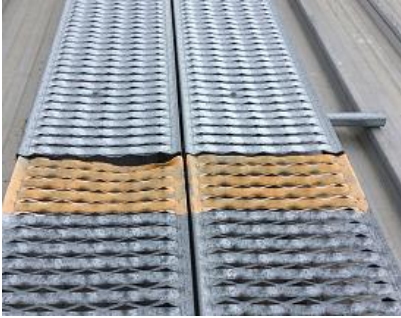
Walkway section is damaged	Trips, Slips and Falls	Awareness induction	Med	Walkway section to be replaced with high visibility safety yellow nosing	Low	Client advised	Outsta nding	OH&S REGULATIONS 3.7
59	Building: General Stores Location Reference: L10 Task: Access to the roof

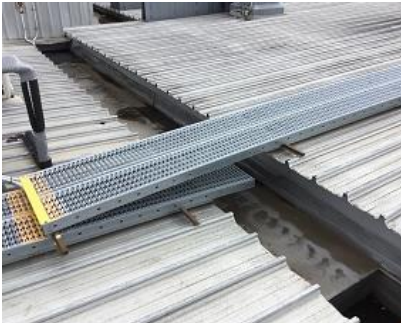
Variation in height between walkway and adjacent surface is greater than required maximum	Trips, Slips and Falls	Awareness induction	Med	Handrails to be installed	Low	Client advised	Outsta nding	OH&S REGULATIONS 3.7 AS/NZS 1657- 2013 5.4.1

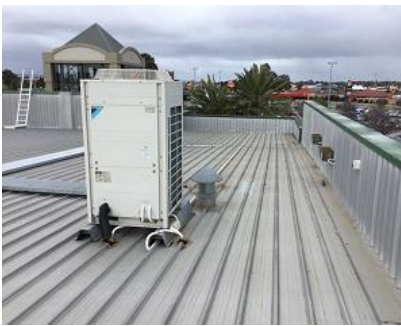
No safe access to the switches	Trips, Slips and Falls	N/A	Low	Supply walkway to the switches	Low	Client advised	Outstanding	-
61	Building: General Stores Location Reference: L37 Task: Access to the ladder

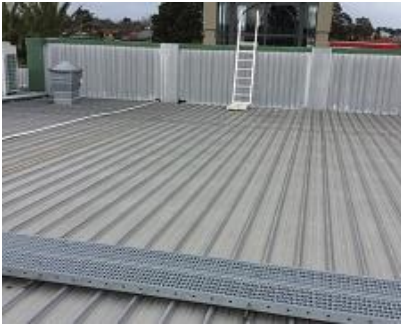
No safe access to the ladder	Trips, Slips and Falls	N/A	Low	Supply walkway to the ladder	Low	Client advised	Outstanding	-

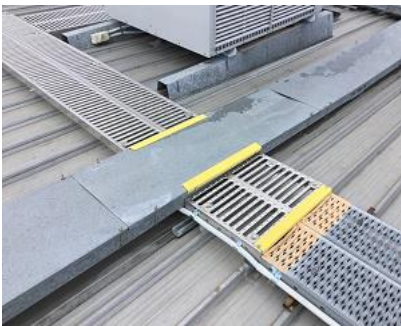
Cable tray installed over the walkway path	Trips, Slips and Falls	Awareness induction	Med	Step bridge including handrail to be installed	Low	Client advised	Outstanding	OH&S REGULATIONS 3.7 AS/NZS 1657-2018 3.1.4
63	Building: General Stores Location Reference: L36 Task: Access to the ladder

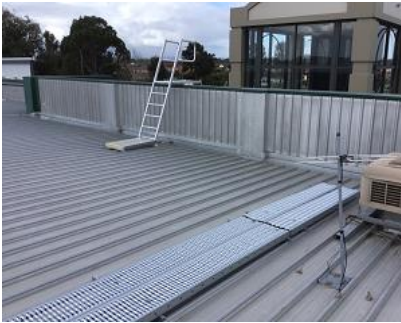
No safe access to the ladder	Trips, Slips and Falls	N/A	Low	Supply walkway to the ladder	Low	Client advised	Outstanding	-

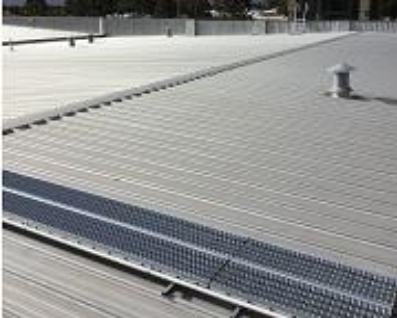
No safe access to the ladder	Trips, Slips and Falls	N/A	Low	Supply walkway to the ladder	Low	Client advised	Outsta nding	-
