Roof Safety Report

**Maddington Central,
WA 6109**

Prepared By: Safemaster Safety Products
Date: 30-August-2018

Roof Safety Report for
Maddington Central, WA 6109

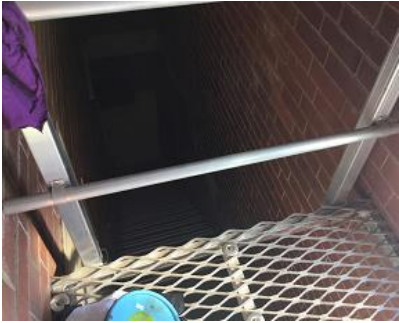
Toe board is missing for landing	Trips, Slips and Falls	Awareness induction	Med	Toe board to be installed	Low	Client advised	Outstanding	OH&S REGULATIONS 3.7 AS/NZS 1657-2018 4.6
75	Building: General Stores Location Reference: L05 Task: Access to the roof

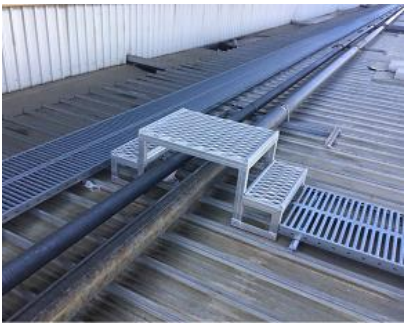
Uneven tread risers are present and handrail is missing	Trips, Slips and Falls	Awareness induction	Med	Existing step over bridge to be removed and new step bridge including handrails to be installed	Low	Client advised	Outstanding	OH&S REGULATIONS 3.7 AS/NZS 1657-2018 7.2.3.2

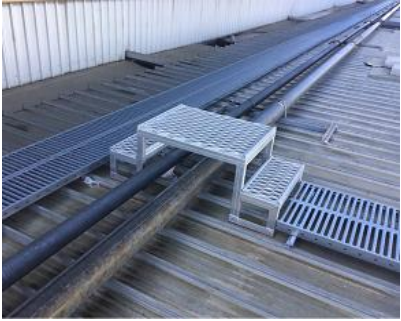
Uneven tread risers are present and handrail is missing	Trips, Slips and Falls	Awareness induction	Med	Existing step over bridge to be removed and new step bridge including handrails to be installed	Low	Client advised	Outstanding	OH&S REGULATIONS 3.7 AS/NZS 1657-2018 7.2.3.2
77	Building: General Stores Location Reference: L07 Task: Access to the roof

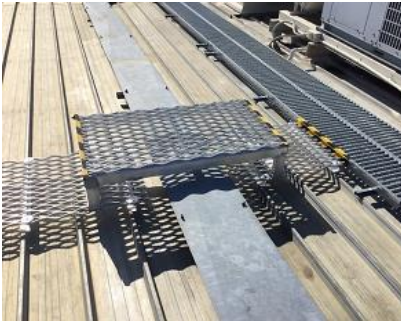
Variation in height between landing and roof is greater than required maximum	Trips, Slips and Falls	Awareness induction	Med	Existing landing to be lowered and high visibility safety yellow nosing's to be installed	Low	Client advised	Outstanding	OH&S REGULATIONS 3.7 AS/NZS 1657-2018 3.1.4

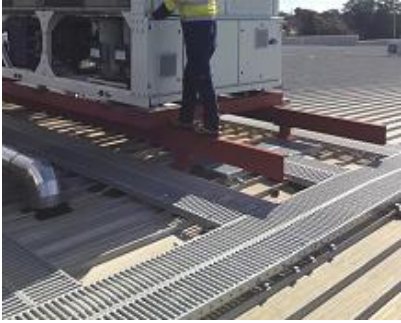
Variation in height between walkway panels are greater than required maximum	Trips, Slips and Falls	Awareness induction	Med	High visibility safety yellow nosing's to be installed	Low	Client advised	Outstanding	OH&S REGULATIONS 3.7 AS/NZS 1657-2018 3.3.4
79	Building: General Stores Location Reference: L09 Task: Access to the roof

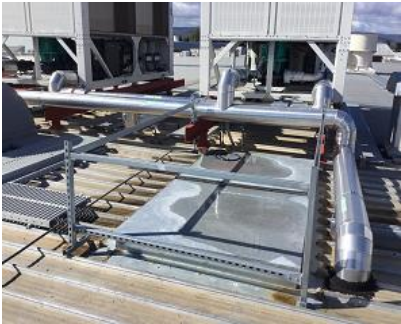
Non-trafficable sections are present	Trips, Slips and Falls	Awareness induction	High	"Keep Off-Brittle and Fragile Roof" sign to be installed	Low	Client advised	Outstanding	OH&S REGULATIONS 3.57

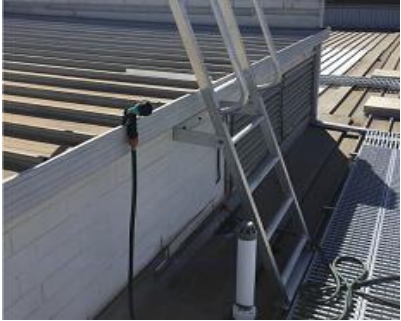
Top rung not levelled with landing	Trips, Slips and Falls	Awareness induction	Med	Landing platform at top to be installed	Low	Client advised	Outstanding	OH&S REGULATIONS 3.7 AS/NZS 1657-2018 7.4.3.3
81	Building: General Stores Location Reference: L21 Task: Access to the roof

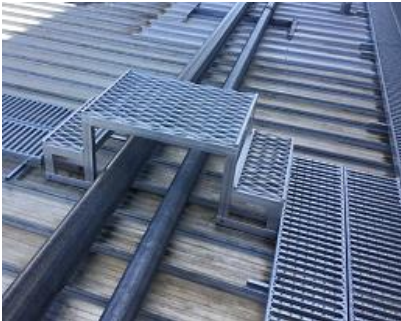
Uneven tread risers are present and handrail is missing	Trips, Slips and Falls	Awareness induction	Med	Existing step over bridge to be removed and new step bridge including handrails to be installed	Low	Client advised	Outstanding	OH&S REGULATIONS 3.7 AS/NZS 1657-2018 7.2.3.2

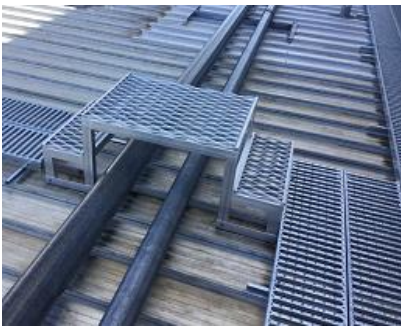
Uneven tread risers are present and handrail is missing	Trips, Slips and Falls	Awareness induction	Med	Existing step over bridge to be removed and new step bridge including handrails to be installed	Low	Client advised	Outstanding	OH&S REGULATIONS 3.7 AS/NZS 1657-2018 7.2.3.2
83	Building: General Stores Location Reference: L20 Task: Access to the roof

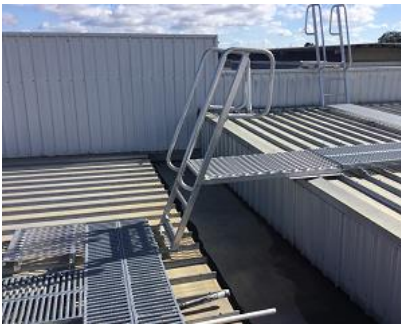
Un even landing platform is present and handrail is missing for landing	Trips, Slips and Falls	Awareness induction	Med	Landing platform and handrail for top landing to be installed	Low	Client advised	Outstanding	OH&S REGULATIONS 3.7 AS/NZS 1657-2018 7.3.6 & 4.4

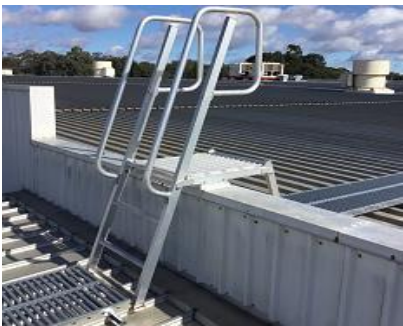
Bottom rung heights are less than required minimum and top landing is less than required minimum	Trips, Slips and Falls	Awareness induction	Med	Existing ladder to be replaced	Low	Client advised	Outstanding	OH&S REGULATIONS 3.7 AS/NZS 1657-2018 7.4.3.3 & 7.3.6
85	Building: General Stores Location Reference: L56 Task: Access to the A/c units

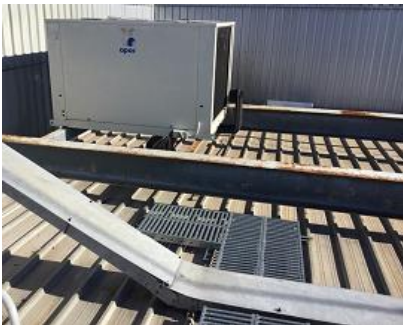
No safe access to the A/c units	Trips, Slips and Falls	N/A	Low	Walkway and step bridge to be installed	Low	Client advised	Outstanding	-

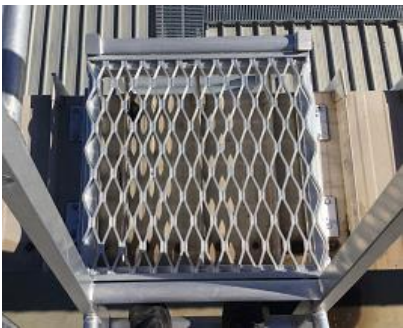
Top rung not levelled with landing and clearance behind the ladder is less than required minimum	Trips, Slips and Falls	Awareness induction	Med	Existing ladder to be re-installed with landing platform and new brackets	Low	Client advised	Outstanding	OH&S REGULATIONS 3.7 AS/NZS 1657-2018 7.4.3.3 & 7.4.5
87	Building: General Stores Location Reference: L54 Task: Access to the roof

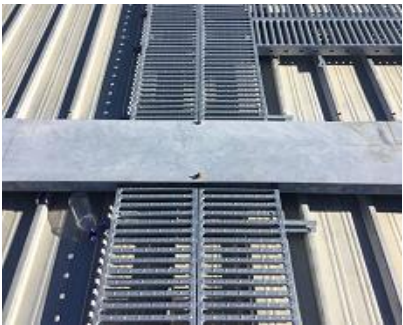
Cable tray installed over the walkway path	Trips, Slips and Falls	Awareness induction	Med	Step bridge to be installed	Low	Client advised	Outstanding	OH&S REGULATIONS 3.7 AS/NZS 1657-2018 3.1.4

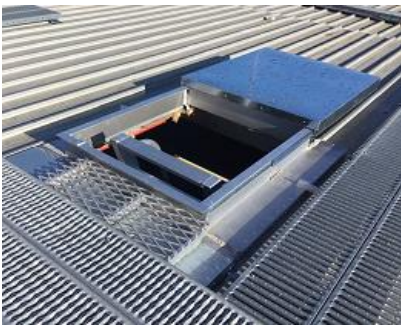
Handrail is missing for ladder and no fall protection for hatch	Trips, Slips and Falls	Awareness induction	Med	Extendable stiles to ladder and guardrail to hatch to be installed	Low	Client advised	Outstanding	OH&S REGULATIONS 3.7 & 3.55 AS/NZS 1657-2018 4.4
89	Building: General Stores Location Reference: L44 Task: Access to the roof

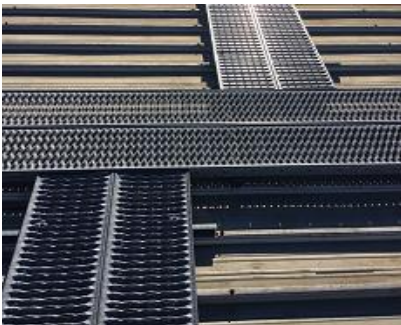
Variation in height between walkway panels are greater than required maximum	Trips, Slips and Falls	Awareness induction	Med	High visibility safety yellow nosing's to be installed	Low	Client advised	Outstanding	OH&S REGULATIONS 3.7 AS/NZS 1657-2018 3.3.4

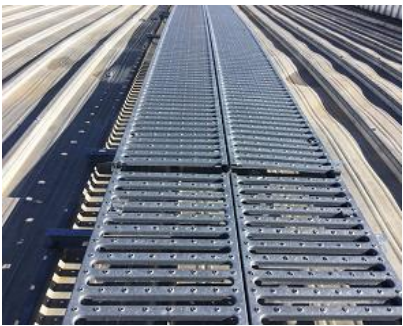
Walkway not fully secured	Trips, Slips and Falls	Awareness induction	Med	Walkway to be secured	Low	Client advised	Outstanding	OH&S REGULATIONS 3.7
91	Building: General Stores Location Reference: L53 Task: Access to the roof

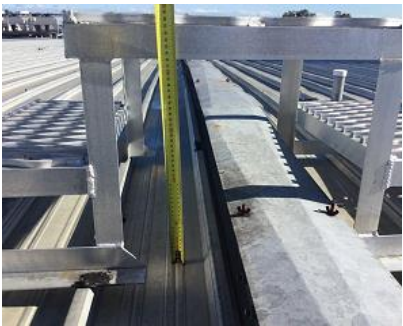
Step bridge height is greater than required maximum	Trips, Slips and Falls	Awareness induction	Med	Existing step bridge to be replaced with handrails	Low	Client advised	Outstanding	OH&S REGULATIONS 3.7 AS/NZS 1657-2018 3.1.4

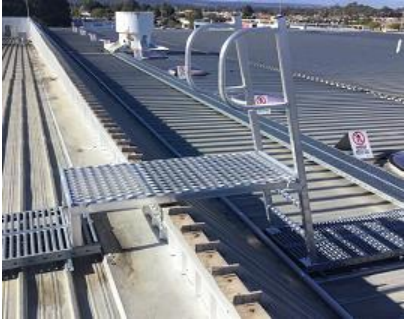
Variation in height between landing and roof is greater than required maximum and handrail is missing for landing	Trips, Slips and Falls	Awareness induction	Med	New step including handrail to landing to be installed	Low	Client advised	Outstanding	OH&S REGULATIONS 3.7 AS/NZS 1657-2018 3.1.4 & 4.4
93	Building: General Stores Location Reference: L61 Task: Access to the roof

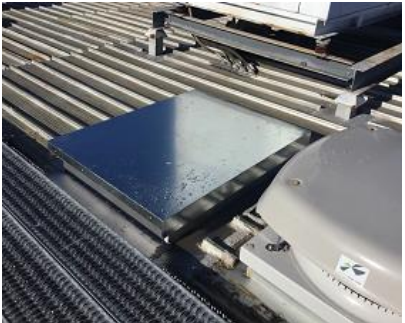
No fall prevention installed for hatch	Trips, Slips and Falls	Awareness induction	High	Fall prevention anchor to be installed	Low	Client advised	Outstanding	OH&S REGULATIONS 3.55

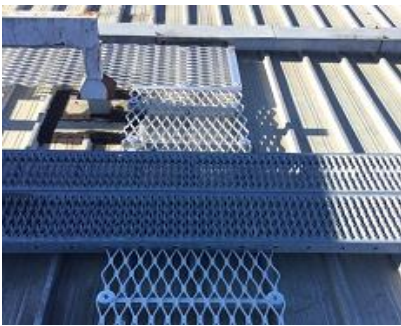
Variation in height between walkway panels are greater than required maximum	Trips, Slips and Falls	Awareness induction	Med	High visibility safety yellow nosing's to be installed	Low	Client advised	Outstanding	OH&S REGULATIONS 3.7 AS/NZS 1657-2018 3.3.4
95	Building: General Stores Location Reference: L05 Task: Access to the roof

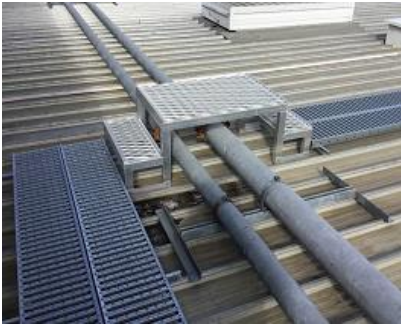
Un-even step heights are present and guardrail is missing for steps	Trips, Slips and Falls	Awareness induction	Med	Existing steps to be modified and re-installed with handrails	Low	Client advised	Outstanding	OH&S REGULATIONS 3.7 AS/NZS 1657-2018 4.4

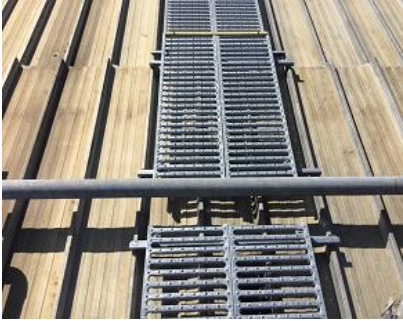
Gap between walkway panels are greater than required maximum and pipe installed over the walkway path	Trips, Slips and Falls	Awareness induction	Med	Step bridge to be installed	Low	Client advised	Outstanding	OH&S REGULATIONS 3.7 AS/NZS 1657-2018 3.2.3.4
97	Building: General Stores Location Reference: L23 Task: Access to the roof

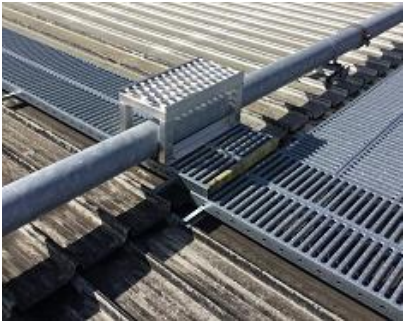
Step height is greater than required maximum and landing is less than required minimum	Trips, Slips and Falls	Awareness induction	Med	Existing step to be replaced	Low	Client advised	Outstanding	OH&S REGULATIONS 3.7 AS/NZS 1657-2018 7.2.3.2 & 7.2.4

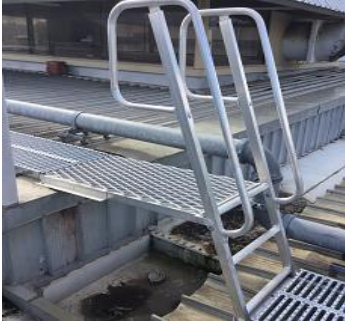
Top rung not levelled with landing and handrail is missing for landing	Trips, Slips and Falls	Awareness induction	Med	Landing platform to be re-installed with handrails	Low	Client advised	Outstanding	OH&S REGULATIONS 3.7 AS/NZS 1657-2018 7.4.3.3 & 4.4
99	Building: General Stores Location Reference: L23 Task: Access to the roof

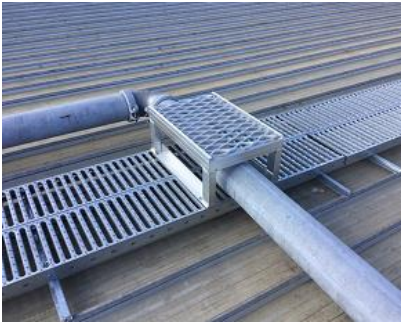
Landing height is greater than required maximum and landing is less than required minimum	Trips, Slips and Falls	Awareness induction	Med	Existing step to be replaced including handrails	Low	Client advised	Outstanding	OH&S REGULATIONS 3.7 AS/NZS 1657-2018 3.1.4 & 4.4

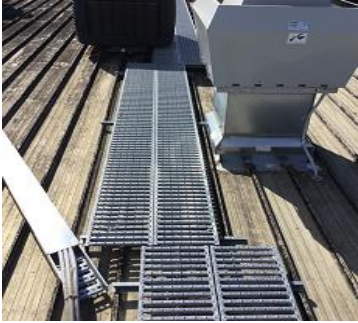
Walkway width is less than required minimum	Trips, Slips and Falls	Awareness induction	Med	Additional walkway sections to be installed	Low	Client advised	Outstanding	OH&S REGULATIONS 3.7 AS/NZS 1657-2018 5.1.3
101	Building: General Stores Location Reference: L32 Task: Access to the roof

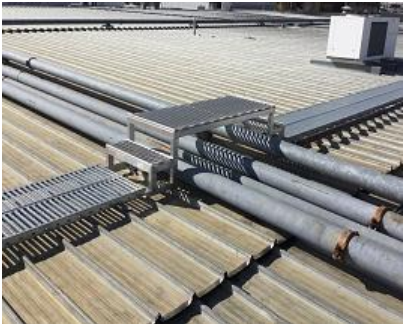
Un-even risers heights are present and handrail is missing for landing	Trips, Slips and Falls	Awareness induction	Med	Existing step bridge to be replaced with guardrails	Low	Client advised	Outstanding	OH&S REGULATIONS 3.7 AS/NZS 1657-2018 7.2.3.2 & 7.2.4

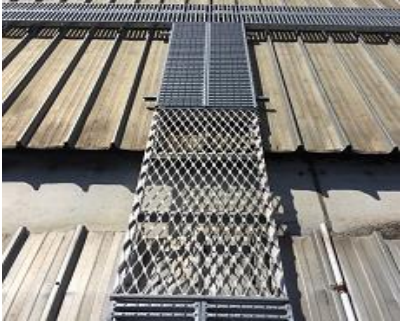
Variation in height between walkway panels are greater than required maximum	Trips, Slips and Falls	Awareness induction	Med	High visibility safety yellow nosing's to be installed	Low	Client advised	Outstanding	OH&S REGULATIONS 3.7 AS/NZS 1657-2018 3.3.4
103	Building: General Stores Location Reference: L29 Task: Access to the roof

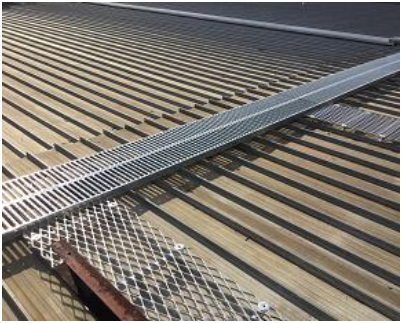
Variation in height between walkway panels are greater than required maximum	Trips, Slips and Falls	Awareness induction	Med	High visibility safety yellow nosing's to be installed	Low	Client advised	Outstanding	OH&S REGULATIONS 3.7 AS/NZS 1657-2018 3.3.4

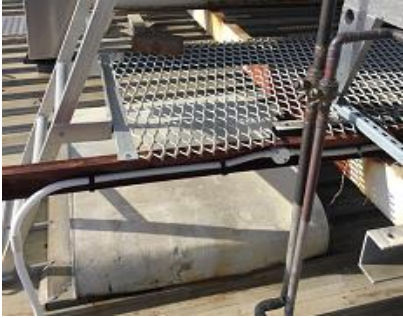
Gap between top rung and landing is greater than required maximum and bottom rung height is less than required minimum	Trips, Slips and Falls	Awareness induction	Med	Existing ladder to be re-installed with landing platform and handrails	Low	Client advised	Outstanding	OH&S REGULATIONS 3.7 AS/NZS 1657-2018 7.4.8.4 & 7.4.3.4
105	Building: General Stores Location Reference: L29 Task: Access to the roof

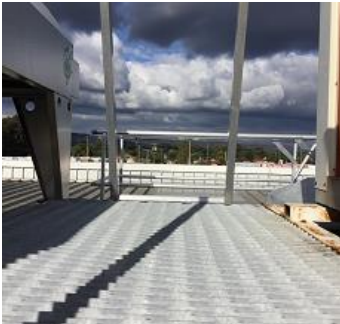
Gap between top rung and landing is greater than required maximum and bottom rung height is less than required minimum	Trips, Slips and Falls	Awareness induction	Med	Existing ladders(x3) to be re-installed with landing platform and handrails	Low	Client advised	Outstanding	OH&S REGULATIONS 3.7 AS/NZS 1657-2018 7.4.8.4 & 7.4.3.4

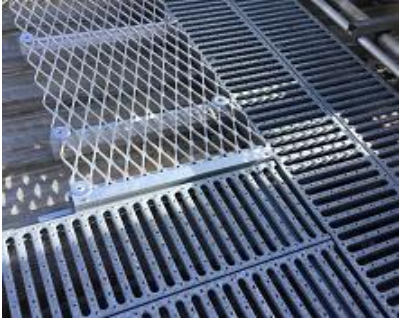
Variation in height between walkway panels are greater than required maximum	Trips, Slips and Falls	Awareness induction	Med	High visibility safety yellow nosing's to be installed	Low	Client advised	Outstanding	OH&S REGULATIONS 3.7 AS/NZS 1657-2018 3.3.4
107	Building: General Stores Location Reference: L62 Task: Access to the roof

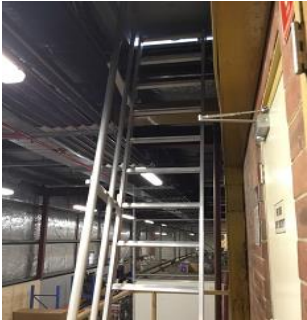
Existing handrail protection for ladder is not complaint	Trips, Slips and Falls	Awareness induction	Med	Cage to be installed	Low	Client advised	Outstanding	OH&S REGULATIONS 3.7 AS/NZS 1657-2018 7.4.7

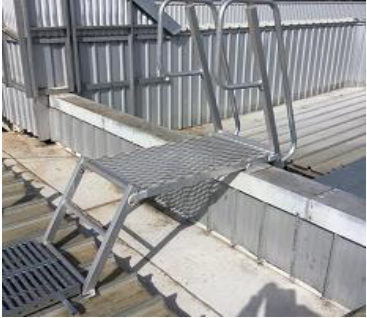
Top rung not levelled with landing and handrail is missing for landing	Trips, Slips and Falls	Awareness induction	Med	Existing landing platform to be re-installed with new ladder head and brackets	Low	Client advised	Outstanding	OH&S REGULATIONS 3.7 AS/NZS 1657-2018 7.4.3.3 & 4.4
