Roof Safety Report

**Maddington Central,
WA 6109**

Prepared By: Safemaster Safety Products
Date: 06-08-2019

Roof Safety Report for
Maddington Central, WA 6109

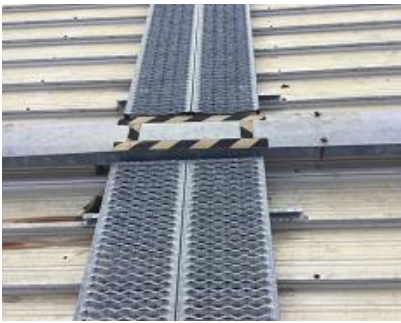
Cable tray installed over the walkway path	Trips, Slips and Falls	Awareness induction	Med	Step bridge to be installed	Low	Client advised	Outstanding	OH&S REGULATIONS 3.7 AS/NZS 1657-2018 3.1.4
110	Building: General Stores Location Reference: L61 Task: Access to the roof

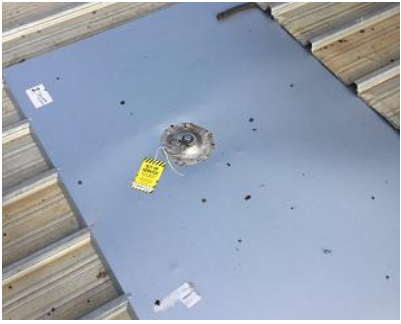
Fixings not visible and it is un-certifiable	Trips, Slips and Falls	Awareness induction	High	Replace the anchor	Low	Client advised	Outstanding	OH&S REGULATIONS 3.55
