Roof Safety Report

Maddington Central,
WA 6109

Prepared By: Safemaster Safety Products
Date: 27-07-2020

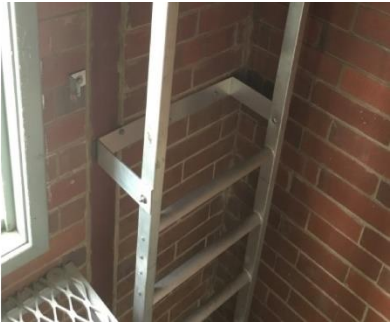
Ladder rungs does not pass the landing for safe access and bottom rung height is less than required minimum	Trips, Slips and Falls	Awareness induction	Med	Ladder to be replaced and "Uneven bottom rung" signs to be installed	Low	Client advised	Outstanding	OH&S REGULATIONS 3.7 & 3.11 AS 1657-2018 7.4
112	Building: General Stores Location Reference: L01 Task: Access to the roof

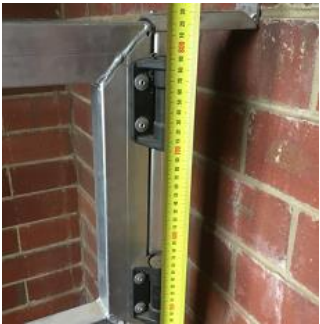
Self-closing gate height is less than required minimum	Trips, Slips and Falls	Awareness induction	Med	Existing gate to be replaced	Low	Client advised	Outstanding	OH&S REGULATIONS 3.7 AS 1657-2018 4.4

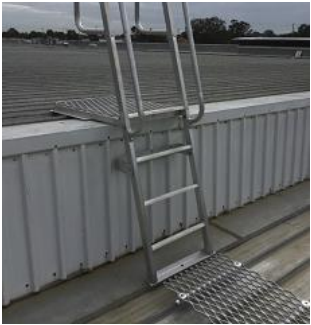
Abandoned ladder to be removed alternative roof access is present	Trips, Slips and Falls	Awareness induction	Med	Ladder to be removed	Low	Client advised	Outstanding	OH&S REGULATIONS 3.7
114	Building: General Stores Location Reference: L12 Task: Access to the A/c units

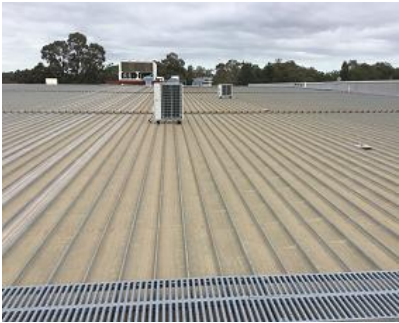
No safe access to the A/c units	Trips, Slips and Falls	N/A	Low	Supply walkway to the A/c units	Low	Client advised	Outstanding	-

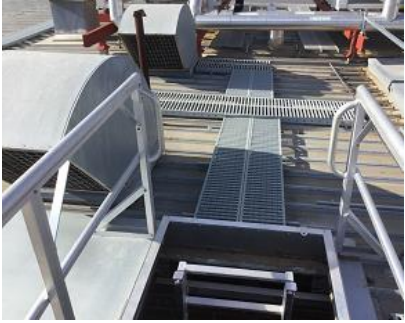
Access anchor is missing	Trips, Slips and Falls	Awareness induction	High	Access anchor to be installed	Low	Client advised	Outstanding	OH&S REGULATIONS 3.7 & 3.55
116	Building: General Stores Location Reference: L55-L56-L57 Task: Access to the roof

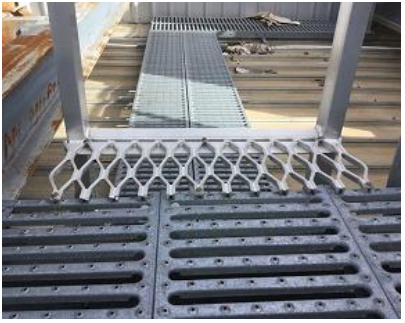
Top landing is less than required minimum	Trips, Slips and Falls	Awareness induction	Med	3x landing platform to be installed	Low	Client advised	Outstanding	OH&S REGULATIONS 3.7 AS1657-2018 7.4

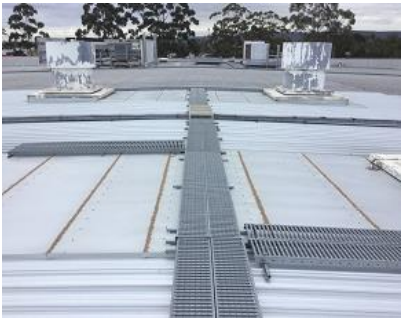
Existing walkway re-installed in-correctly	Trips, Slips and Falls	Awareness induction	Med	Existing walkway to be re-installed with additional supports and high visibility safety yellow nosing's	Low	Client advised	Outstanding	OH&S REGULATIONS 3.7 AS1657-2018 3.1.4
118	Building: General Stores Location Reference: L41 Task: Access to the roof

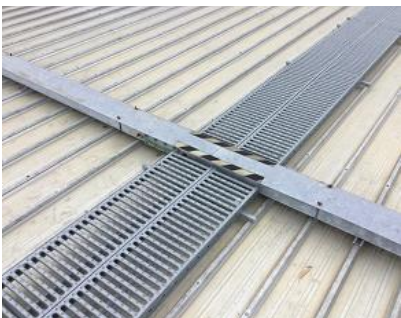
Cable tray installed over the walkway path	Trips, Slips and Falls	Awareness induction	Med	Step bridge including high visibility safety yellow nosing's to be installed	Low	Client advised	Outstanding	OH&S REGULATIONS 3.7 AS1657-2018 3.3.4

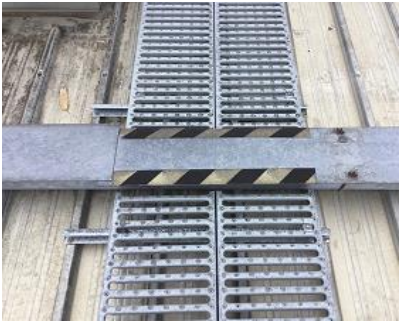
Cable tray installed over the walkway path	Trips, Slips and Falls	Awareness induction	Med	Step bridge including high visibility safety yellow nosing's to be installed	Low	Client advised	Outstanding	OH&S REGULATIONS 3.7 AS1657-2018 3.3.4
120	Building: General Stores Location Reference: L43 Task: Access to the roof

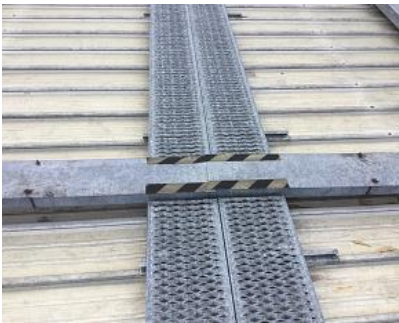
Cable tray installed over the walkway path	Trips, Slips and Falls	Awareness induction	Med	Step bridge including high visibility safety yellow nosing's to be installed	Low	Client advised	Outstanding	OH&S REGULATIONS 3.7 AS1657-2018 3.3.4

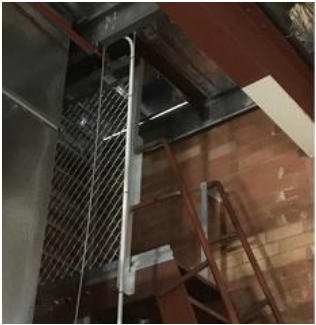
Gap between top rung and landing is greater than required maximum	Trips, Slips and Falls	Awareness induction	Med	Existing ladder to be replaced	Low	Client advised	Outstanding	OH&S REGULATIONS 3.7 AS1657-2018 7.4
122	Building: General Stores Location Reference: L61 Task: Access to the roof

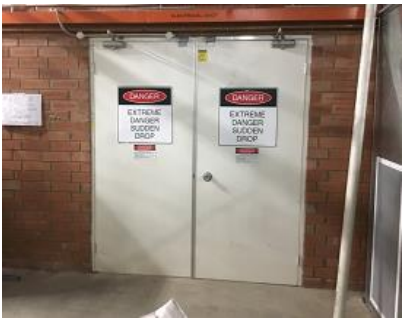
No fall protection at access door	Trips, Slips and Falls	Awareness induction	High	2x concrete fix anchor to be installed	Low	Client advised	Outstanding	OH&S REGULATIONS 3.55

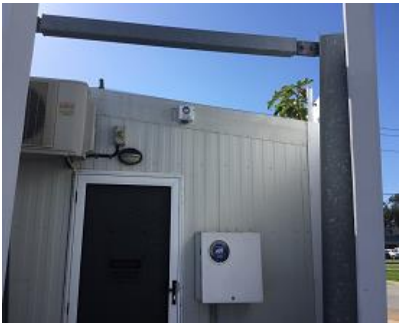
No height safety system installed	Trips, Slips and Falls	Awareness induction	High	Ladder bracket, sign, strop and anchors to be installed	Low	Client advised	Outstanding	OH&S REGULATIONS 3.7 & 3.55
