Roof Safety Report

Mandurah Forum, WA 6210

Prepared By: Safemaster Safety Products
Date: 28 May 2018

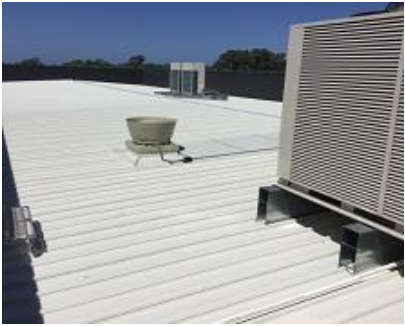
No safe access to the A/c units	Trips, Slips and Falls	N/A	Low	Supply walkway to the A/c units	Low	Client advised	Outstanding	-
02	Building: General Stores Location Reference: L01 Task: Access to the roof

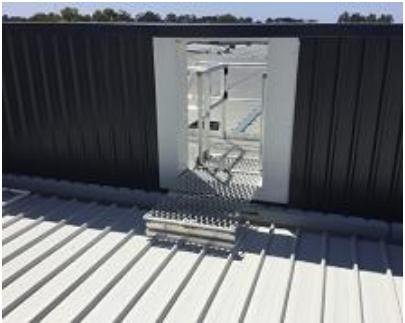
Headroom is less than required minimum	Trips, Slips and Falls	Awareness induction	Med	"Caution-Low Headroom" signs to be installed	Low	Client advised	Outstanding	OH&S REGULATIONS 3.7 AS/NZS 1657-2013 3.1.5

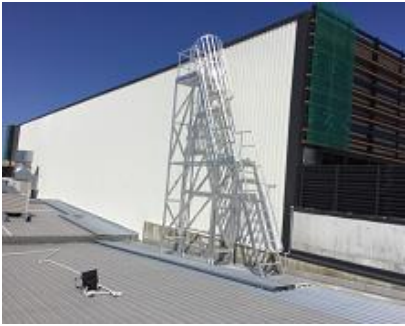
Bottom rung height is greater than required maximum	Trips, Slips and Falls	Awareness induction	Med	Landing platform to be installed	Low	Client advised	Outstanding	OH&S REGULATIONS 3.7 AS/NZS 1657-2013 7.4.3.4
04	Building: General Stores Location Reference: L01 Task: Access to the roof

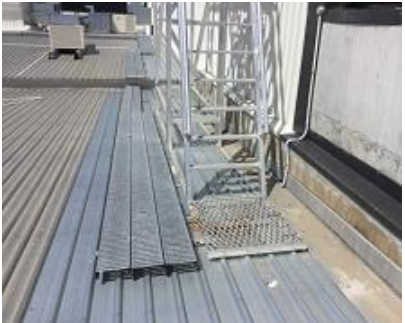
Gap between walkway panels are greater than required maximum	Trips, Slips and Falls	Awareness induction	Med	Additional walkway section including high visibility safety yellow nosing to be installed	Low	Client advised	Outstanding	OH&S REGULATIONS 3.7 AS/NZS 1657-2013 3.3.4

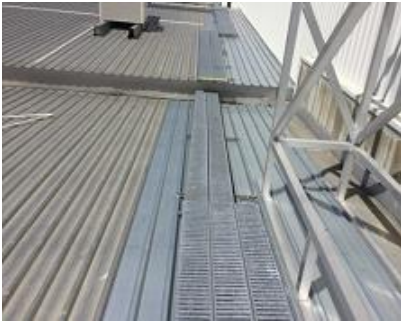
Walkway width is less than required minimum	Trips, Slips and Falls	Awareness induction	Med	Existing walkway to be removed and new walkway to be installed	Low	Client advised	Outstanding	OH&S REGULATIONS 3.7 AS/NZS 1657-2013 5.1.3
06	Building: General Stores Location Reference: L01 Task: Access to the roof

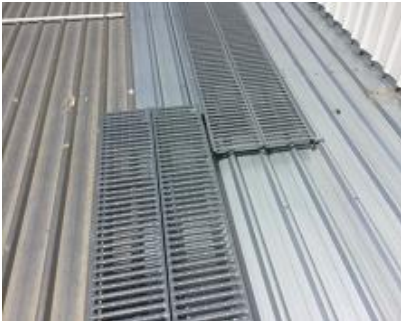
Walkway width is less than required minimum	Trips, Slips and Falls	Awareness induction	Med	Additional walkway section to be installed	Low	Client advised	Outstanding	OH&S REGULATIONS 3.7 AS/NZS 1657-2013 5.1.3

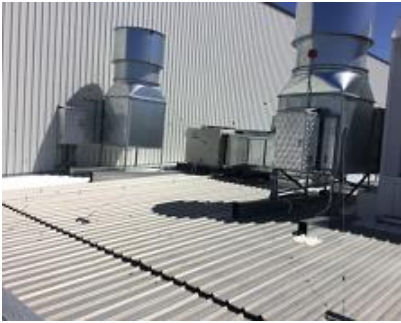
No safe access to the A/c units	Trips, Slips and Falls	N/A	Low	Supply walkway to the A/c units	Low	Client advised	Outstanding	-
08	Building: General Stores Location Reference: L03 Task: Access to the roof

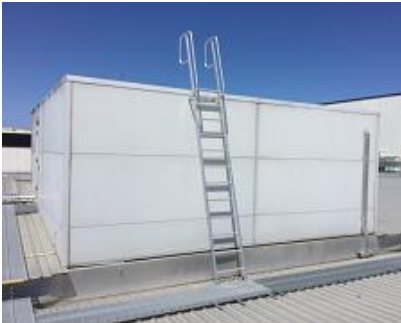
Top rung not levelled with landing, bottom rung height is less than required minimum, handrail projecting towards the user, landing is less than required minimum and need more bracing	Trips, Slips and Falls	Awareness induction	Med	Existing ladder to be removed and new ladder to be installed	Low	Client advised	Outstanding	OH&S REGULATIONS 3.7 AS/NZS 1657-2013 7.4.3.3, 7.4.3.4, 7.4.8.5 & 7.3.6

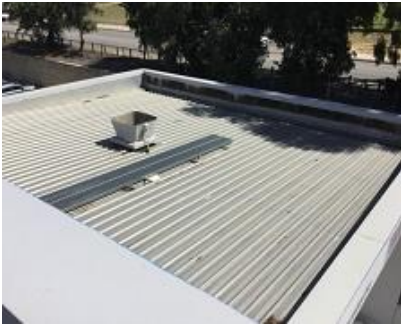
No height safety system installed	Trips, Slips and Falls	Awareness induction	High	Fall arrest anchors to be installed	Low	Client advised	Outstanding	OH&S REGULATIONS 3.55
10	Building: General Stores Location Reference: L04 Task: Access to the roof

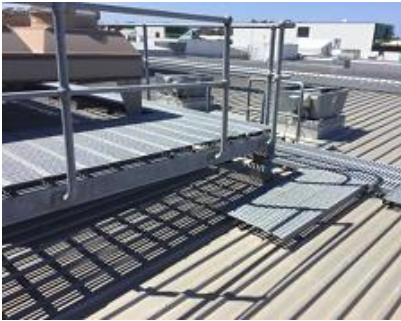
Variation in height between plant deck and roof is greater than required maximum	Trips, Slips and Falls	Awareness induction	Med	Access ladder to be installed	Low	Client advised	Outstanding	OH&S REGULATIONS 3.7 AS/NZS 1657-2013 3.1.4
12	Building: General Stores Location Reference: L05 Task: Access to the roof

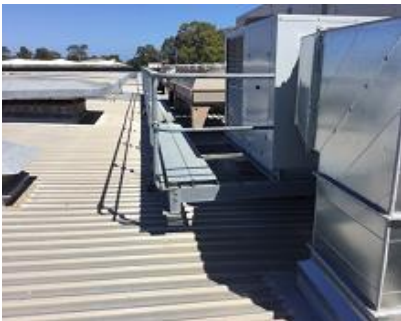
Gap between unit and plant deck is greater than required maximum	Trips, Slips and Falls	Awareness induction	Med	Additional walkway sections to be installed	Low	Client advised	Outstanding	OH&S REGULATIONS 3.7 AS/NZS 1657-2013 3.2.3.4

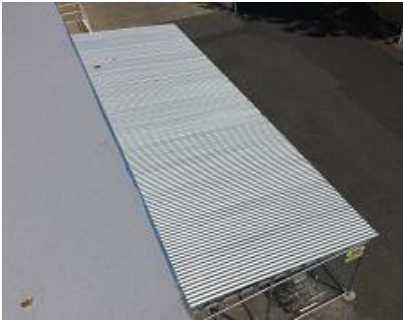
No height safety system installed	Trips, Slips and Falls	Restrict Access	High	"EWP Access Only" sign to be installed	Low	Client advised	Outstanding	OH&S REGULATIONS 3.55 & 3.11
14	Building: General Stores Location Reference: L07 Task: Access to the roof

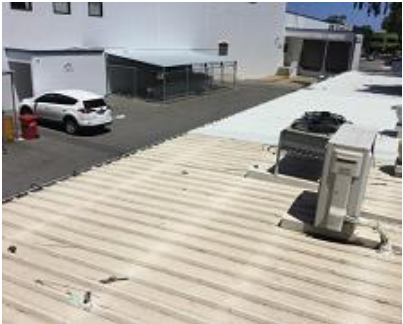
Not enough anchors installed	Trips, Slips and Falls	Awareness induction	High	Fall arrest anchors to be installed	Low	Client advised	Outstanding	OH&S REGULATIONS 3.55

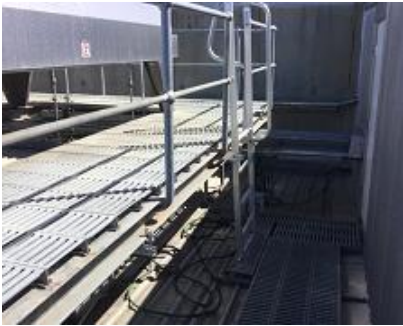
Top rung not levelled with landing, bottom rung height is less than required minimum and handrail projecting towards the user	Trips, Slips and Falls	Awareness induction	Med	Existing ladder to be re-installed with landing platforms, bracket and handrails	Low	Client advised	Outstanding	OH&S REGULATIONS 3.7 AS/NZS 1657-2013 7.4.3.3, 7.4.3.4 & 7.4.8.5
16	Building: General Stores Location Reference: L08 Task: Access to the roof

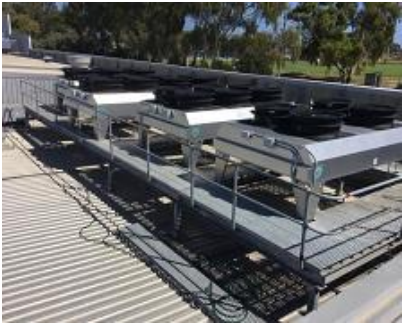
Variation in height between plant deck and unit is greater than required maximum	Trips, Slips and Falls	Awareness induction	Med	Mid rail to be installed	Low	Client advised	Outstanding	OH&S REGULATIONS 3.7 AS/NZS 1657-2013 6.2.1.2

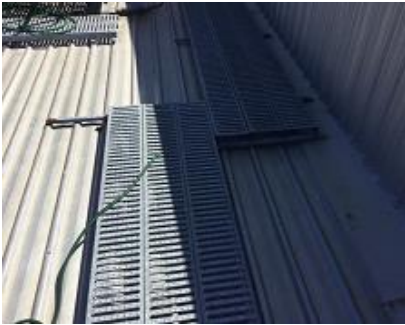
Walkway width is less than required minimum	Trips, Slips and Falls	Awareness induction	Med	Additional walkway section to be installed	Low	Client advised	Outstanding	OH&S REGULATIONS 3.7 AS/NZS 1657-2013 5.1.3
18	Building: General Stores Location Reference: L09 Task: Restrict access to the roof

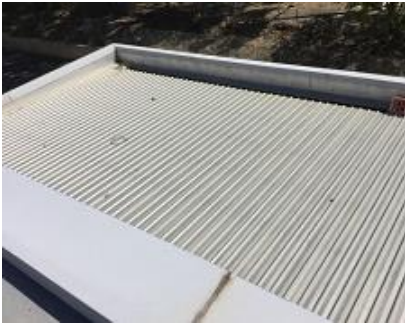
No height safety system installed	Trips, Slips and Falls	Restrict Access	High	"EWP Access Only" sign to be installed	Low	Client advised	Outstanding	OH&S REGULATIONS 3.55 & 3.11

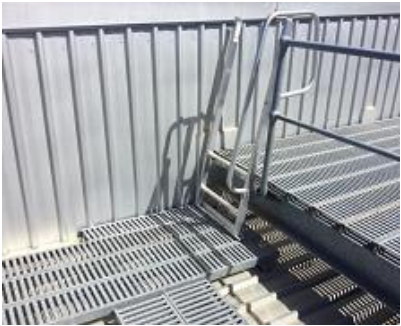
Bottom rung height is less than required minimum and handrail projecting towards the user	Trips, Slips and Falls	Awareness induction	Med	Existing ladder to be removed and new ladder to be installed	Low	Client advised	Outstanding	OH&S REGULATIONS 3.7 AS/NZS 1657-2013 7.4.3.4 & 7.4.8.5
20	Building: General Stores Location Reference: L10 Task: Access to the A/c units

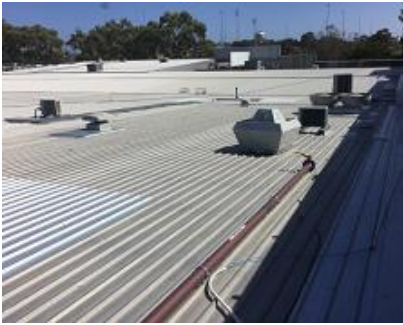
No safe access to the A/c units	Trips, Slips and Falls	N/A	Low	Supply walkway to the A/c units	Low	Client advised	Outstanding	-
22	Building: General Stores Location Reference: L12 Task: Access to the A/c units

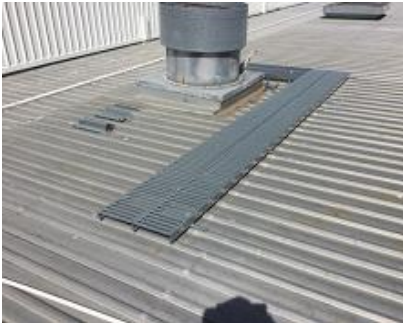
No safe access to the A/c units	Trips, Slips and Falls	N/A	Low	Supply walkway to the A/c units	Low	Client advised	Outstanding	-

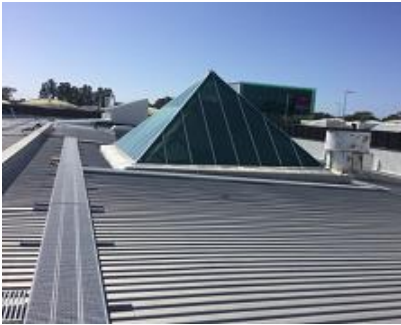
Brittle roof (Non-trafficable roof)	Trips, Slips and Falls	Restrict Access	High	"Warning-Keep Off-Brittle and Fragile Roof" signs to be installed	Low	Client advised	Outstanding	OH&S REGULATIONS 3.57
24	Building: General Stores Location Reference: L14 Task: Access to the roof

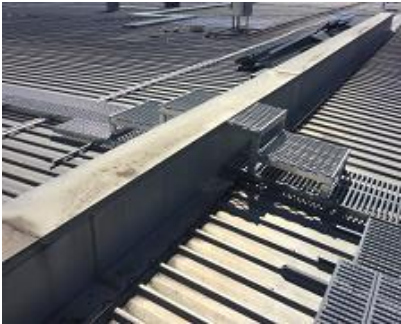
Non-complaint step is present	Trips, Slips and Falls	Awareness induction	Med	Existing step to be removed and new ladder to be installed	Low	Client advised	Outstanding	OH&S REGULATIONS 3.7 AS/NZS 1657-2013 3.1.4

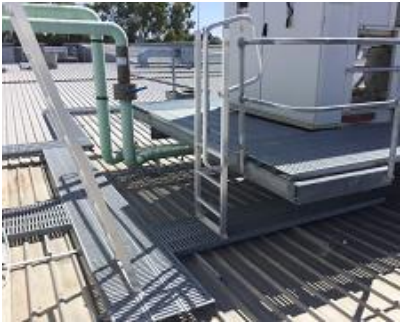
Bottom rung height is less than required minimum and handrail projecting towards the user	Trips, Slips and Falls	Awareness induction	Med	Existing ladder to be removed and new ladder to be installed	Low	Client advised	Outstanding	OH&S REGULATIONS 3.7 AS/NZS 1657-2013 7.4.3.4 & 7.4.8.5
26	Building: General Stores Location Reference: L15 Task: Access to the roof

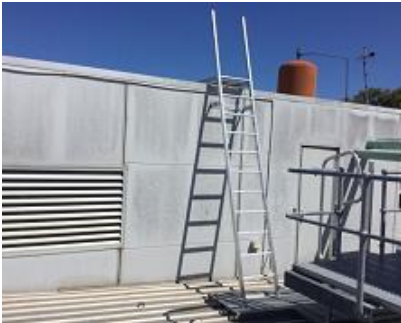
Landing is less than required minimum	Trips, Slips and Falls	Awareness induction	Med	Landing platform to existing ladder to be installed	Low	Client advised	Outstanding	OH&S REGULATIONS 3.7 AS/NZS 1657-2013 7.3.6

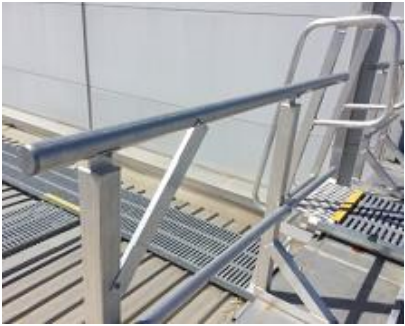
Sharp edges on handrails and not enough post installed	Trips, Slips and Falls	Awareness induction	Med	Tek screws to be replaced with rivets	Low	Client advised	Outstanding	OH&S REGULATIONS 3.7 AS/NZS 1657-2013 5.6 & 4.4
28	Building: General Stores Location Reference: L16 Task: Access to the roof

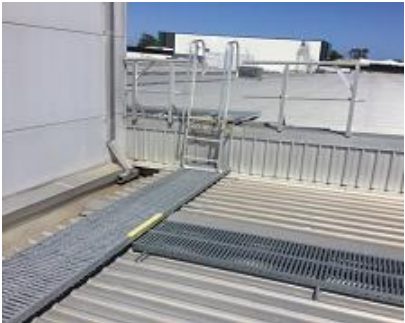
Bottom rung height is less than required minimum and handrail projecting towards the user	Trips, Slips and Falls	Awareness induction	Med	Existing ladder to be re-installed with landing platforms and handrails	Low	Client advised	Outstanding	OH&S REGULATIONS 3.7 AS/NZS 1657-2013 7.4.3.4 & 7.4.8.5

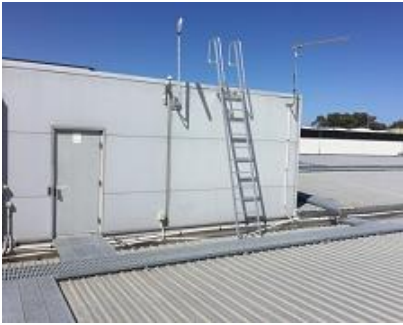
Landing is less than required minimum and handrail projects towards the user	Trips, Slips and Falls	Awareness induction	Med	Landing platforms including handrails to be installed	Low	Client advised	Outstanding	OH&S REGULATIONS 3.7 AS/NZS 1657-2013 7.3.6 & 7.4.8.5
30	Building: General Stores Location Reference: L17 Task: Access to the roof

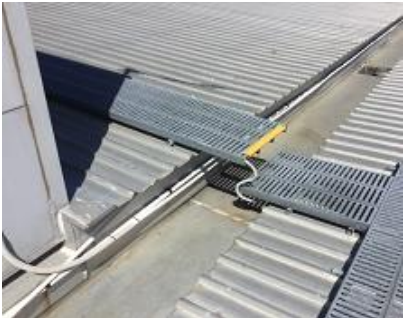
Variation in height between walkway and adjacent surface is greater than require maximum	Trips, Slips and Falls	Awareness induction	Med	Handrail to be installed	Low	Client advised	Outstanding	OH&S REGULATIONS 3.7 AS/NZS 1657-2013 4.4

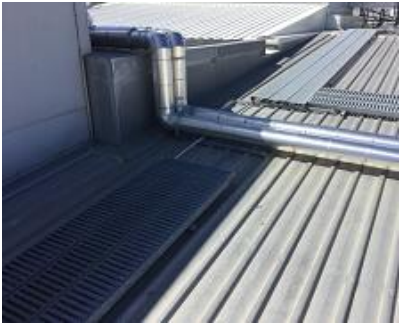
Pipe installed between walkway panels	Trips, Slips and Falls	Awareness induction	Med	Walkway, Step bridge and handrail to be installed	Low	Client advised	Outstanding	OH&S REGULATIONS 3.7 AS/NZS 1657-2013 3.1.4
32	Building: General Stores Location Reference: L18 Task: Access to the roof

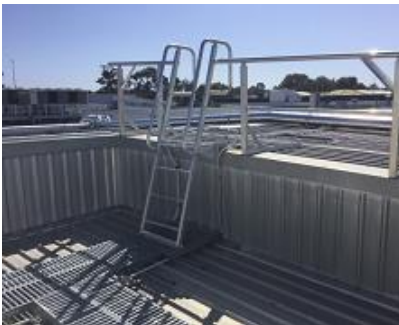
Bottom rung height is less than required minimum and handrail projecting towards the user	Trips, Slips and Falls	Awareness induction	Med	Existing ladder to be re-installed with landing platforms and handrails	Low	Client advised	Outstanding	OH&S REGULATIONS 3.7 AS/NZS 1657-2013 7.4.3.4 & 7.4.8.5

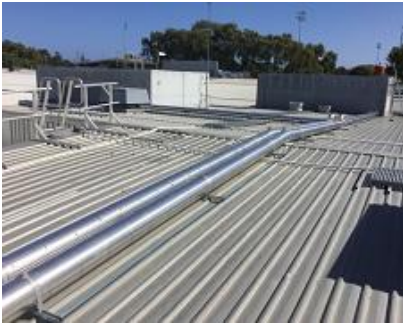
No safe access to the A/c units	Trips, Slips and Falls	N/A	Low	Supply walkway and step bridge to the A/c units	Low	Client advised	Outstanding	-
34	Building: General Stores Location Reference: L19 Task: Access to the roof

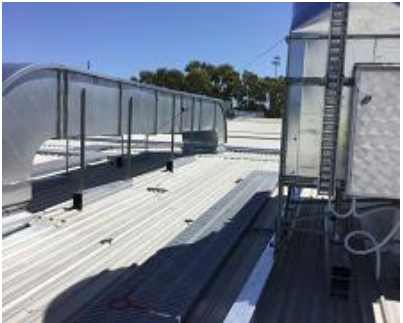
Head room is less than required minimum	Trips, Slips and Falls	Awareness induction	Med	"Caution-Low Headroom" signs to be installed	Low	Client advised	Outstanding	OH&S REGULATIONS 3.7 AS/NZS 1657-2013 3.1.5

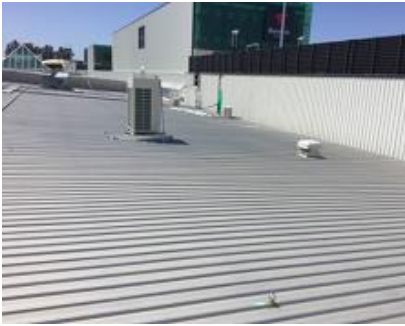
No safe access to the A/c units	Trips, Slips and Falls	N/A	Low	Supply walkway to the A/c units	Low	Client advised	Outstanding	-
36	Building: General Stores Location Reference: L21 Task: Access to the roof

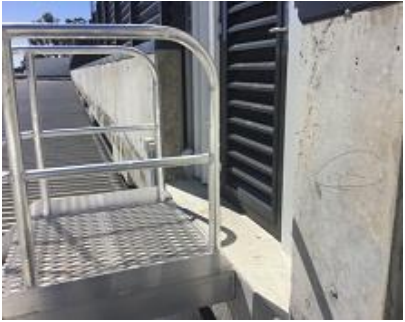
Gap between handrail and permanent structure is greater than required maximum	Trips, Slips and Falls	Awareness induction	Med	Handrail to be extended	Low	Client advised	Outstanding	OH&S REGULATIONS 3.7 AS/NZS 1657-2013 4.4

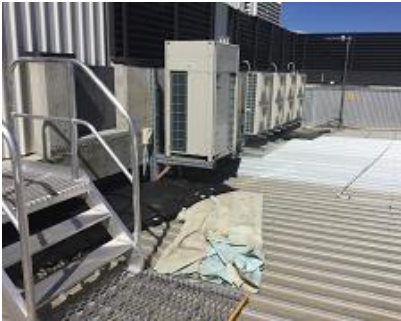
No safe access to the A/c units	Trips, Slips and Falls	N/A	Low	Supply walkway to the A/c units	Low	Client advised	Outstanding	-
38	Building: General Stores Location Reference: L22 Task: Access to the A/c units

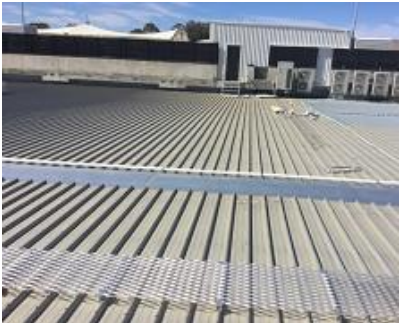
No safe access to the A/c units	Trips, Slips and Falls	N/A	Low	Supply walkway to the A/c units	Low	Client advised	Outstanding	-

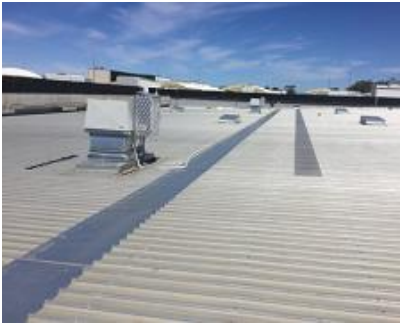
No safe access to the A/c units	Trips, Slips and Falls	N/A	Low	Supply walkway to the A/c units	Low	Client advised	Outstanding	-
40	Building: General Stores Location Reference: L23 Task: Access to the roof

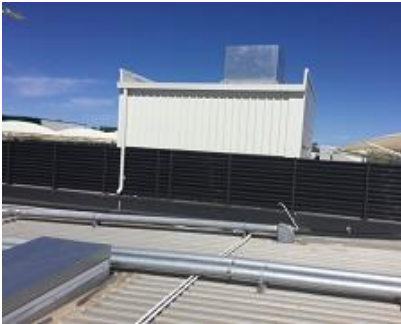
No height safety system installed	Trips, Slips and Falls	Awareness induction	High	Ladder access bracket, ladder support platform, anchor strop and fall arrest anchors to be installed	Low	Client advised	Outstanding	OH&S REGULATIONS 3.55

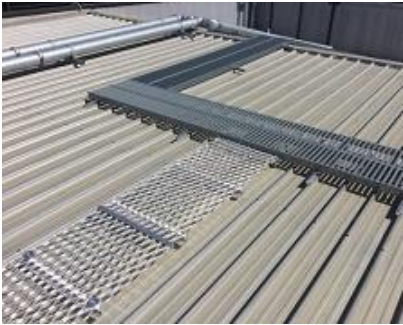
Variation in height between walkway panels are greater than required maximum	Trips, Slips and Falls	Awareness induction	Med	High visibility safety yellow nosing's to be installed	Low	Client advised	Outstanding	OH&S REGULATIONS 3.7 AS/NZS 1657-2013 3.3.4
42	Building: General Stores Location Reference: L24 Task: Access to the roof

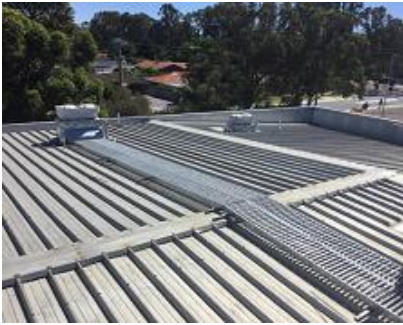
No safe access to the A/c units	Trips, Slips and Falls	N/A	Low	Supply walkway to the A/c units	Low	Client advised	Outstanding	-
44	Building: General Stores Location Reference: L26 Task: Access to the A/c units

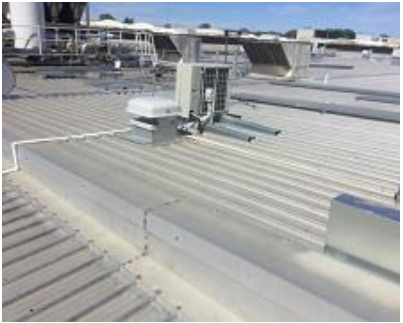
No safe access to the A/c units	Trips, Slips and Falls	N/A	Low	Supply walkway to the A/c units	Low	Client advised	Outstanding	-

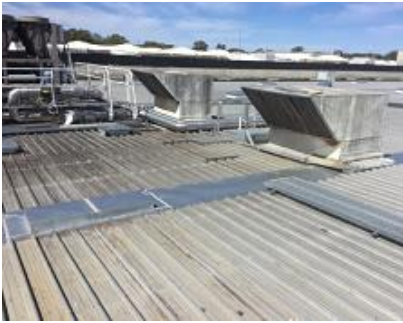
No safe access to the A/c units	Trips, Slips and Falls	N/A	Low	Supply walkway to the A/c units	Low	Client advised	Outstanding	-
46	Building: General Stores Location Reference: L27 Task: Access to the plant deck

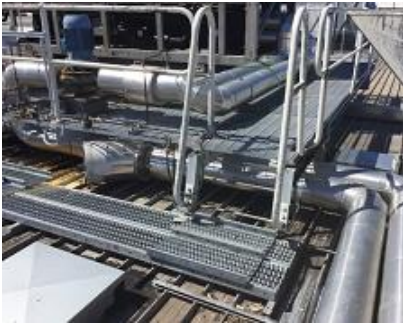
Bottom rung height is less than required minimum and no slip resistance on ladder rungs	Trips, Slips and Falls	Awareness induction	Med	Existing ladder to be removed and new ladder to be installed	Low	Client advised	Outstanding	OH&S REGULATIONS 3.7 AS/NZS 1657-2013 7.4.3.4 & 7.4.3.1

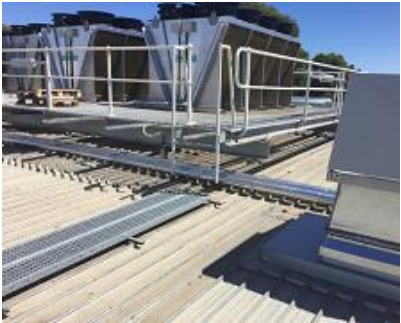
Bottom rung height is less than required minimum and no slip resistance on ladder rungs	Trips, Slips and Falls	Awareness induction	Med	Existing ladder to be removed and new ladder to be installed	Low	Client advised	Outstanding	OH&S REGULATIONS 3.7 AS/NZS 1657-2013 7.4.3.4 & 7.4.3.1
48	Building: General Stores Location Reference: L27 Task: Access to the roof

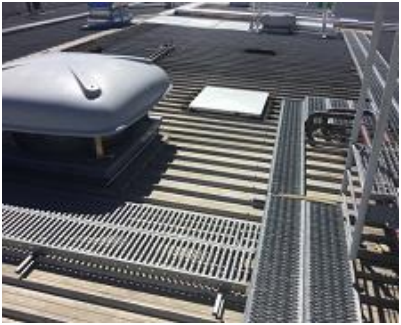
Walkway width is less than required minimum	Trips, Slips and Falls	Awareness induction	Med	Additional walkway sections to be installed	Low	Client advised	Outstanding	OH&S REGULATIONS 3.7 AS/NZS 1657-2013 5.1.3
50	Building: General Stores Location Reference: L28 Task: Access to the A/c units

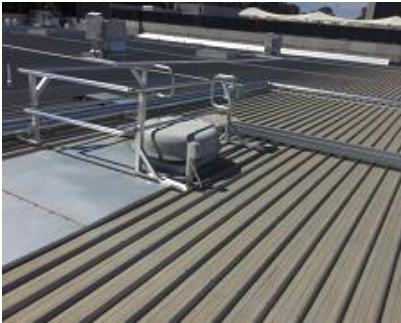
No safe access to the A/c units	Trips, Slips and Falls	N/A	Low	Supply walkway to the A/c units	Low	Client advised	Outstanding	-

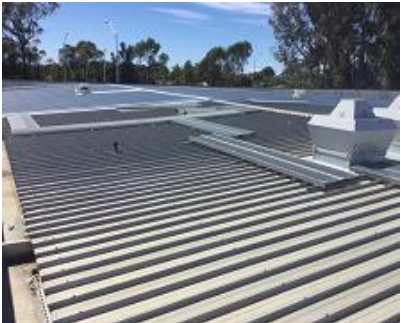
No safe access to the A/c units	Trips, Slips and Falls	N/A	Low	Supply walkway to the A/c units	Low	Client advised	Outstanding	-

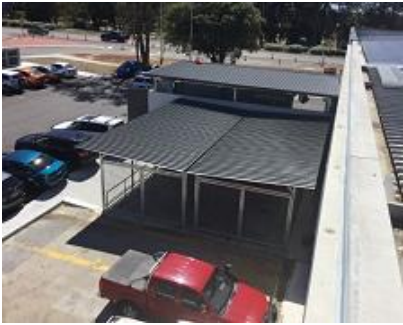
No height safety system installed	Trips, Slips and Falls	Restrict Access	High	"EWP Access Only" signs to be installed	Low	Client advised	Outstanding	OH&S REGULATIONS 3.55 & 3.11
54	Building: General Stores Location Reference: L32 Task: Access to the A/c units

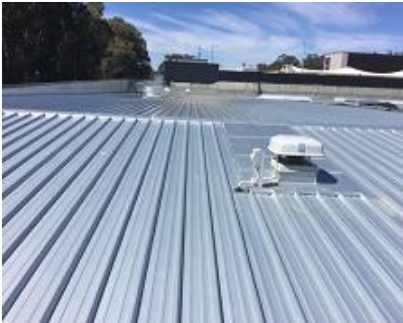
No safe access to the A/c units	Trips, Slips and Falls	N/A	Low	Supply walkway to the A/c units	Low	Client advised	Outstanding	-

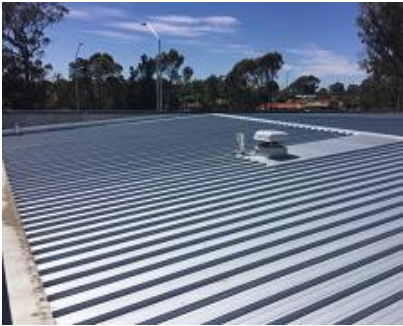
No height safety system installed	Trips, Slips and Falls	Awareness induction	High	Fall arrest anchors to be installed	Low	Client advised	Outstanding	OH&S REGULATIONS 3.55
56	Building: General Stores Location Reference: L33 Task: Access to the A/c units

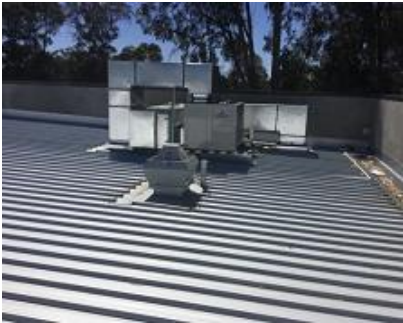
No safe access to the A/c units	Trips, Slips and Falls	N/A	Low	Supply walkway to the A/c units	Low	Client advised	Outstanding	-

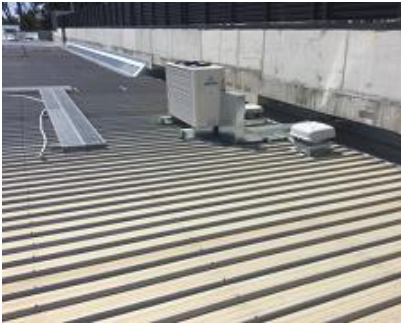
No safe access to the A/c units	Trips, Slips and Falls	N/A	Low	Supply walkway to the A/c units	Low	Client advised	Outstanding	-
60	Building: General Stores Location Reference: L35 Task: Access to the roof
