# Roof Safety Report

Mandurah Forum, WA 6210

Prepared By: Safemaster Safety Products  
Date: 10-09-2020

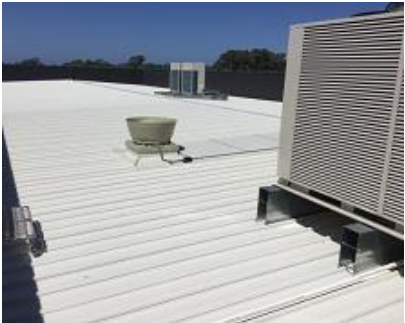
No safe access to the A/c units	Trips, Slips and Falls	N/A	Low	Supply walkway to the A/c units	Low	Client advised	Outsta nding	-
02	Building: General Stores Location Reference: <a href="#">L01</a> Task: Access to the roof

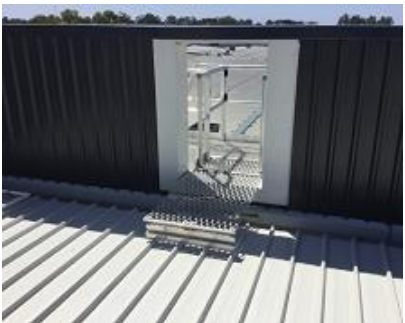
Headroom is less than required minimum	Trips, Slips and Falls	Awareness induction	Med	"Caution-Low Headroom" signs to be installed	Low	Client advised	Outsta nding	OH&S REGULATIONS 3.7  AS1657-2018 3.1.5

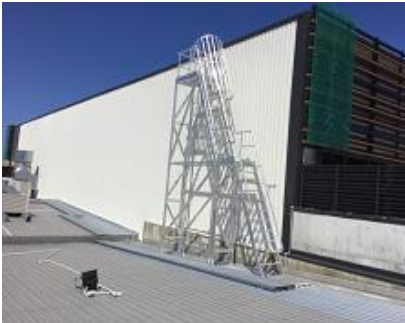
Bottom rung height is greater than required maximum	Trips, Slips and Falls	Awareness induction	Med	Landing platform to be installed	Low	Client advised	Outstanding	OH&S REGULATIONS 3.7  AS1657-2018 7.4.3.4
04	Building: General Stores Location Reference: <a href="#">L01</a> Task: Access to the roof

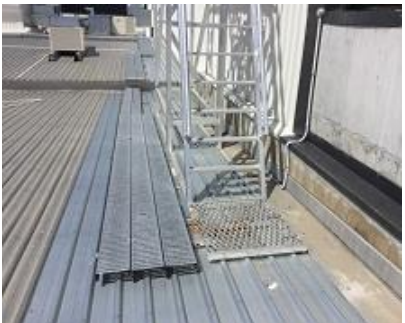
Gap between walkway panels are greater than required maximum	Trips, Slips and Falls	Awareness induction	Med	Additional walkway section including high visibility safety yellow nosing to be installed	Low	Client advised	Outstanding	OH&S REGULATIONS 3.7  AS1657-2018 3.3.4

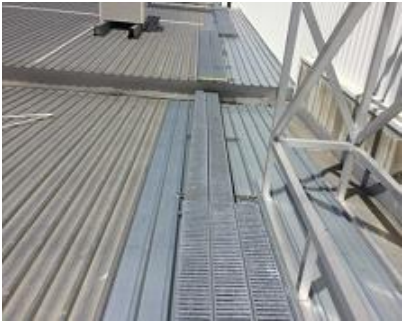
Walkway width is less than required minimum	Trips, Slips and Falls	Awareness induction	Med	Existing walkway to be removed and new walkway to be installed	Low	Client advised	Outstanding	OH&S REGULATIONS 3.7  AS1657-2018 5.1.3
06	Building: General Stores Location Reference: <a href="#">L01</a> Task: Access to the roof

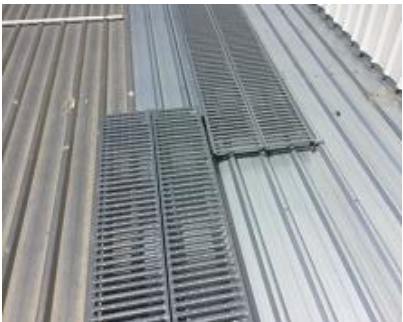
Walkway width is less than required minimum	Trips, Slips and Falls	Awareness induction	Med	Additional walkway section to be installed	Low	Client advised	Outstanding	OH&S REGULATIONS 3.7  AS1657-2018 5.1.3

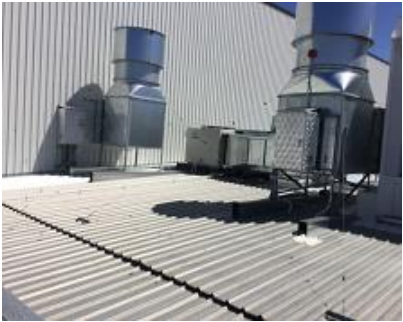
No safe access to the A/c units	Trips, Slips and Falls	N/A	Low	Supply walkway to the A/c units	Low	Client advised	Outsta nding	-

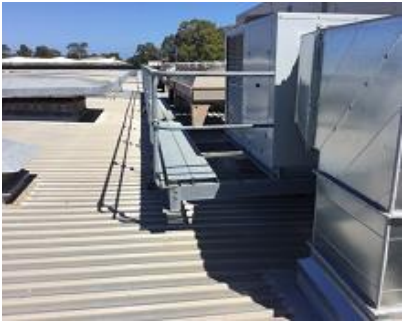
Gap between unit and plant deck is greater than required maximum	Trips, Slips and Falls	Awareness induction	Med	Additional walkway sections to be installed	Low	Client advised	Outstanding	OH&S REGULATIONS 3.7  AS1657-2018 3.2.3.4

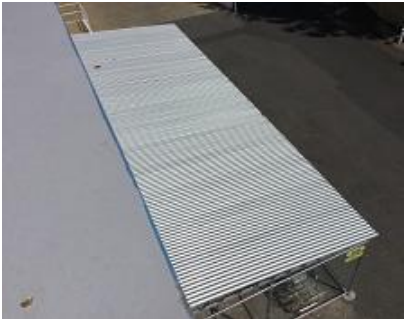
No height safety system installed	Trips, Slips and Falls	Restrict Access	High	"EWP Access Only" sign to be installed	Low	Client advised	Outsta nding	OH&S REGULATIONS 3.55 & 3.11

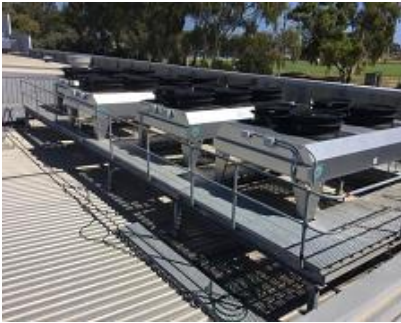
Variation in height between plant deck and unit is greater than required maximum	Trips, Slips and Falls	Awareness induction	Med	Mid rail to be installed	Low	Client advised	Outstanding	OH&S REGULATIONS 3.7  AS1657-2018 6.2.1.2

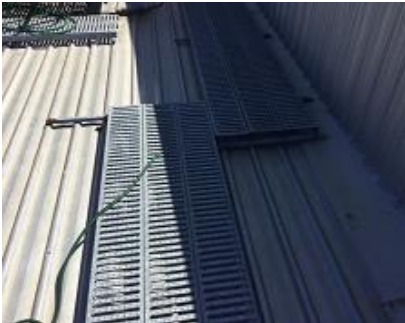
Walkway width is less than required minimum	Trips, Slips and Falls	Awareness induction	Med	Additional walkway section to be installed	Low	Client advised	Outstanding	OH&S REGULATIONS 3.7  AS1657-2018 5.1.3
18	Building: General Stores Location Reference: <a href="#">L09</a> Task: Restrict access to the roof

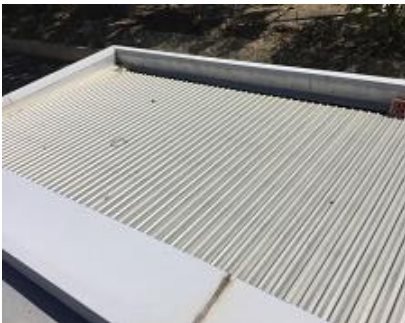
No height safety system installed	Trips, Slips and Falls	Restrict Access	High	"EWP Access Only" sign to be installed	Low	Client advised	Outstanding	OH&S REGULATIONS 3.55 & 3.11

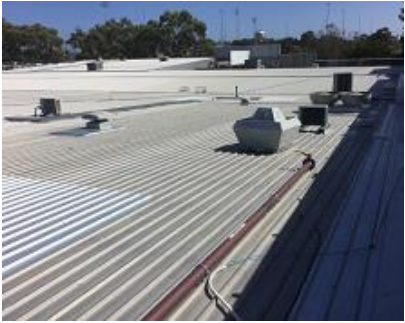
No safe access to the A/c units	Trips, Slips and Falls	N/A	Low	Supply walkway to the A/c units	Low	Client advised	Outstanding	-
22	Building: General Stores Location Reference: <a href="#">L12</a> Task: Access to the A/c units

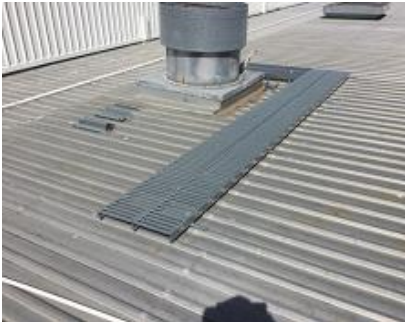
No safe access to the A/c units	Trips, Slips and Falls	N/A	Low	Supply walkway to the A/c units	Low	Client advised	Outstanding	-

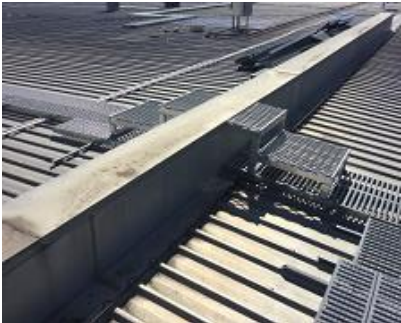
Non-compliant step is present	Trips, Slips and Falls	Awareness induction	Med	Existing step to be removed and new ladder to be installed	Low	Client advised	Outstanding	OH&S REGULATIONS 3.7  AS1657-2018 3.1.4

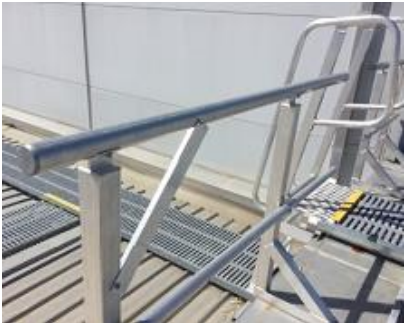
Sharp edges on handrails and not enough post installed	Trips, Slips and Falls	Awareness induction	Med	Tek screws to be replaced with rivets	Low	Client advised	Outstanding	OH&S REGULATIONS 3.7  AS1657-2018 5.6 & 4.4

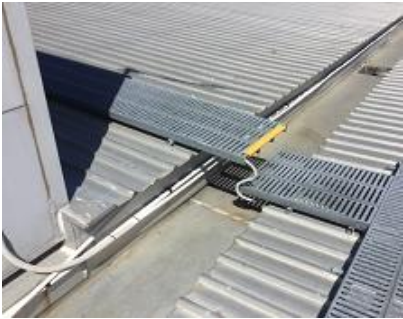
Variation in height between walkway and adjacent surface is greater than require maximum	Trips, Slips and Falls	Awareness induction	Med	Handrail to be installed	Low	Client advised	Outstanding	OH&S REGULATIONS 3.7  AS1657-2018 4.4

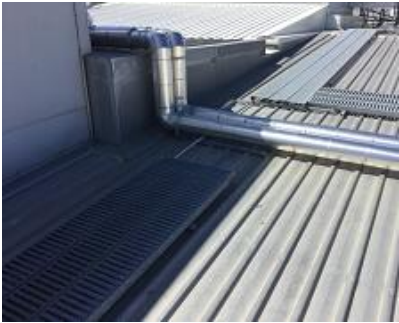
Pipe installed between walkway panels	Trips, Slips and Falls	Awareness induction	Med	Walkway, Step bridge and handrail to be installed	Low	Client advised	Outstanding	OH&S REGULATIONS 3.7  AS1657-2018 3.1.4

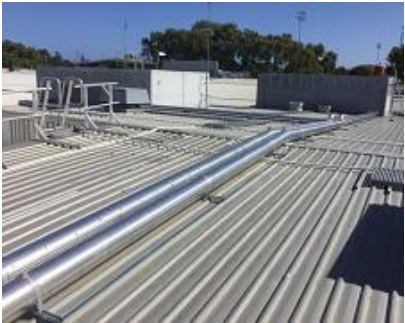
No safe access to the A/c units	Trips, Slips and Falls	N/A	Low	Supply walkway and step bridge to the A/c units	Low	Client advised	Outstanding	-
34	Building: General Stores Location Reference: <a href="#">L19</a> Task: Access to the roof

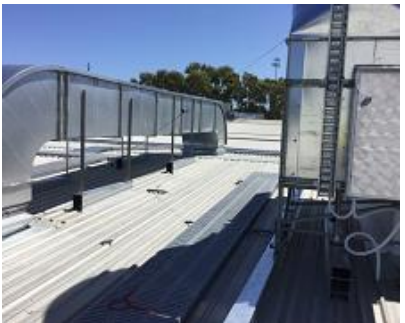
Head room is less than required minimum	Trips, Slips and Falls	Awareness induction	Med	"Caution-Low Headroom" signs to be installed	Low	Client advised	Outstanding	OH&S REGULATIONS 3.7  AS1657-2018 3.1.5

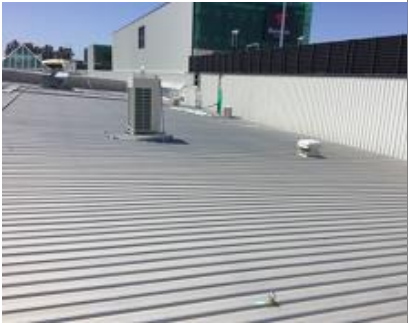
No safe access to the A/c units	Trips, Slips and Falls	N/A	Low	Supply walkway to the A/c units	Low	Client advised	Outsta nding	-

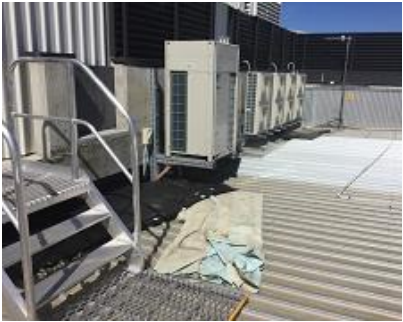
No safe access to the A/c units	Trips, Slips and Falls	N/A	Low	Supply walkway to the A/c units	Low	Client advised	Outstanding	-

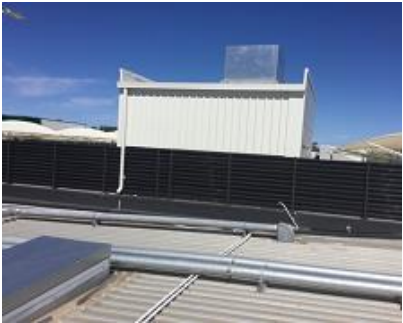
No height safety system installed	Trips, Slips and Falls	Awareness induction	High	Ladder access bracket, ladder support platform, anchor strop and fall arrest anchors to be installed	Low	Client advised	Outsta nding	OH&S REGULATIONS 3.55

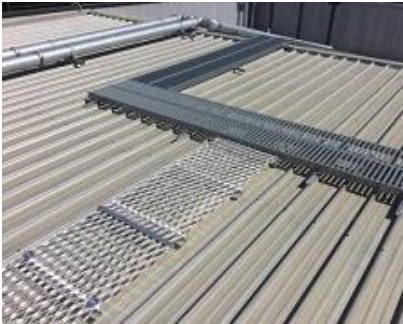
Variation in height between walkway panels are greater than required maximum	Trips, Slips and Falls	Awareness induction	Med	High visibility safety yellow nosing's to be installed	Low	Client advised	Outstanding	OH&S REGULATIONS 3.7  AS1657-2018 3.3.4
42	Building: General Stores Location Reference: <a href="#">L24</a> Task: Access to the roof

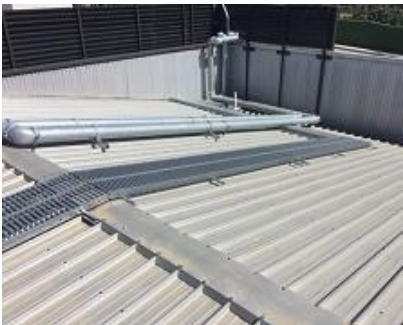
Walkway slope across the walking path is greater than required maximum and pipes in the way	Trips, Slips and Falls	Awareness induction	Med	Levelled walkway including step bridge to be installed	Low	Client advised	Outstanding	OH&S REGULATIONS 3.7  AS1657-2018 5.1.1

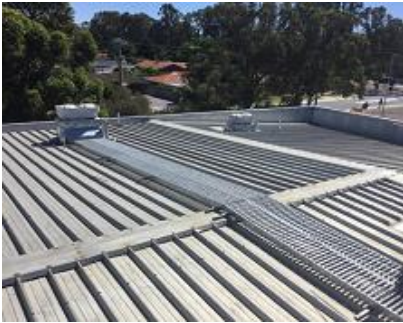
No safe access to the A/c units	Trips, Slips and Falls	N/A	Low	Supply walkway to the A/c units	Low	Client advised	Outstanding	-
44	Building: General Stores Location Reference: <a href="#">L26</a> Task: Access to the A/c units

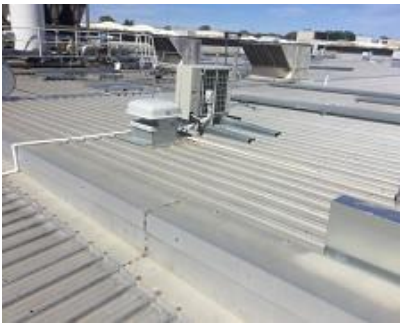
No safe access to the A/c units	Trips, Slips and Falls	N/A	Low	Supply walkway to the A/c units	Low	Client advised	Outstanding	-

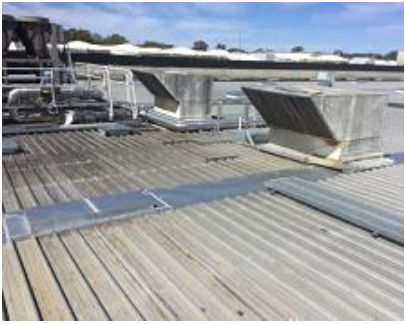
No safe access to the A/c units	Trips, Slips and Falls	N/A	Low	Supply walkway to the A/c units	Low	Client advised	Outsta nding	-
48	Building: General Stores Location Reference: <a href="#">L27</a> Task: Access to the roof

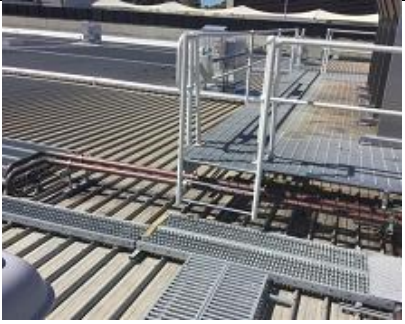
Bottom rung height is less than required minimum and no slip resistance on ladder rungs	Trips, Slips and Falls	Awareness induction	Med	Existing ladder to be removed and new ladder to be installed	Low	Client advised	Outsta nding	OH&S REGULATIONS 3.7  AS1657-2018 7.4.3.4 & 7.4.3.1

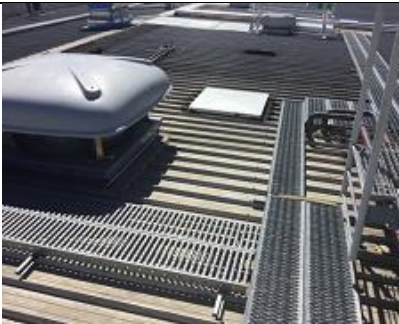
Walkway width is less than required minimum	Trips, Slips and Falls	Awareness induction	Med	Additional walkway sections to be installed	Low	Client advised	Outstanding	OH&S REGULATIONS 3.7  AS1657-2018 5.1.3
50	Building: General Stores Location Reference: <a href="#">L28</a> Task: Access to the A/c units

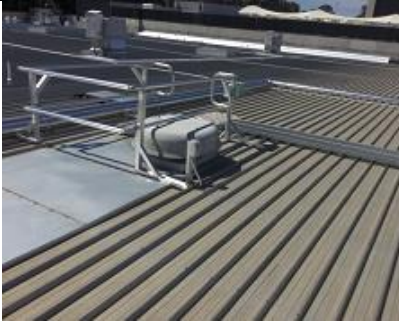
No safe access to the A/c units	Trips, Slips and Falls	N/A	Low	Supply walkway to the A/c units	Low	Client advised	Outstanding	-

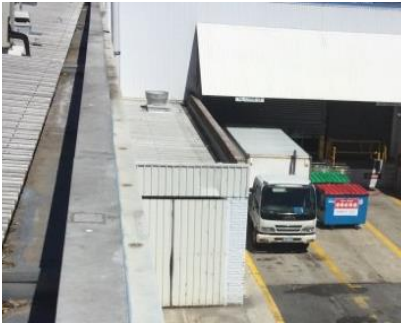
No height safety system installed	Trips, Slips and Falls	Awareness induction	High	Ladder access bracket, sign, anchor strop and fall arrest anchors to be installed	Low	Client advised	Outsta nding	OH&S REGULATIONS 3.55
52	Building: General Stores Location Reference: <a href="#">L30</a> Task: Access to the A/c units

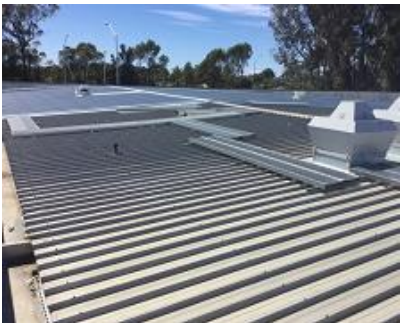
No safe access to the A/c units	Trips, Slips and Falls	N/A	Low	Supply walkway to the A/c units	Low	Client advised	Outsta nding	-

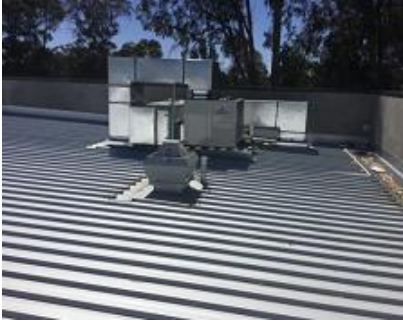
No safe access to the A/c units	Trips, Slips and Falls	N/A	Low	Supply walkway to the A/c units	Low	Client advised	Outsta nding	-
57	Building: General Stores Location Reference: <a href="#">L34</a> Task: Access to the roof

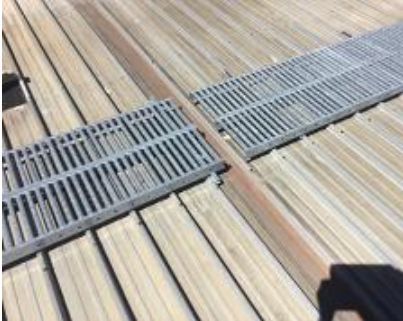
Gap between walkway panels are greater than required maximum	Trips, Slips and Falls	Awareness induction	Med	Step bridge to be installed	Low	Client advised	Outsta nding	OH&S REGULATIONS 3.7  AS1657-2018 3.2.3.4

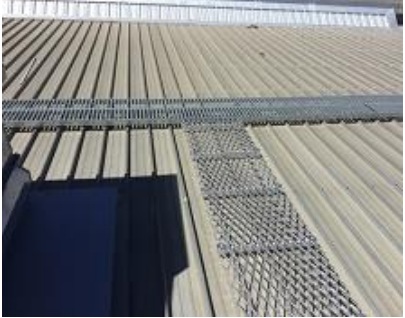
Variation in height between walkway panels are greater than required maximum	Trips, Slips and Falls	Awareness induction	Med	High visibility safety yellow nosing to be installed	Low	Client advised	Outsta nding	OH&S REGULATIONS 3.7  AS1657-2018 3.3.4

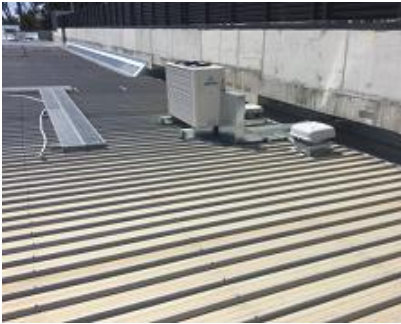
No safe access to the A/c units	Trips, Slips and Falls	N/A	Low	Supply walkway to the A/c units	Low	Client advised	Outstanding	-
60	Building: General Stores Location Reference: <a href="#">L35</a> Task: Access to the roof

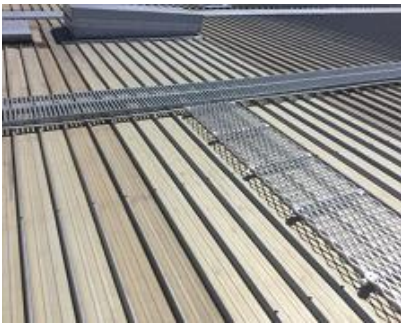
Variation in height between walkway panels are greater than required maximum	Trips, Slips and Falls	Awareness induction	Med	High visibility safety yellow nosing to be installed	Low	Client advised	Outstanding	OH&S REGULATIONS 3.7  AS1657-2018 3.3.4

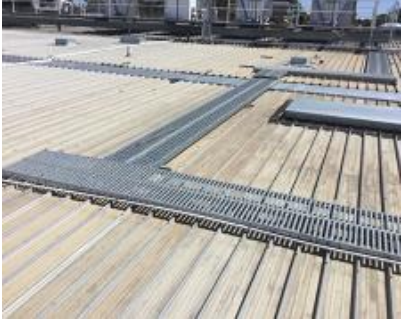
Existing walkway not fully secured	Trips, Slips and Falls	Awareness induction	Med	Existing walkway to be re- installed with additional channels	Low	Client advised	Outstanding	OH&S REGULATIONS 3.7
62	Building: General Stores Location Reference: <a href="#">L36</a> Task: Access to the roof

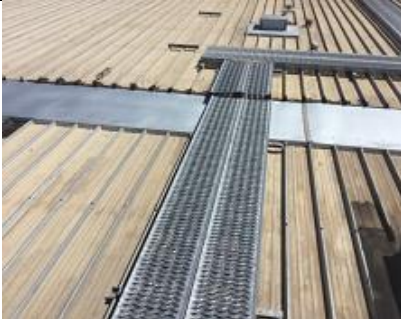
Variation in height between walkway panels are greater than required maximum	Trips, Slips and Falls	Awareness induction	Med	High visibility safety yellow nosing to be installed	Low	Client advised	Outstanding	OH&S REGULATIONS 3.7  AS1657-2018 3.3.4

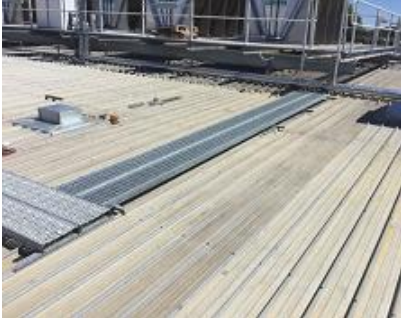
Existing walkway not fully secured	Trips, Slips and Falls	Awareness induction	Med	Existing walkway to be re- installed with additional channels	Low	Client advised	Outsta nding	OH&S REGULATIONS 3.7

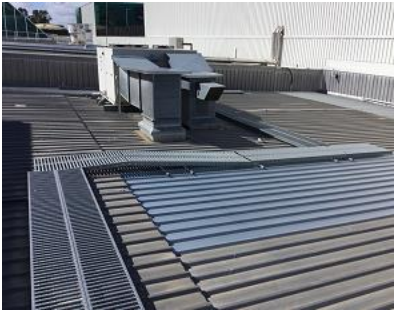
Walkway is damaged	Trips, Slips and Falls	Awareness induction	Med	Damaged walkway to be replaced	Low	Client advised	Outsta nding	OH&S REGULATIONS 3.7  AS/NZS 1657- 2018 3.3.4
65	Building: General Stores Location Reference: <a href="#">L18</a> Task: Access to the roof

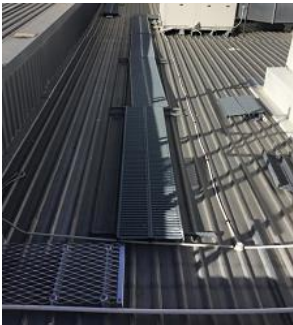
Walkway is damaged	Trips, Slips and Falls	Awareness induction	Med	Damaged walkway to be replaced	Low	Client advised	Outsta nding	OH&S REGULATIONS 3.7  AS/NZS 1657- 2018 3.3.4

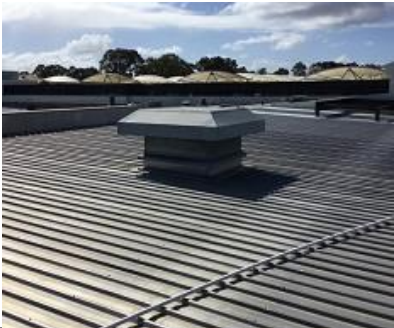
No safe access to the A/c unit	Trips, Slips and Falls	Awareness induction	Low	Supply walkway to the A/c units	Low	Client advised	Outstanding	-
67	Building: General Stores Location Reference: <a href="#">L24</a> Task: Access to the roof

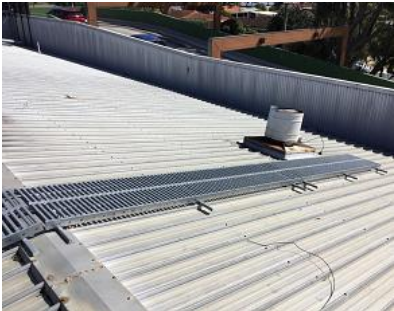
Cleats are missing for 4x sloping walkway section	Trips, Slips and Falls	Awareness induction	Med	Cleats to 4x existing walkway sections to be installed	Low	Client advised	Outstanding	OH&S REGULATIONS 3.7 AS1657-2018 5.1.1

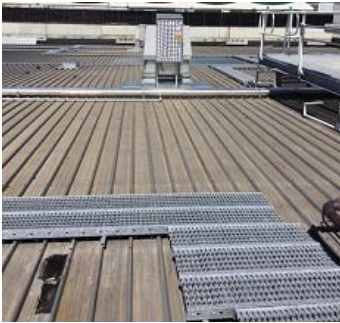
No safe access to the A/c unit	Trips, Slips and Falls	Awareness induction	Low	Supply walkway to the A/c units	Low	Client advised	Outsta nding	-
69	Building: General Stores Location Reference: <a href="#">L28</a> Task: Access to the A/c unit

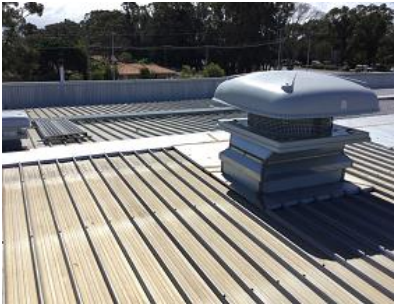
No safe access to the A/c unit	Trips, Slips and Falls	Awareness induction	Low	Supply walkway to the A/c units	Low	Client advised	Outsta nding	-
