# Roof Safety Report

**Mildura Central Shopping  
Centre, VIC 3500**

Prepared By: Safemaster Safety Products  
Date: 10-01-2020

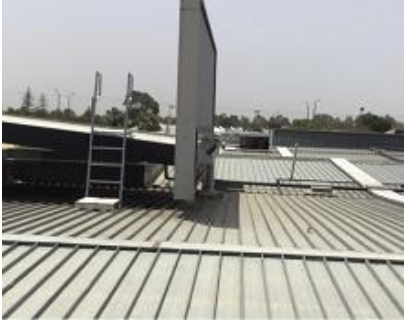
| No | Photo of Hazard | Details of Hazard | Details of Risk | Existing/<br>Immediate<br>Control<br>Measure | Current<br>Risk<br>Level | Proposed Permanent<br>Solution | Residual<br>Risk<br>Assessment | Details of<br>Action<br>Taken | Status | Reference |
|---|--|---|---|--|---|---|---|---|---|---|
| | | No safe access to the ladder | Trips, Slips and Falls | Awareness induction | Low | Supply walkway to the ladder | Low | Client advised | Outstanding | - |

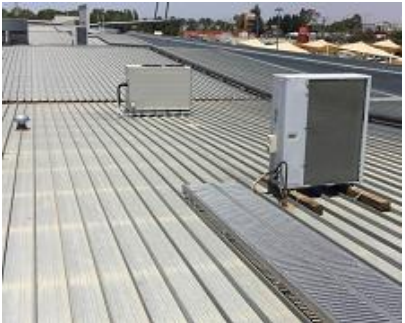
| No | Photo of Hazard | Details of Hazard | Details of Risk | Existing/<br>Immediate<br>Control<br>Measure | Current<br>Risk<br>Level | Proposed Permanent<br>Solution | Residual<br>Risk<br>Assessment | Details of<br>Action<br>Taken | Status | Reference |
|---|--|---|---|--|---|---|---|---|---|---|
| | | No safe access to the A/c units | Trips, Slips and Falls | Awareness induction | Low | Supply walkway to the A/c units | Low | Client advised | Outstanding | - |

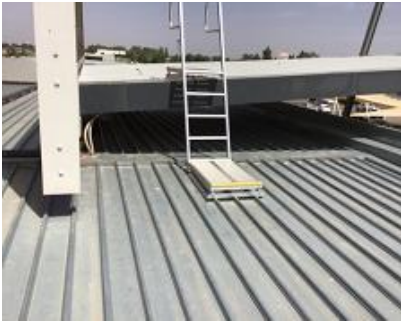
| No | Photo of Hazard | Details of Hazard | Details of Risk | Existing/<br>Immediate<br>Control<br>Measure | Curren<br>t Risk<br>Level | Proposed Permanent<br>Solution | Residu<br>al Risk<br>Assess<br>ment | Details of<br>Action<br>Taken | Status | Reference |
|---|---|---|---|--|---|--|---|---|---|---|
| | | No safe access to the ladder | Trips, Slips and Falls | Awareness induction | Low | Supply walkway and step bridge to the ladder | Low | Client advised | Outstanding | - |

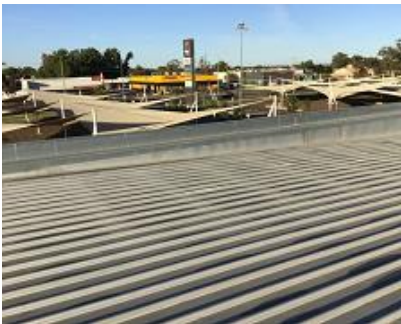
| No | Photo of Hazard | Details of Hazard | Details of Risk | Existing/<br>Immediate<br>Control<br>Measure | Curren<br>t Risk<br>Level | Proposed Permanent<br>Solution | Residu<br>al Risk<br>Assess<br>ment | Details of<br>Action<br>Taken | Status | Reference |
|---|---|---|---|--|---|--|---|---|---|---|
| | | No height safety system installed | Trips, Slips and Falls | Awareness induction | High | Anchors to be installed | Low | Client advised | Outstanding | OH&S REGULATIONS 3.55 |

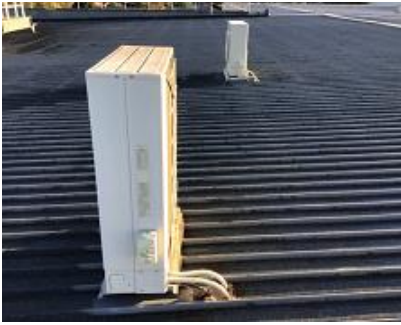
| No | Photo of Hazard | Details of Hazard | Details of Risk | Existing/<br>Immediate<br>Control<br>Measure | Curren<br>t Risk<br>Level | Proposed Permanent<br>Solution | Residu<br>al Risk<br>Assess<br>ment | Details of<br>Action<br>Taken | Status | Reference |
|---|--|---|---|--|---|---|---|---|---|---|
| | | No safe access to the A/c units | Trips, Slips and Falls | Awareness induction | Low | Supply walkway to the A/c units | Low | Client advised | Outstanding | - |
