Roof Safety Report

**The Myer Centre Brisbane,
QLD 4000**

Prepared By: Safemaster Safety Products
Date: 12 March 2019

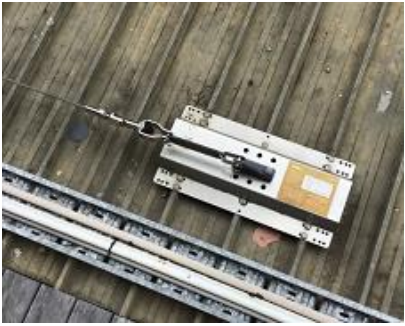
Static line installed incorrectly	Trips, Slips and Falls	Awareness induction	High	Existing static line to be replaced	Low	Client advised	Outstanding	OH&S REGULATIONS 3.55
02	Building: General Stores Location Reference: L02 Task: Access to the roof

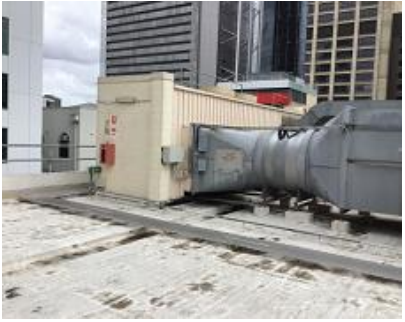
No safe access to the roof and units	Trips, Slips and Falls	Awareness induction	High	Access ladder and handrail on roof to be installed	Low	Client advised	Outstanding	OH&S REGULATIONS 3.7 & 3.55 AS/NZS 1657-2013 3.1.4

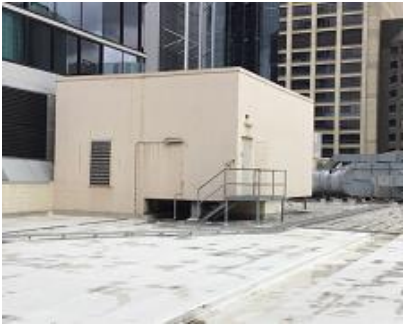
No height safety and safe access system installed	Trips, Slips and Falls	Awareness induction	High	Access ladder, Anchors and strop to be installed	Low	Client advised	Outstanding	OH&S REGULATIONS 3.7 & 3.55 AS/NZS 1657-2013 3.1.4
04	Building: General Stores Location Reference: L05 Task: Access to the roof

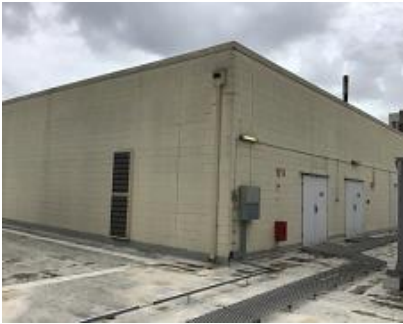
No height safety and safe access system installed	Trips, Slips and Falls	Awareness induction	High	Access ladder, Anchors and strop to be installed	Low	Client advised	Outstanding	OH&S REGULATIONS 3.7 & 3.55 AS/NZS 1657-2013 3.1.4

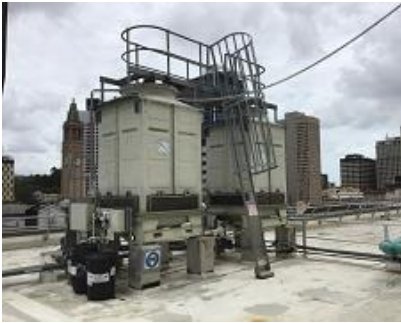
Bottom rung height is greater than required maximum, no slip resistance on ladder rungs and toe board is missing for landing platform at top	Trips, Slips and Falls	Awareness induction	Med	Landing platform at base, non-clip rung caps and toe board to be installed	Low	Client advised	Outstanding	OH&S REGULATIONS 3.7 AS/NZS 1657-2013 7.4.3.4, 7.4.3.1 & 4.6
06	Building: General Stores Location Reference: L06 Task: Access to the roof

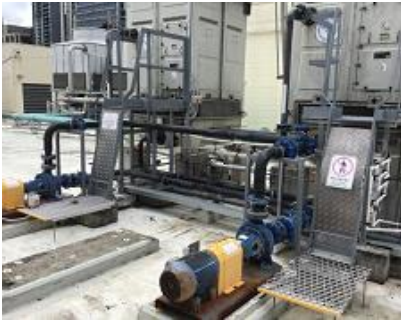
No slip resistance on (x2) ladder rungs	Trips, Slips and Falls	Awareness induction	Med	Non-slip rung caps to existing ladders (x2) to be installed	Low	Client advised	Outstanding	OH&S REGULATIONS 3.7 AS/NZS 1657-2013 7.4.3.1

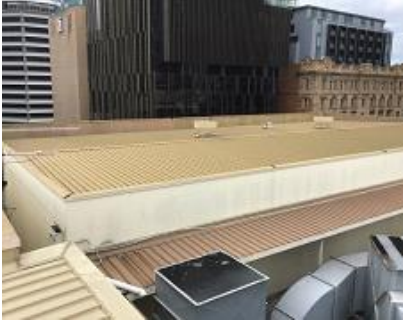
No height safety and safe access system installed	Trips, Slips and Falls	Awareness induction	High	Access ladder, Anchors and strop to be installed	Low	Client advised	Outstanding	OH&S REGULATIONS 3.7 & 3.55 AS/NZS 1657-2013 3.1.4
08	Building: General Stores Location Reference: L11 Task: Access to the roof

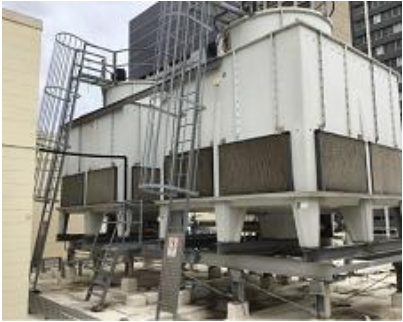
No slip resistance on (x2) ladder rungs	Trips, Slips and Falls	Awareness induction	Med	Non-slip rung caps to existing ladders (x2) to be installed	Low	Client advised	Outstanding	OH&S REGULATIONS 3.7 AS/NZS 1657-2013 7.4.3.1

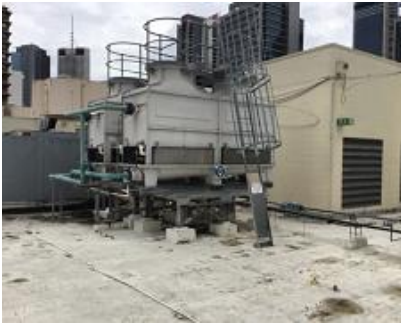
Bottom rung height is greater than required maximum and no slip resistance on ladder rungs	Trips, Slips and Falls	Awareness induction	Med	Landing platform at base and non-slip rung caps to be installed	Low	Client advised	Outstanding	OH&S REGULATIONS 3.7 AS/NZS 1657-2013 7.4.3.4 & 7.4.3.1
10	Building: General Stores Location Reference: L13 Task: Access to the roof

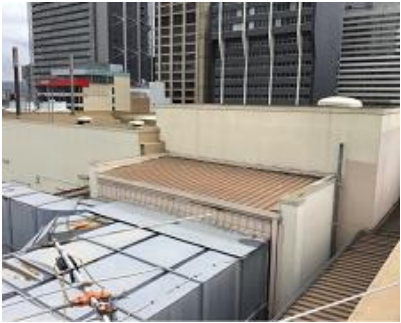
No height safety and safe access system installed	Trips, Slips and Falls	Awareness induction	High	Access ladders (x3), Anchors and strops to be installed	Low	Client advised	Outstanding	OH&S REGULATIONS 3.7 & 3.55 AS/NZS 1657-2013 3.1.4

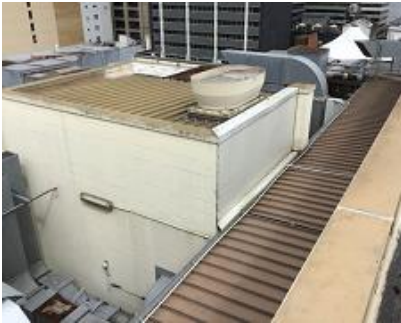
No height safety and safe access system installed	Trips, Slips and Falls	Awareness induction	High	Access ladders (x2), Handrails, Anchors and strops to be installed	Low	Client advised	Outstanding	OH&S REGULATIONS 3.7 & 3.55 AS/NZS 1657-2013 3.1.4
12	Building: General Stores Location Reference: L17 Task: Access to the roof

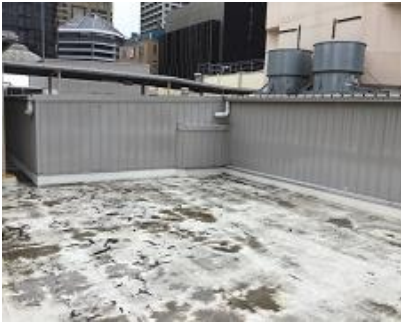
Variation in height between roofs are greater than required maximum	Trips, Slips and Falls	Awareness induction	Med	Access ladder to be installed	Low	Client advised	Outstanding	OH&S REGULATIONS 3.7 AS/NZS 1657-2013 3.1.4

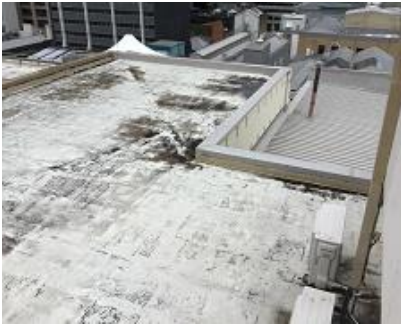
Variation in height between roofs are greater than required maximum	Trips, Slips and Falls	Awareness induction	Med	Access ladder to be installed	Low	Client advised	Outstanding	OH&S REGULATIONS 3.7 AS/NZS 1657-2013 3.1.4
14	Building: General Stores Location Reference: L18 Task: Access to the roof

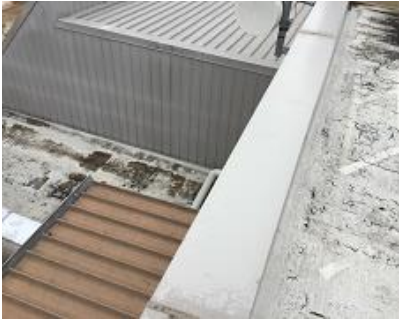
No height safety system installed	Trips, Slips and Falls	Awareness induction	High	Fall arrest anchors to be installed	Low	Client advised	Outstanding	OH&S REGULATIONS 3.55

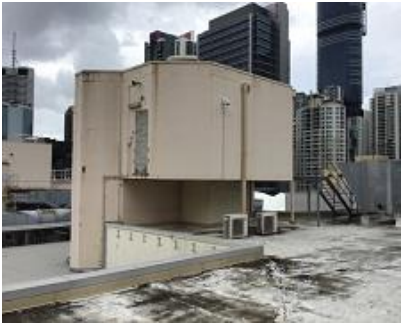
No height safety and safe access system installed	Trips, Slips and Falls	Awareness induction	High	Caged access ladder, Anchors and Strops to be installed	Low	Client advised	Outstanding	OH&S REGULATIONS 3.7 & 3.55 AS/NZS 1657-2013 3.1.4
16	Building: General Stores Location Reference: L19 Task: Access to the roof

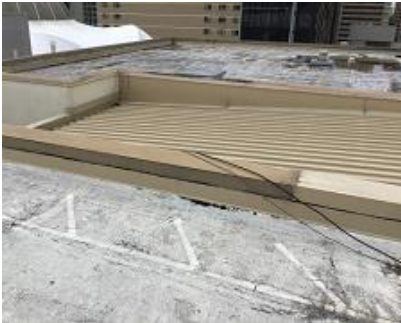
Variation in height between roof levels are greater than required maximum	Trips, Slips and Falls	Awareness induction	Med	Access ladders (x2) to be installed	Low	Client advised	Outstanding	OH&S REGULATIONS 3.7 AS/NZS 1657-2013 3.1.4

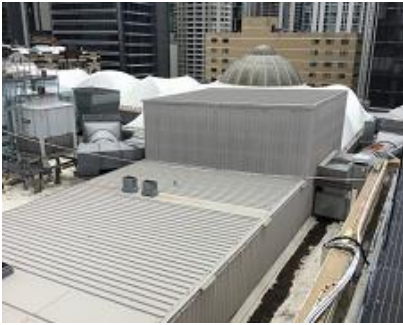
No height safety system installed	Trips, Slips and Falls	Awareness induction	High	Fall arrest anchors to be installed	Low	Client advised	Outstanding	OH&S REGULATIONS 3.55
18	Building: General Stores Location Reference: L20 Task: Access to the roof

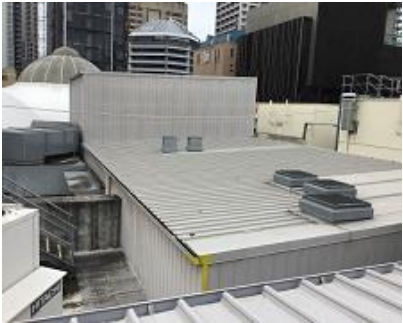
Variation in height between roof levels are greater than required maximum	Trips, Slips and Falls	Awareness induction	Med	Access ladders (x2) to be installed	Low	Client advised	Outstanding	OH&S REGULATIONS 3.7 AS/NZS 1657-2013 3.1.4

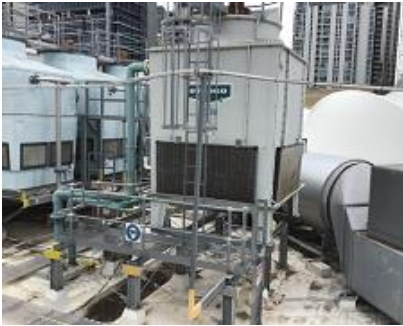
No slip resistance on (x2) ladder rungs	Trips, Slips and Falls	Awareness induction	Med	Non-slip rung caps to existing ladders (x2) to be installed	Low	Client advised	Outstanding	OH&S REGULATIONS 3.7 AS/NZS 1657-2013 7.4.3.1
20	Building: General Stores Location Reference: L24 Task: Access to the roof

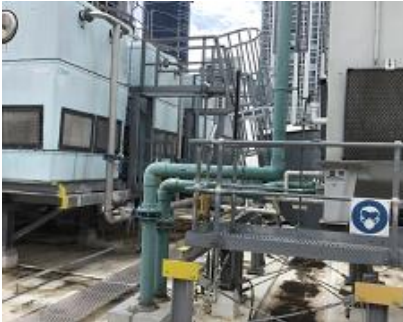
No slip resistance on (x4) ladder rungs	Trips, Slips and Falls	Awareness induction	Med	Non-slip rung caps to existing ladders (x4) to be installed	Low	Client advised	Outstanding	OH&S REGULATIONS 3.7 AS/NZS 1657-2013 7.4.3.1

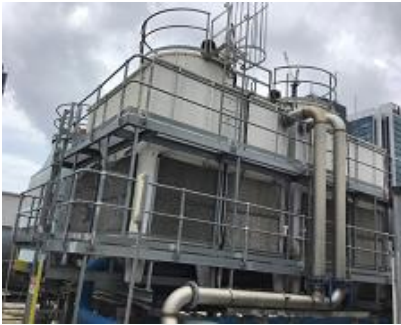
No slip resistance on (x3) ladder rungs and cage is missing for middle level ladder	Trips, Slips and Falls	Awareness induction	Med	Non-slip rung caps to existing ladders (x3) and cage to middle level ladder to be installed	Low	Client advised	Outstanding	OH&S REGULATIONS 3.7 AS/NZS 1657-2013 7.4.3.1 & 7.4.7
22	Building: General Stores Location Reference: L26 Task: Access to the roof

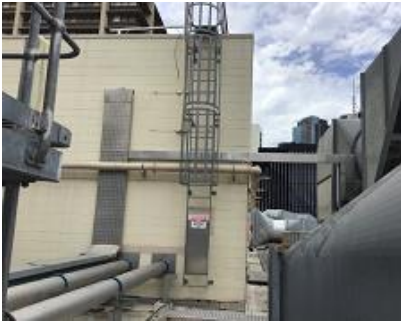
Bottom rung height is greater than required maximum and no slip resistance on ladder rungs	Trips, Slips and Falls	Awareness induction	Med	Landing platform including handrails, step and non-slip rung caps to be installed	Low	Client advised	Outstanding	OH&S REGULATIONS 3.7 AS/NZS 1657-2013 7.4.3.4 & 7.4.3.1

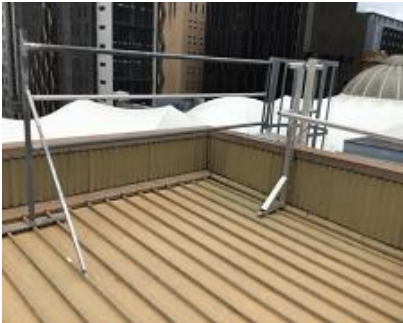
Return ladder is missing	Trips, Slips and Falls	Awareness induction	Med	Return ladder including landing platform to be installed	Low	Client advised	Outsta nding	OH&S REGULATIONS 3.7 AS/NZS 1657- 2013 3.1.4
