# Roof Safety Report

**Northgate, TAS 7010**

Prepared By: Safemaster Safety Products  
Date: 14 March 2018

CLIENT	BUILDINGS INSPECTED	SYSTEMS INSPECTED
Northgate Shopping Centre	387-393 Main Road, Glenorchy TAS 7010	Anchor Points Signage Handrail Ladder Stair Mechanical Platform Roof Walkway

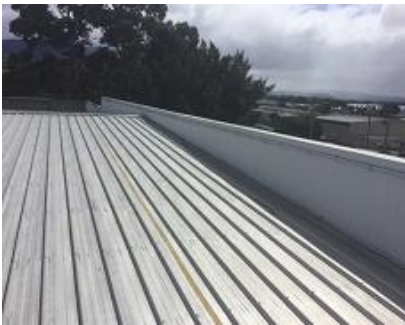
No height safety system installed	Trips, Slips and Falls	Awareness induction	High	Fall arrest anchors to be installed	Low	Client advised	Outstanding	OH&S REGULATIONS 3.55

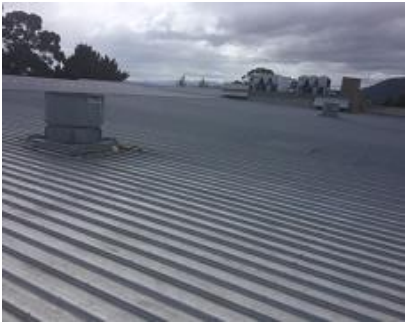
No safe access to the A/c units	Trips, Slips and Falls	N/A	Low	Supply walkway to the A/c units	Low	Client advised	Outstanding	-

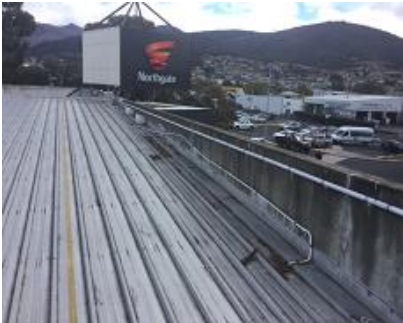
No height safety system installed	Trips, Slips and Falls	Awareness induction	High	Fall arrest anchors to be installed	Low	Client advised	Outstanding	OH&S REGULATIONS 3.55

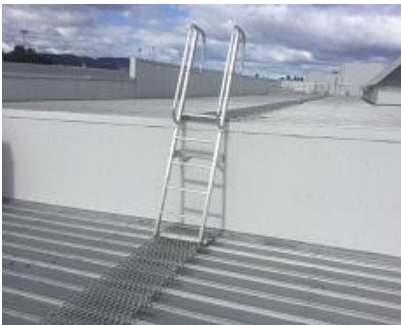
Top rung not levelled with landing, bottom rung height is less than required minimum and handrails projecting towards the user	Trips, Slips and Falls	Awareness induction	Med	Existing handrails to be removed. Existing ladder to be re-installed with new brackets, landing platforms and preformed handrails	Low	Client advised	Outstanding	OH&S REGULATIONS 3.7  AS/NZS 1657-2013 7.4.3.3, 7.4.3.4 & 7.4.8.5

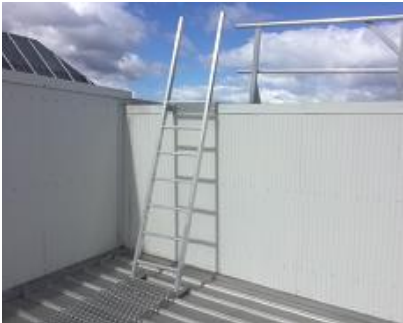
Gap between top rung and landing is greater than required maximum and bottom rung height is less than required minimum	Trips, Slips and Falls	Awareness induction	Med	Existing ladder to be re-installed with landing platforms, brackets and preformed handrails	Low	Client advised	Outstanding	OH&S REGULATIONS 3.7  AS/NZS 1657-2013 7.4.8.4 & 7.4.3.4

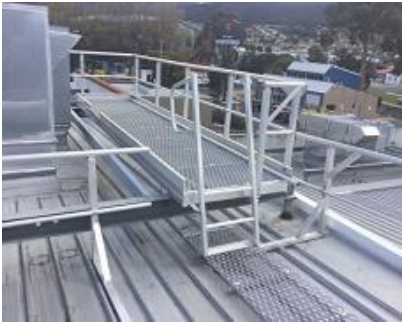
Variation in height between plant deck and roof is greater than required maximum	Trips, Slips and Falls	Awareness induction	Med	Handrail to be installed	Low	Client advised	Outstanding	OH&S REGULATIONS 3.7  AS/NZS 1657-2013 4.4

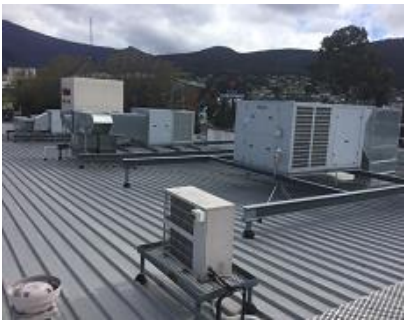
No safe access to the A/c units	Trips, Slips and Falls	Awareness induction	Med	Access ladders, Grating, Handrails and walkway to be installed	Low	Client advised	Outstanding	OH&S REGULATIONS 3.7  AS/NZS 1657-2013 3.1.4

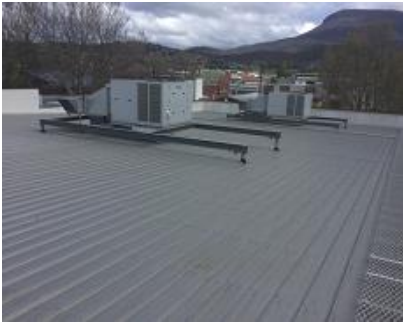
No safe access to the A/c units	Trips, Slips and Falls	Awareness induction	Med	Access ladders, Grating, Handrails and walkway to be installed	Low	Client advised	Outstanding	OH&S REGULATIONS 3.7  AS/NZS 1657-2013 3.1.4

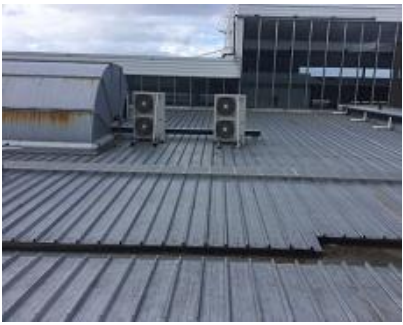
No safe access to the A/c units	Trips, Slips and Falls	N/A	Low	Supply walkway to the A/c units	Low	Client advised	Outstanding	-

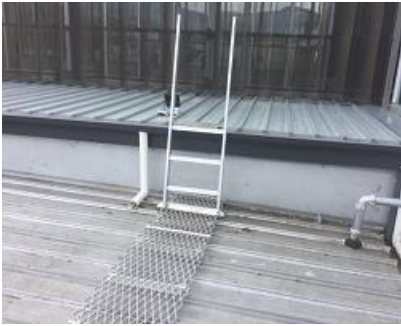
Bottom rung height is less than required minimum and landing is less than required minimum	Trips, Slips and Falls	Awareness induction	Med	Existing ladder to be re-installed with landing platforms, brackets and preformed handrails	Low	Client advised	Outstanding	OH&S REGULATIONS 3.7  AS/NZS 1657-2013 7.4.3.4 & 7.3.6
30	Building: General Stores Location Reference: <a href="#">L22</a> Task: Access to the A/c units

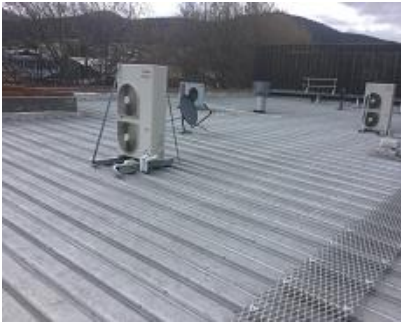
No safe access to the A/c units	Trips, Slips and Falls	N/A	Low	Supply walkway to the A/c units	Low	Client advised	Outstanding	-

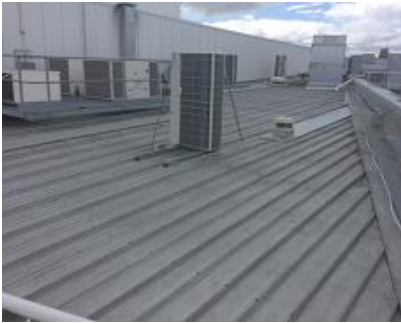
No safe access to the A/c units	Trips, Slips and Falls	N/A	Low	Supply walkway to the A/c units	Low	Client advised	Outstanding	-

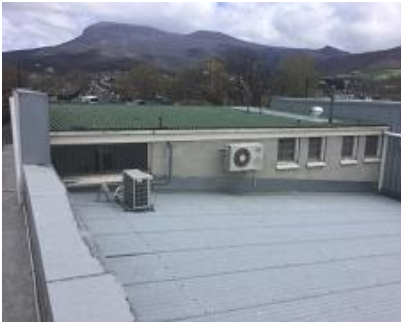
No height safety system installed	Trips, Slips and Falls	Awareness induction	High	Fall arrest anchors to be installed	Low	Client advised	Outstanding	OH&S REGULATIONS 3.55

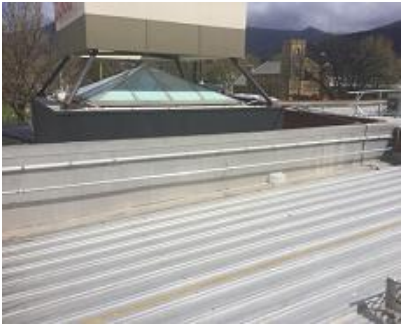
No height safety system installed	Trips, Slips and Falls	Awareness induction	High	Fall arrest anchors to be installed	Low	Client advised	Outstanding	OH&S REGULATIONS 3.55

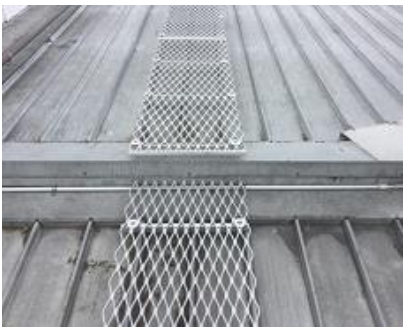
Variation in height between walkway panels are greater than required maximum	Trips, Slips and Falls	Awareness induction	Med	High visibility safety yellow nosing to be installed	Low	Client advised	Outstanding	OH&S REGULATIONS 3.7  AS/NZS 1657-2013 3.3.4
42	Building: General Stores Location Reference: <a href="#">L27</a> Task: Access to the roof

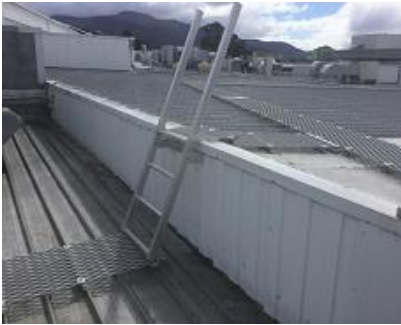
Bottom rung height is less than required minimum, landing is less than required minimum and gap between ladder and permanent structure is less than required minimum	Trips, Slips and Falls	Awareness induction	Med	Existing ladder to be re-installed with landing platforms, brackets and handrails to be installed	Low	Client advised	Outstanding	OH&S REGULATIONS 3.7  AS/NZS 1657-2013 7.4.3.4, 7.3.6 & 7.4.5
46	Building: General Stores Location Reference: <a href="#">L28</a> Task: Access to the roof

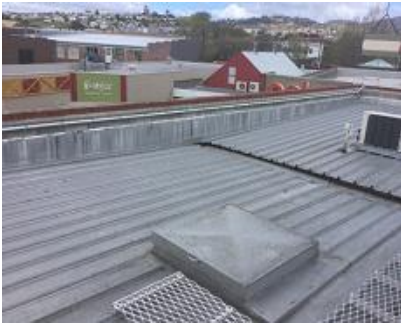
No height safety system installed	Trips, Slips and Falls	Awareness induction	High	Fall arrest anchors to be installed	Low	Client advised	Outstanding	OH&S REGULATIONS 3.55

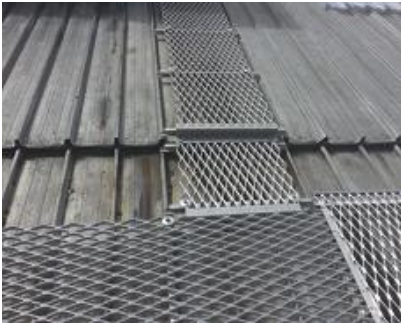
Variation in height between walkway panels are greater than required maximum	Trips, Slips and Falls	Awareness induction	Med	High visibility safety yellow nosing to be installed	Low	Client advised	Outstanding	OH&S REGULATIONS 3.7  AS/NZS 1657-2013 3.3.4

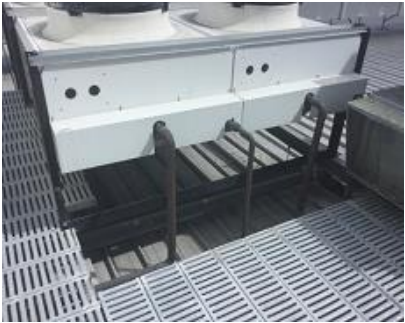
Gap between grating and unit is greater than required maximum	Trips, Slips and Falls	Awareness induction	Med	Gap to be filled	Low	Client advised	Outstanding	OH&S REGULATIONS 3.7  AS/NZS 1657-2013 3.2.3.4

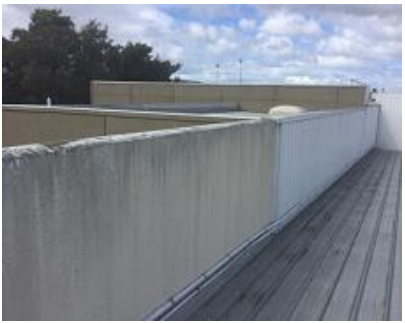
Variation in height between roofs are greater than required maximum	Trips, Slips and Falls	Awareness induction	Med	Access ladder to be installed	Low	Client advised	Outstanding	OH&S REGULATIONS 3.7  AS/NZS 1657-2013 3.1.4

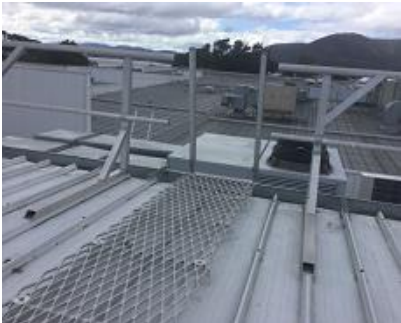
Bottom rung heights are less than required minimum, landing is less than required minimum and gap between ladder and permanent structure is less than required minimum	Trips, Slips and Falls	Awareness induction	Med	Existing ladder to be re-installed with landing platforms, brackets and handrails	Low	Client advised	Outstanding	OH&S REGULATIONS 3.7  AS/NZS 1657-2013 7.4.3.4, 7.3.6 & 7.4.8.4
