# Roof Safety Report

**Northgate, TAS 7010**

Prepared By: Safemaster Safety Products  
Date: 31-08-2020

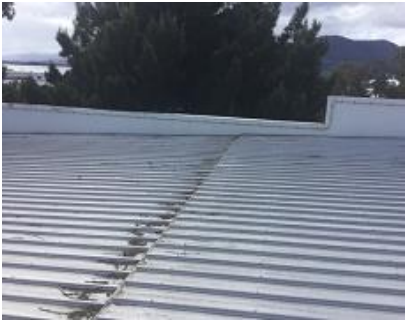
No	Photo of Hazard	Details of Hazard	Details of Risk	Existing/ Immediate Control Measure	Curre nt Risk Level	Proposed Permanent Solution	Resid ual Risk Asse sme nt	Details of Action Taken	Status	Reference
01	Building: General Stores Location Reference: <a href="#">L02</a> Task: Access to the roof

No height safety system installed	Trips, Slips and Falls	Awareness induction	High	Fall arrest anchors to be installed	Low	Client advised	Outstanding	OH&S REGULATIONS 3.55
02	Building: General Stores Location Reference: <a href="#">L02</a> Task: Access to the roof

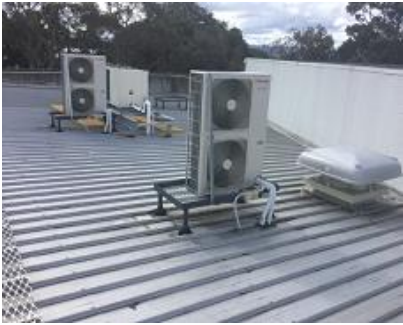
No safe access to the A/c units	Trips, Slips and Falls	N/A	Low	Supply walkway to the A/c units	Low	Client advised	Outstanding	-
06	Building: General Stores Location Reference: <a href="#">L06</a> Task: Access to the roof

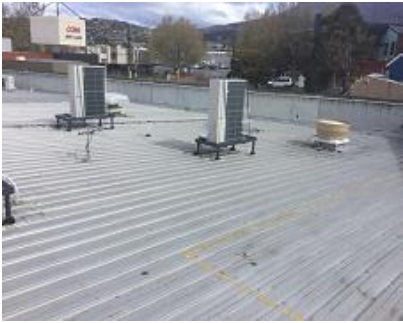
No safe access to the A/c units	Trips, Slips and Falls	N/A	Low	Supply walkway to the A/c units	Low	Client advised	Outstanding	-
08	Building: General Stores Location Reference: <a href="#">L07</a> Task: Access to the A/c units

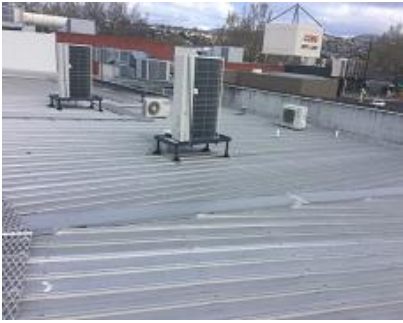
No safe access to the A/c units	Trips, Slips and Falls	N/A	Low	Supply walkway to the A/c units	Low	Client advised	Outstanding	-

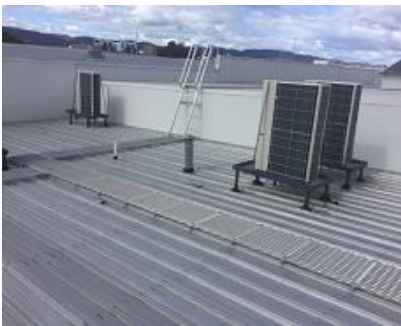
No safe access to the A/c units	Trips, Slips and Falls	N/A	Low	Supply walkway to the A/c units	Low	Client advised	Outstanding	-
10	Building: General Stores Location Reference: <a href="#">L08</a> Task: Access to the roof

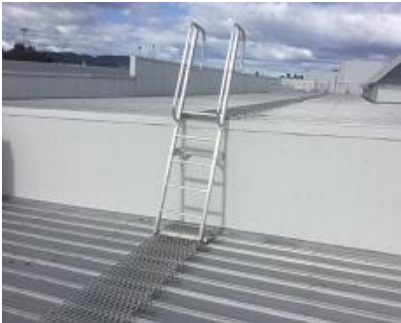
Top rung not levelled with landing, bottom rung height is less than required minimum and handrails projecting towards the user	Trips, Slips and Falls	Awareness induction	Med	Existing handrails to be removed. Existing ladder to be re-installed with new brackets, landing platforms and preformed handrails	Low	Client advised	Outstanding	OH&S REGULATIONS 3.7  AS/NZS 1657-2013 7.4.3.3, 7.4.3.4 & 7.4.8.5

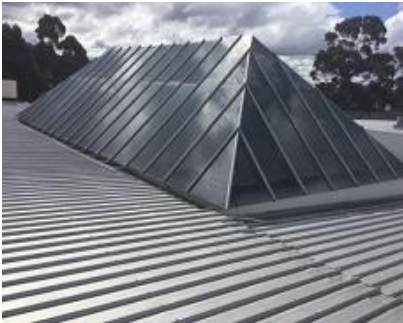
Brittle roof (Non-trafficable roof)	Trips, Slips and Falls	Awareness induction	High	"Warning-Keep Off-Brittle and Fragile Roof" signs to be installed	Low	Client advised	Outstanding	OH&S REGULATIONS 3.57
12	Building: General Stores Location Reference: <a href="#">L10</a> Task: Access to the roof

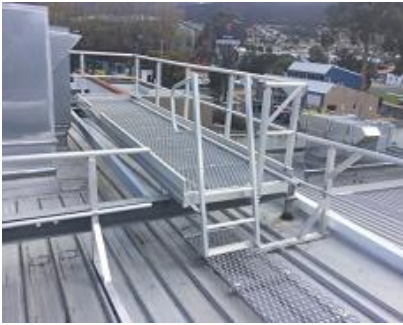
Bottom rung height is less than required minimum	Trips, Slips and Falls	Awareness induction	Med	Existing ladder to be re-installed with landing platform and handrails	Low	Client advised	Outstanding	OH&S REGULATIONS 3.7  AS/NZS 1657-2013 7.4.3.4
14	Building: General Stores Location Reference: <a href="#">L1</a> Task: Access to the plant deck

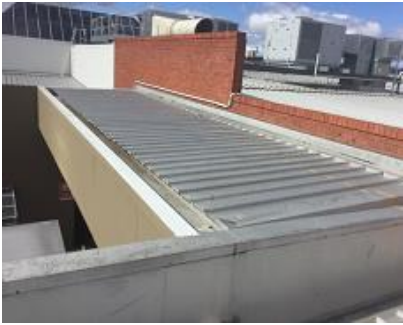
No	Photo of Hazard	Details of Hazard	Details of Risk	Existing/ Immediate Control Measure	Curre nt Risk Level	Proposed Permanent Solution	Resid ual Risk Asse sme nt	Details of Action Taken	Status	Reference
15	Building: General Stores Location Reference: <a href="#">L12</a> Task: Access to the roof

No height safety system installed	Trips, Slips and Falls	Awareness induction	High	Fall arrest anchor to be installed	Low	Client advised	Outstanding	OH&S REGULATIONS 3.55
16	Building: General Stores Location Reference: <a href="#">L12</a> Task: Access to the roof

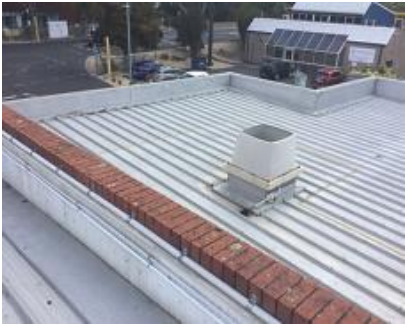
No	Photo of Hazard	Details of Hazard	Details of Risk	Existing/ Immediate Control Measure	Curre nt Risk Level	Proposed Permanent Solution	Resid ual Risk Asse sme nt	Details of Action Taken	Status	Reference
17	Building: General Stores Location Reference: <a href="#">L12</a> Task: Access to the roof

No height safety system installed	Trips, Slips and Falls	Awareness induction	High	Fall arrest anchors to be installed	Low	Client advised	Outstanding	OH&S REGULATIONS 3.55
18	Building: General Stores Location Reference: <a href="#">L13</a> Task: Access to the A/c units

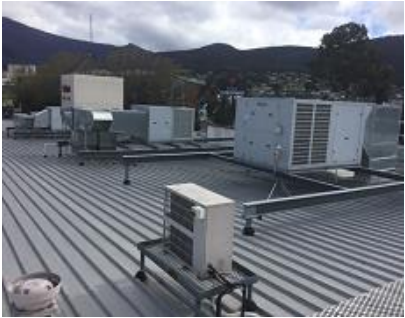
No safe access to the A/c units	Trips, Slips and Falls	Awareness induction	Med	Access ladders, Grating, Handrails and walkway to be installed	Low	Client advised	Outstanding	OH&S REGULATIONS 3.7  AS/NZS 1657-2013 3.1.4

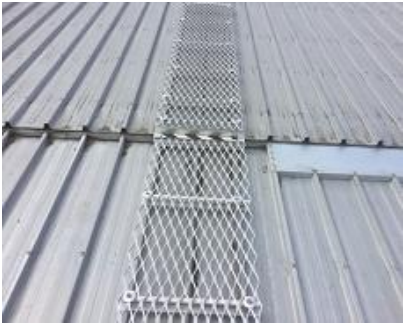
No	Photo of Hazard	Details of Hazard	Details of Risk	Existing/ Immediate Control Measure	Curre nt Risk Level	Proposed Permanent Solution	Resid ual Risk Asse sme nt	Details of Action Taken	Status	Reference
19	Building: General Stores Location Reference: <a href="#">L14</a> Task: Access to the roof

Variation in height between walkway panels are greater than required maximum	Trips, Slips and Falls	Awareness induction	Med	High visibility safety yellow nosing to be installed	Low	Client advised	Outstanding	OH&S REGULATIONS 3.7  AS/NZS 1657-2013 3.3.4
20	Building: General Stores Location Reference: <a href="#">L14</a> Task: Access to the A/c units

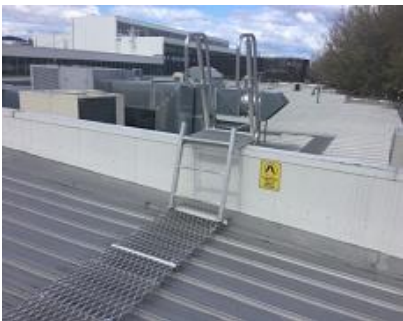
No	Photo of Hazard	Details of Hazard	Details of Risk	Existing/ Immediate Control Measure	Curre nt Risk Level	Proposed Permanent Solution	Resid ual Risk Asse sme nt	Details of Action Taken	Status	Reference
21	Building: General Stores Location Reference: <a href="#">L15</a> Task: Access to the roof

Bottom rung height is less than required minimum and handrails projecting towards the user	Trips, Slips and Falls	Awareness induction	Med	Existing handrails to be removed. Landing platforms and handrails to be installed	Low	Client advised	Outstanding	OH&S REGULATIONS 3.7  AS/NZS 1657-2013 7.4.3.4 & 7.4.8.5
22	Building: General Stores Location Reference: <a href="#">L16</a> Task: Access to the A/c units

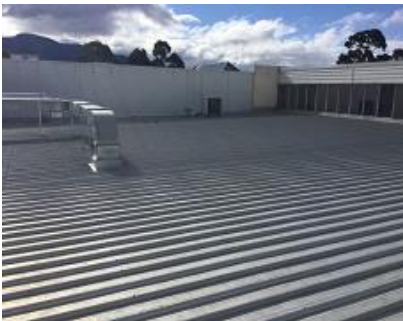
No safe access to the A/c units	Trips, Slips and Falls	N/A	Low	Supply walkway to the A/c units	Low	Client advised	Outstanding	-

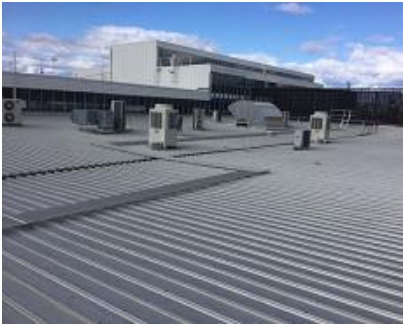
No safe access to the A/c units	Trips, Slips and Falls	N/A	Low	Supply walkway to the A/c units	Low	Client advised	Outstanding	-
24	Building: General Stores Location Reference: <a href="#">L16</a> Task: Access to the A/c units

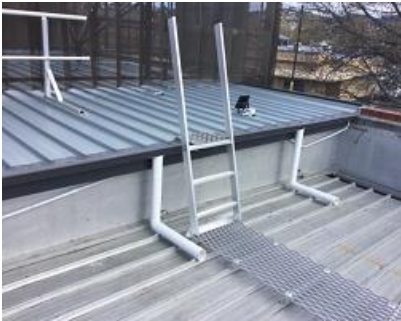
No	Photo of Hazard	Details of Hazard	Details of Risk	Existing/ Immediate Control Measure	Curre nt Risk Level	Proposed Permanent Solution	Resid ual Risk Asse sme nt	Details of Action Taken	Status	Reference
25	Building: General Stores Location Reference: <a href="#">L17</a> Task: Access to the roof

Bottom rung height is less than required minimum and landing is less than required minimum	Trips, Slips and Falls	Awareness induction	Med	Existing ladder to be re-installed with landing platforms and handrails	Low	Client advised	Outstanding	OH&S REGULATIONS 3.7  AS/NZS 1657-2013 7.4.3.4 & 7.3.6
26	Building: General Stores Location Reference: <a href="#">L18</a> Task: Access to the roof

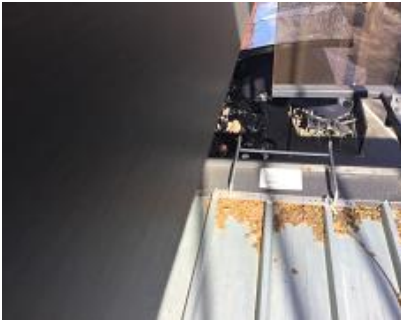
Headroom is less than required minimum	Trips, Slips and Falls	Awareness induction	High	"Warning-Low Head Room" sign to be installed	Low	Client advised	Outstanding	OH&S REGULATIONS 3.7  AS/NZS 1657-2013 3.1.5

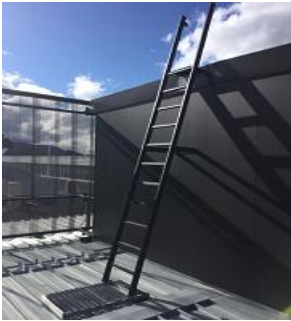
No	Photo of Hazard	Details of Hazard	Details of Risk	Existing/ Immediate Control Measure	Curre nt Risk Level	Proposed Permanent Solution	Resid ual Risk Asse sme nt	Details of Action Taken	Status	Reference
27	Building: General Stores Location Reference: <a href="#">L19</a> Task: Access to the roof

Landing is less than required minimum	Trips, Slips and Falls	Awareness induction	Med	Existing ladder to be re-installed with new landing platforms, brackets, handrails and anchor strop.	Low	Client advised	Outstanding	OH&S REGULATIONS 3.7  AS/NZS 1657-2013 7.3.6
28	Building: General Stores Location Reference: <a href="#">L20</a> Task: Access to the roof

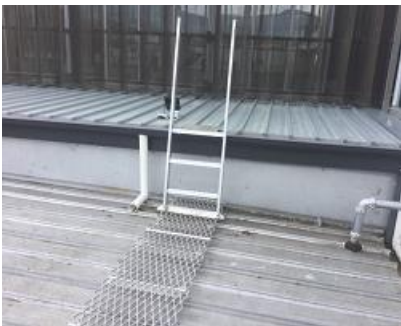
No	Photo of Hazard	Details of Hazard	Details of Risk	Existing/ Immediate Control Measure	Curre nt Risk Level	Proposed Permanent Solution	Resid ual Risk Asse sme nt	Details of Action Taken	Status	Reference
29	Building: General Stores Location Reference: <a href="#">L21</a> Task: Access to the roof

Bottom rung height is less than required minimum and landing is less than required minimum	Trips, Slips and Falls	Awareness induction	Med	Existing ladder to be re-installed with landing platforms, brackets and preformed handrails	Low	Client advised	Outstanding	OH&S REGULATIONS 3.7  AS/NZS 1657-2013 7.4.3.4 & 7.3.6
30	Building: General Stores Location Reference: <a href="#">L22</a> Task: Access to the A/c units

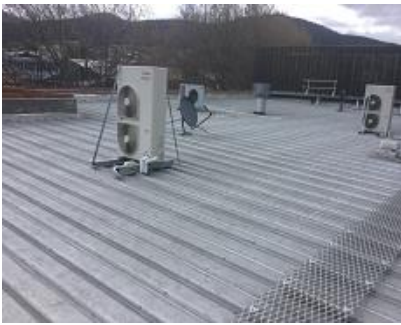
No safe access to the A/c units	Trips, Slips and Falls	N/A	Low	Supply walkway to the A/c units	Low	Client advised	Outstanding	-

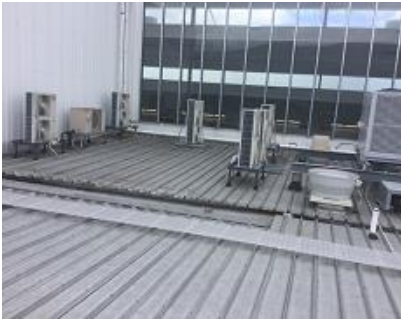
No safe access to the A/c units	Trips, Slips and Falls	N/A	Low	Supply walkway, step over and handrail to the A/c units	Low	Client advised	Outstanding	-
32	Building: General Stores Location Reference: <a href="#">L22</a> Task: Access to the A/c units

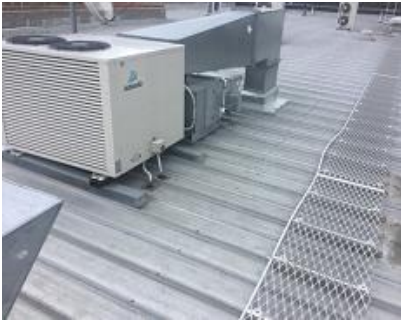
No safe access to the A/c units	Trips, Slips and Falls	N/A	Low	Supply walkway to the A/c units	Low	Client advised	Outstanding	-
34	Building: General Stores Location Reference: <a href="#">L22</a> Task: Access to the A/c units

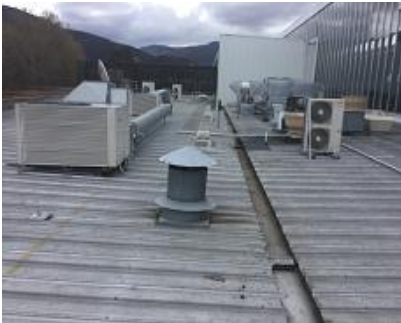
No safe access to the A/c units	Trips, Slips and Falls	N/A	Low	Supply walkway to the A/c units	Low	Client advised	Outstanding	-

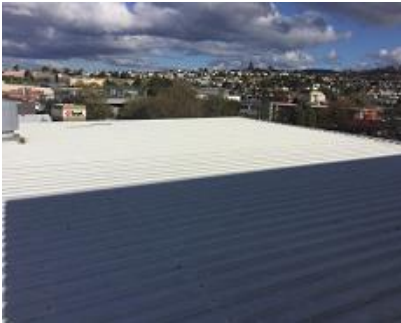
No	Photo of Hazard	Details of Hazard	Details of Risk	Existing/ Immediate Control Measure	Curre nt Risk Level	Proposed Permanent Solution	Resid ual Risk Asse sme nt	Details of Action Taken	Status	Reference
35	Building: General Stores Location Reference: <a href="#">L23</a> Task: Access to the roof

No height safety system installed	Trips, Slips and Falls	Awareness induction	High	Fall arrest anchors to be installed	Low	Client advised	Outstanding	OH&S REGULATIONS 3.55
36	Building: General Stores Location Reference: <a href="#">L24</a> Task: Access to the A/c units

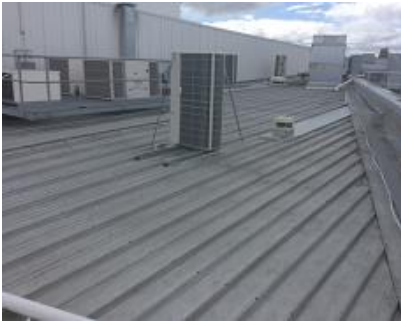
No safe access to the A/c units	Trips, Slips and Falls	N/A	Low	Supply walkway to the A/c units	Low	Client advised	Outstanding	-

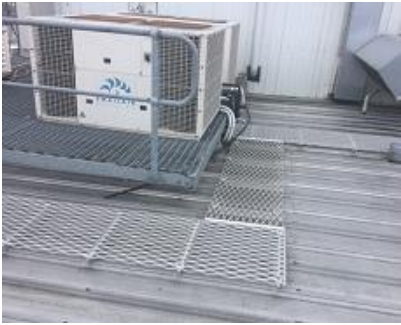
Gap between plant deck and walkway is greater than required maximum	Trips, Slips and Falls	Awareness induction	Med	Additional walkway section to be installed	Low	Client advised	Outstanding	OH&S REGULATIONS 3.7  AS/NZS 1657-2013 3.2.3.4
38	Building: General Stores Location Reference: <a href="#">L25</a> Task: Access to the roof

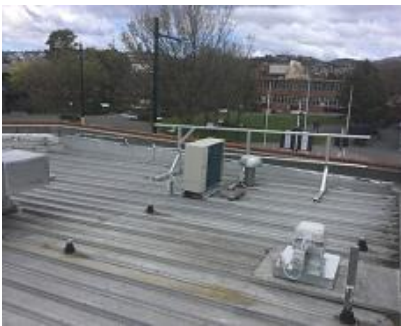
No	Photo of Hazard	Details of Hazard	Details of Risk	Existing/ Immediate Control Measure	Curre nt Risk Level	Proposed Permanent Solution	Resid ual Risk Asse sme nt	Details of Action Taken	Status	Reference
39	Building: General Stores Location Reference: <a href="#">L25</a> Task: Access to the roof

No height safety system installed	Trips, Slips and Falls	Awareness induction	High	Fall arrest anchors to be installed	Low	Client advised	Outstanding	OH&S REGULATIONS 3.55
40	Building: General Stores Location Reference: <a href="#">L26</a> Task: Access to the roof

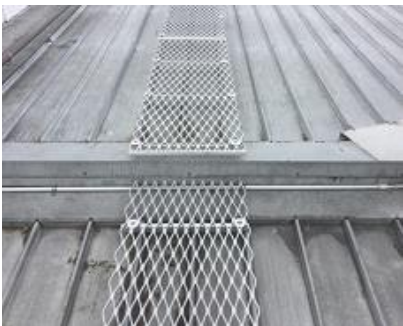
No	Photo of Hazard	Details of Hazard	Details of Risk	Existing/ Immediate Control Measure	Curre nt Risk Level	Proposed Permanent Solution	Resid ual Risk Asse sme nt	Details of Action Taken	Status	Reference
41	Building: General Stores Location Reference: <a href="#">L27</a> Task: Access to the roof

Variation in height between walkway panels are greater than required maximum	Trips, Slips and Falls	Awareness induction	Med	High visibility safety yellow nosing to be installed	Low	Client advised	Outstanding	OH&S REGULATIONS 3.7  AS/NZS 1657-2013 3.3.4
42	Building: General Stores Location Reference: <a href="#">L27</a> Task: Access to the roof

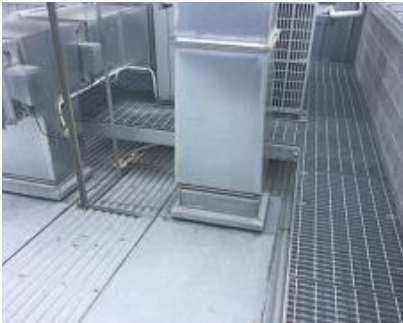
Variation in height between plant deck and roof is greater than required maximum	Trips, Slips and Falls	Awareness induction	Med	Handrails to be installed	Low	Client advised	Outstanding	OH&S REGULATIONS 3.7  AS/NZS 1657-2013 4.4

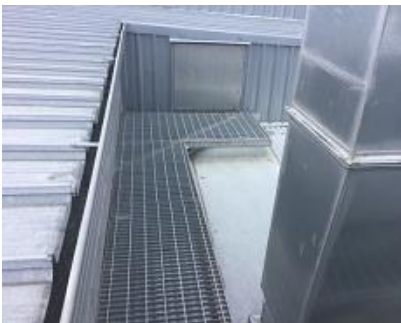
Headroom is less than required minimum	Trips, Slips and Falls	Awareness induction	Med	"Caution-Low Headroom" signs to be installed	Low	Client advised	Outstanding	OH&S REGULATIONS 3.7  AS/NZS 1657-2013 3.1.5
44	Building: General Stores Location Reference: <a href="#">L28</a> Task: Access to the A/c units

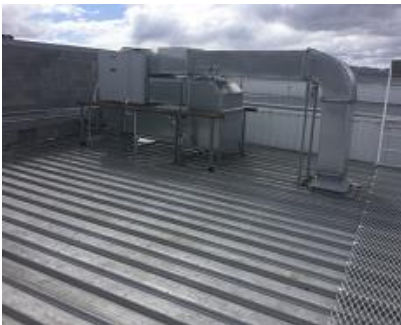
No safe access to the A/c units	Trips, Slips and Falls	N/A	Low	Supply walkway to the A/c units	Low	Client advised	Outstanding	-

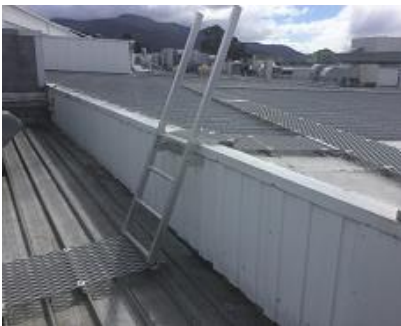
Bottom rung height is less than required minimum, landing is less than required minimum and gap between ladder and permanent structure is less than required minimum	Trips, Slips and Falls	Awareness induction	Med	Existing ladder to be re-installed with landing platforms, brackets and handrails to be installed	Low	Client advised	Outstanding	OH&S REGULATIONS 3.7  AS/NZS 1657-2013 7.4.3.4, 7.3.6 & 7.4.5
46	Building: General Stores Location Reference: <a href="#">L28</a> Task: Access to the roof

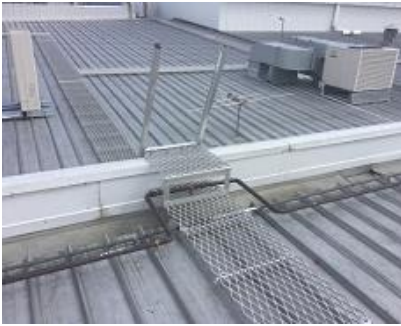
Bottom rung height is less than required minimum and landing is less than required minimum	Trips, Slips and Falls	Awareness induction	Med	Existing ladder to be re-installed with landing platforms, brackets and handrails	Low	Client advised	Outstanding	OH&S REGULATIONS 3.7  AS/NZS 1657-2013 7.4.3.4 & 7.3.6
48	Building: General Stores Location Reference: <a href="#">L30</a> Task: Access to the roof

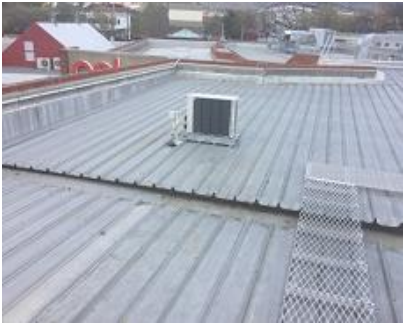
No safe access to the A/c units	Trips, Slips and Falls	N/A	Low	Supply walkway to the A/c units	Low	Client advised	Outstanding	-
50	Building: General Stores Location Reference: <a href="#">L31</a> Task: Access to the A/c units

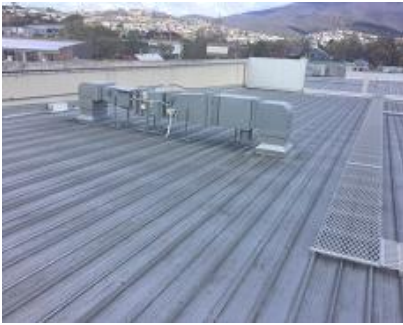
No safe access to the A/c units	Trips, Slips and Falls	N/A	Low	Supply walkway to the A/c units	Low	Client advised	Outstanding	-
52	Building: General Stores Location Reference: <a href="#">L31</a> Task: Access to the A/c units

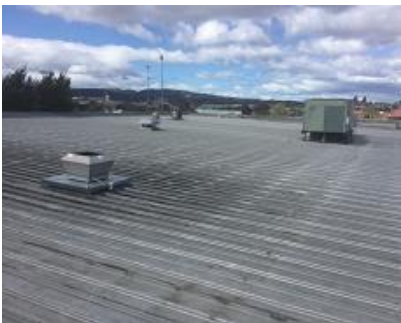
No safe access to the A/c units	Trips, Slips and Falls	N/A	Low	Supply walkway to the A/c units	Low	Client advised	Outstanding	-
54	Building: General Stores Location Reference: <a href="#">L32</a> Task: Access to the roof

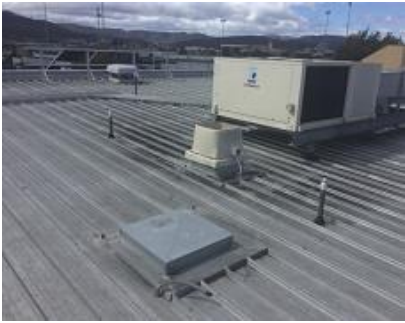
No safe access to the A/c units	Trips, Slips and Falls	N/A	Low	Supply walkway to the A/c units	Low	Client advised	Outstanding	-
56	Building: General Stores Location Reference: <a href="#">L33</a> Task: Access to the plant deck

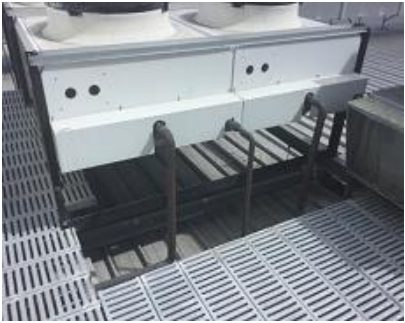
Gap between grating and unit is greater than required maximum	Trips, Slips and Falls	Awareness induction	Med	Gap to be filled	Low	Client advised	Outstanding	OH&S REGULATIONS 3.7  AS/NZS 1657-2013 3.2.3.4

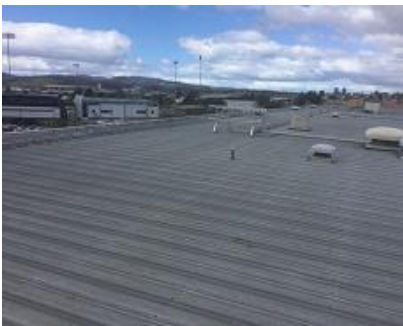
No height safety system installed	Trips, Slips and Falls	Awareness induction	High	Fall arrest anchors to be installed	Low	Client advised	Outstanding	OH&S REGULATIONS 3.55
58	Building: General Stores Location Reference: <a href="#">L34</a> Task: Access to the A/c units

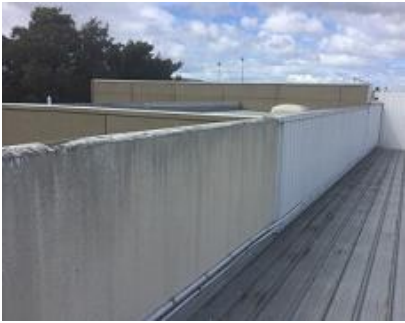
No height safety system installed	Trips, Slips and Falls	Awareness induction	High	Fall arrest anchors to be installed	Low	Client advised	Outstanding	OH&S REGULATIONS 3.55
60	Building: General Stores Location Reference: <a href="#">L35</a> Task: Access to the roof

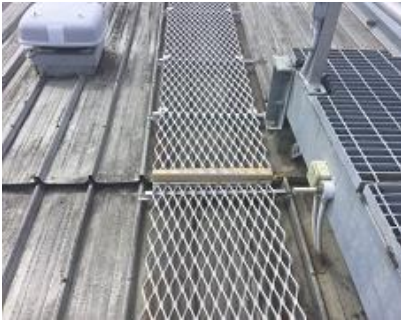
Variation in height between walkway panels are greater than required maximum	Trips, Slips and Falls	Awareness induction	Med	High visibility safety yellow nosing to be installed	Low	Client advised	Outstanding	OH&S REGULATIONS 3.7  AS/NZS 1657-2013 3.3.4
62	Building: General Stores Location Reference: <a href="#">L37</a> Task: Access to the plant deck

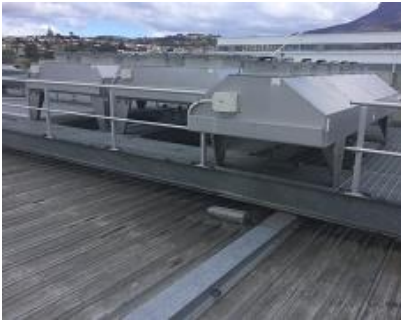
Variation in height between plant deck and unit is greater than required maximum	Trips, Slips and Falls	Awareness induction	Med	Mid rail to be installed	Low	Client advised	Outstanding	OH&S REGULATIONS 3.7  AS/NZS 1657-2013 4.4

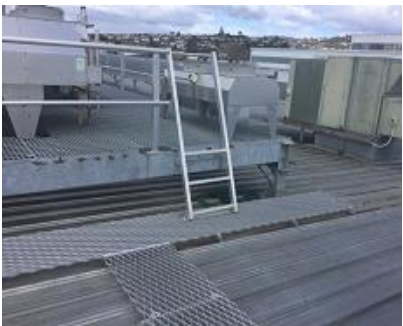
Bottom rung height is less than required minimum and top rung not levelled with landing	Trips, Slips and Falls	Awareness induction	Med	Existing ladder to be re-installed with landing platforms, brackets and handrails	Low	Client advised	Outstanding	OH&S REGULATIONS 3.7  AS/NZS 1657-2013 7.4.3.4 & 7.4.3.3
64	Building: General Stores Location Reference: <a href="#">L38</a> Task: Access to the A/c units

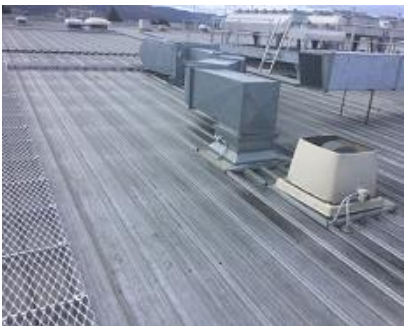
No safe access to the A/c units	Trips, Slips and Falls	N/A	Low	Supply walkway to the A/c units	Low	Client advised	Outstanding	-
66	Building: General Stores Location Reference: <a href="#">L39</a> Task: Access to the roof

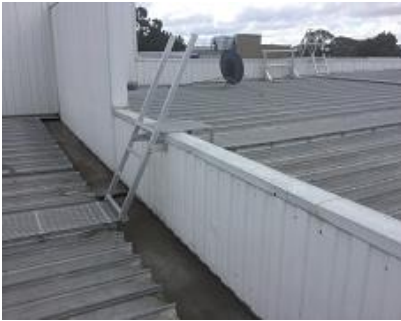
Bottom rung heights are less than required minimum	Trips, Slips and Falls	Awareness induction	Med	Existing ladder to be re-installed with landing platforms, brackets and handrails	Low	Client advised	Outstanding	OH&S REGULATIONS 3.7  AS/NZS 1657-2013 7.4.3.4
68	Building: General Stores Location Reference: <a href="#">L41</a> Task: Access to the roof

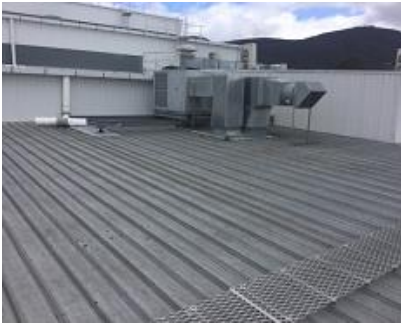
No safe access to the A/c units	Trips, Slips and Falls	N/A	Low	Supply walkway, access ladders, grating and handrail to the A/c units	Low	Client advised	Outstanding	-
70	Building: General Stores Location Reference: <a href="#">L42</a> Task: Access to the A/c units

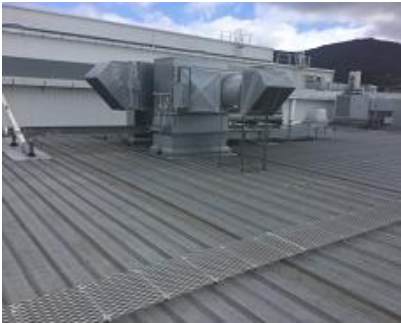
No safe access to the A/c units	Trips, Slips and Falls	N/A	Low	Supply walkway to the A/c units	Low	Client advised	Outstanding	-

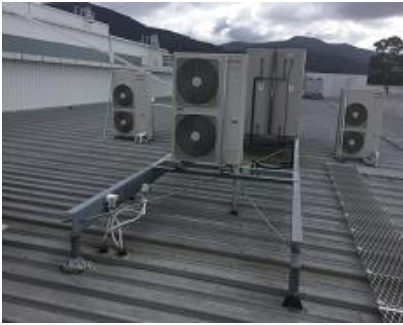
No safe access to the A/c units	Trips, Slips and Falls	N/A	Low	Supply walkway to the A/c units	Low	Client advised	Outstanding	-
72	Building: General Stores Location Reference: <a href="#">L42</a> Task: Access to the A/c units

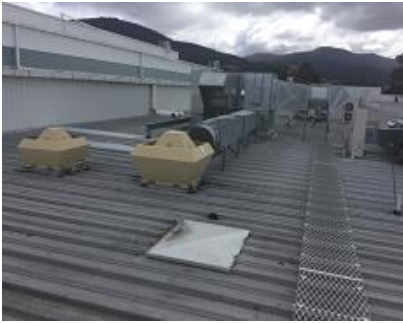
No safe access to the A/c units	Trips, Slips and Falls	N/A	Low	Supply walkway to the A/c units	Low	Client advised	Outstanding	-
74	Building: General Stores Location Reference: <a href="#">L43</a> Task: Access to the roof

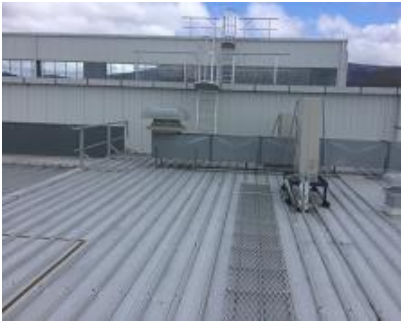
No safe access to the ladder	Trips, Slips and Falls	N/A	Low	Supply walkway to the ladder	Low	Client advised	Outstanding	-
76	Building: General Stores Location Reference: <a href="#">L44</a> Task: Access to the roof

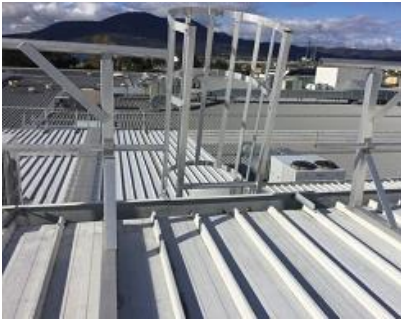
Landing is less than required minimum and required more supports for ladder	Trips, Slips and Falls	Awareness induction	Med	Landing platforms and brackets to be installed	Low	Client advised	Outstanding	OH&S REGULATIONS 3.7  AS/NZS 1657-2013 7.3.6
