# Roof Safety Report

Northland, VIC 3072

Prepared By: Safemaster Safety Products  
Date: 10-09-2020

10-09-2020

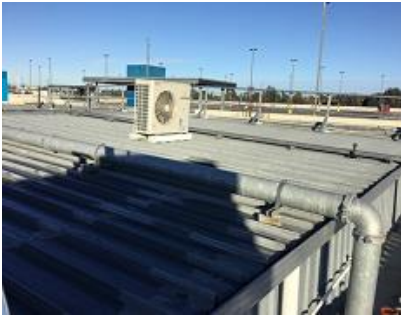
No safe access to the A/c units	Trips, Slips and Falls	N/A	Low	Supply walkway and step over to the A/c units	Low	Client advised	Outsta nding	-
02	Building: General Stores Location Reference: <a href="#">L01</a> Task: Access to the A/c units

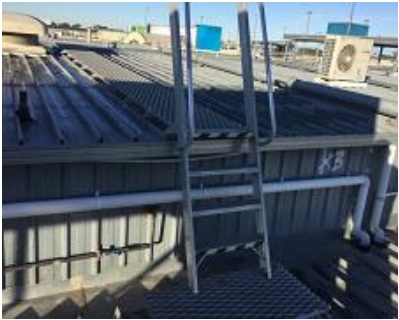
Top tread not levelled with landing	Trips, Slips and Falls	Awareness induction	Med	New landing platform to be installed	Low	Client advised	Outsta nding	OH&S REGULATIONS 3.7  AS/NZS 1657- 2013 7.3.6
04	Building: General Stores Location Reference: <a href="#">L03</a> Task: Access to the plant deck

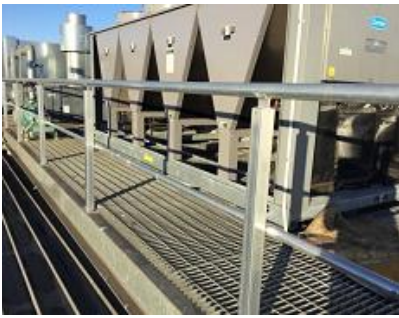
Sharp edges on handrails	Trips, Slips and Falls	Awareness induction	Med	Tek screws to be replaced with rivets	Low	Client advised	Outsta nding	OH&S REGULATIONS 3.7  AS/NZS 1657-2013 5.6

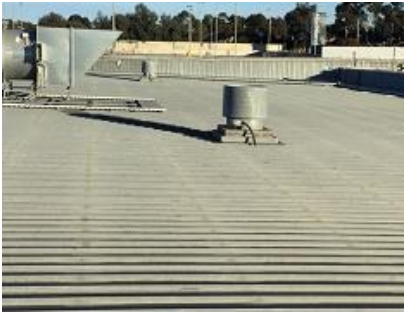
No safe access to the A/c units	Trips, Slips and Falls	N/A	Low	Supply walkway to the A/c units	Low	Client advised	Outstanding	-
08	Building: General Stores Location Reference: <a href="#">L03</a> Task: Access to the A/c units

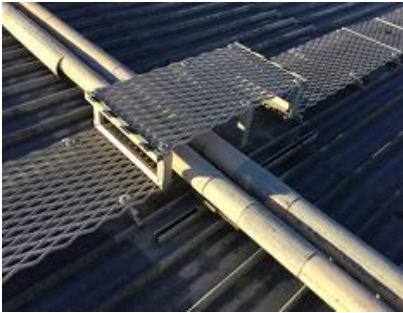
Variation in height between platform and roof is greater than required maximum	Trips, Slips and Falls	Awareness induction	Med	Existing platform to be modified (or) handrails to be installed	Low	Client advised	Outstanding	OH&S REGULATIONS 3.7  AS/NZS 1657-2013 4.4
10	Building: General Stores Location Reference: <a href="#">L04</a> Task: Access to the ladder

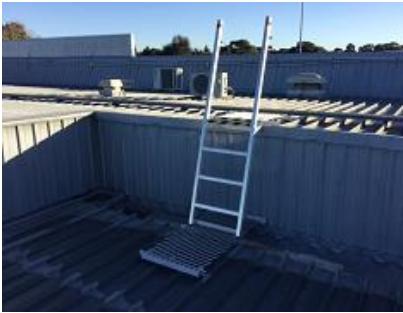
Top rung not levelled with landing and bottom rung height is less than required minimum and gap between top rung and landing is greater than required maximum	Trips, Slips and Falls	Awareness induction	Med	Existing ladder to be re-installed with landing platform and brackets	Low	Client advised	Outstanding	OH&S REGULATIONS 3.7  AS/NZS 1657-2013 7.4.3.3, 7.4.3.4 & 7.4.8.4
12	Building: General Stores Location Reference: <a href="#">L04</a> Task: Access to the A/c units

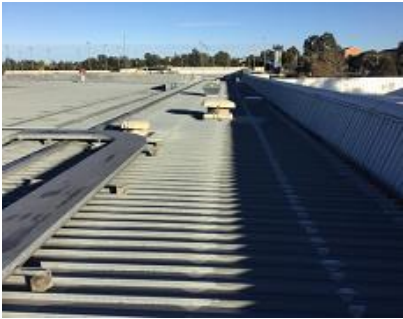
No safe access to the A/c units	Trips, Slips and Falls	N/A	Low	Supply walkway to the A/c units	Low	Client advised	Outsta nding	-

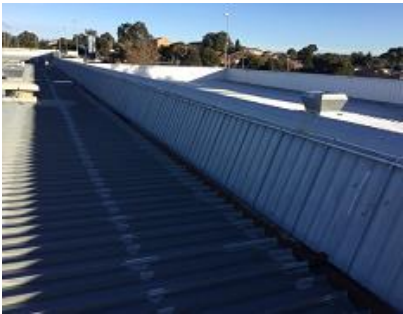
Variation in height between roofs are greater than required maximum	Trips, Slips and Falls	Awareness induction	Med	Access ladder including handrails to be installed	Low	Client advised	Outstanding	OH&S REGULATIONS 3.7  AS/NZS 1657-2013 3.1.4
16	Building: General Stores Location Reference: <a href="#">L06</a> Task: Access to the A/c units

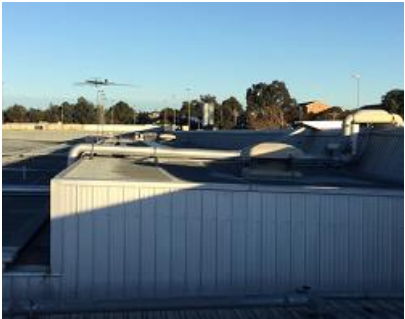
No safe access to the A/c units	Trips, Slips and Falls	N/A	Low	Supply walkway and step overs to the A/c units	Low	Client advised	Outstanding	-

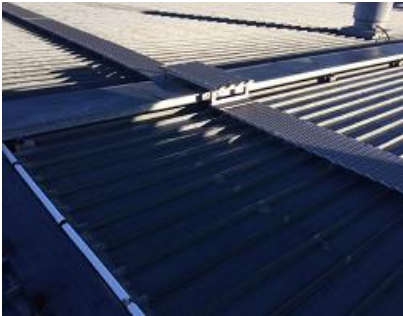
Variation in height between platform and roof is greater than required maximum	Trips, Slips and Falls	Awareness induction	Med	Existing platform to be modified (or) handrails to be installed	Low	Client advised	Outstanding	OH&S REGULATIONS 3.7  AS/NZS 1657-2013 4.4
20	Building: General Stores Location Reference: <a href="#">L09</a> Task: Access to the plant deck

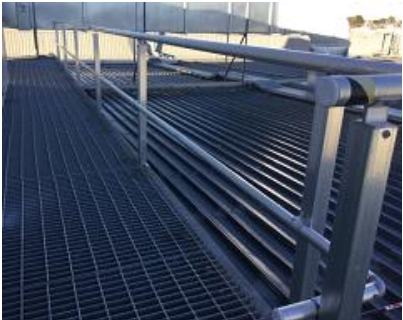
Sharp edges on handrails	Trips, Slips and Falls	Awareness induction	Med	Tek screws to be replaced with rivets	Low	Client advised	Outstanding	OH&S REGULATIONS 3.7  AS/NZS 1657-2013 5.6

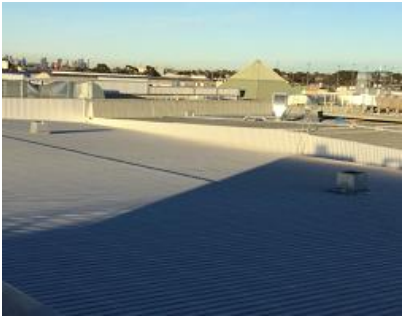
No safe access to the A/c units and ladder	Trips, Slips and Falls	N/A	Low	Supply walkway to the A/c units and ladder	Low	Client advised	Outstanding	-
28	Building: General Stores Location Reference: <a href="#">L10</a> Task: Access to the A/c units

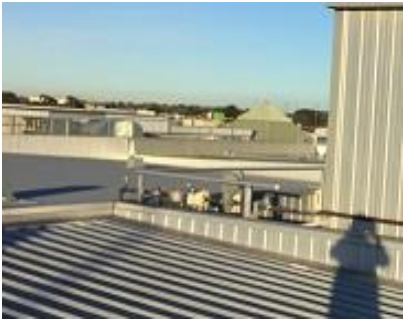
Sharp edges on handrails	Trips, Slips and Falls	Awareness induction	Med	Tek screws to be replaced with rivets	Low	Client advised	Outsta nding	OH&S REGULATIONS 3.7  AS/NZS 1657-2013 5.6

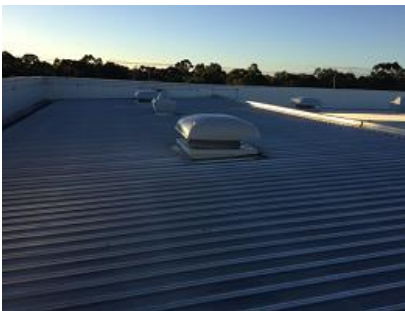
No safe access to the A/c units	Trips, Slips and Falls	N/A	Low	Supply walkway and ladder to the A/c units	Low	Client advised	Outstanding	-
36	Building: General Stores Location Reference: <a href="#">L15</a> Task: Access to the A/c units

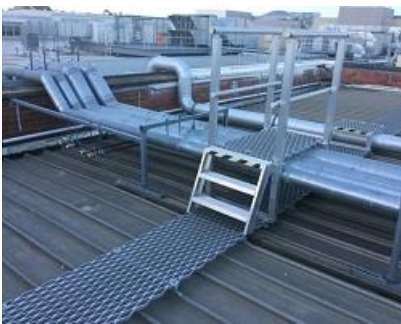
Bottom tread height is less than required minimum	Trips, Slips and Falls	Awareness induction	Med	Landing platforms to be installed	Low	Client advised	Outstanding	OH&S REGULATIONS 3.7  AS/NZS 1657-2013 7.3.3.2
66	Building: General Stores Location Reference: <a href="#">L26</a> Task: Access to the roof

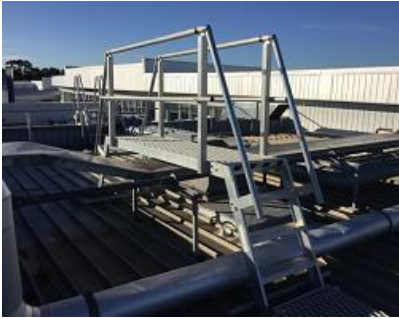
Bottom tread height is less than required minimum, landing is less than required minimum and sharp edges on handrails	Trips, Slips and Falls	Awareness induction	Med	Landing platforms to be installed and tek screws to be replaced with rivets	Low	Client advised	Outstanding	OH&S REGULATIONS 3.7  AS/NZS 1657-2013 7.3.3.2 & 5.6
68	Building: General Stores Location Reference: <a href="#">L27</a> Task: Access to the roof

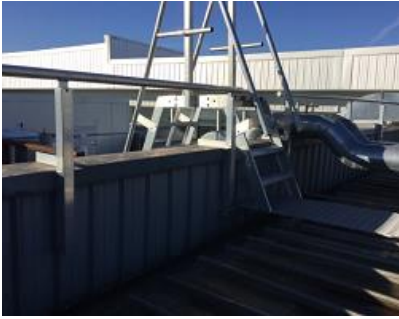
Gap between tread and structure is less than required minimum and bottom tread height is greater than required maximum and handrails is not providing continuous hand hold	Trips, Slips and Falls	Awareness induction	Med	Existing ladder to be removed and new ladder to be installed	Low	Client advised	Outstanding	OH&S REGULATIONS 3.7  AS/NZS 1657-2013 7.3.5, 7.3.3.2 & 7.3.4

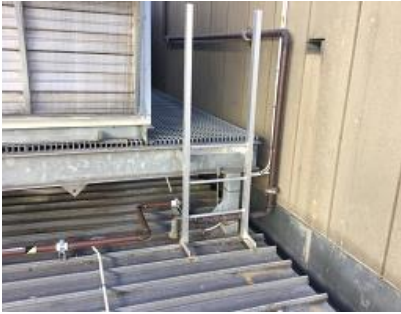
Gap between top rung and structure is greater than required maximum and no landing platform at base	Trips, Slips and Falls	Awareness induction	Med	Existing ladder to be re-installed with landing platform and brackets	Low	Client advised	Outstanding	OH&S REGULATIONS 3.7  AS/NZS 1657-2013 7.4.8.4 & 7.3.6
72	Building: General Stores Location Reference: <a href="#">L28</a> Task: Access to the plant deck

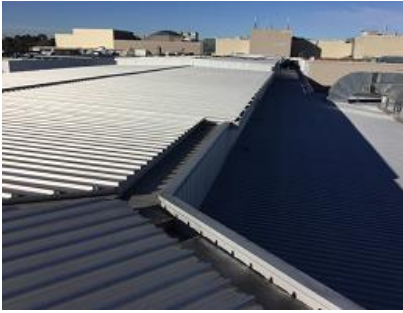
Variation in height between roofs is greater than required maximum	Trips, Slips and Falls	Awareness induction	Med	Access ladder to be installed	Low	Client advised	Outstanding	OH&S REGULATIONS 3.7  AS/NZS 1657-2013 3.1.4
78	Building: General Stores Location Reference: <a href="#">L30</a> Task: Access to the plant deck

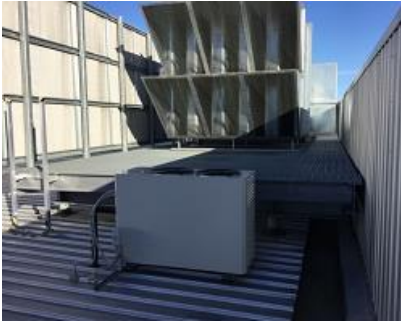
Variation in height between plant deck and roof is greater than required maximum	Trips, Slips and Falls	Awareness induction	Med	Handrails to be installed	Low	Client advised	Outstanding	OH&S REGULATIONS 3.7  AS/NZS 1657-2013 4.4
80	Building: General Stores Location Reference: <a href="#">L30</a> Task: Access to the roof

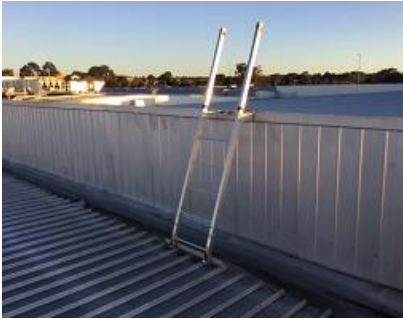
Bottom rung height is less than required minimum and top rung not levelled with landing	Trips, Slips and Falls	Awareness induction	Med	Existing ladder to be re-installed with landing platforms and brackets	Low	Client advised	Outstanding	OH&S REGULATIONS 3.7  AS/NZS 1657-2013 7.4.3.4 & 7.4.3.3
82	Building: General Stores Location Reference: <a href="#">L31</a> Task: Access to the plant deck

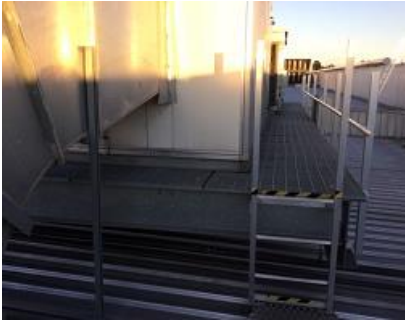
Variation in height between plant deck and roof is greater than required maximum	Trips, Slips and Falls	Awareness induction	Med	Handrail to be installed	Low	Client advised	Outstanding	OH&S REGULATIONS 3.7  AS/NZS 1657-2013 4.4
86	Building: General Stores Location Reference: <a href="#">L32</a> Task: Access to the roof

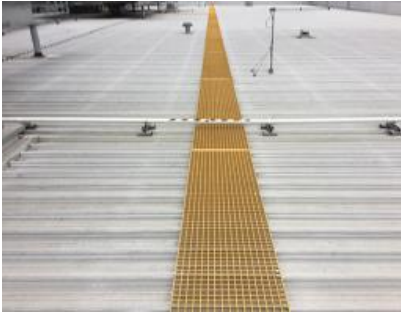
Pipe installed over the walkway path	Trips, Slips and Falls	Awareness induction	Med	Step over to be installed	Low	Client advised	Outstanding	OH&S REGULATIONS 3.7
96	Building: General Stores Location Reference: <a href="#">L35</a> Task: Access to the plant deck

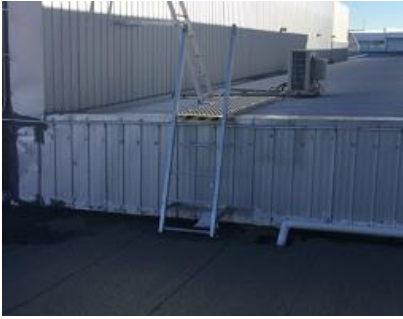
Bottom rung height is less than required minimum	Trips, Slips and Falls	Awareness induction	Med	Landing platform and handrails to be installed	Low	Client advised	Outstanding	OH&S REGULATIONS 3.7  AS/NZS 1657-2013 7.4.3.4
104	Building: General Stores Location Reference: <a href="#">L37</a> Task: Access to the roof

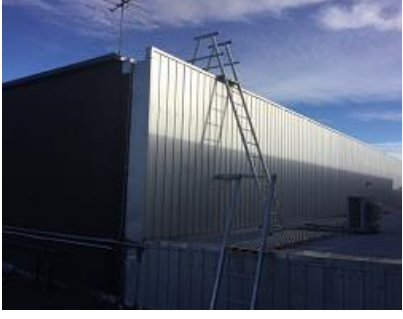
Bottom rung height is less than required minimum, sharp edges on ladder stiles and handrails projecting towards the user	Trips, Slips and Falls	Awareness induction	Med	Tek screws to be replaced with rivets. Existing handrails to be removed and new handrails and landing platforms to be installed	Low	Client advised	Outstanding	OH&S REGULATIONS 3.7  AS/NZS 1657-2013 7.4.3.4, 5.6 & 7.4.8.5

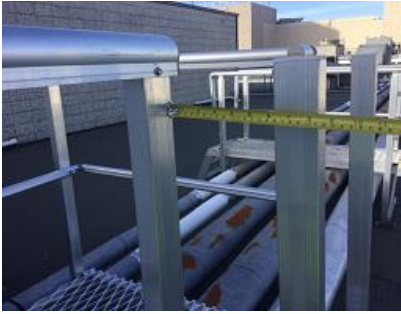
Gap between handrails is greater than required maximum	Trips, Slips and Falls	Awareness induction	Med	Gap to be closed/ handrail to be installed	Low	Client advised	Outstanding	OH&S REGULATIONS 3.7  AS/NZS 1657-2013 4.4
114	Building: General Stores Location Reference: <a href="#">L40</a> Task: Access to the plant deck

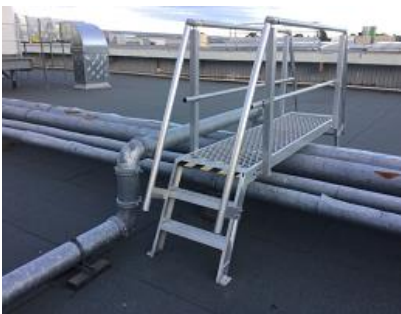
Sharp edges on handrails	Trips, Slips and Falls	Awareness induction	Med	Tek screws to be replaced with rivets	Low	Client advised	Outsta nding	OH&S REGULATIONS 3.7  AS/NZS 1657- 2013 5.6
118	Building: General Stores Location Reference: <a href="#">L41</a> Task: Access to the plant deck

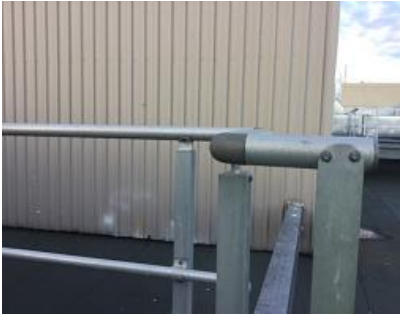
Sharp edges on handrails	Trips, Slips and Falls	Awareness induction	Med	Tek screws to be replaced with rivets	Low	Client advised	Outsta nding	OH&S REGULATIONS 3.7  AS/NZS 1657- 2013 5.6
120	Building: General Stores Location Reference: <a href="#">L41</a> Task: Access to the plant deck

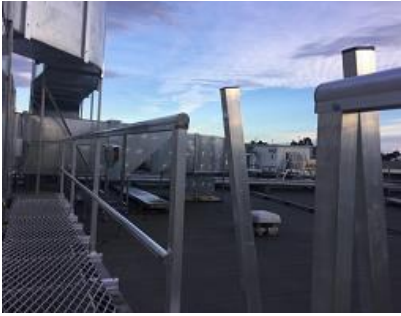
Sharp edges on handrails	Trips, Slips and Falls	Awareness induction	Med	Tek screws to be replaced with rivets	Low	Client advised	Outsta nding	OH&S REGULATIONS 3.7  AS/NZS 1657-2013 5.6

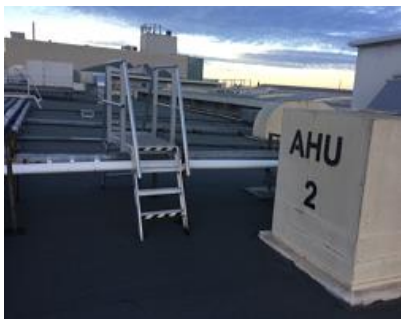
Bottom tread height is greater than required maximum and sharp edges on handrails	Trips, Slips and Falls	Awareness induction	Med	Tek screws to be replaced with rivets. Landing platforms to be installed	Low	Client advised	Outstanding	OH&S REGULATIONS 3.7  AS/NZS 1657-2013 7.3.3.2 & 5.6
122	Building: General Stores Location Reference: <a href="#">L43</a> Task: Access to the plant deck

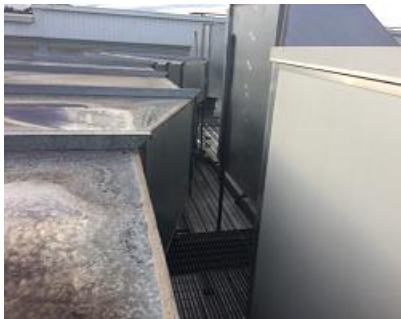
Variation in height between plant deck and roof is greater than required maximum	Trips, Slips and Falls	Awareness induction	Med	Handrails to be installed	Low	Client advised	Outstanding	OH&S REGULATIONS 3.7  AS/NZS 1657-2013 4.4

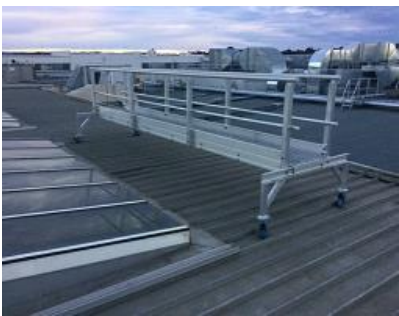
Sharp edges on handrails	Trips, Slips and Falls	Awareness induction	Med	Tek screws to be replaced with rivets	Low	Client advised	Outsta nding	OH&S REGULATIONS 3.7  AS/NZS 1657- 2013 5.6
134	Building: General Stores Location Reference: <a href="#">L46</a> Task: Access to the roof

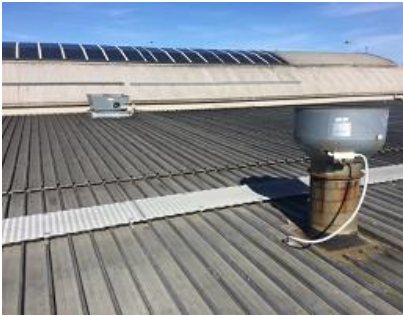
No safe access to the A/c units	Trips, Slips and Falls	N/A	Low	Supply walkway to the A/c units	Low	Client advised	Outstanding	-
164	Building: General Stores Location Reference: <a href="#">L55</a> Task: Access to the roof

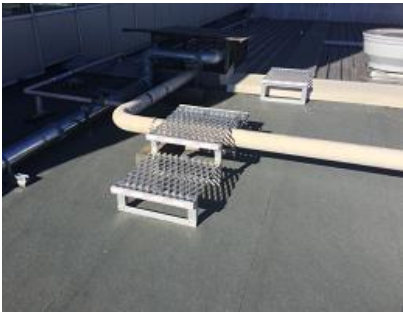
Variation in height between landing platform and roof is greater than required maximum	Trips, Slips and Falls	Awareness induction	Med	Handrails to be installed	Low	Client advised	Outstanding	OH&S REGULATIONS 3.7  AS/NZS 1657-2013 4.4
188	Building: General Stores Location Reference: <a href="#">L63</a> Task: Access to the roof									
	 	Step height is greater than required maximum	Trips, Slips and Falls	Awareness induction	Med	Additional steps and handrail to be installed	Low	Client advised	Outstanding	OH&S REGULATIONS 3.7  AS/NZS 1657-2013 3.1.4 & 4.4

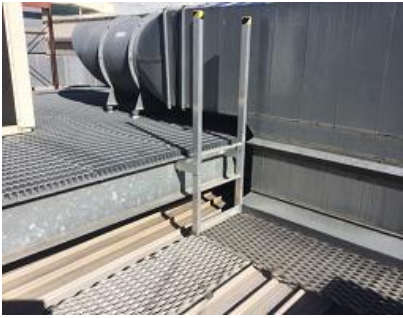
Gap between top rung and landing is greater than required maximum and clearance behind the ladder is less than required minimum	Trips, Slips and Falls	Awareness induction	Med	Existing ladder to be re-installed with landing platform and brackets	Low	Client advised	Outstanding	OH&S REGULATIONS 3.7  AS/NZS 1657-2013 7.4.8.4 & 7.4.5
198	Building: General Stores Location Reference: <a href="#">L65</a> Task: Access to the plant deck

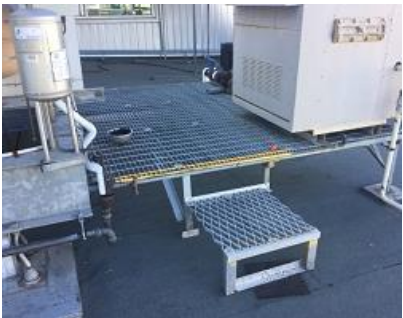
Step height is greater than required maximum	Trips, Slips and Falls	Awareness induction	Med	Existing step to be removed and new steps to be installed	Low	Client advised	Outsta nding	OH&S REGULATIONS 3.7  AS/NZS 1657-2013 3.1.4

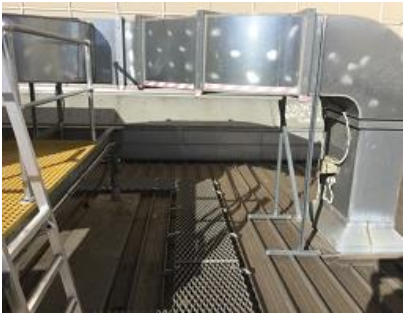
Headroom is less than required minimum	Trips, Slips and Falls	Awareness induction	Med	"Warning-Low head room" signs to be installed	Low	Client advised	Outstanding	OH&S REGULATIONS 3.7  AS/NZS 1657-2013 3.1.5
27 8	Building: General Stores Location Reference: <a href="#">L84</a> Task: Access to the plant deck

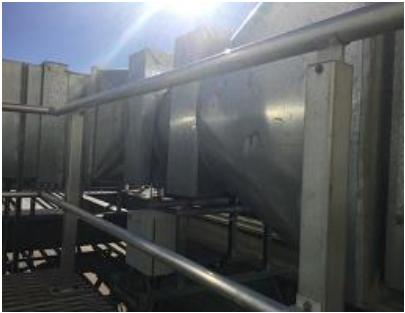
Sharp edges on handrails	Trips, Slips and Falls	Awareness induction	Med	Tek screws to be replaced with rivets	Low	Client advised	Outsta nding	OH&S REGULATIONS 3.7  AS/NZS 1657- 2013 5.6
28 0	Building: General Stores Location Reference: <a href="#">L84</a> Task: Access to the plant deck

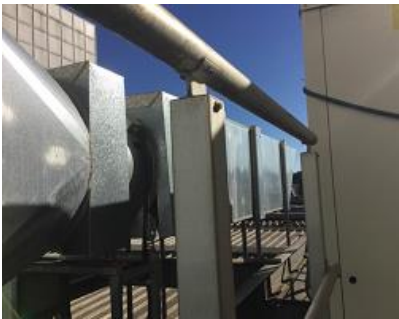
Sharp edges on handrails	Trips, Slips and Falls	Awareness induction	Med	Tek screws to be replaced with rivets	Low	Client advised	Outstanding	OH&S REGULATIONS 3.7  AS/NZS 1657-2013 5.6

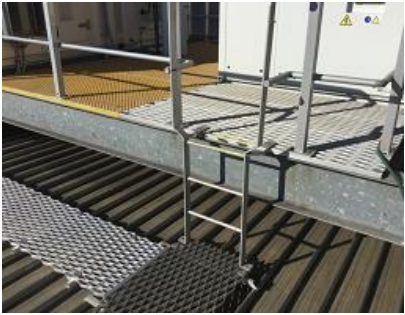
No slip resistance on ladder rungs and gap between top rung and landing is greater than required maximum	Trips, Slips and Falls	Awareness induction	Med	Existing ladder to be removed and new ladder to be installed	Low	Client advised	Outstanding	OH&S REGULATIONS 3.7  AS/NZS 1657-2013 7.4.3.1 & 7.4.8.4
28 4	Building: General Stores Location Reference: <a href="#">L84</a> Task: Access to the plant deck

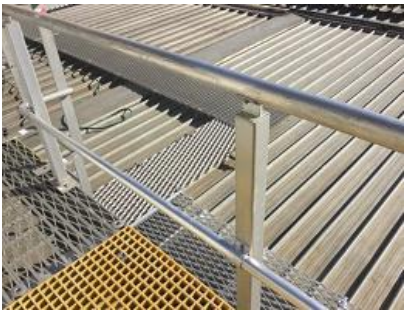
Sharp edges on handrails	Trips, Slips and Falls	Awareness induction	Med	Tek screws to be replaced with rivets	Low	Client advised	Outstanding	OH&S REGULATIONS 3.7  AS/NZS 1657-2013 5.6

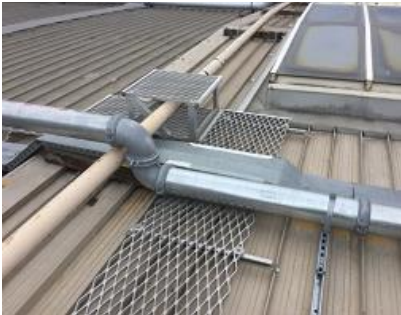
Step height is greater than required maximum and handrails is missing	Trips, Slips and Falls	Awareness induction	Med	Additional steps and handrails to be installed	Low	Client advised	Outstanding	OH&S REGULATIONS 3.7  AS/NZS 1657-2013 3.1.4

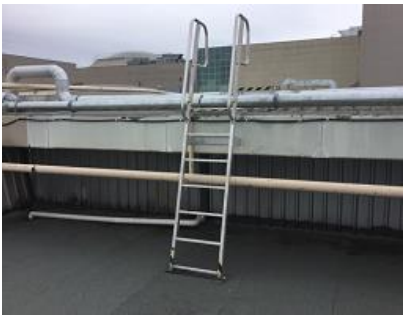
Bottom rung height is less than required minimum, handrails projecting towards the user and pipe installed at ladder landing	Trips, Slips and Falls	Awareness induction	Med	Existing ladder to be removed and new ladder including landing platform over the pipe and handrails to be installed	Low	Client advised	Outstanding	OH&S REGULATIONS 3.7  AS/NZS 1657-2013 7.4.3.4, 7.4.8.5 & 7.3.6

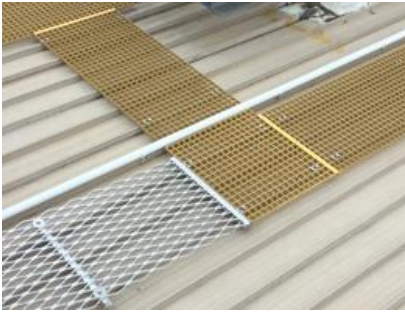
Pipe installed over the walkway path	Trips, Slips and Falls	Awareness induction	Med	Step over to be installed	Low	Client advised	Outsta nding	OH&S REGULATIONS 3.7
29 8	Building: General Stores Location Reference: <a href="#">L88</a> Task: Access to the roof

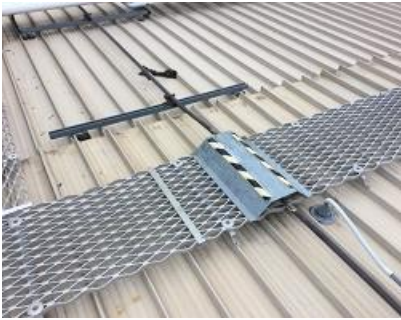
Non-compliant step over is present	Trips, Slips and Falls	Awareness induction	Med	Step over to be installed	Low	Client advised	Outstanding	OH&S REGULATIONS 3.7
306	Building: General Stores Location Reference: <a href="#">L89</a> Task: Access to the A/c units

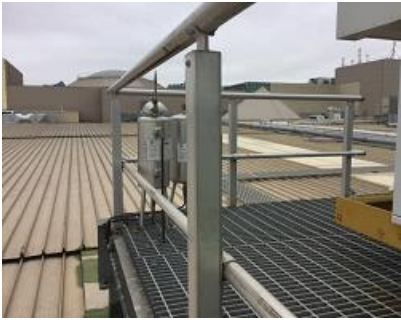
Sharp edges on handrails	Trips, Slips and Falls	Awareness induction	Med	Tek screws to be replaced with rivets	Low	Client advised	Outstanding	OH&S REGULATIONS 3.7  AS/NZS 1657-2013 5.6
310	Building: General Stores Location Reference: <a href="#">L90</a> Task: Access to the A/c units

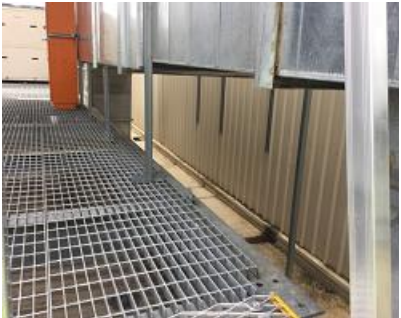
Gap between plant deck and unit is greater than required maximum	Trips, Slips and Falls	Awareness induction	Med	Midrail to be installed	Low	Client advised	Outsta nding	OH&S REGULATIONS 3.7  AS/NZS 1657- 2013 4.4

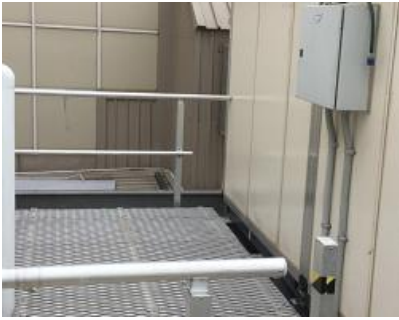
Gap between handrails and unit is greater than required maximum	Trips, Slips and Falls	Awareness induction	Med	Handrails to be installed	Low	Client advised	Outstanding	OH&S REGULATIONS 3.7  AS/NZS 1657-2013 4.4
34 8	Building: General Stores Location Reference: <a href="#">L96</a> Task: Access to the plant deck

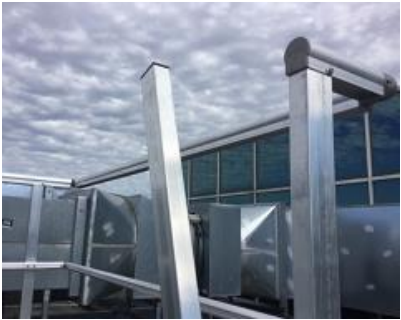
Sharp edges on handrails	Trips, Slips and Falls	Awareness induction	Med	Tek screws to be replaced with rivets	Low	Client advised	Outstanding	OH&S REGULATIONS 3.7  AS/NZS 1657-2013 5.6
361	Building: General Stores Location Reference: <a href="#">L98</a> Task: Access to the plant deck

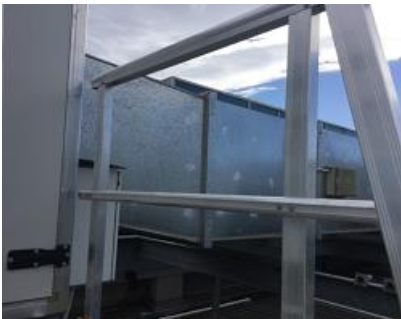
Sharp edges on handrails	Trips, Slips and Falls	Awareness induction	Med	Tek screws to be replaced with rivets	Low	Client advised	Outstanding	OH&S REGULATIONS 3.7  AS/NZS 1657-2013 5.6
