Roof Safety Report

Northland, VIC 3072

Prepared By: Safemaster Safety Products
Date: 15 Jan 2019

Roof Safety Report for
Northland, VIC 3072

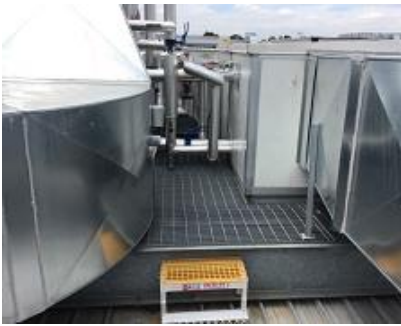
No	Photo of Hazard	Details of Hazard	Details of Risk	Existing/ Immediate Control Measure	Curren t Risk Level	Proposed Permanent Solution	Residu al Risk Assess ment	Details of Action Taken	Status	Reference
46 4	Building: General Stores Location Reference: L47 Task: Access to the roof

Step height is greater than required maximum and handrail is missing for platform entry point	Trips, Slips and Falls	Awareness induction	Med	Existing step to be removed and new step including handrail to be installed	Low	Client advised	Outstanding	OH&S REGULATIONS 3.7 AS/NZS 1657-2018 3.1.4 & 4.4
46 5	Building: General Stores Location Reference: L47 Task: Access to the roof

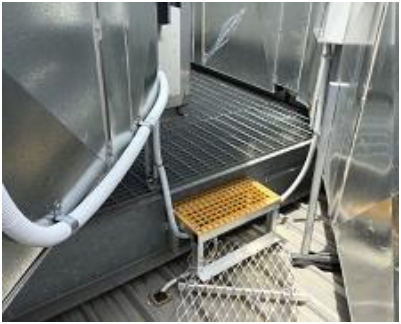
Step height is greater than required maximum and handrail is missing for platform entry point	Trips, Slips and Falls	Awareness induction	Med	Existing step to be removed and new step including handrail to be installed	Low	Client advised	Outstanding	OH&S REGULATIONS 3.7 AS/NZS 1657-2018 3.1.4 & 4.4

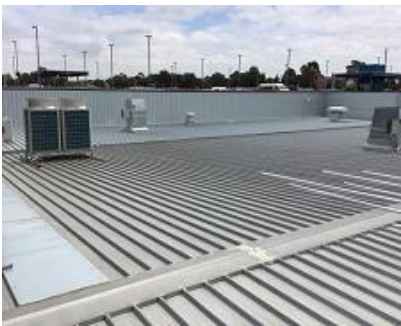
No	Photo of Hazard	Details of Hazard	Details of Risk	Existing/ Immediate Control Measure	Curren t Risk Level	Proposed Permanent Solution	Residu al Risk Assess ment	Details of Action Taken	Status	Reference
46 6	Building: General Stores Location Reference: L48 Task: Access to the A/c units

No safe access to the A/c units	Trips, Slips and Falls	N/A	Low	Supply walkway to the A/c units	Low	Client advised	Outstanding	-
46 7	Building: General Stores Location Reference: L18 Task: Access to the roof

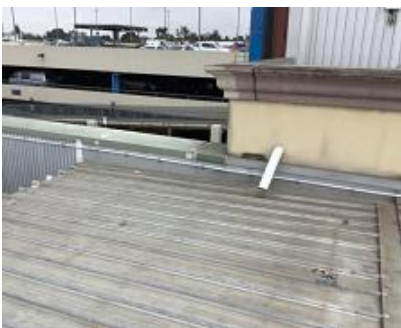
No height safety system installed to cover the fall edge	Trips, Slips and Falls	Awareness induction	High	Anchor point to be installed	Low	Client advised	Outstanding	OH&S REGULATIONS 3.55

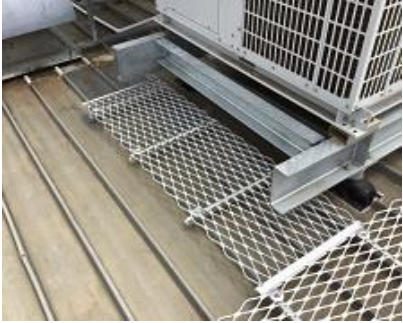
No	Photo of Hazard	Details of Hazard	Details of Risk	Existing/ Immediate Control Measure	Curren t Risk Level	Proposed Permanent Solution	Residu al Risk Assess ment	Details of Action Taken	Status	Reference
46 8	Building: General Stores Location Reference: L24 Task: Access to the roof

Walkway width is less than required minimum	Trips, Slips and Falls	Awareness induction	Med	Additional walkway section to be installed	Low	Client advised	Outstanding	OH&S REGULATIONS 3.7 AS/NZS 1657-2018 5.1.3
46 9	Building: General Stores Location Reference: L32 Task: Access to the roof

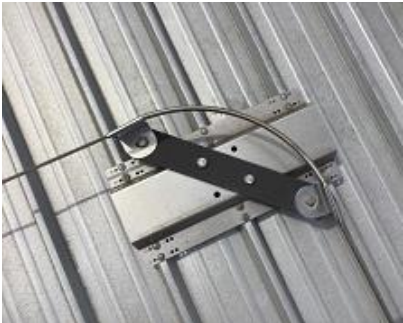
Static installed in-correctly	Trips, Slips and Falls	Awareness induction	High	Existing static line to be replaced	Low	Client advised	Outstanding	OH&S REGULATIONS 3.55

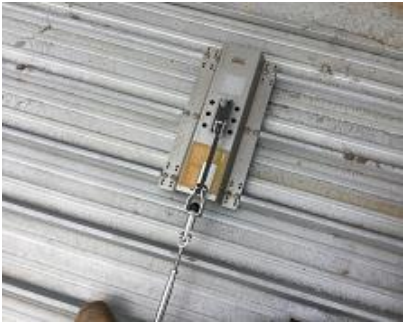
No	Photo of Hazard	Details of Hazard	Details of Risk	Existing/ Immediate Control Measure	Curren t Risk Level	Proposed Permanent Solution	Residu al Risk Assess ment	Details of Action Taken	Status	Reference
470	Building: General Stores Location Reference: L35 Task: Access to the roof

Static installed in-correctly	Trips, Slips and Falls	Awareness induction	High	Existing static line to be replaced	Low	Client advised	Outstanding	OH&S REGULATIONS 3.55
471	Building: General Stores Location Reference: L47 Task: Access to the roof

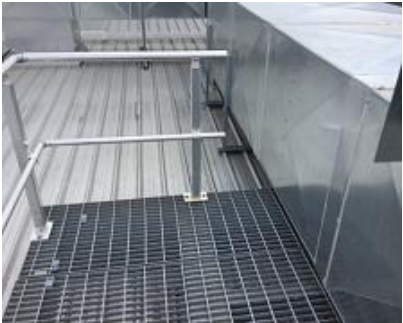
Gap between existing handrail and duct is greater than required maximum	Trips, Slips and Falls	Awareness induction	Med	Handrail to be extended	Low	Client advised	Outstanding	OH&S REGULATIONS 3.7 AS/NZS 1657-2013 4.4
