Roof Safety Report

**Queen Victoria Building,
NSW 2000**

Prepared By: Safemaster Safety Products
Date: 19 November 2018

Roof Safety Report for
Queen Victoria Building, NSW 2000

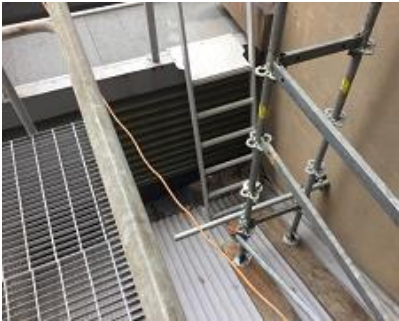
No	Photo of Hazard	Details of Hazard	Details of Risk	Existing/ Immediate Control Measure	Curre nt Risk Level	Proposed Permanent Solution	Resid ual Risk Asse sme nt	Details of Action Taken	Status	Reference
01	Building: General Stores Location Reference: L02 Task: Access to the roof

Bottom rung height is less than required minimum	Trips, Slips and Falls	Awareness induction	Med	Landing platform to be installed	Low	Client advised	Outstanding	OH&S REGULATIONS 3.7 AS/NZS 1657-2013 7.4.3.4
02	Building: General Stores Location Reference: L02 Task: Access to the roof

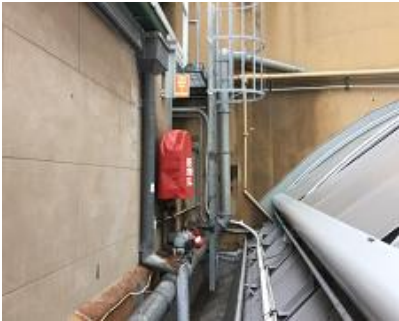
No	Photo of Hazard	Details of Hazard	Details of Risk	Existing/ Immediate Control Measure	Current Risk Level	Proposed Permanent Solution	Residual Risk Assessment	Details of Action Taken	Status	Reference
03	Building: General Stores Location Reference: L02 Task: Access to the roof

No slip resistance on ladder rungs	Trips, Slips and Falls	Awareness induction	Med	Non-slip rung caps to be installed	Low	Client advised	Outstanding	OH&S REGULATIONS 3.7 AS/NZS 1657-2013 7.4.3.1
04	Building: General Stores Location Reference: L02 Task: Access to the roof

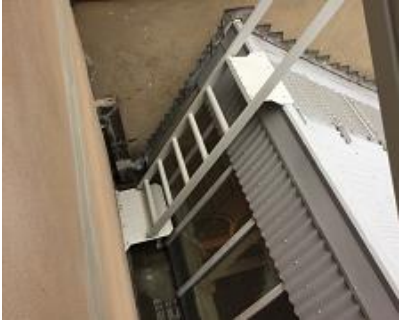
No	Photo of Hazard	Details of Hazard	Details of Risk	Existing/ Immediate Control Measure	Curre nt Risk Level	Proposed Permanent Solution	Resid ual Risk Asse sme nt	Details of Action Taken	Status	Reference
05	Building: General Stores Location Reference: L03 Task: Access to the roof

No safe access to clean the gutters	Trips, Slips and Falls	Awareness induction	High	Static line to be installed	Low	Client advised	Outstanding	OH&S REGULATIONS 3.55
06	Building: General Stores Location Reference: L03 Task: Access to the roof

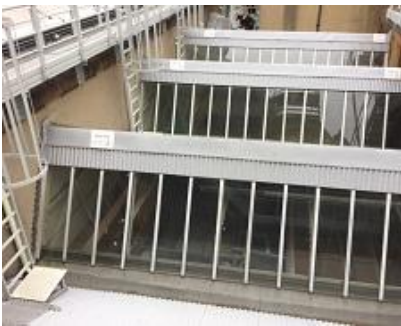
No	Photo of Hazard	Details of Hazard	Details of Risk	Existing/ Immediate Control Measure	Curre nt Risk Level	Proposed Permanent Solution	Resid ual Risk Asse sme nt	Details of Action Taken	Status	Reference
07	Building: General Stores Location Reference: L03 Task: Access to the roof

No safe access to clean the gutters	Trips, Slips and Falls	Awareness induction	High	Static lines (x2) to be installed	Low	Client advised	Outstanding	OH&S REGULATIONS 3.55
08	Building: General Stores Location Reference: L03 Task: Restrict access to the roof

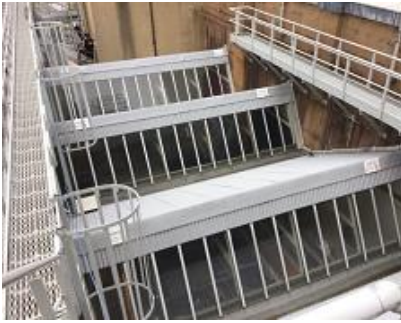
Brittle roof signs are faded	Trips, Slips and Falls	Awareness induction	High	Brittle roof signs to be replaced	Low	Client advised	Outstanding	OH&S REGULATIONS 3.57

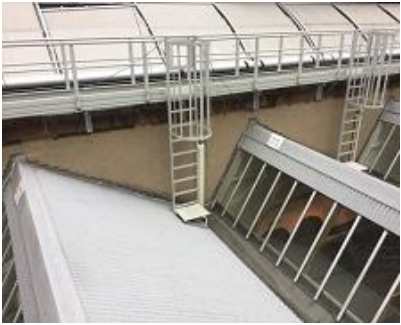
No	Photo of Hazard	Details of Hazard	Details of Risk	Existing/ Immediate Control Measure	Curre nt Risk Level	Proposed Permanent Solution	Resid ual Risk Asse sme nt	Details of Action Taken	Status	Reference
09	Building: General Stores Location Reference: L03 Task: Access to the roof

Bottom rung height is less than required minimum	Trips, Slips and Falls	Awareness induction	Med	Landing platform including handrail to be installed	Low	Client advised	Outstanding	OH&S REGULATIONS 3.7 AS/NZS 1657-2013 7.4.3.4
10	Building: General Stores Location Reference: L03 Task: Access to the roof

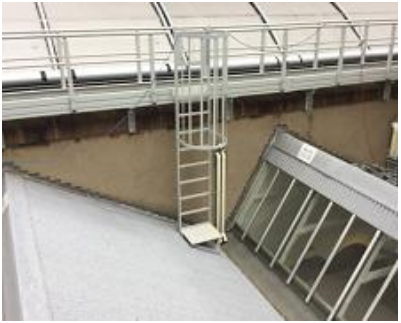
Bottom rung height is less than required minimum	Trips, Slips and Falls	Awareness induction	Med	Landing platform including handrail to be installed	Low	Client advised	Outstanding	OH&S REGULATIONS 3.7 AS/NZS 1657-2013 7.4.3.4

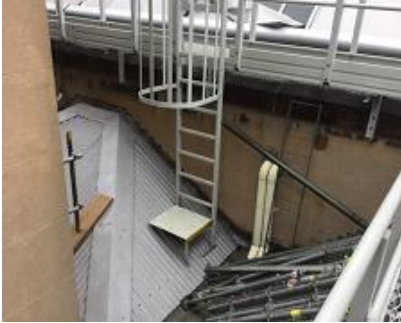
No	Photo of Hazard	Details of Hazard	Details of Risk	Existing/ Immediate Control Measure	Curre nt Risk Level	Proposed Permanent Solution	Resid ual Risk Asse sme nt	Details of Action Taken	Status	Reference
11	Building: General Stores Location Reference: L04 Task: Access to the roof

Bottom rung height is less than required minimum	Trips, Slips and Falls	Awareness induction	Med	Landing platform including handrail to be installed	Low	Client advised	Outstanding	OH&S REGULATIONS 3.7 AS/NZS 1657-2013 7.4.3.4
12	Building: General Stores Location Reference: L04 Task: Access to the roof

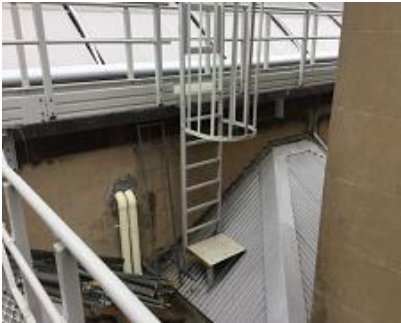
Bottom rung height is less than required minimum	Trips, Slips and Falls	Awareness induction	Med	Landing platform including handrail to be installed	Low	Client advised	Outstanding	OH&S REGULATIONS 3.7 AS/NZS 1657-2013 7.4.3.4

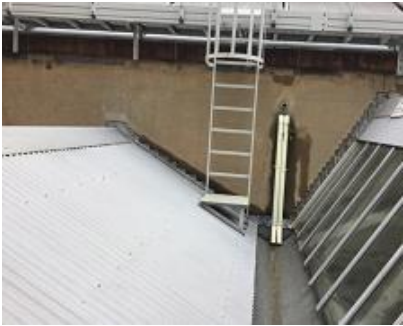
No	Photo of Hazard	Details of Hazard	Details of Risk	Existing/ Immediate Control Measure	Curre nt Risk Level	Proposed Permanent Solution	Resid ual Risk Asse sme nt	Details of Action Taken	Status	Reference
13	Building: General Stores Location Reference: L05 Task: Access to the roof

Bottom rung height is less than required minimum	Trips, Slips and Falls	Awareness induction	Med	Landing platform including handrail to be installed	Low	Client advised	Outstanding	OH&S REGULATIONS 3.7 AS/NZS 1657-2013 7.4.3.4
14	Building: General Stores Location Reference: L05 Task: Access to the roof

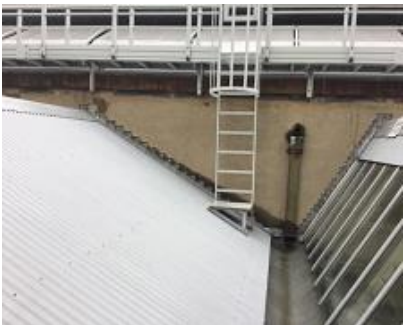
Bottom rung height is less than required minimum	Trips, Slips and Falls	Awareness induction	Med	Landing platform including handrail to be installed	Low	Client advised	Outstanding	OH&S REGULATIONS 3.7 AS/NZS 1657-2013 7.4.3.4

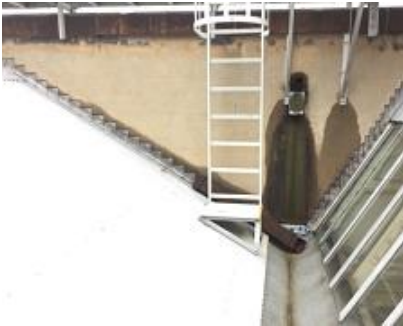
No	Photo of Hazard	Details of Hazard	Details of Risk	Existing/ Immediate Control Measure	Curre nt Risk Level	Proposed Permanent Solution	Resid ual Risk Asse sme nt	Details of Action Taken	Status	Reference
15	Building: General Stores Location Reference: L05 Task: Access to the roof

Bottom rung height is less than required minimum	Trips, Slips and Falls	Awareness induction	Med	Landing platform including handrail to be installed	Low	Client advised	Outstanding	OH&S REGULATIONS 3.7 AS/NZS 1657-2013 7.4.3.4
16	Building: General Stores Location Reference: L05 Task: Restrict access to the roof

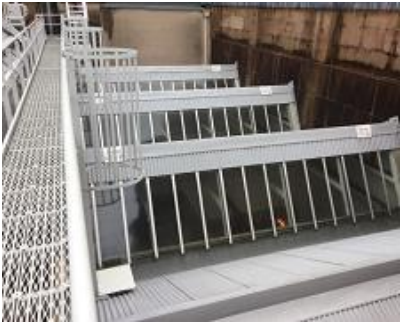
Brittle roof signs are faded	Trips, Slips and Falls	Awareness induction	High	Brittle roof signs to be replaced	Low	Client advised	Outstanding	OH&S REGULATIONS 3.57

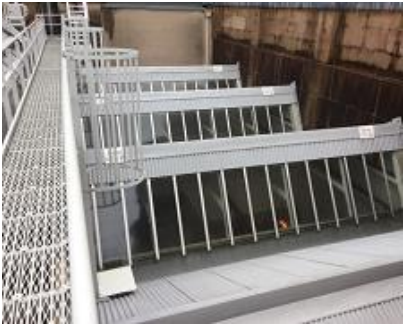
No	Photo of Hazard	Details of Hazard	Details of Risk	Existing/ Immediate Control Measure	Curre nt Risk Level	Proposed Permanent Solution	Resid ual Risk Asse sme nt	Details of Action Taken	Status	Reference
17	Building: General Stores Location Reference: L05 Task: Access to the roof

No safe access to clean the gutters	Trips, Slips and Falls	Awareness induction	High	Static lines (x3) to be installed	Low	Client advised	Outstanding	OH&S REGULATIONS 3.55
18	Building: General Stores Location Reference: L06 Task: Access to the roof

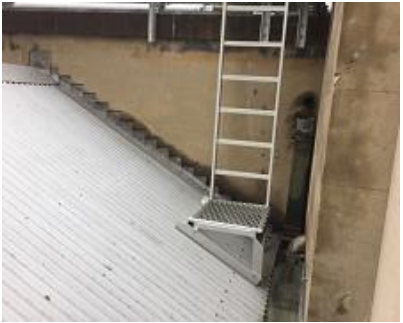
Bottom rung height is less than required minimum	Trips, Slips and Falls	Awareness induction	Med	Landing platform including handrail to be installed	Low	Client advised	Outstanding	OH&S REGULATIONS 3.7 AS/NZS 1657-2013 7.4.3.4

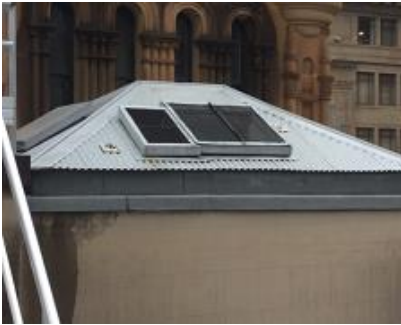
No	Photo of Hazard	Details of Hazard	Details of Risk	Existing/ Immediate Control Measure	Curre nt Risk Level	Proposed Permanent Solution	Resid ual Risk Asse sme nt	Details of Action Taken	Status	Reference
19	Building: General Stores Location Reference: L07 Task: Access to the roof

Non-complaint anchors are present as roof sheet is too small to support the anchors	Trips, Slips and Falls	Awareness induction	High	Existing anchors (x2) to be removed and anchors to be installed	Low	Client advised	Outstanding	OH&S REGULATIONS 3.55
20	Building: General Stores Location Reference: L07 Task: Access to the roof

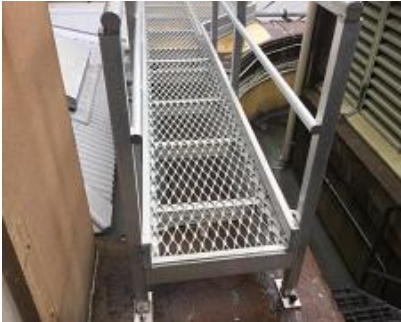
High visibility nosing is missing at access point	Trips, Slips and Falls	Awareness induction	Med	High visibility safety yellow nosing to be installed	Low	Client advised	Outstanding	OH&S REGULATIONS 3.7

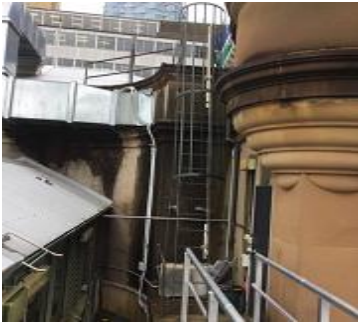
No	Photo of Hazard	Details of Hazard	Details of Risk	Existing/ Immediate Control Measure	Curre nt Risk Level	Proposed Permanent Solution	Resid ual Risk Asse sme nt	Details of Action Taken	Status	Reference
21	Building: General Stores Location Reference: L08 Task: Access to the roof

No slip resistance on ladder rungs and bottom rung height is less than required minimum	Trips, Slips and Falls	Awareness induction	Med	Non-slip rung caps and "Un-even rung height is Present" signs to be installed	Low	Client advised	Outstanding	OH&S REGULATIONS 3.7 AS/NZS 1657-2013 7.4.3.1 & 7.4.3.4
22	Building: General Stores Location Reference: L10 Task: Access to the roof

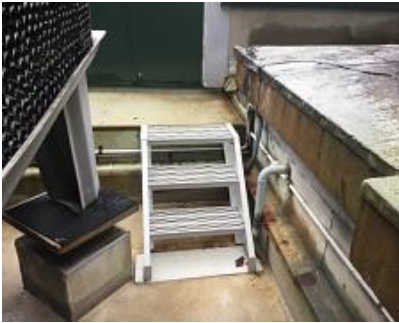
Handrail is missing for stair	Trips, Slips and Falls	Awareness induction	Med	Handrail to be installed	Low	Client advised	Outstanding	OH&S REGULATIONS 3.7 AS/NZS 1657-2013 7.2.6

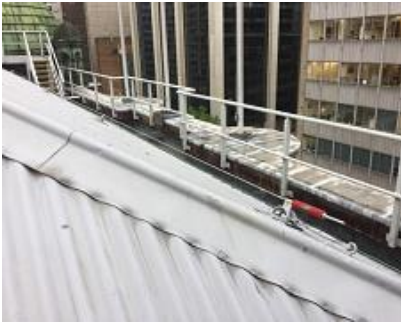
No	Photo of Hazard	Details of Hazard	Details of Risk	Existing/ Immediate Control Measure	Curre nt Risk Level	Proposed Permanent Solution	Resid ual Risk Asse sme nt	Details of Action Taken	Status	Reference
23	Building: General Stores Location Reference: L1 Task: Access to the roof

Static line will be expired on May 2019	Trips, Slips and Falls	Awareness induction	High	Static line to be replaced	Low	Client advised	Outstanding	OH&S REGULATIONS 3.55
24	Building: General Stores Location Reference: L1 Task: Access to the roof

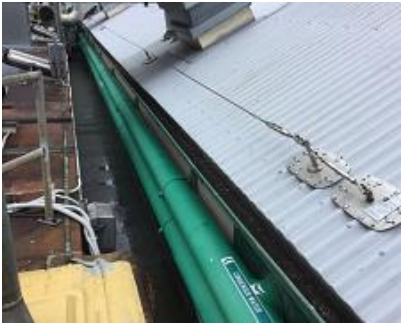
Static line will be expired on May 2019	Trips, Slips and Falls	Awareness induction	High	Static line to be replaced	Low	Client advised	Outstanding	OH&S REGULATIONS 3.55

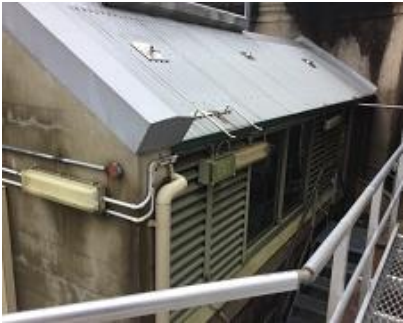
No	Photo of Hazard	Details of Hazard	Details of Risk	Existing/ Immediate Control Measure	Curre nt Risk Level	Proposed Permanent Solution	Resid ual Risk Asse sme nt	Details of Action Taken	Status	Reference
25	Building: General Stores Location Reference: L12 Task: Access to the roof

No safe access to the access anchor	Trips, Slips and Falls	Awareness induction	High	Anchor stop to be installed	Low	Client advised	Outstanding	OH&S REGULATIONS 3.55
26	Building: General Stores Location Reference: L12 Task: Restrict access to the roof

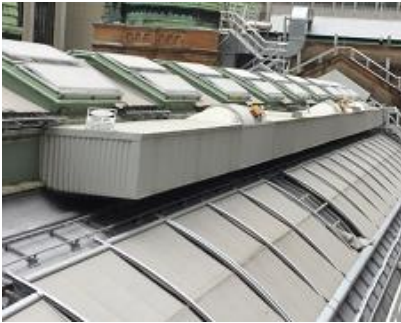
No	Photo of Hazard	Details of Hazard	Details of Risk	Existing/ Immediate Control Measure	Curre nt Risk Level	Proposed Permanent Solution	Resid ual Risk Asse sme nt	Details of Action Taken	Status	Reference
27	Building: General Stores Location Reference: L13 Task: Access to the roof

Brittle roof signs are faded	Trips, Slips and Falls	Awareness induction	High	Brittle roof signs to be replaced	Low	Client advised	Outsta nding	OH&S REGULATIONS 3.57
28	Building: General Stores Location Reference: L16 Task: Access to the roof

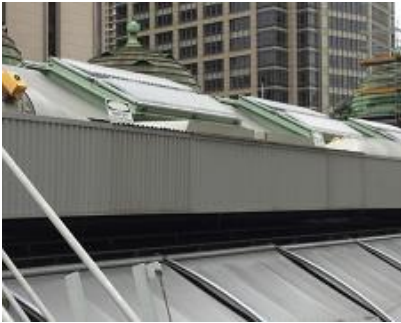
Brittle roof signs are faded	Trips, Slips and Falls	Awareness induction	High	Brittle roof signs to be replaced	Low	Client advised	Outsta nding	OH&S REGULATIONS 3.57

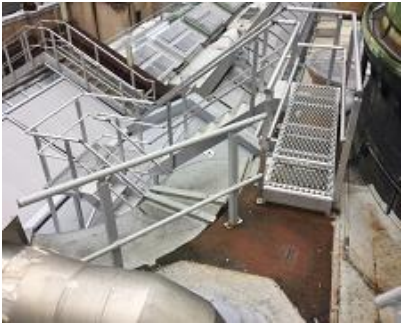
No	Photo of Hazard	Details of Hazard	Details of Risk	Existing/ Immediate Control Measure	Curre nt Risk Level	Proposed Permanent Solution	Resid ual Risk Asse sme nt	Details of Action Taken	Status	Reference
29	Building: General Stores Location Reference: L19 Task: Access to the roof

Variation in height between walkway panels are greater than required maximum	Trips, Slips and Falls	Awareness induction	Med	High visibility safety yellow nosing to be installed	Low	Client advised	Outstanding	OH&S REGULATIONS 3.7 AS/NZS 1657-2013 3.3.4
30	Building: General Stores Location Reference: L20 Task: Access to the roof

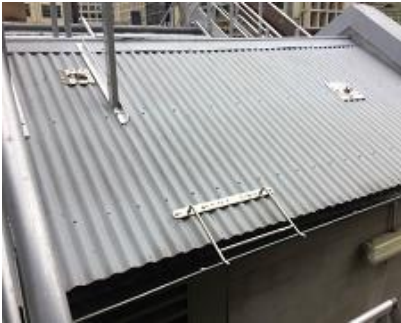
Ladder installed below the ladder access bracket	Trips, Slips and Falls	Awareness induction	Med	Existing ladder access bracket to be re-located	Low	Client advised	Outstanding	OH&S REGULATIONS 3.7

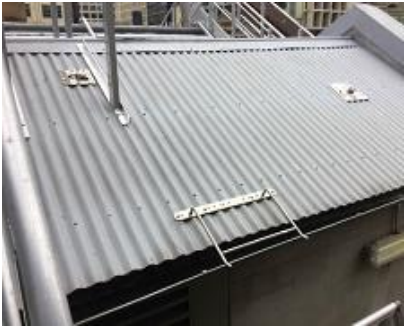
No	Photo of Hazard	Details of Hazard	Details of Risk	Existing/ Immediate Control Measure	Curre nt Risk Level	Proposed Permanent Solution	Resid ual Risk Asse sme nt	Details of Action Taken	Status	Reference
31	Building: General Stores Location Reference: L20 Task: Access to the roof

No safe access to the access anchor	Trips, Slips and Falls	Awareness induction	High	Anchor strop to be installed	Low	Client advised	Outstanding	OH&S REGULATIONS 3.55
32	Building: General Stores Location Reference: L20 Task: Access to the roof

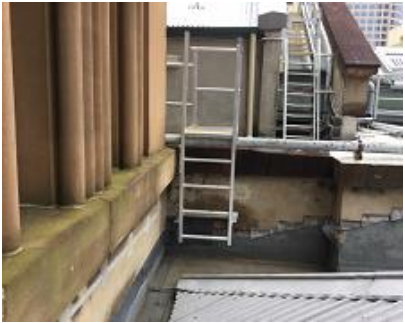
Bottom rung height is greater than required maximum	Trips, Slips and Falls	Awareness induction	Med	Landing platform to be installed	Low	Client advised	Outstanding	OH&S REGULATIONS 3.7 AS/NZS 1657-2013 7.4.3.4

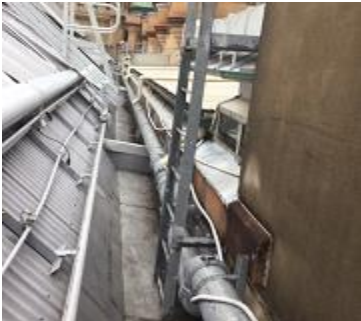
No	Photo of Hazard	Details of Hazard	Details of Risk	Existing/ Immediate Control Measure	Curre nt Risk Level	Proposed Permanent Solution	Resid ual Risk Asse sme nt	Details of Action Taken	Status	Reference
33	Building: General Stores Location Reference: L21 Task: Access to the roof

No slip resistance on ladder rungs	Trips, Slips and Falls	Awareness induction	Med	Non-slip rung caps to be installed	Low	Client advised	Outstanding	OH&S REGULATIONS 3.7 AS/NZS 1657-2013 7.4.3.1
34	Building: General Stores Location Reference: L21 Task: Access to the roof

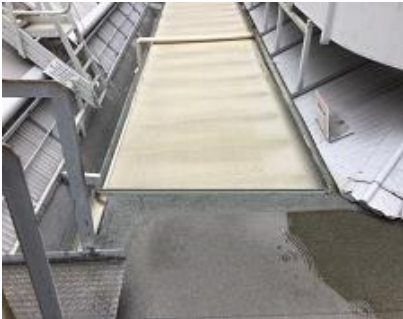
Fall edge is present	Trips, Slips and Falls	Awareness induction	High	Handrail to be installed	Low	Client advised	Outstanding	OH&S REGULATIONS 3.55

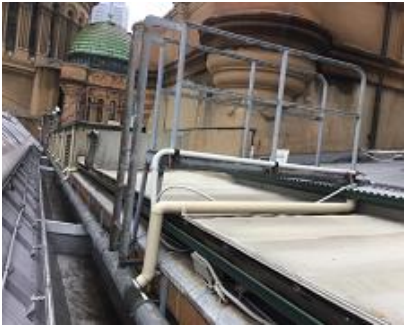
No	Photo of Hazard	Details of Hazard	Details of Risk	Existing/ Immediate Control Measure	Curre nt Risk Level	Proposed Permanent Solution	Resid ual Risk Asse sme nt	Details of Action Taken	Status	Reference
35	Building: General Stores Location Reference: L22 Task: Access to the roof

No slip resistance on ladder rung and bottom rung height is greater than required maximum	Trips, Slips and Falls	Awareness induction	Med	Existing ladder to be replaced	Low	Client advised	Outstanding	OH&S REGULATIONS 3.7 AS/NZS 1657-2013 7.4.3.1 & 7.4.3.4
36	Building: General Stores Location Reference: L22 Task: Access to the roof

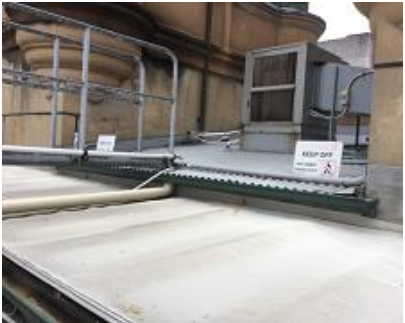
Fall edge is present	Trips, Slips and Falls	Awareness induction	High	Handrail to be installed	Low	Client advised	Outstanding	OH&S REGULATIONS 3.55

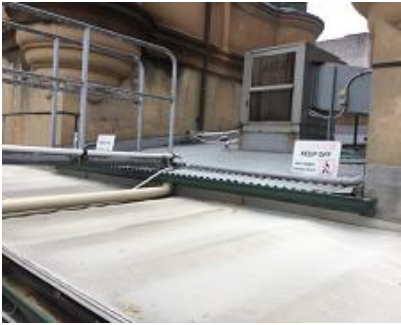
No	Photo of Hazard	Details of Hazard	Details of Risk	Existing/ Immediate Control Measure	Curre nt Risk Level	Proposed Permanent Solution	Resid ual Risk Asse sme nt	Details of Action Taken	Status	Reference
37	Building: General Stores Location Reference: L22 Task: Restrict access to the roof

Brittle roof signs are faded	Trips, Slips and Falls	Awareness induction	High	Brittle roof signs to be replaced	Low	Client advised	Outstanding	OH&S REGULATIONS 3.57
38	Building: General Stores Location Reference: L23 Task: Access to the roof

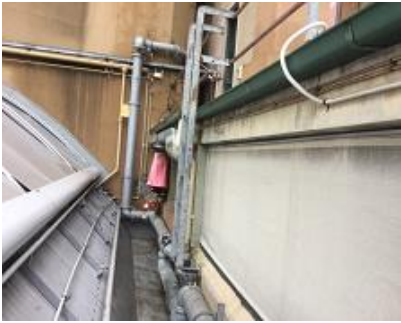
No slip resistance on ladder rung and bottom rung height is greater than required maximum and top rung not levelled with landing	Trips, Slips and Falls	Awareness induction	Med	Existing ladder to be replaced	Low	Client advised	Outstanding	OH&S REGULATIONS 3.7 AS/NZS 1657-2013 7.4.3.1 & 7.4.3.4 & 7.4.3.3

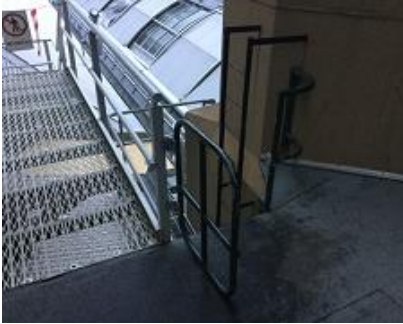
No	Photo of Hazard	Details of Hazard	Details of Risk	Existing/ Immediate Control Measure	Curre nt Risk Level	Proposed Permanent Solution	Resid ual Risk Asse sme nt	Details of Action Taken	Status	Reference
39	Building: General Stores Location Reference: L24 Task: Access to the roof

No slip resistance on ladder rungs and gap between landing and ladder is greater than required maximum	Trips, Slips and Falls	Awareness induction	Med	Non-slip rung caps, platform, handrail and self-closing gate to be installed	Low	Client advised	Outstanding	OH&S REGULATIONS 3.7 AS/NZS 1657-2013 7.4.3.1 & 7.4.8.2
40	Building: General Stores Location Reference: L24 Task: Access to the roof

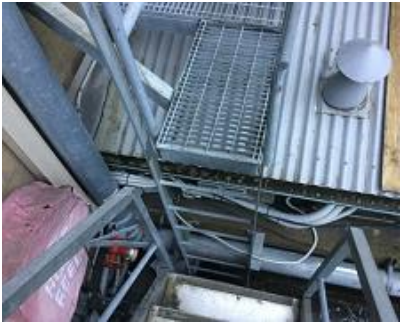
No slip resistance on ladder rungs	Trips, Slips and Falls	Awareness induction	Med	Non-slip rung caps to be installed	Low	Client advised	Outstanding	OH&S REGULATIONS 3.7 AS/NZS 1657-2013 7.4.3.1 & 7.4.8.2

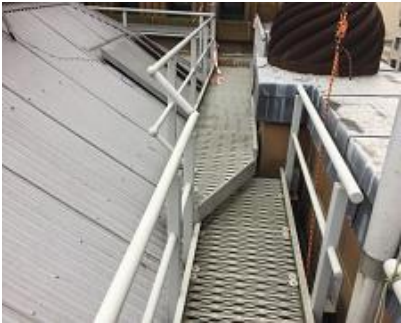
No	Photo of Hazard	Details of Hazard	Details of Risk	Existing/ Immediate Control Measure	Curre nt Risk Level	Proposed Permanent Solution	Resid ual Risk Asse sme nt	Details of Action Taken	Status	Reference
41	Building: General Stores Location Reference: L25 Task: Access to the roof

Variation in height between walkway panels are greater than required maximum	Trips, Slips and Falls	Awareness induction	Med	High visibility safety yellow nosing to be installed	Low	Client advised	Outstanding	OH&S REGULATIONS 3.7 AS/NZS 1657-2013 3.3.4
42	Building: General Stores Location Reference: L26 Task: Access to the roof

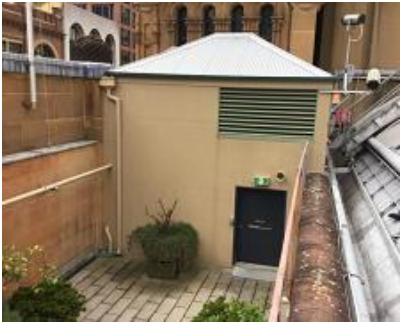
No safe access to the roof	Trips, Slips and Falls	Awareness induction	High	Ladder access bracket, sign, strop and anchors to be installed	Low	Client advised	Outstanding	OH&S REGULATIONS 3.55

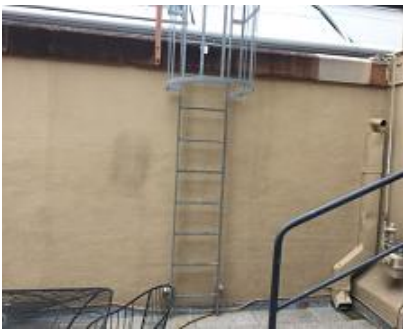
No	Photo of Hazard	Details of Hazard	Details of Risk	Existing/ Immediate Control Measure	Curre nt Risk Level	Proposed Permanent Solution	Resid ual Risk Asse sme nt	Details of Action Taken	Status	Reference
43	Building: General Stores Location Reference: L27 Task: Access to the roof

No slip resistance on ladder rungs and top rung not levelled landing	Trips, Slips and Falls	Awareness induction	Med	Existing ladder to be replaced	Low	Client advised	Outstanding	OH&S REGULATIONS 3.7 AS/NZS 1657-2013 7.4.3.1 & 7.4.3.3
44	Building: General Stores Location Reference: L27 Task: Access to the roof

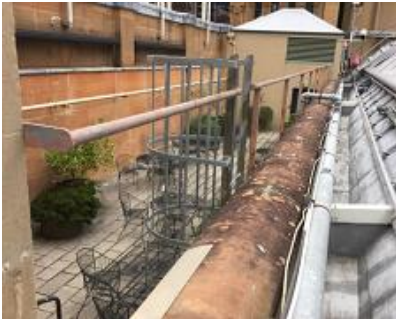
Handrail height is less than required minimum	Trips, Slips and Falls	Awareness induction	Med	Handrail to be replaced	Low	Client advised	Outstanding	OH&S REGULATIONS 3.7 AS/NZS 1657-2013 4.4

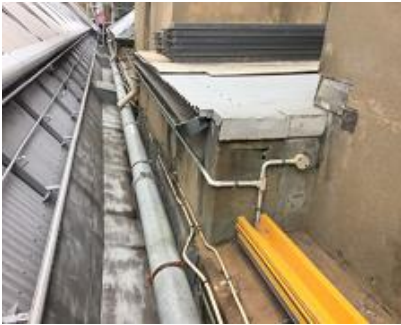
Variation in height between roofs are greater than required maximum	Trips, Slips and Falls	Awareness induction	Med	Access ladder to be installed	Low	Client advised	Outstanding	OH&S REGULATIONS 3.7 AS/NZS 1657-2013 3.1.4
46	Building: General Stores Location Reference: L28 Task: Access to the roof

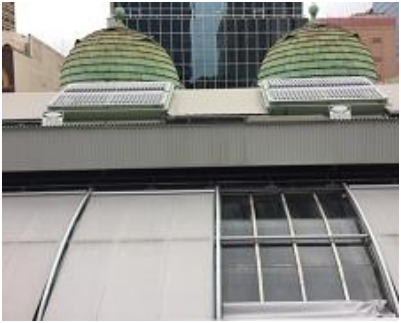
Brittle roof signs are faded	Trips, Slips and Falls	Awareness induction	High	Brittle roof signs to be replaced	Low	Client advised	Outstanding	OH&S REGULATIONS 3.57

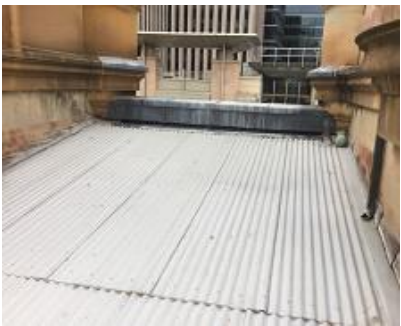
Fall edge is present	Trips, Slips and Falls	Awareness induction	High	Anchor point to be installed	Low	Client advised	Outsta nding	OH&S REGULATIONS 3.55
48	Building: General Stores Location Reference: L29 Task: Restrict access to the roof

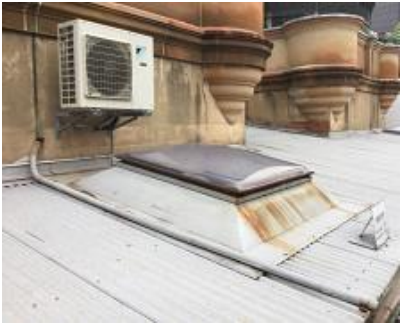
Brittle roof signs are faded	Trips, Slips and Falls	Awareness induction	High	Brittle roof signs to be replaced	Low	Client advised	Outsta nding	OH&S REGULATIONS 3.57

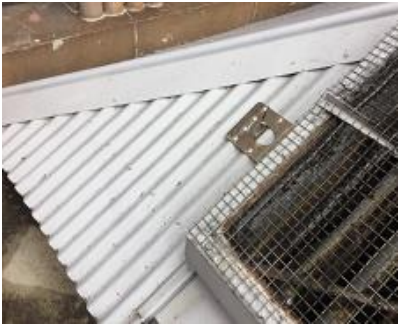
Non-complaint anchors are present as roof sheet is too small to support the anchors	Trips, Slips and Falls	Awareness induction	High	Existing anchors (x2) to be removed and handrail to be installed	Low	Client advised	Outstanding	OH&S REGULATIONS 3.55
50	Building: General Stores Location Reference: L31 Task: Access to the roof

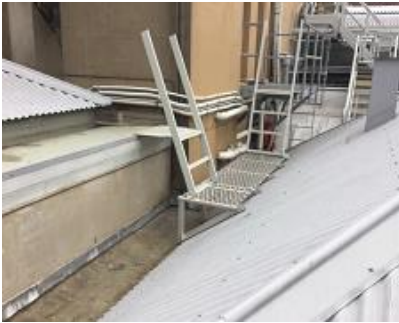
Variation in height between walkway and adjacent surface is greater than required maximum	Trips, Slips and Falls	Awareness induction	Med	Handrail to be installed	Low	Client advised	Outstanding	OH&S REGULATIONS 3.7 AS/NZS 1657-2013 4.4

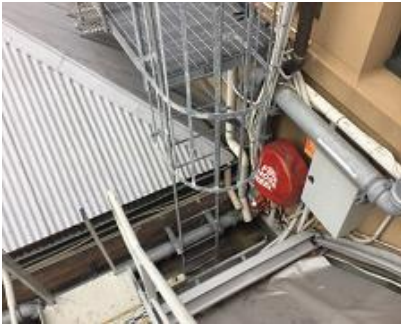
No slip resistance on ladder rungs	Trips, Slips and Falls	Awareness induction	Med	Non-slip rung caps to be installed	Low	Client advised	Outstanding	OH&S REGULATIONS 3.7 AS/NZS 1657-2013 7.4.3.1
52	Building: General Stores Location Reference: L31 Task: Access to the roof

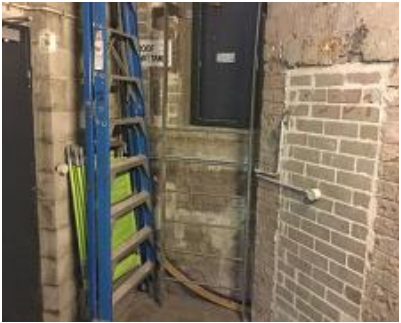
Non-complaint ladder is present	Trips, Slips and Falls	Awareness induction	Med	Existing ladder to be replaced	Low	Client advised	Outstanding	OH&S REGULATIONS 3.7 AS/NZS 1657-2013 7.4

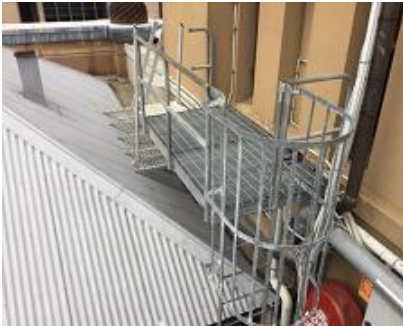
Toe board is missing for handrail	Trips, Slips and Falls	Awareness induction	Med	Toe board to be installed	Low	Client advised	Outstanding	OH&S REGULATIONS 3.7 AS/NZS 1657-2013 4.6
54	Building: General Stores Location Reference: L34 Task: Access to the roof

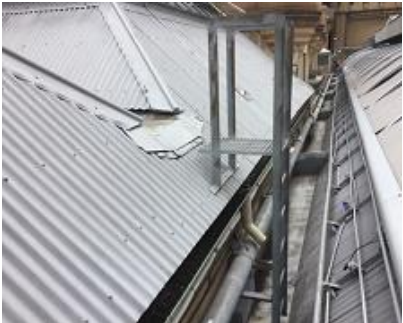
Non-complaint ladder is present	Trips, Slips and Falls	Awareness induction	Med	Existing ladder to be replaced	Low	Client advised	Outstanding	OH&S REGULATIONS 3.7 AS/NZS 1657-2013 7.4

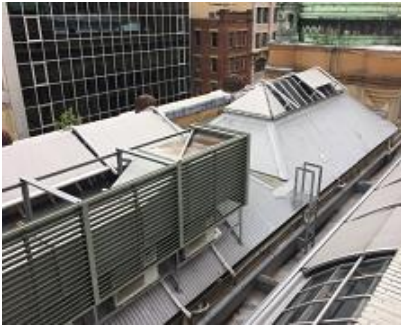
Brittle and Fragile roof sections are present	Trips, Slips and Falls	Restrict Access	High	Brittle roof signs to be installed	Low	Client advised	Outstanding	OH&S REGULATIONS 3.57
56	Building: General Stores Location Reference: L35 Task: Access to the roof

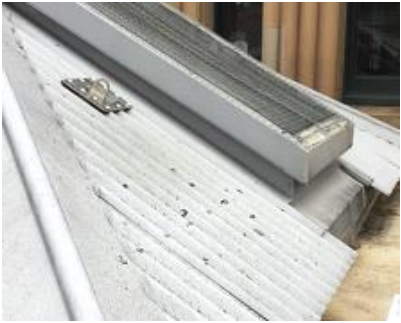
Non-complaint anchors are present as roof sheet is too small to support the anchors	Trips, Slips and Falls	Awareness induction	High	Existing anchors (x2) to be removed	Low	Client advised	Outstanding	OH&S REGULATIONS 3.55

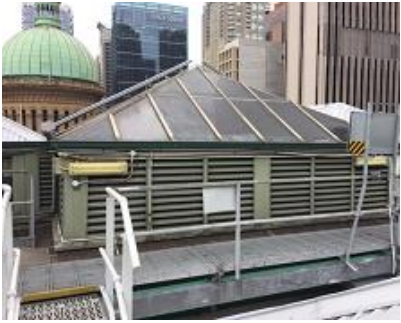
Brittle and Fragile roof sections are present	Trips, Slips and Falls	Restrict Access	High	Brittle roof signs to be installed	Low	Client advised	Outstanding	OH&S REGULATIONS 3.57
