Roof Safety Report

**Queens Plaza Shopping Centre,
QLD 4000**

Prepared By: Safemaster Safety Products
Date: 14 March 2019

Roof Safety Report for
Queens Plaza Shopping Centre, QLD 4000

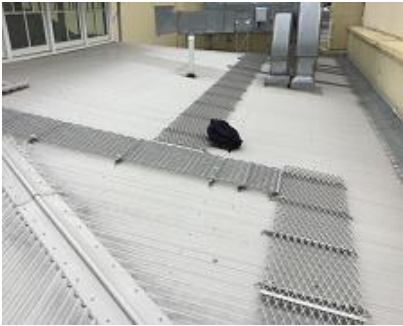
Roof walkway slope perpendicular to the direction of travel is greater than required maximum	Trips, Slips and Falls	Awareness induction	Med	Existing walkway to be re-installed with levelled brackets	Low	Client advised	Outstanding	OH&S REGULATIONS 3.7 AS/NZS 1657-2013 5.1.1
02	Building: General Stores Location Reference: L01 Task: Access to the roof

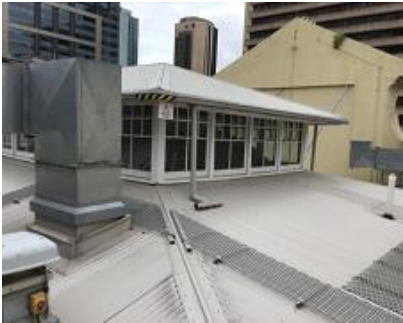
Roof walkway slope direction of travel is greater than required maximum	Trips, Slips and Falls	Awareness induction	Med	Cleats to be installed on existing walkway	Low	Client advised	Outstanding	OH&S REGULATIONS 3.7 AS/NZS 1657-2013 5.1.1

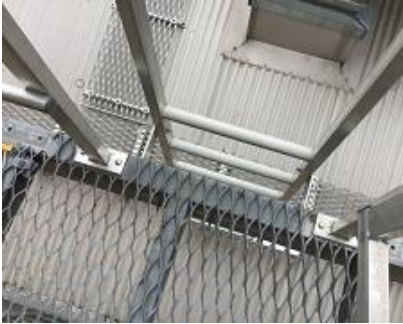
Gap behind the ladder is greater than required maximum	Trips, Slips and Falls	Awareness induction	Med	Gap to be closed	Low	Client advised	Outstanding	OH&S REGULATIONS 3.7 AS/NZS 1657-2013 7.4.8.4
04	Building: General Stores Location Reference: L05 Task: Access to the roof

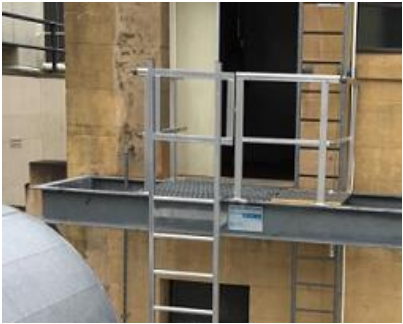
Toe board is missing for handrail	Trips, Slips and Falls	Awareness induction	Med	Toe board to be installed	Low	Client advised	Outstanding	OH&S REGULATIONS 3.7 AS/NZS 1657-2013 4.6

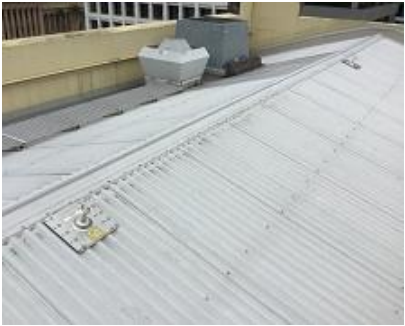
Anchors (x2) installed in- correctly	Trips, Slips and Falls	Awareness induction	High	Anchors (x2) to be replaced	Low	Client advised	Outsta nding	OH&S REGULATIONS 3.55
06	Building: General Stores Location Reference: L06 Task: Access to the roof

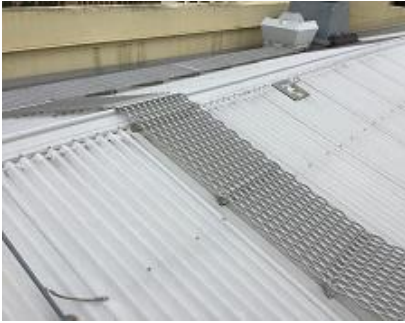
Roof walkway slope direction of travel is greater than required maximum	Trips, Slips and Falls	Awareness induction	Med	Cleats to be installed on existing walkway	Low	Client advised	Outsta nding	OH&S REGULATIONS 3.7 AS/NZS 1657- 2013 5.1.1

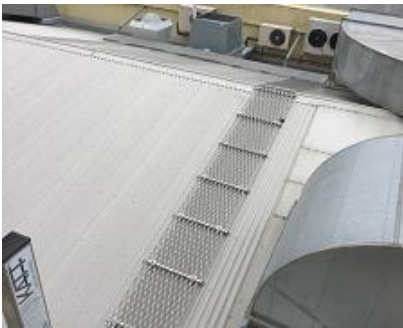
Roof walkway slope direction of travel is greater than required maximum	Trips, Slips and Falls	Awareness induction	Med	Cleats to be installed on existing walkway	Low	Client advised	Outstanding	OH&S REGULATIONS 3.7 AS/NZS 1657-2013 5.1.1
08	Building: General Stores Location Reference: L08 Task: Access to the roof

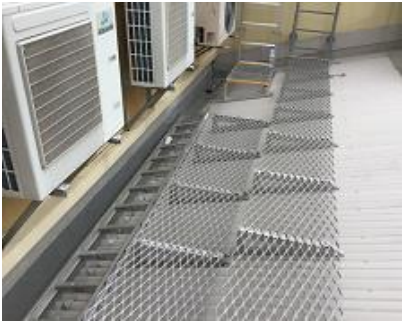
Gap between walkway panels are greater than required maximum	Trips, Slips and Falls	Awareness induction	Med	Additional walkway sections including high visibility safety yellow nosing's to be installed	Low	Client advised	Outstanding	OH&S REGULATIONS 3.7 AS/NZS 1657-2013 3.2.3.4 & 3.3.4

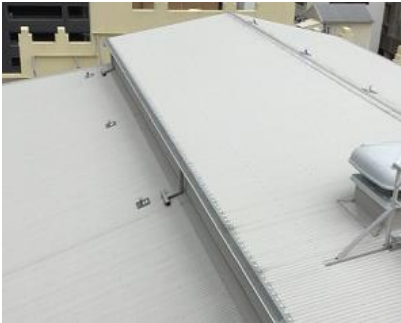
Variation in height between roof levels are greater than required maximum	Trips, Slips and Falls	Awareness induction	Med	Access ladder to be installed	Low	Client advised	Outstanding	OH&S REGULATIONS 3.7 AS/NZS 1657-2013 3.1.4
10	Building: General Stores Location Reference: L10 Task: Restrict Access to the roof

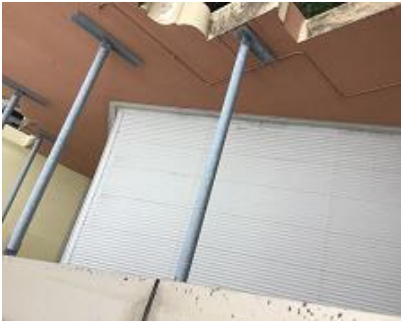
No height safety and safe access system installed	Trips, Slips and Falls	Restrict Access	High	"EWP Access Only" or "No Access" sign to be installed.	Low	Client advised	Outstanding	OH&S REGULATIONS 3.55 & 3.11

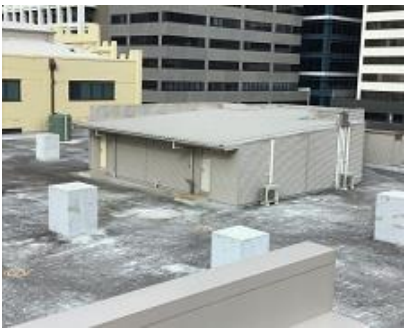
No height safety and safe access system installed	Trips, Slips and Falls	Awareness induction	High	Access ladder, strop and anchors to be installed	Low	Client advised	Outstanding	OH&S REGULATIONS 3.7 & 3.55 AS/NZS 1657-2013 3.1.4
12	Building: General Stores Location Reference: L12 Task: Access to the roof

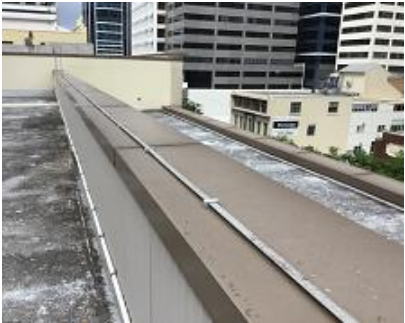
No height safety and safe access system installed	Trips, Slips and Falls	Awareness induction	High	Access ladder and anchors to be installed	Low	Client advised	Outstanding	OH&S REGULATIONS 3.7 & 3.55 AS/NZS 1657-2013 3.1.4

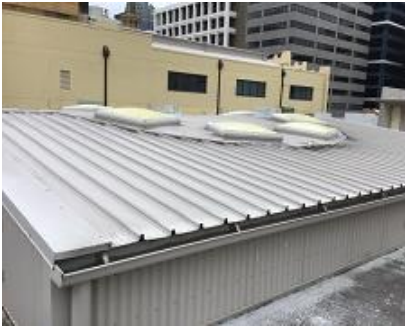
Variation in height between roof levels are greater than required maximum	Trips, Slips and Falls	Awareness induction	Med	Access ladder to be installed	Low	Client advised	Outstanding	OH&S REGULATIONS 3.7 AS/NZS 1657-2013 3.1.4
14	Building: General Stores Location Reference: L14 Task: Access to the roof

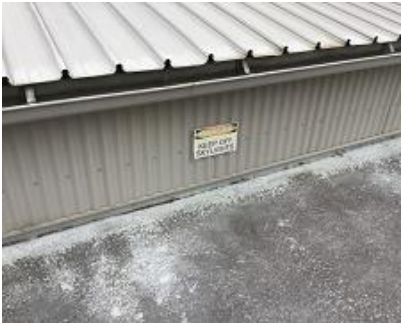
Faded signs are present	Trips, Slips and Falls	Awareness induction	Med	Existing signs to be replaced	Low	Client advised	Outstanding	OH&S REGULATIONS 3.7 & 3.11

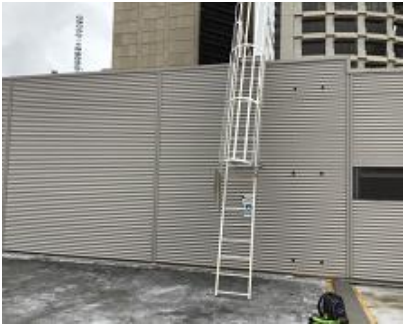
Bottom rung height is less than required minimum	Trips, Slips and Falls	Awareness induction	Med	Landing platform to be installed	Low	Client advised	Outstanding	OH&S REGULATIONS 3.7 AS/NZS 1657-2013 7.4.3.4
16	Building: General Stores Location Reference: L15 Task: Access to the roof

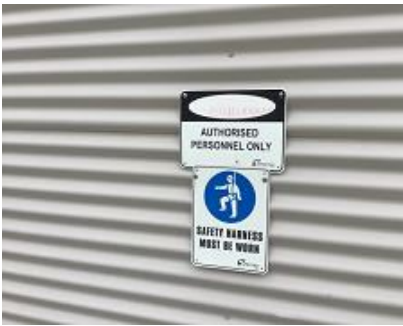
Faded signs are present	Trips, Slips and Falls	Awareness induction	Med	Existing signs to be replaced	Low	Client advised	Outstanding	OH&S REGULATIONS 3.7 & 3.11

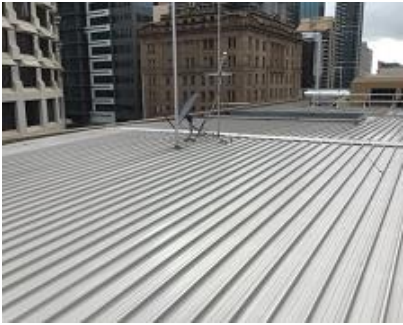
No height safety system installed	Trips, Slips and Falls	Awareness induction	High	Fall arrest anchors to be installed	Low	Client advised	Outstanding	OH&S REGULATIONS 3.55
18	Building: General Stores Location Reference: L18 Task: Access to the roof

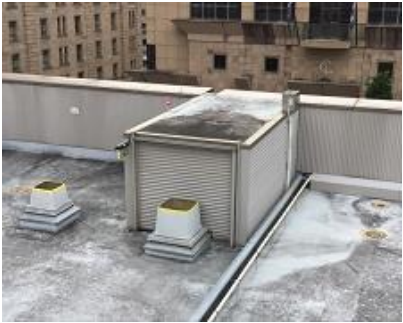
No height safety and safe access system installed	Trips, Slips and Falls	Awareness induction	High	Access ladder and anchors to be installed	Low	Client advised	Outstanding	OH&S REGULATIONS 3.7 & 3.55 AS/NZS 1657-2013 3.1.4

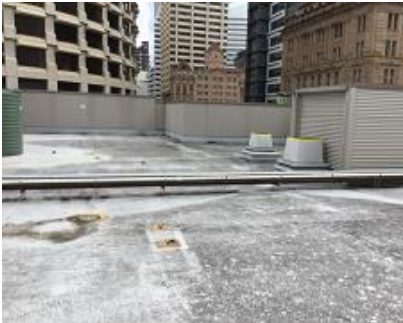
No safe access over cable tray	Trips, Slips and Falls	Awareness induction	Med	Step bridge including handrails and steps at both ends to be installed	Low	Client advised	Outstanding	OH&S REGULATIONS 3.7 AS/NZS 1657-2013 3.1.4
