# Roof Safety Report

**Riverside Plaza Shopping  
Centre, NSW 2620**

Prepared By: Safemaster Safety Products  
Date: 18/09/2019

04-09-2019

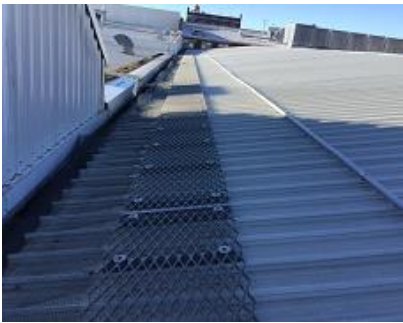
No	Photo of Hazard	Details of Hazard	Details of Risk	Existing/ Immediate Control Measure	Curren t Risk Level	Proposed Permanent Solution	Residu al Risk Assess ment	Details of Action Taken	Status	Reference
121	Building: General Stores Location Reference: <a href="#">L24</a> Task: Access to the roof

Walkway slope perpendicular to the direction of travel is greater than required maximum	Trips, Slips and Falls	Awareness induction	Med	Existing walkway to be replaced with levelled walkway	Low	Client advised	Outstanding	OH&S REGULATIONS 3.7  AS/NZS 1657-2018 5.1
122	Building: General Stores Location Reference: <a href="#">L29</a> Task: Access to the roof

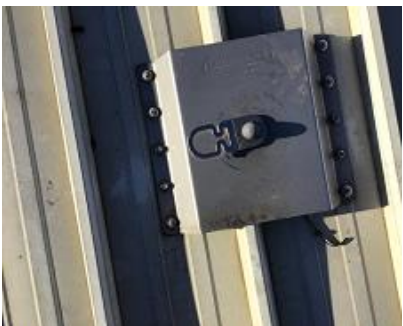
Existing surface mount abseil anchors in-correctly installed	Trips, Slips and Falls	Awareness induction	High	Existing abseil anchors to be replaced (x4)	Low	Client advised	Outstanding	OH&S REGULATIONS 3.55

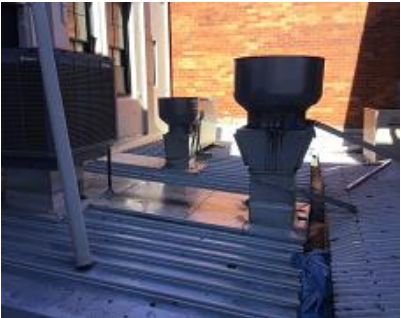
No	Photo of Hazard	Details of Hazard	Details of Risk	Existing/ Immediate Control Measure	Current Risk Level	Proposed Permanent Solution	Residual Risk Assessment	Details of Action Taken	Status	Reference
123	Building: General Stores Location Reference: <a href="#">L43</a> Task: Access to the roof and A/c units

No safe access to the roof and A/c units	Trips, Slips and Falls	Awareness induction	Med	Ladder access bracket, sign, handrails, walkway and ladder to be installed	Low	Client advised	Outstanding	OH&S REGULATIONS 3.7  AS/NZS 1657-2018 3.1.4
