Roof Safety Report

**Riverside Plaza Shopping
Centre, NSW 2620**

Prepared By: Safemaster Safety Products
Date: 08 Jan 2019

20/11/2018

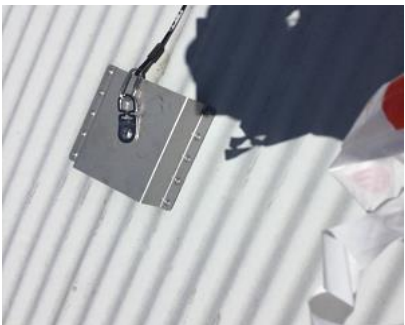
No	Photo of Hazard	Details of Hazard	Details of Risk	Existing/ Immediate Control Measure	Curren t Risk Level	Proposed Permanent Solution	Residu al Risk Assess ment	Details of Action Taken	Status	Reference
120	Building: General Stores Location Reference: L15 Task: Access to the roof

Anchor points installed in- correctly	Trips, Slips and Falls	Awareness induction	High	Existing anchors and strop to be replaced	Low	Client advised	Outsta nding	OH&S REGULATIONS 3.55
