Roof Safety Report

Rockingham Centre, WA 6168

Prepared By: Safemaster Safety Products
Date: 10 Aug 2017

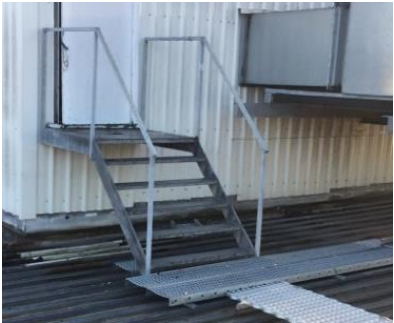
Non-complaint stair is present	Trips, Slips and Falls	Awareness induction	Med	Existing stair to be removed and new ladder to be installed	Low	Client advised	Outstanding	OH&S REGULATIONS 3.7 AS/NZS 1657-2013 7.2
02	Building: Coles Location Reference: L01 Task: Access to the roof

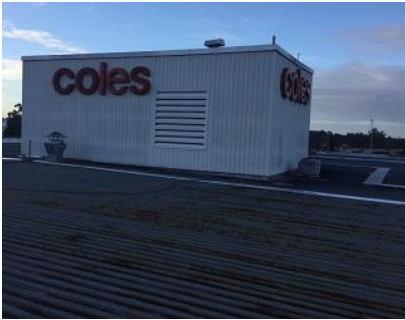
No safe access to the A/c units	Trips, Slips and Falls	N/A	Low	Supply walkway to the A/c units	Low	Client advised	Outstanding	-
04	Building: Coles Location Reference: L03 Task: Access to the plant deck

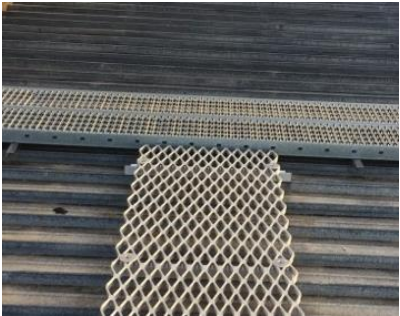
Variation in height between walkway panels are greater than required maximum	Trips, Slips and Falls	Awareness induction	Med	High visibility safety yellow nosing to be installed	Low	Client advised	Outstanding	OH&S REGULATIONS 3.7 AS/NZS 1657-2013 3.3.4

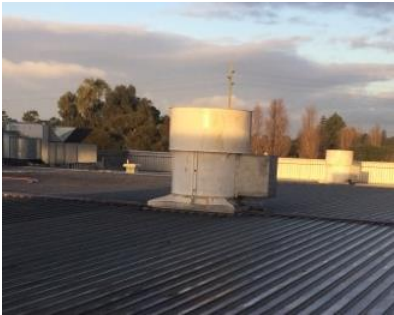
No safe access to the A/c unit	Trips, Slips and Falls	N/A	Low	Supply walkway to the A/c unit	Low	Client advised	Outstanding	-
08	Building: Coles Location Reference: L04 Task: Access to the roof

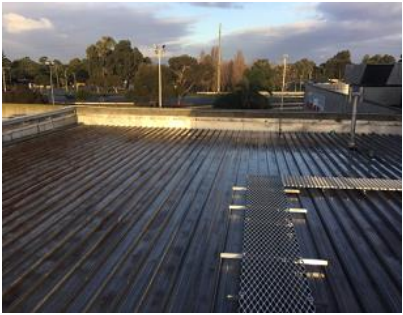
No height safety system installed	Trips, Slips and Falls	Awareness induction	High	Fall arrest anchors to be installed	Low	Client advised	Outstanding	OH&S REGULATIONS 3.55
12	Building: General Stores Location Reference: L07 Task: Access to the A/c unit

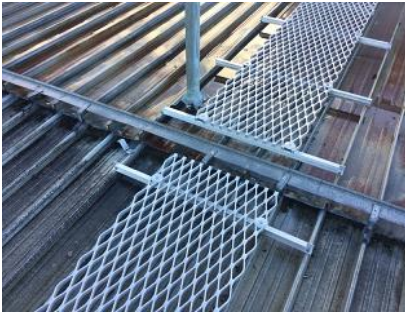
Gap between walkway panels are greater than required maximum	Trips, Slips and Falls	Awareness induction	Med	Bridging walkway section with high visibility safety yellow nosing's to be installed	Low	Client advised	Outstanding	OH&S REGULATIONS 3.7 AS/NZS 1657-2013 3.2.3.4
14	Building: Coles Location Reference: L07 Task: Access to the plant deck

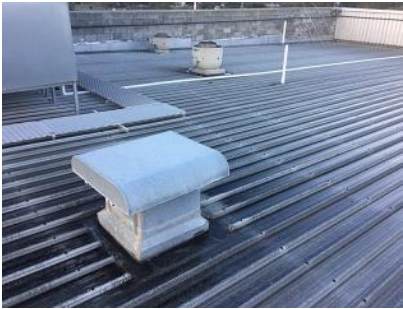
No safe access to the A/c units	Trips, Slips and Falls	N/A	Low	Supply walkway to the A/c units	Low	Client advised	Outstanding	-
16	Building: Coles Location Reference: L08 Task: Restrict access to the roof

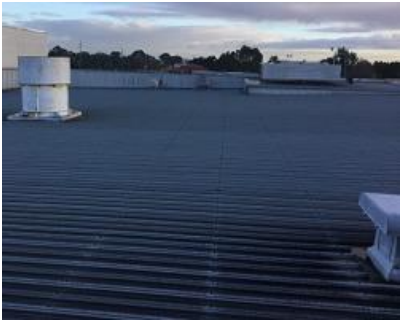
No safe access to the A/c units	Trips, Slips and Falls	N/A	Low	Supply walkway to the A/c units	Low	Client advised	Outstanding	-
18	Building: Coles Location Reference: L10 Task: Access to the plant deck

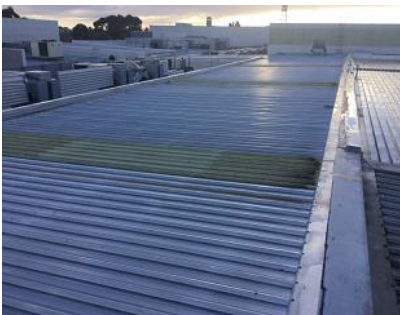
Brittle roof (Non-trafficable roof)	Trips, Slips and Falls	Restrict Access	High	"Warning-Keep Off Brittle and Fragile roof" signs to be installed	Low	Client advised	Outstanding	OH&S REGULATIONS 3.57
22	Building: General Stores Location Reference: L14 Task: Access to the roof

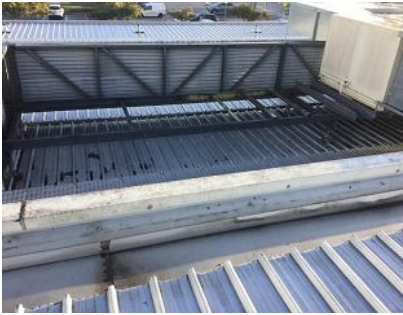
No safe access to the plant deck	Trips, Slips and Falls	Awareness induction	Med	Access ladder, Walkway mesh and handrails to be installed	Low	Client advised	Outstanding	OH&S REGULATIONS 3.7 AS/NZS 1657-2013 3.1.4 & 4.4
24	Building: General Stores Location Reference: L14 Task: Access to the plant deck

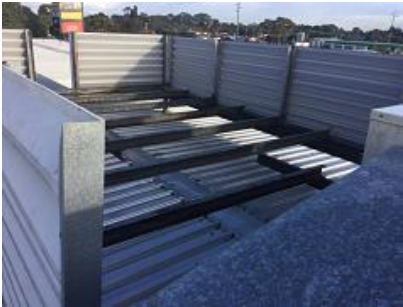
No safe access to the plant deck	Trips, Slips and Falls	Awareness induction	Med	Access ladder, Walkway mesh and handrails to be installed	Low	Client advised	Outstanding	OH&S REGULATIONS 3.7 AS/NZS 1657-2013 3.1.4 & 4.4
26	Building: General Stores Location Reference: L15 Task: Access to the plant deck

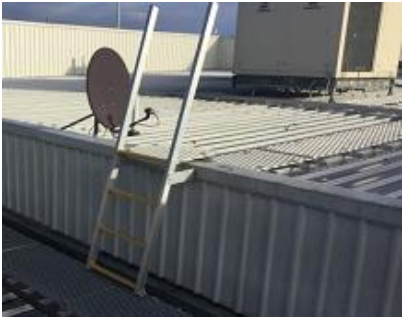
Landing is less than required minimum and bottom rung height is less than required minimum	Trips, Slips and Falls	Awareness induction	Med	Existing ladder to be re-installed with landing platforms and handrails	Low	Client advised	Outstanding	OH&S REGULATIONS 3.7 AS/NZS 1657-2013 7.3.6 & 7.4.3.4
32	Building: General Stores Location Reference: L19 Task: Access to the roof

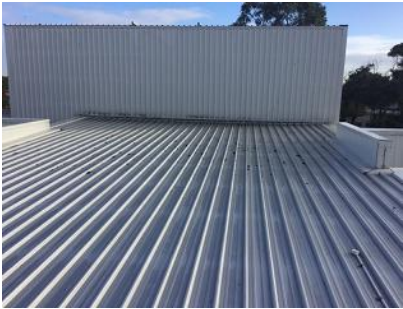
No height safety system installed	Trips, Slips and Falls	Awareness induction	High	Fall arrest anchor to be installed	Low	Client advised	Outstanding	OH&S REGULATIONS 3.55
34	Building: General Stores Location Reference: L21 Task: Access to the roof

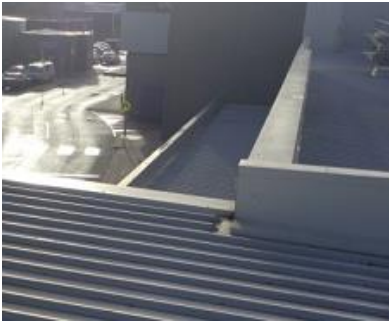
No height safety system installed and No safe access to roof	Trips, Slips and Falls	Awareness induction	High	Fall arrest anchors, anchor stop and access ladder to be installed	Low	Client advised	Outstanding	OH&S REGULATIONS 3.55 & 3.7 AS/NZS 1657-2013 3.1.4
36	Building: General Stores Location Reference: L23 Task: Access to the roof

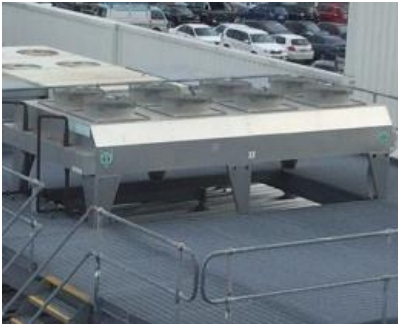
Variation in height between plant deck and unit is greater than required maximum	Trips, Slips and Falls	Awareness induction	Med	Midrail to be installed	Low	Client advised	Outstanding	OH&S REGULATIONS 3.7 AS/NZS 1657-2013 4.4
38	Building: General Stores Location Reference: L24 Task: Access to the roof

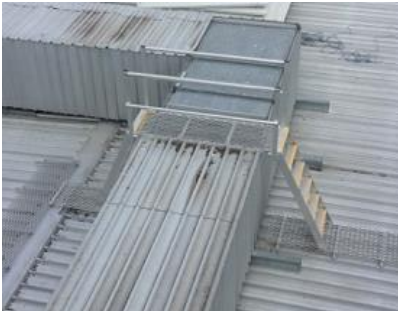
Handrail is missing at ladder	Trips, Slips and Falls	Awareness induction	Med	Existing handrails to be removed and new handrails to be installed	Low	Client advised	Outstanding	OH&S REGULATIONS 3.7 AS/NZS 1657-2013 7.3.4

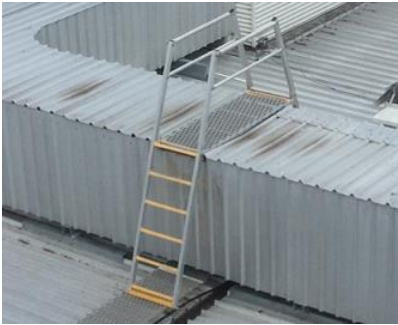
Bottom rung height is less than required minimum and non-complaint handrails is present	Trips, Slips and Falls	Awareness induction	Med	Landing platforms to be installed and mid rails to be re-positioned	Low	Client advised	Outstanding	OH&S REGULATIONS 3.7 AS/NZS 1657-2013 7.4.3.4 & 4.4
42	Building: General Stores Location Reference: L28 Task: Access to the plant deck

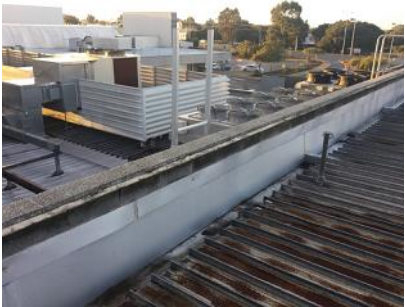
Landing platform and return ladder is missing	Trips, Slips and Falls	Awareness induction	Med	Return ladder including landing platforms and preformed handrails to be installed	Low	Client advised	Outstanding	OH&S REGULATIONS 3.7 AS/NZS 1657-2013 7.3.6 & 3.1.4
54	Building: General Stores Location Reference: L32 Task: Access to the roof

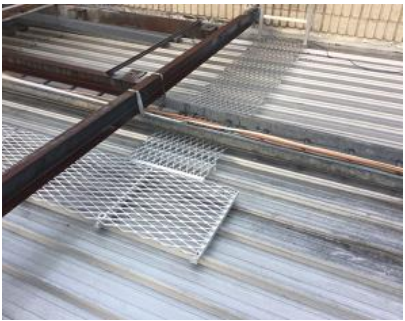
Cable tray and beam installed over the walkway path	Trips, Slips and Falls	Awareness induction	Med	Step over and Bridging platform ladder to be installed	Low	Client advised	Outstanding	OH&S REGULATIONS 3.7 AS/NZS 1657-2013 3.1.4

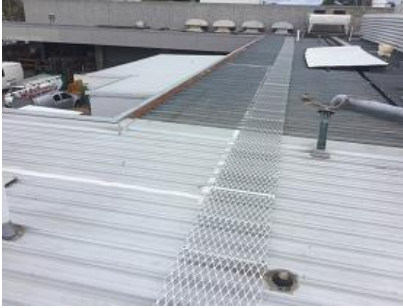
No height safety system installed	Trips, Slips and Falls	Awareness induction	High	Static line to be installed	Low	Client advised	Outstanding	OH&S REGULATIONS 3.55
62	Building: General Stores Location Reference: L37 Task: Access to the plant deck

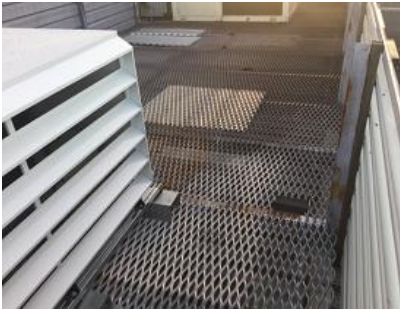
Hole in the plant deck mesh	Trips, Slips and Falls	Awareness induction	Med	Walkway mesh to be installed to cover the holes	Low	Client advised	Outstanding	OH&S REGULATIONS 3.7
66	Building: General Stores Location Reference: L37 Task: Access to the plant deck

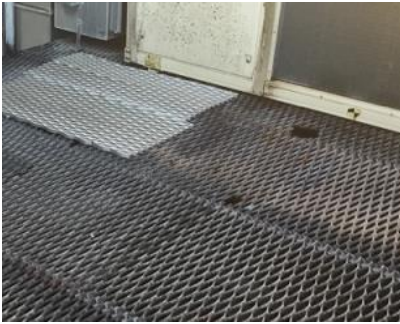
Hole in the plant deck mesh	Trips, Slips and Falls	Awareness induction	Med	Walkway mesh to be installed to cover the holes	Low	Client advised	Outstanding	OH&S REGULATIONS 3.7

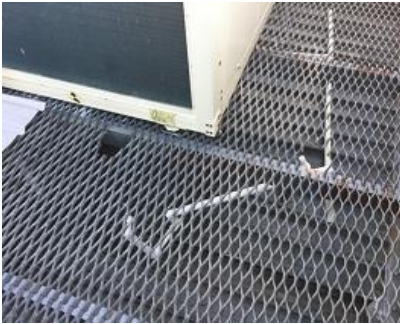
Hole in the plant deck mesh	Trips, Slips and Falls	Awareness induction	Med	Walkway mesh to be installed to cover the holes	Low	Client advised	Outsta nding	OH&S REGULATIONS 3.7

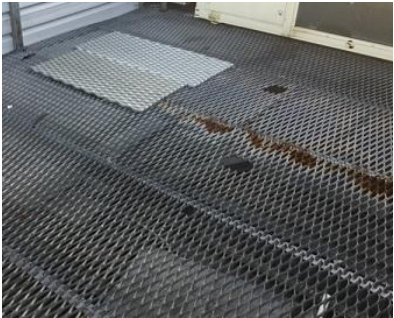
Hole in the plant deck mesh	Trips, Slips and Falls	Awareness induction	Med	Walkway mesh to be installed to cover the holes	Low	Client advised	Outstanding	OH&S REGULATIONS 3.7
70	Building: General Stores Location Reference: L38 Task: Access to the plant deck

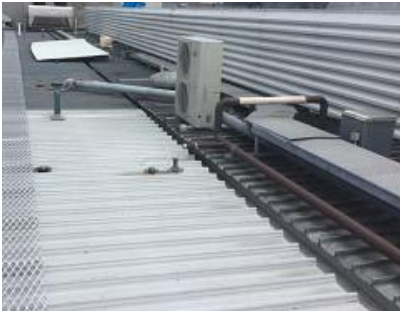
No safe access to the A/c units	Trips, Slips and Falls	N/A	Low	Supply walkway to the A/c units	Low	Client advised	Outstanding	-

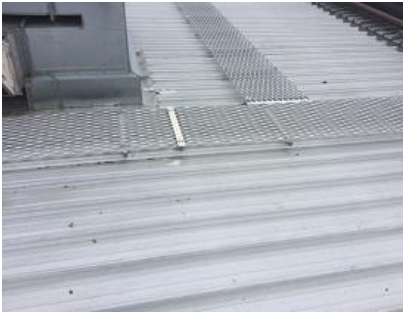
Roof walkway installed with insufficient channels	Trips, Slips and Falls	Awareness induction	Med	Additional channels to be installed	Low	Client advised	Outstanding	OH&S REGULATIONS 3.7
76	Building: General Stores Location Reference: L39 Task: Access to the A/c units

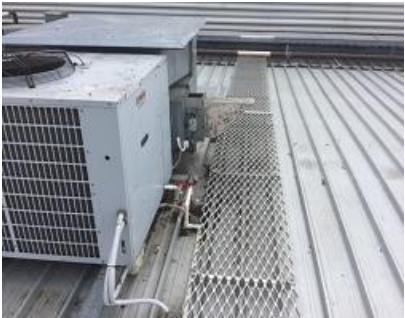
A/c unit duct protrudes over the walkway path	Trips, Slips and Falls	Awareness induction	Med	Additional walkway section to be installed	Low	Client advised	Outstanding	OH&S REGULATIONS 3.7
78	Building: General Stores Location Reference: L39 Task: Access to the A/c units

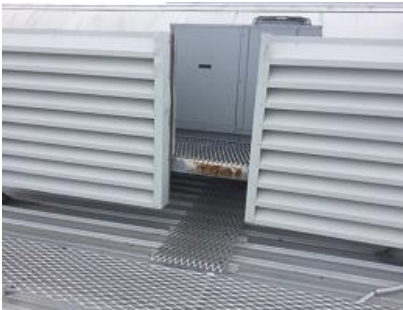
Variation in height between plant deck and roof is greater than required maximum	Trips, Slips and Falls	Awareness induction	Med	Access ladder including handrails to be installed	Low	Client advised	Outstanding	OH&S REGULATIONS 3.7 AS/NZS 1657-2013 3.1.4
82	Building: General Stores Location Reference: L40 Task: Access to the plant deck

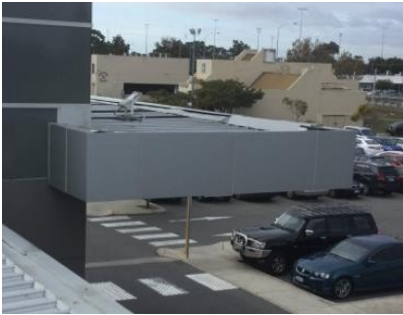
No height safety system installed	Trips, Slips and Falls	Restrict Access	High	"EWP Access Only" sign to be installed	Low	Client advised	Outstanding	OH&S REGULATIONS 3.55 & 3.11
86	Building: General Stores Location Reference: L44 Task: Restrict access to the roof

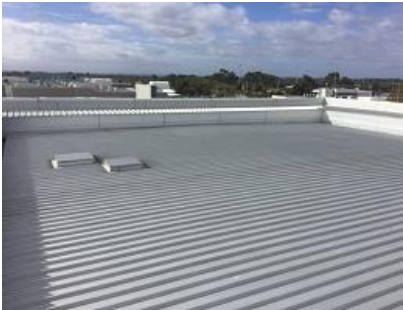
Variation in height between roofs are greater than required maximum	Trips, Slips and Falls	Awareness induction	Med	Access ladder including handrails to be installed	Low	Client advised	Outstanding	OH&S REGULATIONS 3.7 AS/NZS 1657-2013 3.1.4
92	Building: General Stores Location Reference: L47 Task: Access to the A/c unit

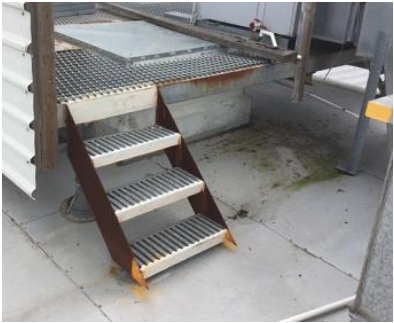
Non-complaint stair is present	Trips, Slips and Falls	Awareness induction	Med	Existing stair to be removed and New ladder including handrails to be installed	Low	Client advised	Outstanding	OH&S REGULATIONS 3.7 AS/NZS 1657-2013 7.2
94	Building: General Stores Location Reference: L48 Task: Access to the plant deck

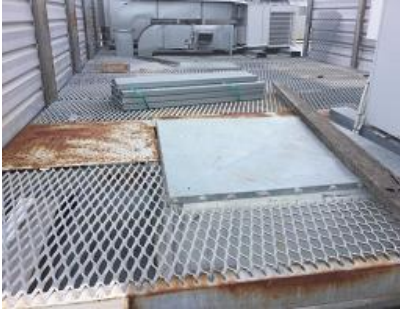
Trip hazards over the plant deck	Trips, Slips and Falls	Awareness induction	Med	High visibility safety yellow tape to be installed	Low	Client advised	Outstanding	OH&S REGULATIONS 3.7
96	Building: General Stores Location Reference: L48 Task: Access to the plant deck

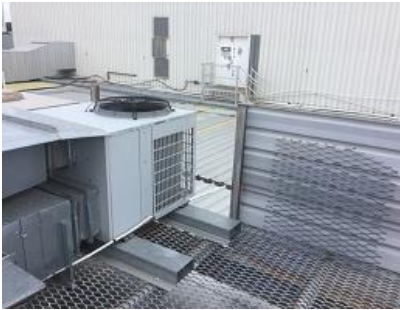
Variation in height between plant deck and roof is greater than required maximum	Trips, Slips and Falls	Awareness induction	Med	Handrails to be installed	Low	Client advised	Outstanding	OH&S REGULATIONS 3.7 AS/NZS 1657-2013 4.4

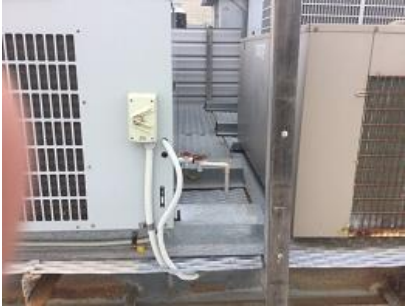
Trip hazards over the plant deck	Trips, Slips and Falls	Awareness induction	Med	High visibility safety yellow tape to be installed	Low	Client advised	Outstanding	OH&S REGULATIONS 3.7
98	Building: General Stores Location Reference: L49 Task: Access to the plant deck

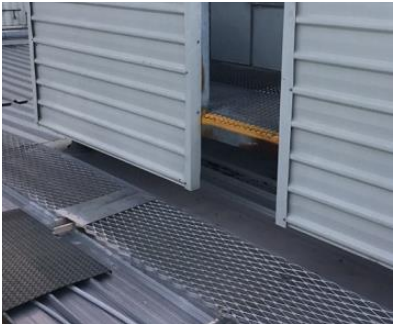
Variation in height between plant deck and roof is greater than required maximum	Trips, Slips and Falls	Awareness induction	Med	Access ladder including handrails to be installed	Low	Client advised	Outstanding	OH&S REGULATIONS 3.7 AS/NZS 1657-2013 3.1.4

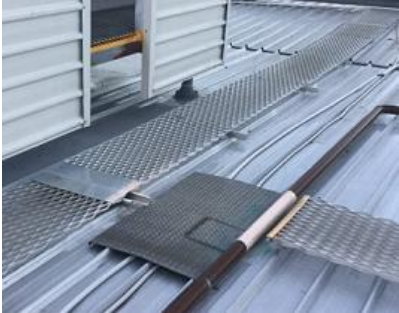
Variation in height between walkway panels are greater than required maximum and pipe installed over the walkway path	Trips, Slips and Falls	Awareness induction	Med	Additional walkway sections and step over to be installed	Low	Client advised	Outstanding	OH&S REGULATIONS 3.7 AS/NZS 1657-2013 3.3.4
100	Building: General Stores Location Reference: L49 Task: Access to the roof

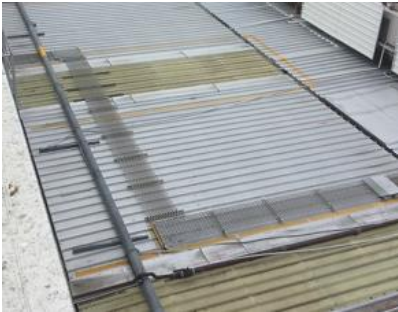
Walkway installed over the fragile roof and Pipe installed over the walkway path	Trips, Slips and Falls	Restrict Access	High	Handrails and step over to be installed	Low	Client advised	Outstanding	OH&S REGULATIONS 3.7 AS/NZS 1657-2013 5.4.1 & 3.1.4
102	Building: General Stores Location Reference: L50 Task: Access to the roof

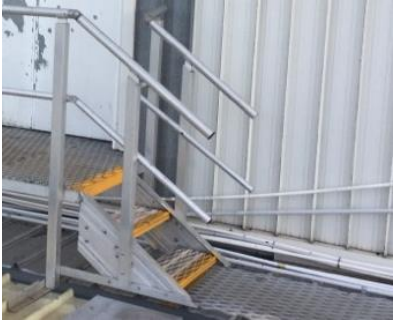
Non-complaint stair is present	Trips, Slips and Falls	Awareness induction	Med	Existing stair to be removed and New ladder including handrails to be installed	Low	Client advised	Outstanding	OH&S REGULATIONS 3.7 AS/NZS 1657-2013 7.2
104	Building: General Stores Location Reference: L50 Task: Access to the roof

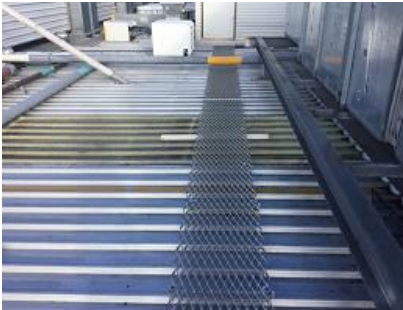
Brittle roof (Non-trafficable roof)	Trips, Slips and Falls	Restrict Access	High	Handrails to be installed and "Warning-Keep Off-Brittle and Fragile roof" sign to be installed	Low	Client advised	Outstanding	OH&S REGULATIONS 3.7 & 3.57 AS/NZS 1657-2013 4.4
112	Building: General Stores Location Reference: L52 Task: Access to the roof

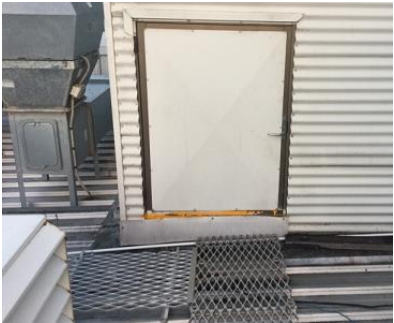
Headroom is less than required minimum	Trips, Slips and Falls	Awareness induction	High	"Caution-Low Headroom" Signs to be installed	Low	Client advised	Outstanding	OH&S REGULATIONS 3.11 & 3.7 AS/NZS 1657-2013 3.1.5
114	Building: General Stores Location Reference: L54 Task: Restrict access to the roof

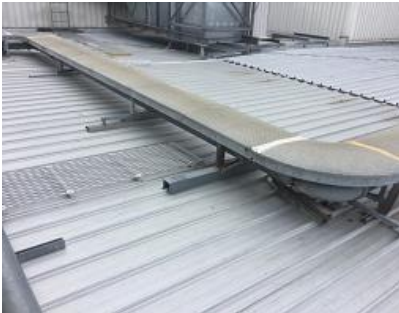
Variation in height between walkway panels are greater than required maximum	Trips, Slips and Falls	Awareness induction	Med	Single step to be installed	Low	Client advised	Outstanding	OH&S REGULATIONS 3.7 AS/NZS 1657-2013 3.1.4

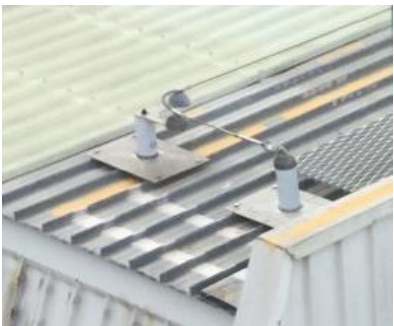
Non-complaint static line is present	Trips, Slips and Falls	Awareness induction	High	Existing static line to be removed and new static line to be installed	Low	Client advised	Outstanding	OH&S REGULATIONS 3.55
130	Building: General Stores Location Reference: L61 Task: Restrict access to the roof

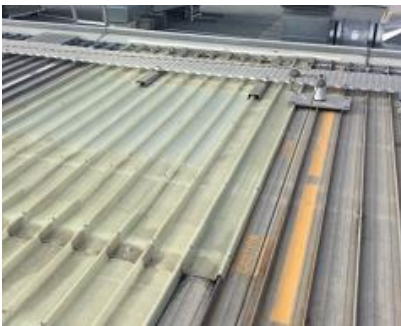
Gap between walkway and fall edge is less than required minimum	Trips, Slips and Falls	Awareness induction	High	Handrails to be installed	Low	Client advised	Outstanding	OH&S REGULATIONS 3.7 AS/NZS 1657-2013 4.4
132	Building: General Stores Location Reference: L62 Task: Access to the roof

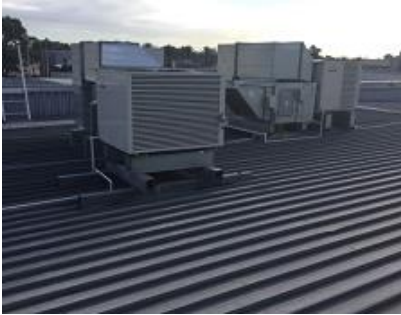
No safe access to the A/c units	Trips, Slips and Falls	N/A	Low	Supply walkway to the A/c units	Low	Client advised	Outstanding	-
136	Building: General Stores Location Reference: L62 Task: Access to the roof

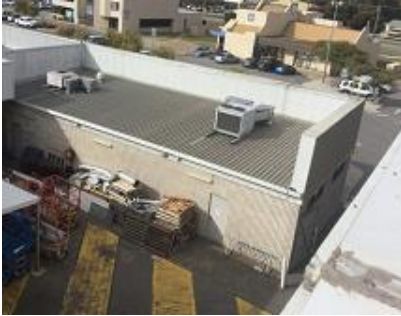
No height safety system installed	Trips, Slips and Falls	Awareness induction	High	Fall arrest anchors, anchor stop, ladder access bracket and signage to be installed	Low	Client advised	Outstanding	OH&S REGULATIONS 3.55
146	Building: General Stores Location Reference: L66 Task: Access to the A/c units

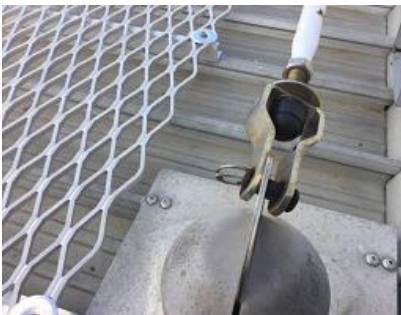
Non-compliant static line is present	Trips, Slips and Falls	Awareness induction	High	Existing static line to be removed and new static line to be installed	Low	Client advised	Outstanding	OH&S REGULATIONS 3.55
150	Building: General Stores Location Reference: L69 Task: Restrict access to the roof

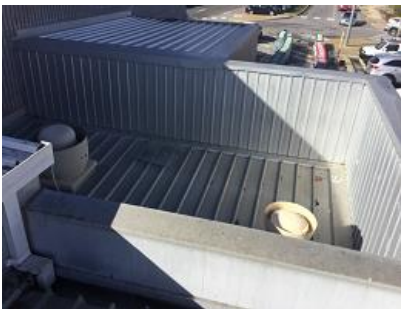
Variation in height between roofs are greater than required maximum	Trips, Slips and Falls	Awareness induction	Med	Access ladders including handrails to be installed	Low	Client advised	Outstanding	OH&S REGULATIONS 3.7 AS/NZS 1657-2013 3.1.4
152	Building: General Stores Location Reference: L70 Task: Access to the roof

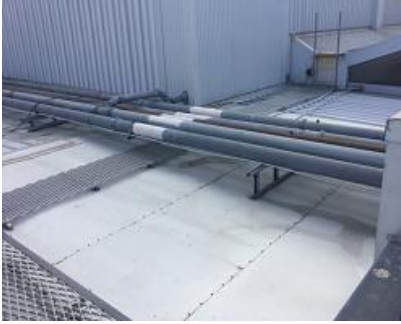
Pipes installed over the walkway path	Trips, Slips and Falls	Awareness induction	Med	Step Bridge to be installed	Low	Client advised	Outstanding	OH&S REGULATIONS 3.7 AS/NZS 1657-2013 3.1.4
166	Building: General Stores Location Reference: L74 Task: Access to the roof

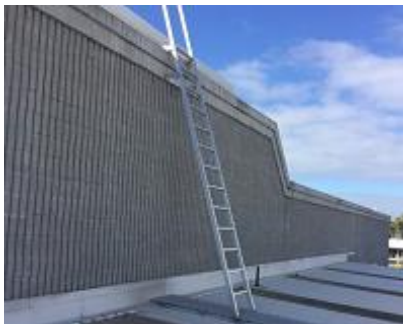
Bottom rung height is less than required minimum and Landing platforms and handrails is missing	Trips, Slips and Falls	Awareness induction	Med	Existing ladder to be re-installed with new landing platforms, brackets and handrails to be installed	Low	Client advised	Outstanding	OH&S REGULATIONS 3.7 AS/NZS 1657-2013 7.4.3.4 & 7.3.6
228	Building: Kmart Location Reference: L97 Task: Access to the A/c unit
