# Roof Safety Report

**Roxburgh Village, VIC 3064**

Prepared By: Safemaster Safety Products  
Date: 18 June 2018

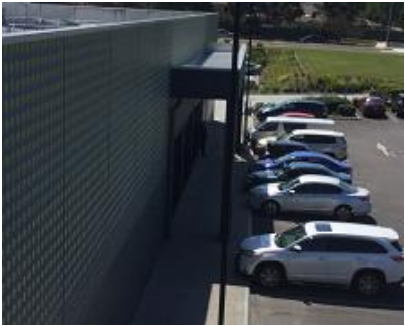
No height safety system installed	Trips, Slips and Falls	Restrict Access	High	"EWP Access Only" signs to be installed	Low	Client advised	Outstanding	OH&S REGULATIONS 3.55 & 3.11
02	Building: General Stores Location Reference: <a href="#">L02</a> Task: Access to the roof

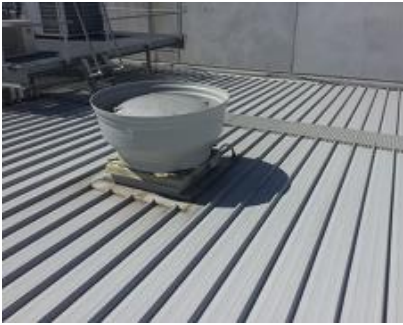
No safe access to the A/c units	Trips, Slips and Falls	N/A	Low	Supply Walkway to the A/c units	Low	Client advised	Outstanding	-
04	Building: General Stores Location Reference: <a href="#">L03</a> Task: Access to the roof

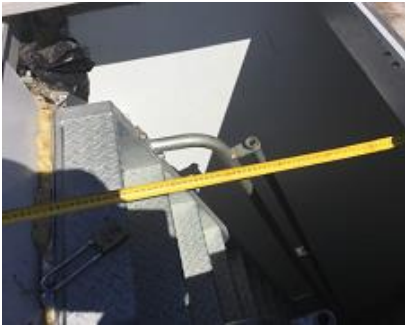
Clearance behind the ladder is less than required minimum	Trips, Slips and Falls	Awareness induction	Med	Existing hatch to be removed and new hatch to be installed	Low	Client advised	Outstanding	OH&S REGULATIONS 3.7  AS/NZS 1657-2013 7.4.5
06	Building: General Stores Location Reference: <a href="#">L04</a> Task: Access to the A/c units

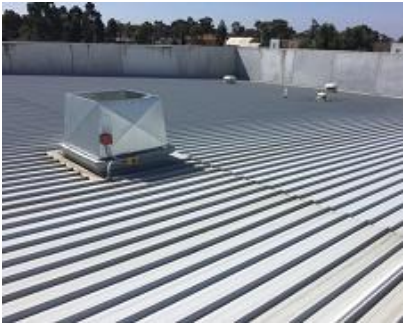
No safe access to the A/c units	Trips, Slips and Falls	N/A	Low	Supply Walkway to the A/c units	Low	Client advised	Outstanding	-
08	Building: General Stores Location Reference: <a href="#">L05</a> Task: Access to the roof

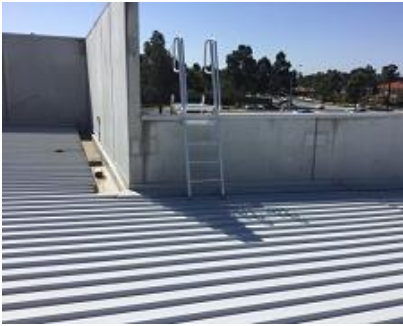
Bottom rung height is greater than required maximum, Handrail projecting towards the user and No landing platform installed	Trips, Slips and Falls	Awareness induction	Med	Existing handrail to be removed and new handrail including landing platforms to be installed	Low	Client advised	Outstanding	OH&S REGULATIONS 3.7  AS/NZS 1657-2013 7.4.3.4, 7.4.8.5 & 7.3.6
10	Building: General Stores Location Reference: <a href="#">L06</a> Task: Restrict access to the roof

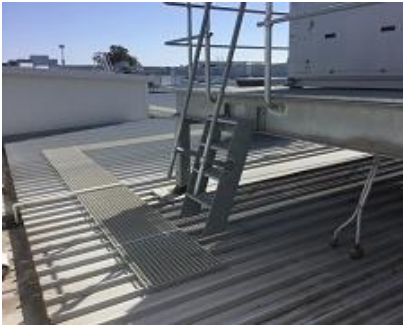
Bottom tread height is greater than required maximum and landing is less than required minimum	Trips, Slips and Falls	Awareness induction	Med	Landing platform to be installed	Low	Client advised	Outstanding	OH&S REGULATIONS 3.7  AS/NZS 1657-2013 7.4.3.4 & 7.3.6
12	Building: General Stores Location Reference: <a href="#">L08</a> Task: Access to the roof

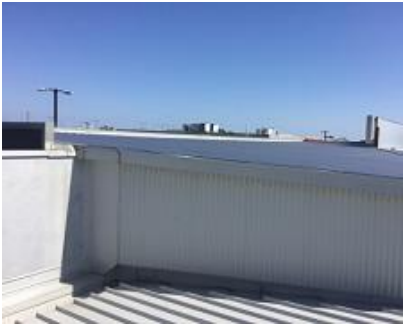
No height safety system installed	Trips, Slips and Falls	Awareness induction	High	Fall arrest anchors to be installed	Low	Client advised	Outstanding	OH&S REGULATIONS 3.55
14	Building: General Stores Location Reference: <a href="#">L09</a> Task: Access to the roof

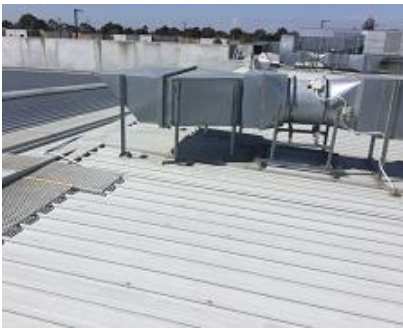
No safe access to the A/c units	Trips, Slips and Falls	N/A	Low	Supply Walkway to the A/c units	Low	Client advised	Outstanding	-
16	Building: General Stores Location Reference: <a href="#">L10</a> Task: Access to the roof

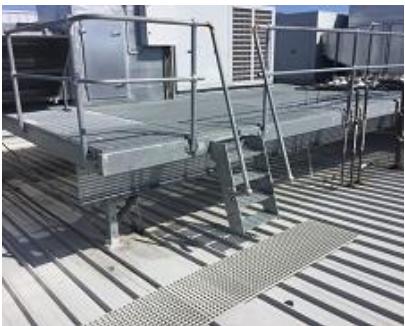
Landing is less than required minimum	Trips, Slips and Falls	Awareness induction	Med	Landing platform to be installed	Low	Client advised	Outstanding	OH&S REGULATIONS 3.7  AS/NZS 1657-2013 7.3.6
18	Building: General Stores Location Reference: <a href="#">L12</a> Task: Access to the roof

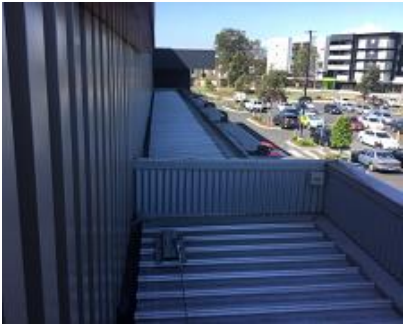
No height safety system installed	Trips, Slips and Falls	Awareness induction	High	Fall arrest static line to be installed	Low	Client advised	Outstanding	OH&S REGULATIONS 3.55
20	Building: General Stores Location Reference: <a href="#">L13</a> Task: Access to the roof

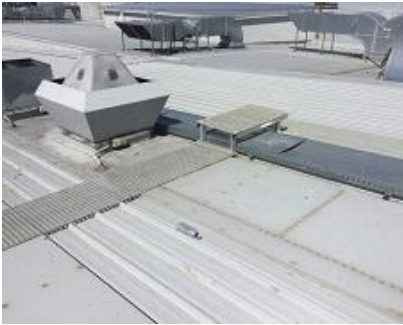
Non-complaint step is present	Trips, Slips and Falls	Awareness induction	Med	Existing step to be removed and new step to be installed	Low	Client advised	Outstanding	OH&S REGULATIONS 3.7  AS/NZS 1657-2013 3.1.4
22	Building: General Stores Location Reference: <a href="#">L14</a> Task: Access to the A/c units

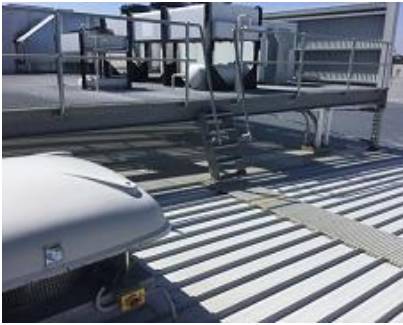
Non-complaint ladder is present	Trips, Slips and Falls	Awareness induction	Med	Existing ladder to be removed and new ladder to be installed	Low	Client advised	Outstanding	OH&S REGULATIONS 3.7  AS/NZS 1657-2013 7.4
24	Building: General Stores Location Reference: <a href="#">L15</a> Task: Access to the roof

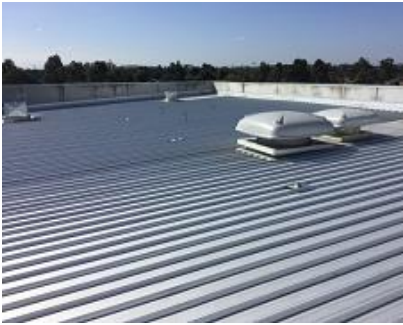
No safe access to the A/c units	Trips, Slips and Falls	N/A	Low	Supply Walkway and handrail to the A/c units	Low	Client advised	Outstanding	-
26	Building: General Stores Location Reference: <a href="#">L17</a> Task: Access to the roof

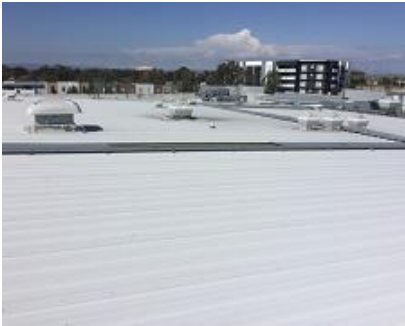
No safe access to the A/c units	Trips, Slips and Falls	N/A	Low	Supply Walkway, Step overs and Handrail to the A/c units	Low	Client advised	Outstanding	-
30	Building: General Stores Location Reference: <a href="#">L20</a> Task: Access to the A/c units

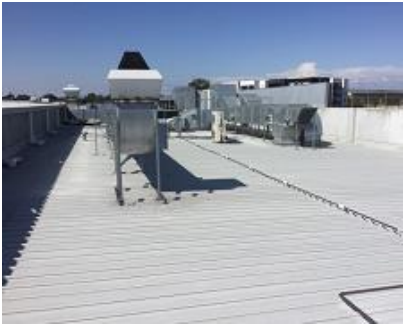
No safe access to the A/c units	Trips, Slips and Falls	N/A	Low	Supply Walkway to the A/c units	Low	Client advised	Outstanding	-
32	Building: General Stores Location Reference: <a href="#">L21</a> Task: Access to the A/c units

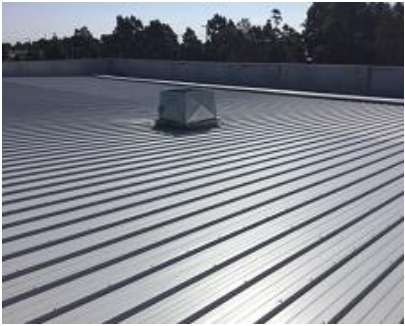
No safe access to the A/c units	Trips, Slips and Falls	N/A	Low	Supply Walkway to the A/c units	Low	Client advised	Outstanding	-
34	Building: General Stores Location Reference: <a href="#">L23</a> Task: Access to the roof

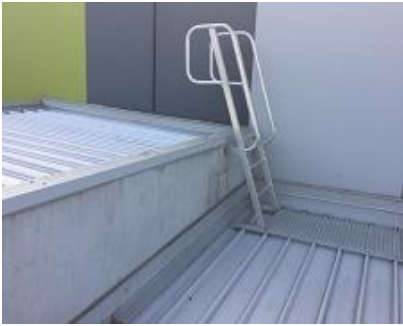
Top rung not levelled with landing, Bottom rung height is greater than required maximum and handrail projecting towards the user	Trips, Slips and Falls	Awareness induction	Med	Existing handrail to be removed. Existing ladder to be re-installed with landing platforms, brackets and handrail	Low	Client advised	Outstanding	OH&S REGULATIONS 3.7  AS/NZS 1657-2013 7.4.3.3, 7.4.3.4 & 7.4.8.5
36	Building: General Stores Location Reference: <a href="#">L24</a> Task: Access to the A/c units

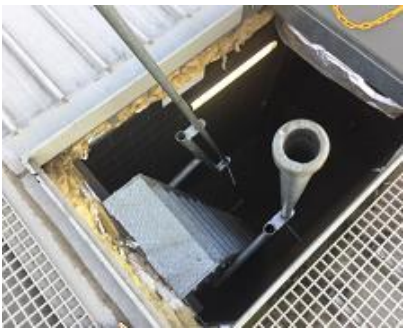
Top rung not levelled with landing	Trips, Slips and Falls	Awareness induction	Med	Existing ladder to be removed and new ladder to be installed	Low	Client advised	Outstanding	OH&S REGULATIONS 3.7  AS/NZS 1657-2013 7.4.3.3
38	Building: General Stores Location Reference: <a href="#">L25</a> Task: Access to the roof

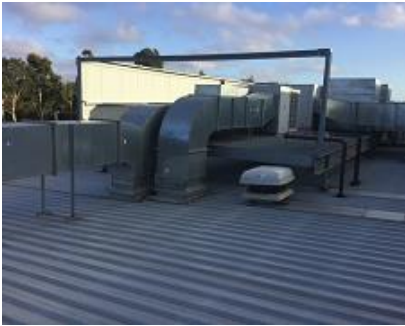
Variation in height between plant deck and roof is greater than required maximum	Trips, Slips and Falls	Awareness induction	Med	Handrail to be installed	Low	Client advised	Outstanding	OH&S REGULATIONS 3.7  AS/NZS 1657-2013 4.4
40	Building: General Stores Location Reference: <a href="#">L26</a> Task: Access to the A/c units

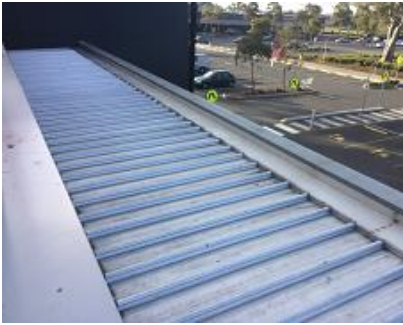
No height safety system installed	Trips, Slips and Falls	Restrict Access	High	"EWP Access Only" sign to be installed	Low	Client advised	Outstanding	OH&S REGULATIONS 3.55 & 3.11
42	Building: General Stores Location Reference: <a href="#">L28</a> Task: Access to the roof

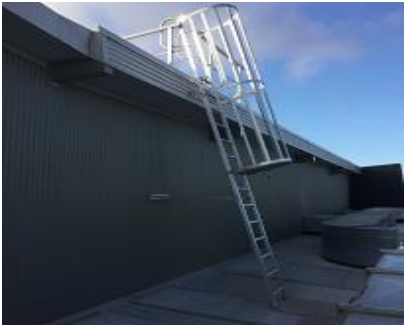
Bottom rung height is less than required minimum	Trips, Slips and Falls	Awareness induction	Med	Landing platform to be installed	Low	Client advised	Outstanding	OH&S REGULATIONS 3.7  AS/NZS 1657-2013 7.4.3.4
44	Building: General Stores Location Reference: <a href="#">L29</a> Task: Access to the roof

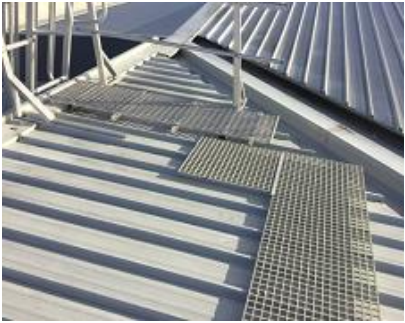
Variation in height between walkway panels are greater than required maximum	Trips, Slips and Falls	Awareness induction	Med	High visibility safety yellow nosing to be installed	Low	Client advised	Outstanding	OH&S REGULATIONS 3.7  AS/NZS 1657-2013 3.3.4

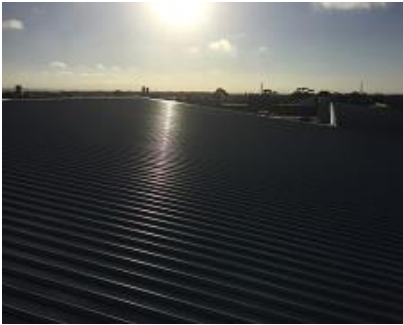
No height safety system installed	Trips, Slips and Falls	Awareness induction	High	Fall arrest anchors to be installed	Low	Client advised	Outstanding	OH&S REGULATIONS 3.55
46	Building: General Stores Location Reference: <a href="#">L30</a> Task: Access to the roof

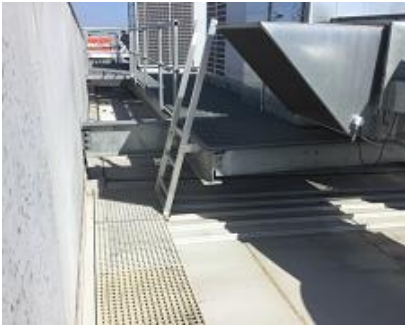
Bottom rung height is less than required minimum and top rung not levelled with landing	Trips, Slips and Falls	Awareness induction	Med	Existing ladder to be re-installed with landing platforms and brackets	Low	Client advised	Outstanding	OH&S REGULATIONS 3.7  AS/NZS 1657-2013 7.4.3.4 & 7.4.3.3
48	Building: General Stores Location Reference: <a href="#">L31</a> Task: Access to the roof

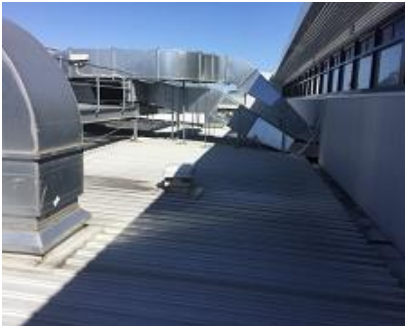
No safe access to the A/c units	Trips, Slips and Falls	N/A	Low	Supply Walkway to the A/c units	Low	Client advised	Outstanding	-
50	Building: General Stores Location Reference: <a href="#">L31</a> Task: Access to the roof

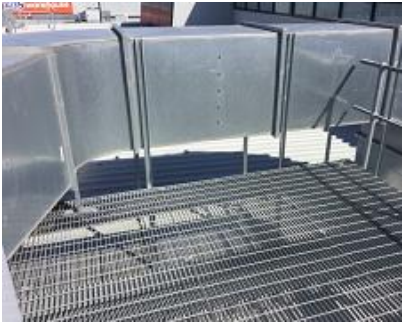
Variation in height between plant deck and roof is greater than required maximum	Trips, Slips and Falls	Awareness induction	Med	Handrail to be installed	Low	Client advised	Outstanding	OH&S REGULATIONS 3.7  AS/NZS 1657-2013 4.4

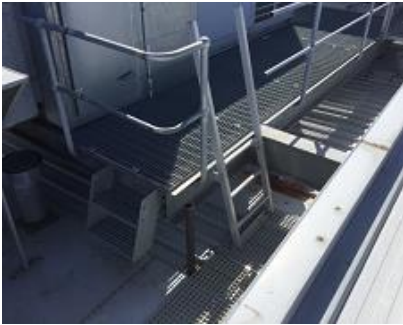
Bottom rung height is less than required minimum and top rung not levelled with landing	Trips, Slips and Falls	Awareness induction	Med	Existing ladder to be re-installed with landing platforms and brackets	Low	Client advised	Outstanding	OH&S REGULATIONS 3.7  AS/NZS 1657-2013 7.4.3.4 & 7.4.3.3
52	Building: General Stores Location Reference: <a href="#">L32</a> Task: Access to the roof

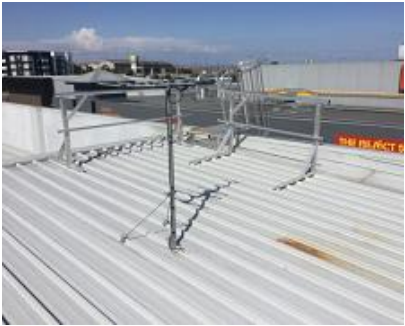
No safe access to the ladder	Trips, Slips and Falls	N/A	Low	Supply Walkway to the ladder	Low	Client advised	Outstanding	-
54	Building: General Stores Location Reference: <a href="#">L33</a> Task: Access to the roof

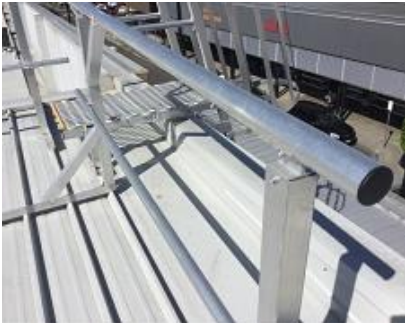
Sharp edges on handrails	Trips, Slips and Falls	Awareness induction	Med	Tek screws to be replaced with rivets	Low	Client advised	Outstanding	OH&S REGULATIONS 3.7  AS/NZS 1657-2013 5.6

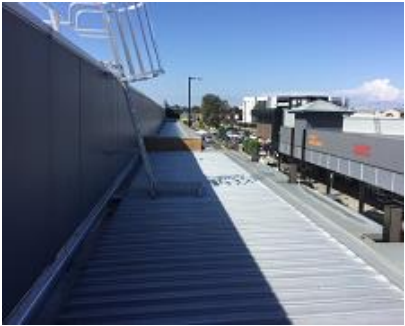
No height safety system installed	Trips, Slips and Falls	Awareness induction	High	Fall arrest anchors to be installed	Low	Client advised	Outstanding	OH&S REGULATIONS 3.55
58	Building: General Stores Location Reference: <a href="#">L34</a> Task: Access to the roof

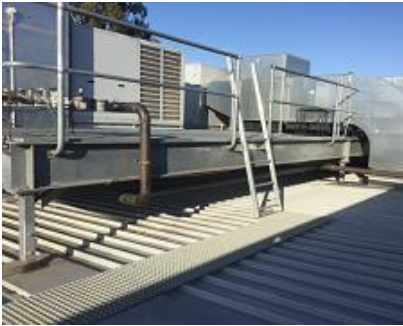
Bottom rung height is less than required minimum and landing is less than required minimum	Trips, Slips and Falls	Awareness induction	Med	Landing platform to be installed	Low	Client advised	Outstanding	OH&S REGULATIONS 3.7  AS/NZS 1657-2013 7.3.6
60	Building: General Stores Location Reference: <a href="#">L35</a> Task: Access to the roof

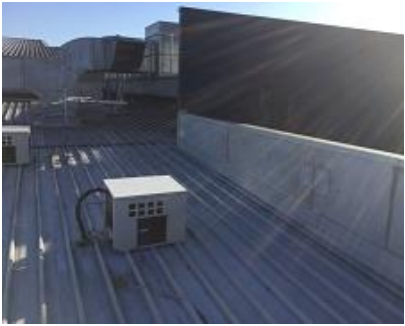
No height safety system installed	Trips, Slips and Falls	Awareness induction	High	Fall arrest anchors to be installed	Low	Client advised	Outstanding	OH&S REGULATIONS 3.55
62	Building: General Stores Location Reference: <a href="#">L36</a> Task: Access to the A/c units

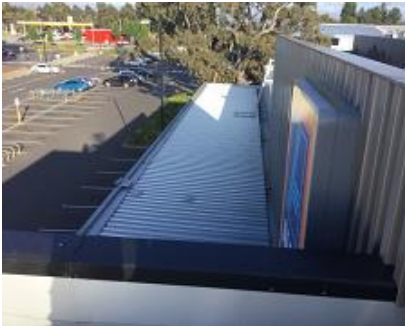
No height safety system installed	Trips, Slips and Falls	Awareness induction	High	Fall arrest anchors to be installed	Low	Client advised	Outstanding	OH&S REGULATIONS 3.55
64	Building: General Stores Location Reference: <a href="#">L38</a> Task: Access to the A/c units

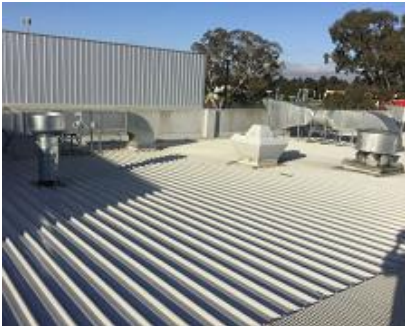
No safe access to the A/c units	Trips, Slips and Falls	N/A	Low	Supply Walkway to the A/c units	Low	Client advised	Outstanding	-
66	Building: General Stores Location Reference: <a href="#">L38</a> Task: Access to the ladder

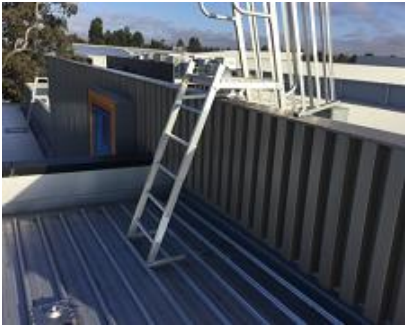
Bottom rung heights are less than required minimum	Trips, Slips and Falls	Awareness induction	Med	Landing platforms to be installed	Low	Client advised	Outstanding	OH&S REGULATIONS 3.7  AS/NZS 1657-2013 7.4.3.4
68	Building: General Stores Location Reference: <a href="#">L39</a> Task: Access to the roof

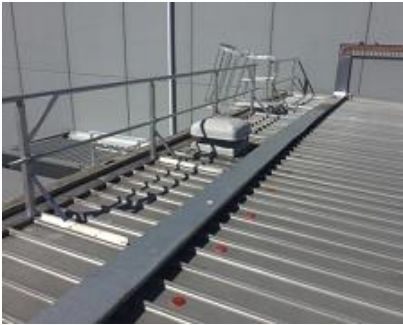
No safe access to the ladder	Trips, Slips and Falls	N/A	Low	Supply Walkway, handrail and step over to the ladder	Low	Client advised	Outstanding	-
76	Building: General Stores Location Reference: <a href="#">L44</a> Task: Access to the roof

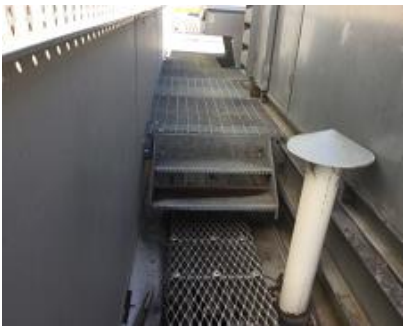
Handrail is missing for stair	Trips, Slips and Falls	Awareness induction	Med	Handrail to be installed	Low	Client advised	Outstanding	OH&S REGULATIONS 3.7  AS/NZS 1657-2013 7.2.6
78	Building: General Stores Location Reference: <a href="#">L45</a> Task: Access to the roof

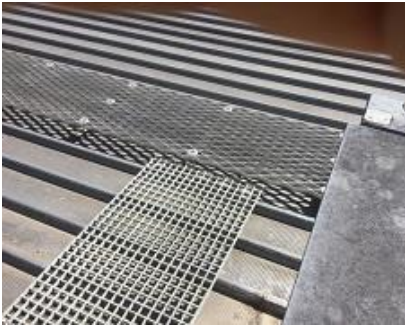
Variation in height between walkway panels are greater than required maximum	Trips, Slips and Falls	Awareness induction	Med	High visibility safety yellow nosing to be installed	Low	Client advised	Outstanding	OH&S REGULATIONS 3.7  AS/NZS 1657-2013 3.3.4
80	Building: General Stores Location Reference: <a href="#">L46</a> Task: Access to the roof

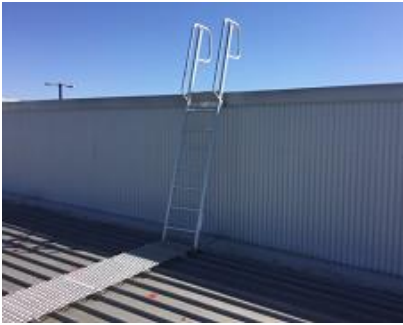
Bottom rung height is less than required minimum and handrail projecting towards the user	Trips, Slips and Falls	Awareness induction	Med	Existing handrail to be removed. Landing platform and handrail to be installed	Low	Client advised	Outstanding	OH&S REGULATIONS 3.7  AS/NZS 1657-2013 7.4.3.4 & 7.4.8.5
82	Building: General Stores Location Reference: <a href="#">L48</a> Task: Restrict access to the roof

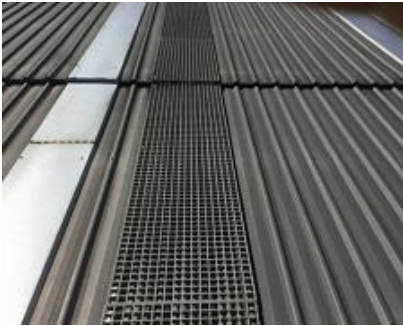
Variation in height between walkway panels are greater than required maximum	Trips, Slips and Falls	Awareness induction	Med	High visibility safety yellow nosing to be installed	Low	Client advised	Outstanding	OH&S REGULATIONS 3.7  AS/NZS 1657-2013 3.3.4
84	Building: General Stores Location Reference: <a href="#">L49</a> Task: Access to the roof

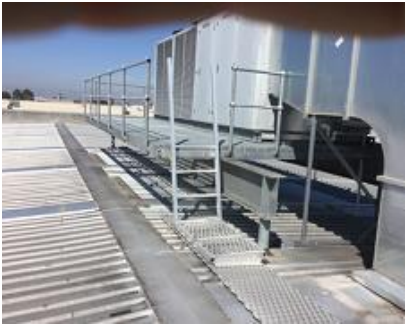
Non-complaint ladder is present	Trips, Slips and Falls	Awareness induction	Med	Existing ladder to be re-installed with landing platform and handrails	Low	Client advised	Outstanding	OH&S REGULATIONS 3.7  AS/NZS 1657-2013 7.4
90	Building: General Stores Location Reference: <a href="#">L51</a> Task: Access to the roof

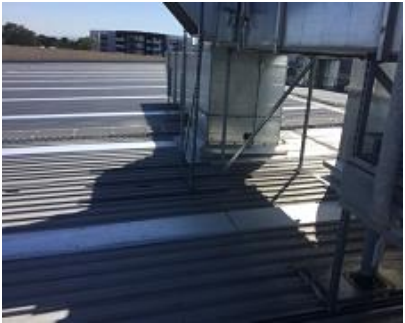
Walkway goes under the duct	Trips, Slips and Falls	Awareness induction	Med	Additional walkway sections to be installed	Low	Client advised	Outstanding	OH&S REGULATIONS 3.7

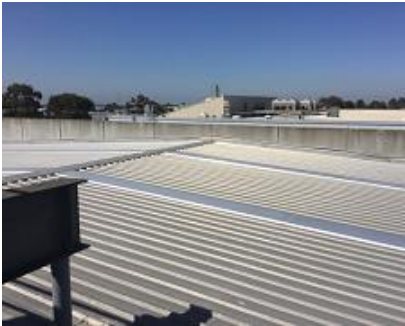
No height safety system installed	Trips, Slips and Falls	Awareness induction	High	Fall arrest anchors to be installed	Low	Client advised	Outstanding	OH&S REGULATIONS 3.55
92	Building: General Stores Location Reference: <a href="#">L53</a> Task: Access to the A/c units

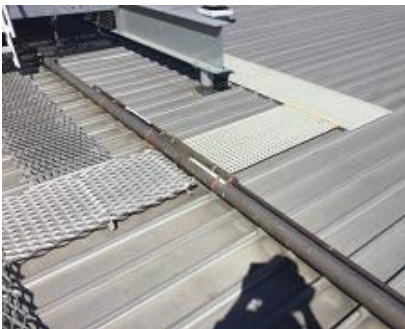
Pipes installed over the walkway path	Trips, Slips and Falls	Awareness induction	Med	Step bridge to be installed	Low	Client advised	Outstanding	OH&S REGULATIONS 3.7  AS/NZS 1657-2013 3.1.4
94	Building: General Stores Location Reference: <a href="#">L54</a> Task: Access to the roof

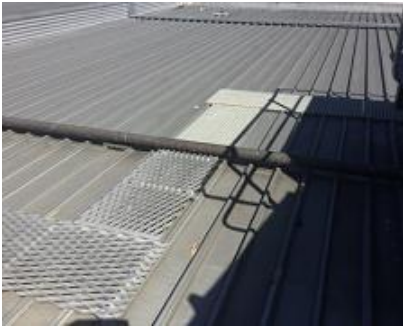
Pipes installed over the walkway path	Trips, Slips and Falls	Awareness induction	Med	Step bridge to be installed	Low	Client advised	Outstanding	OH&S REGULATIONS 3.7  AS/NZS 1657-2013 3.1.4
96	Building: General Stores Location Reference: <a href="#">L54</a> Task: Access to the roof

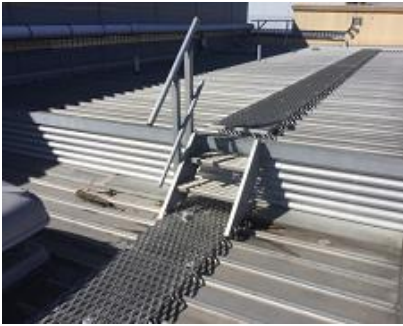
Non-complaint stair is present	Trips, Slips and Falls	Awareness induction	Med	Existing stair to be removed and new ladder to be installed	Low	Client advised	Outstanding	OH&S REGULATIONS 3.7  AS/NZS 1657-2013 7.2
98	Building: General Stores Location Reference: <a href="#">L56</a> Task: Access to the roof

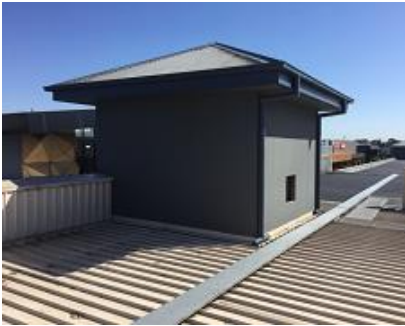
No height safety system installed	Trips, Slips and Falls	Restrict Access	High	"No Access to Roof" sign to be installed	Low	Client advised	Outstanding	OH&S REGULATIONS 3.55 & 3.11
100	Building: General Stores Location Reference: <a href="#">L58</a> Task: Access to the roof

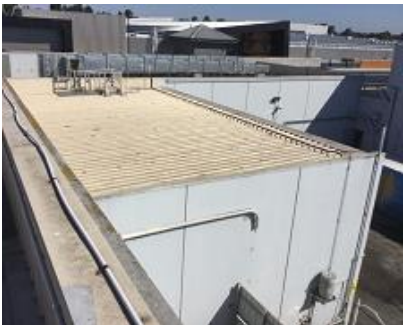
No height safety system installed	Trips, Slips and Falls	Awareness induction	High	Fall arrest anchors to be installed	Low	Client advised	Outstanding	OH&S REGULATIONS 3.55

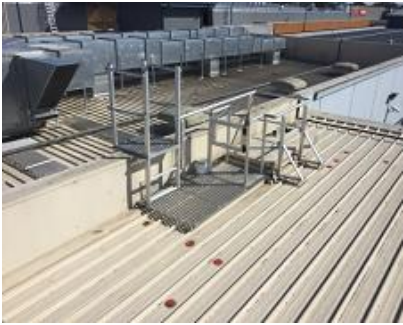
Bottom rung heights are less than required minimum and landing is less than required minimum	Trips, Slips and Falls	Awareness induction	Med	Landing platforms to be installed	Low	Client advised	Outstanding	
102	Building: General Stores Location Reference: <a href="#">L58</a> Task: Access to the roof
