Roof Safety Report

**Runaway Bay Centre,
QLD 4216**

Prepared By: Safemaster Safety Products
Date: 10 Aug 2017

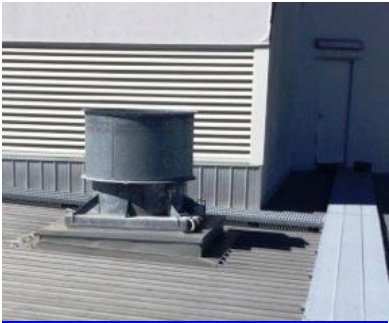
Roof walkway not installed for safe access to the A/c units	Trips, Slips and Falls	N/A	Low	Supply walkway to the A/c units	Low	Client advised	Outstanding	-
02	Building: Target Location Reference: L3 Task: Access to the roof

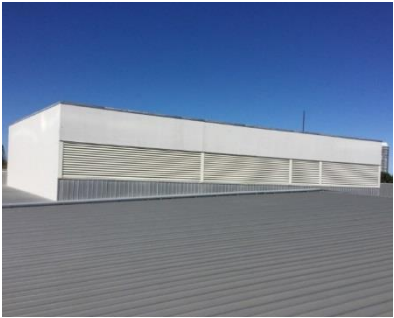
No height safety system installed	Trips, Slips and Falls	Awareness induction	High	Fall restraint anchors to be installed	Low	Client advised	Outstanding	OH&S REGULATIONS 3.55
04	Building: Target Location Reference: L5 Task: Access to the roof

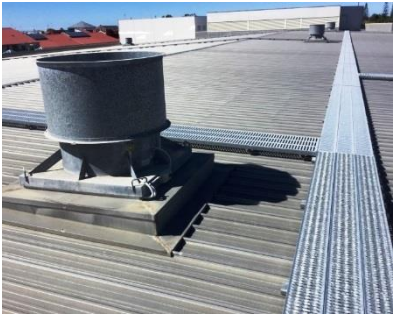
No safe access to the A/c units	Trips, Slips and Falls	N/A	Low	Supply walkway to the A/c units	Low	Client advised	Outstanding	-
08	Building: Target Location Reference: L9 Task: Access to the A/c units

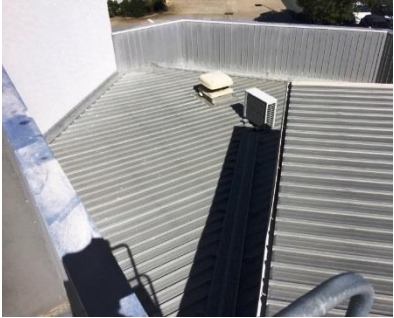
No safe access to the A/c units	Trips, Slips and Falls	N/A	Low	Supply walkway to the A/c units	Low	Client advised	Outstanding	-
12	Building: Target Location Reference: L13 Task: Access to the A/c units

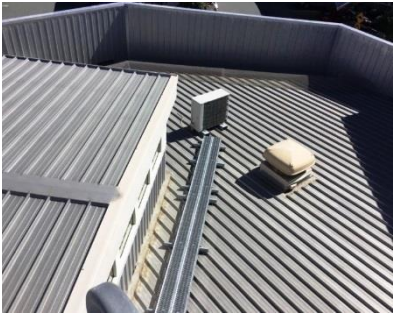
No safe access to the A/c units	Trips, Slips and Falls	N/A	Low	Supply walkway to the A/c units	Low	Client advised	Outstanding	-
14	Building: Target Location Reference: L15 Task: Access to the A/c units

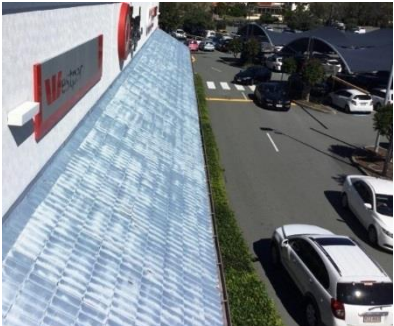
No height safety system installed (No serviceable items on roof)	Trips, Slips and Falls	Awareness induction	High	"EWP ACCESS ONLY" sign to be installed	Low	Client advised	Outstanding	OH&S REGULATIONS 3.55 & 3.11
18	Building: Target Location Reference: L18 Task: Access to the A/c units

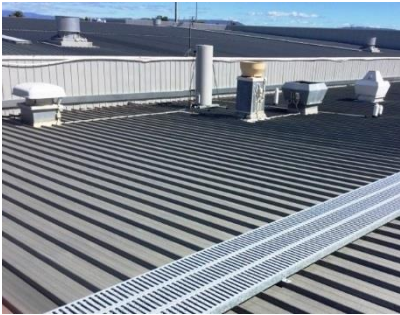
No safe access to the A/c units	Trips, Slips and Falls	N/A	Low	Supply walkway to the A/c units	Low	Client advised	Outstanding	-
24	Building: General Stores Location Reference: L24 Task: Restrict access to the roof

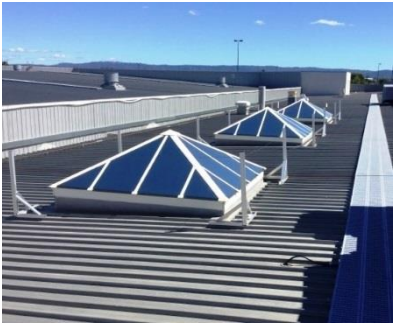
Brittle roof (Non-Trafficable roof)	Fall hazard	Awareness induction	High	"WARNING-KEEP OFF-BRITTLE AND FRAGILE ROOF" signs to be installed	Low	Client advised	Outstanding	OH&S REGULATIONS 3.57

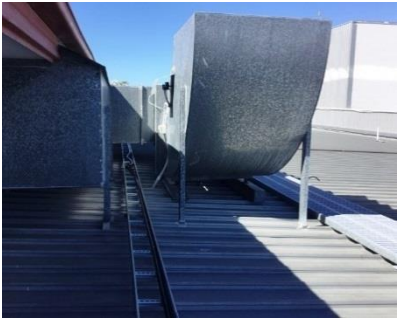
No safe access to the A/c units	Trips, Slips and Falls	N/A	Low	Supply walkway to the A/c units	Low	Client advised	Outstanding	-
26	Building: General Stores Location Reference: L26 Task: Access to the roof

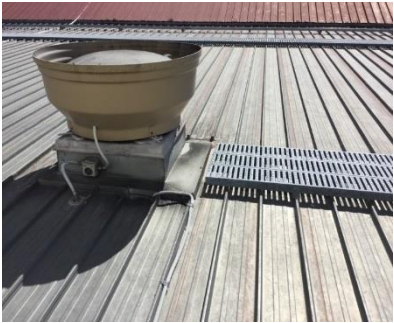
No safe access to the A/c unit	Trips, Slips and Falls	N/A	Low	Supply walkway to the A/c unit	Low	Client advised	Outstanding	-
28	Building: General Stores Location Reference: L28 Task: Access to the roof

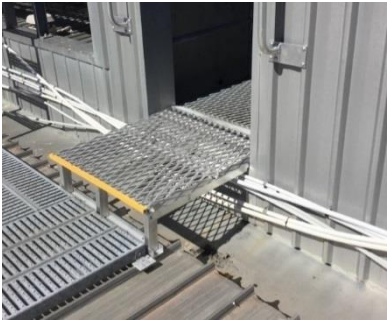
Handrail is missing at landing	Trips, Slips and Falls	Awareness induction	Med	Handrail to be installed	Low	Client advised	Outstanding	OH&S REGULATIONS 3.7 AS/NZS 1657-2013 4.4

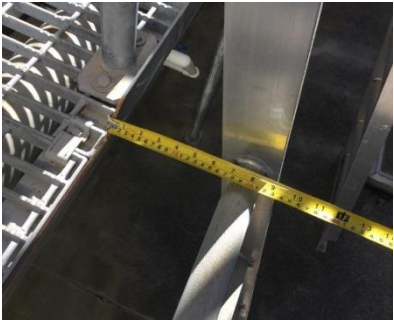
Bottom rung height is less than required minimum and gap between the top rung and landing is greater than required maximum	Trips, Slips and Falls	Awareness induction	Med	Existing ladder to be re-installed with landing platforms	Low	Client advised	Outstanding	OH&S REGULATIONS 3.7 AS/NZS 1657-2013 7.4.3.4 & 7.4.8.4
32	Building: General Stores Location Reference: L29 Task: Access to the roof

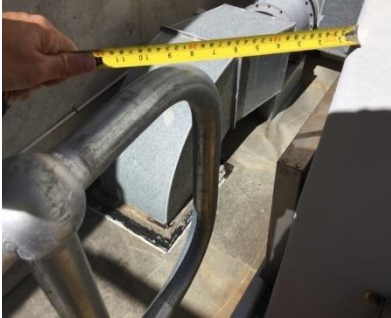
Handrail section is missing	Trips, Slips and Falls	Awareness induction	Med	Handrail section to be installed to close the gap	Low	Client advised	Outstanding	OH&S REGULATIONS 3.7 AS/NZS 1657-2013 4.4
34	Building: General Stores Location Reference: L30 Task: Access to the plant deck

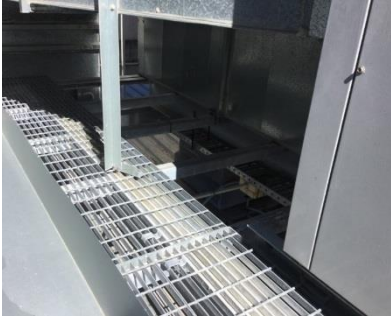
Gap between the grating panel and unit is greater than required minimum	Trips, Slips and Falls	Awareness induction	Med	Additional grating/mesh to be installed	Low	Client advised	Outstanding	OH&S REGULATIONS 3.7 AS/NZS 1657-2013 3.2.3.4
40	Building: General Stores Location Reference: L32 Task: Access to the roof

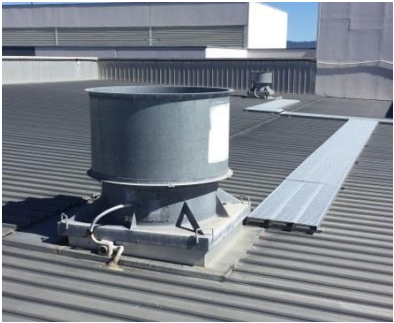
No safe access to the A/c unit	Trips, Slips and Falls	N/A	Low	Supply walkway to the A/c unit	Low	Client advised	Outstanding	-
44	Building: General Stores Location Reference: L35 Task: Access to the A/c unit

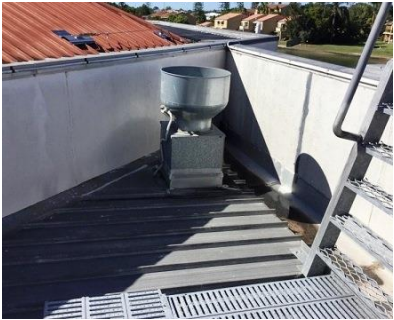
No safe access to the A/c unit	Trips, Slips and Falls	N/A	Low	Supply walkway to the A/c unit	Low	Client advised	Outstanding	-
52	Building: General Stores Location Reference: L41 Task: Access to the roof

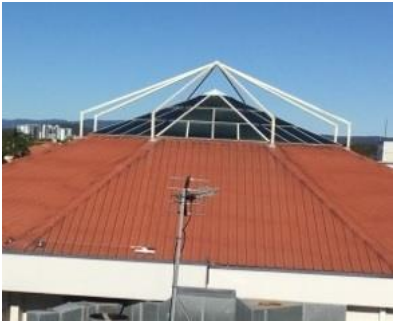
Brittle roof (Non-trafficable roof)	Trips, Slips and Falls	Awareness induction	High	"WARNING-KEEP OFF-BRITTLE AND FRAGILE ROOF" signs to be installed	Low	Client advised	Outstanding	OH&S REGULATIONS 3.57
58	Building: General Stores Location Reference: L47 Task: Access to the A/c units

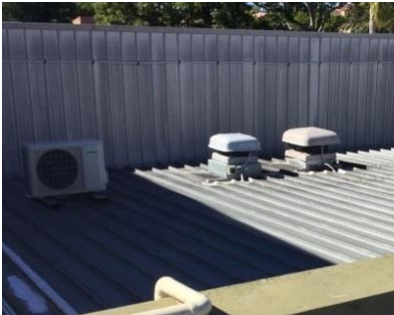
No safe access to the A/c units	Trips, Slips and Falls	N/A	Low	Supply walkway to the A/c units	Low	Client advised	Outstanding	-
60	Building: General Stores Location Reference: L49 Task: Access to the roof

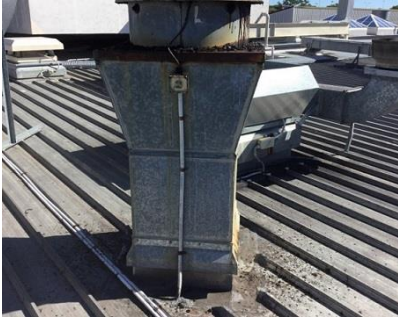
No safe access to the A/c units	Trips, Slips and Falls	N/A	Low	Supply walkway to the A/c units	Low	Client advised	Outstanding	-
62	Building: General Stores Location Reference: L51 Task: Access to the A/c units

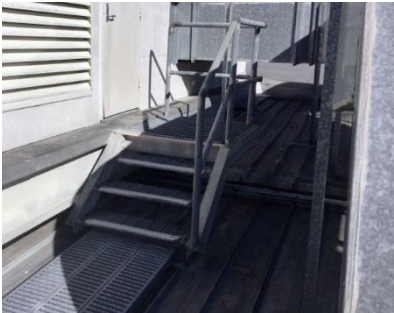
Un even tread risers	Trips, Slips and Falls	Awareness induction	Med	Existing stair to be removed and New access ladder including handrails to be installed	Low	Client advised	Outstanding	OH&S REGULATIONS 3.7 AS/NZS 1657-2013 7.2.3.2
66	Building: General Stores Location Reference: L55 Task: Restrict access to the roof

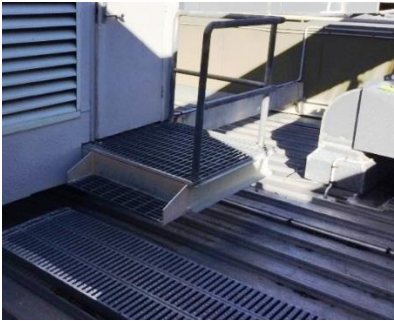
Landing at base is less than required minimum	Trips, Slips and Falls	Awareness induction	Med	Additional walkway section at base to be installed	Low	Client advised	Outstanding	OH&S REGULATIONS 3.7 AS/NZS 1657-2013 7.3.6
68	Building: General Stores Location Reference: L57 Task: Access to the roof

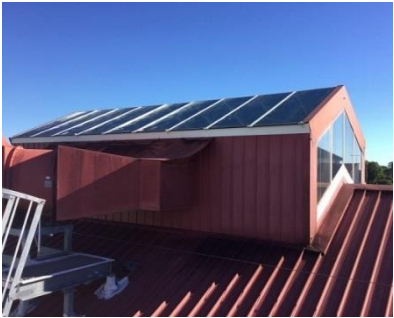
Brittle roof (Non-Trafficable roof)	Fall hazard	Awareness induction	High	“WARNING-KEEP OFF-BRITTLE AND FRAGILE ROOF” signs to be installed	Low	Client advised	Outstanding	OH&S REGULATIONS 3.57
72	Building: General Stores Location Reference: L61 Task: Access to the A/c unit

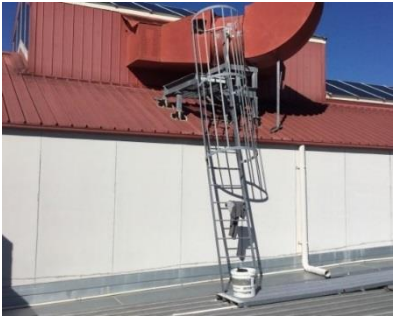
Non complaint ladder	Trips, Slips and Falls	Awareness induction	Med	Existing ladder to be removed and New ladder including landing platform and handrails to be installed	Low	Client advised	Outstanding	OH&S REGULATIONS 3.7 AS/NZS 1657-2013 7.4.3.1 & 7.4.3.2

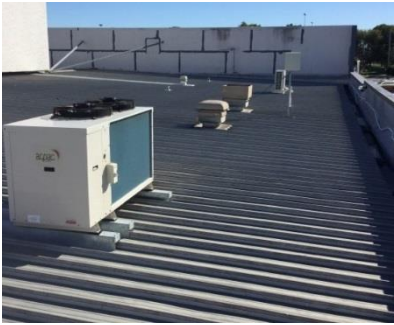
No safe access to the A/c units	Trips, Slips and Falls	N/A	Low	Supply walkway to the A/c units	Low	Client advised	Outstanding	-
80	Building: General Stores Location Reference: L74 Task: Restrict access to the roof

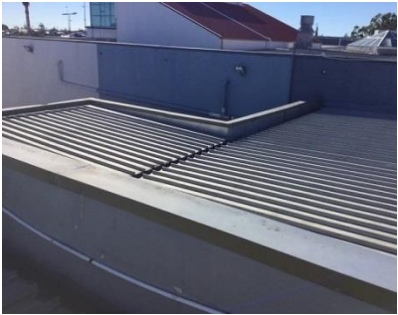
Not enough anchors installed for safe access	Trips, Slips and Falls	Awareness induction	High	Fall arrest anchors to be installed	Low	Client advised	Outstanding	OH&S REGULATIONS 3.55
82	Building: General Stores Location Reference: L76 Task: Access to the roof

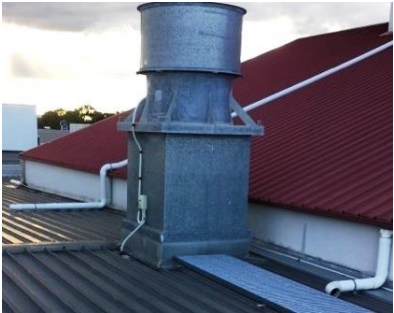
No safe access to the A/c units	Trips, Slips and Falls	N/A	Low	Supply walkway to the A/c units	Low	Client advised	Outstanding	-

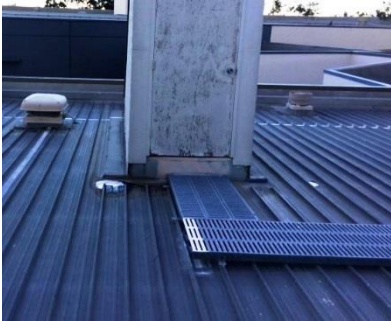
No safe access to the A/c units	Trips, Slips and Falls	N/A	Low	Supply walkway to the A/c units	Low	Client advised	Outstanding	-
90	Building: General Stores Location Reference: L84 Task: Access to the roof

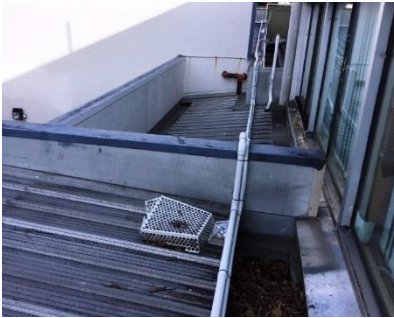
No safe access to the roof	Trips, Slips and Falls	Awareness induction	Med	Access ladder including handrails to be installed	Low	Client advised	Outstanding	OH&S REGULATIONS 3.7 AS/NZS 1657-2013 3.1.4
94	Building: General Stores Location Reference: L91 Task: Access to the A/c unit

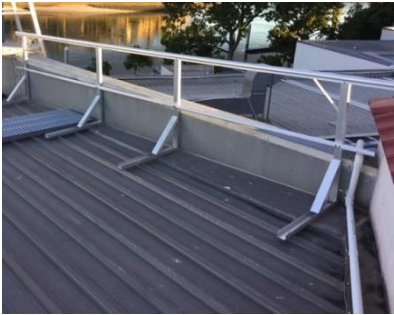
Sharp edges on handrails	Hand injury	Awareness induction	Med	Tek screws to be replaced with rivets	Low	Client advised	Outstanding	OH&S REGULATIONS 3.7 AS/NZS 1657-2013 5.6
96	Building: General Stores Location Reference: L93 Task: Access to the roof

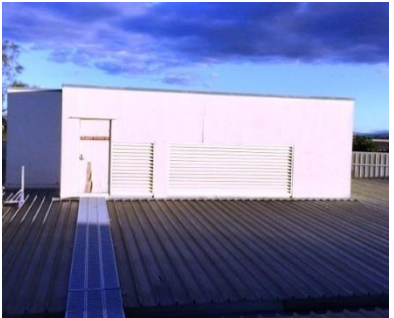
No height safety system installed	Trips, Slips and Falls	Awareness induction	High	Fall arrest anchors, anchor stop and ladder access bracket to be installed	Low	Client advised	Outstanding	OH&S REGULATIONS 3.55

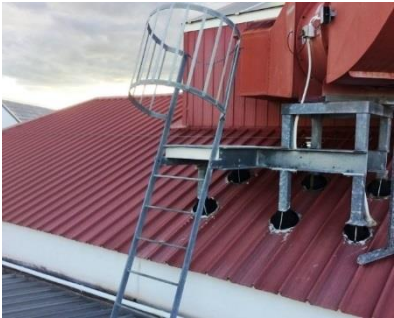
Non-compliant ladder	Trips, Slips and Falls	Awareness induction	Med	Existing ladder to be removed and Access ladder including handrails to be installed	Low	Client advised	Outstanding	OH&S REGULATIONS 3.7 AS/NZS 1657-2013 3.1.4
98	Building: General Stores Location Reference: L95 Task: Restrict access to the roof

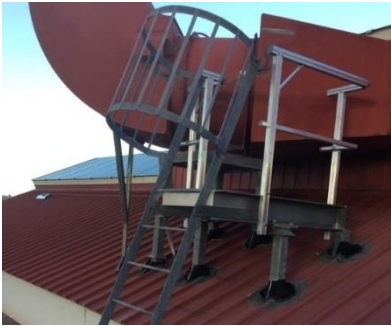
Non-compliant ladder	Trips, Slips and Falls	Awareness induction	Med	Existing ladder to be removed and Access ladder including handrails to be installed	Low	Client advised	Outstanding	OH&S REGULATIONS 3.7 AS/NZS 1657-2013 3.1.4
100	Building: General Stores Location Reference: L97 Task: Access to the A/c unit

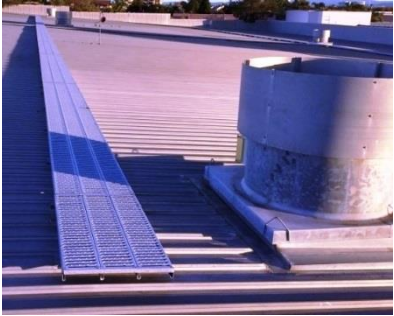
No safe access to the A/c units	Trips, Slips and Falls	N/A	Low	Supply walkway to the A/c units	Low	Client advised	Outstanding	-
102	Building: BIG W Location Reference: L99 Task: Access to the roof

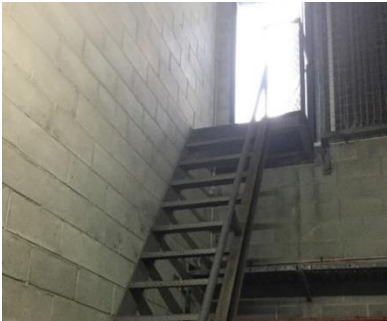
Midrail and toeboard is missing at landing	Head Injury	Awareness induction	Med	Midrail and toeboard to be installed	Low	Client advised	Outstanding	OH&S REGULATIONS 3.7 AS/NZS 1657-2013 4.4

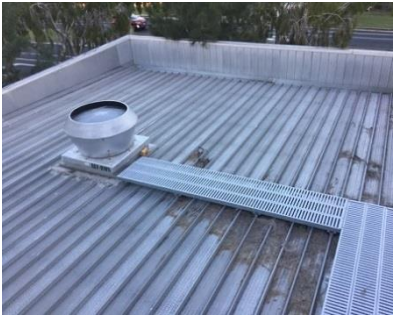
No height safety system installed	Trips, Slips and Falls	Awareness induction	High	Fall arrest anchors to be installed	Low	Client advised	Outstanding	OH&S REGULATIONS 3.55
106	Building: BIG W Location Reference: L103 Task: Restrict access to the roof

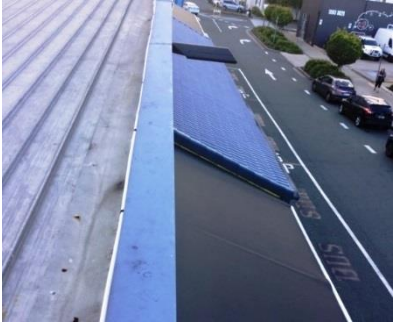
No height safety system installed (No serviceable items on roof)	Trips, Slips and Falls	Awareness induction	High	"EWP ACCESS ONLY" signs to be installed	Low	Client advised	Outstanding	OH&S REGULATIONS 3.55 & 3.11
110	Building: Woolworths Location Reference: L107 Task: Access to the A/c units

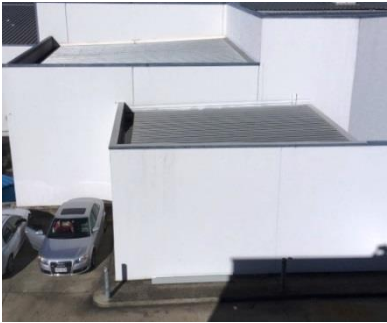
No height safety system installed (No serviceable items on roof)	Trips, Slips and Falls	Awareness induction	High	"EWP ACCESS ONLY" signs to be installed	Low	Client advised	Outstanding	OH&S REGULATIONS 3.55 & 3.11
112	Building: Woolworths Location Reference: L109 Task: Access to the plant deck

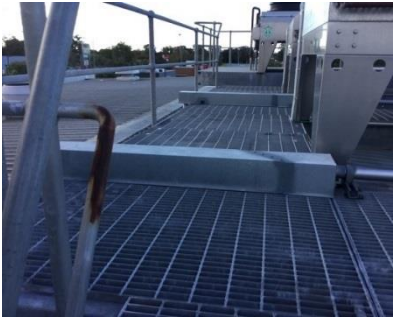
Pipe covers is present over walkway path	Trips, Slips and Falls	Awareness induction	Med	High visibility safety yellow tape to be installed	Low	Client advised	Outstanding	OH&S REGULATIONS 3.6
114	Building: Woolworths Location Reference: L109 Task: Access to the plant deck

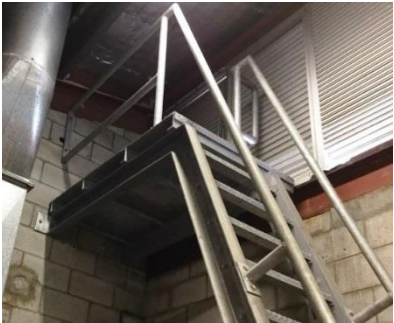
Toe board is missing at landing	Trips, Slips and Falls	Awareness induction	Med	Toe board to be installed	Low	Client advised	Outstanding	OH&S REGULATIONS 3.7 AS/NZS 1657-2013 4.6

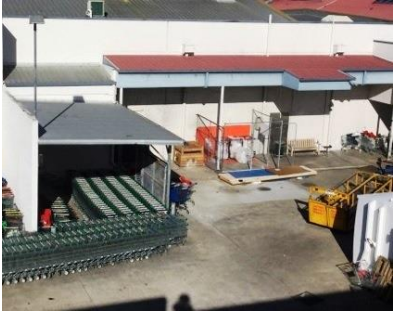
No height safety system installed (No serviceable items)	Trips, Slips and Falls	Awareness induction	High	"EWP Access Only" signs to be installed	Low	Client advised	Outstanding	OH&S REGULATIONS 3.55 & 3.11
120	Building: Woolworths Location Reference: L115 Task: Access to the roof

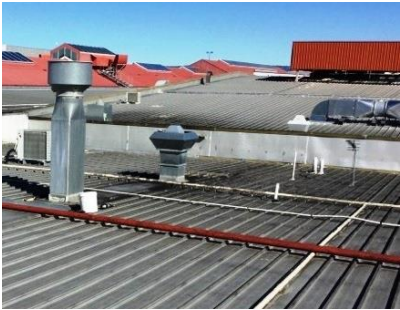
No safe access to the A/c units	Trips, Slips and Falls	N/A	Low	Supply walkway to the A/c units	Low	Client advised	Outstanding	-
122	Building: General Stores Location Reference: L116,117,118,119,120 & 121 Task: Restrict access to the roof

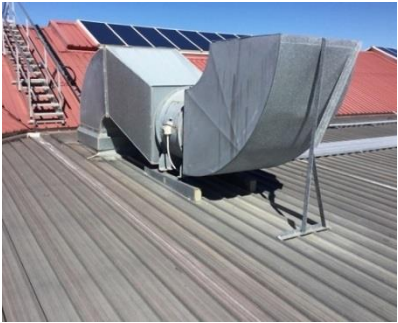
No safe access to the A/c unit	Trips, Slips and Falls	N/A	Low	Supply walkway to the A/c unit	Low	Client advised	Outstanding	-
124	Building: General Stores Location Reference: L125 Task: Access to the roof

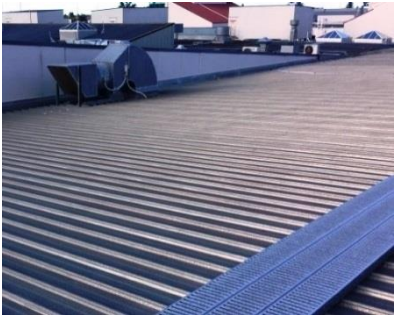
No safe access to the A/c unit	Trips, Slips and Falls	N/A	Low	Supply walkway to the A/c unit	Low	Client advised	Outstanding	-
126	Building: General Stores Location Reference: L127 Task: Access to the A/c unit

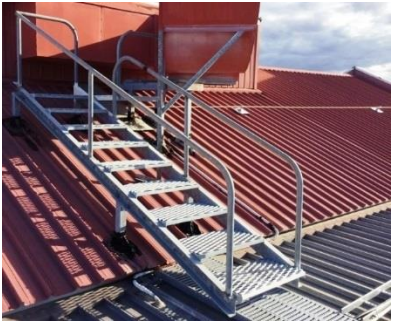
Bottom tread height is less than required minimum and midrail is missing	Trips, Slips and Falls	Awareness induction	Med	Landing platform at base and mid rails to be installed	Low	Client advised	Outstanding	OH&S REGULATIONS 3.7 AS/NZS 1657-2013 7.2.4 & 4.4

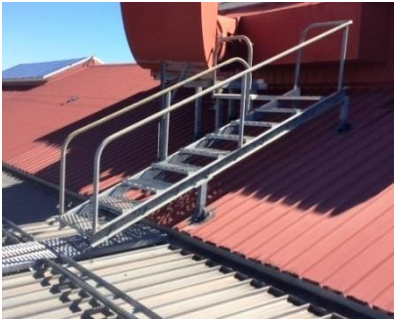
Bottom tread height is greater than required maximum, Going is greater than required maximum and Midrail is missing	Trips, Slips and Falls	Awareness induction	Med	Existing stair to be removed and New ladder including landing platforms and handrails to be installed	Low	Client advised	Outstanding	OH&S REGULATIONS 3.7 AS/NZS 1657-2013 7.2.4 & 4.4
128	Building: General Stores Location Reference: L131 Task: Access to the roof

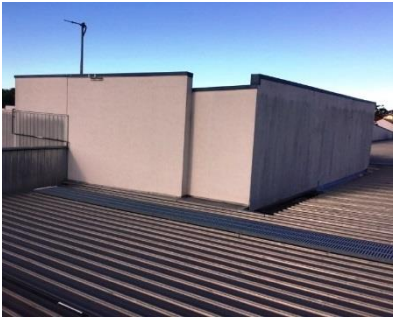
No height safety system installed	Trips, Slips and Falls	Awareness induction	High	Fall arrest anchors and anchor stop to be installed	Low	Client advised	Outstanding	OH&S REGULATIONS 3.55

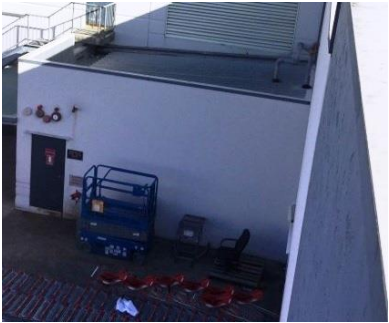
No height safety system is installed (No serviceable items)	Trips, Slips and Falls	Awareness induction	High	"EWP Access Only" sign to be installed	Low	Client advised	Outstanding	OH&S REGULATIONS 3.55 & 3.11
130	Building: General Stores Location Reference: L135 Task: Restrict access to the roof

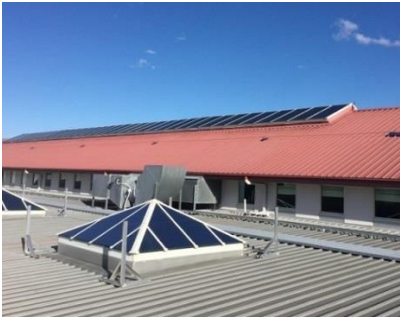
Brittle roof (Non-Trafficable roof)	Fall Hazard	Awareness induction	High	"Warning-Keep Off-Brittle and Fragile Roof" signs to be installed	Low	Client advised	Outstanding	OH&S REGULATIONS 3.57

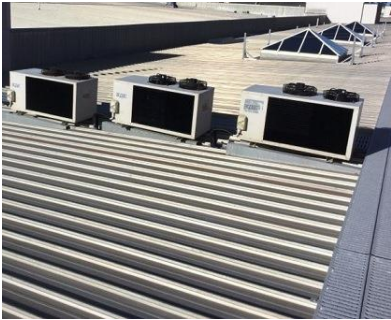
No safe access to the A/c units	Trips, Slips and Falls	N/A	Low	Supply walkway to the A/c units	Low	Client advised	Outstanding	-
138	Building: General Stores Location Reference: L146 Task: Access to the A/c unit

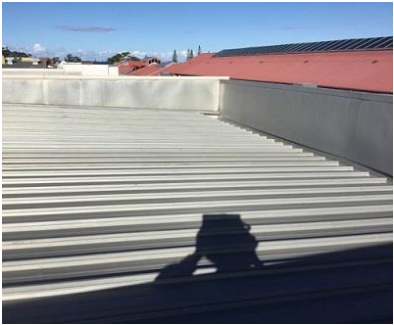
No safe access to the roof	Trips, Slips and Falls	Awareness induction	Med	Access ladder including handrails to be installed	Low	Client advised	Outstanding	OH&S REGULATIONS 3.7 AS/NZS 1657-2013 3.1.4
140	Building: General Stores Location Reference: L147 Task: Access to the A/c units

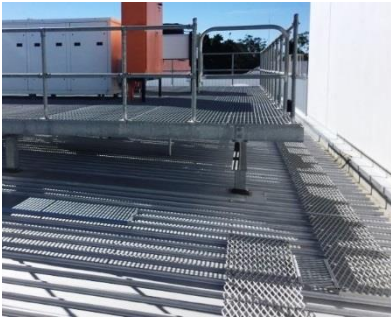
No safe access to the plant deck	Trips, Slips and Falls	Awareness induction	Med	Access ladder including landing platform and handrails to be installed	Low	Client advised	Outstanding	OH&S REGULATIONS 3.7 AS/NZS 1657-2013 3.1.4
148	Building: ALDI Location Reference: L155 Task: Access to the A/c unit
