# Roof Safety Report

Runaway Bay Centre,

Prepared By: Safemaster Safety Products  
Date: 03-09-2020

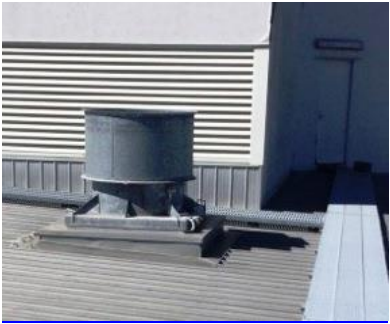
Roof walkway not installed for safe access to the A/c units	Trips, Slips and Falls	N/A	Low	Supply walkway to the A/c units	Low	Client advised	Outstanding	-
02	Building: Target Location Reference: <a href="#">L3</a> Task: Access to the roof

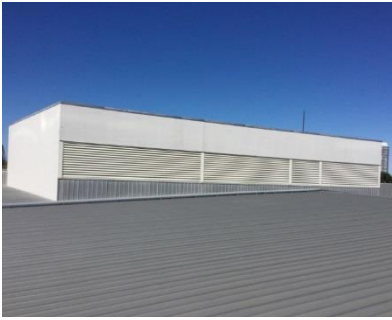
No height safety system installed	Trips, Slips and Falls	Awareness induction	High	Fall restraint anchors to be installed	Low	Client advised	Outsta nding	OH&S REGULATIONS 3.55
04	Building: Target Location Reference: <a href="#">L5</a> Task: Access to the roof

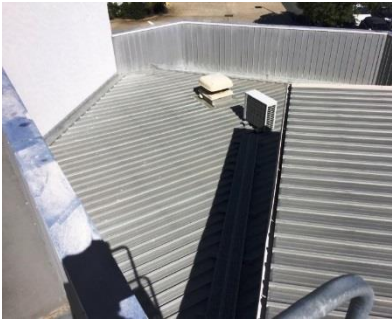
No safe access to the A/c units	Trips, Slips and Falls	N/A	Low	Supply walkway to the A/c units	Low	Client advised	Outstanding	-
12	Building: Target Location Reference: <a href="#">L13</a> Task: Access to the A/c units

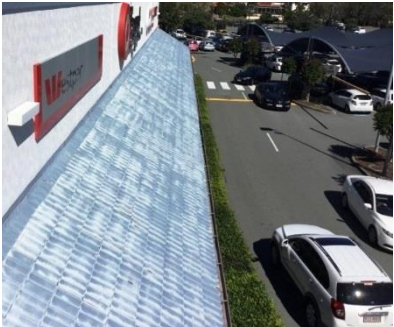
No height safety system installed (No serviceable items on roof)	Trips, Slips and Falls	Awareness induction	High	"EWP ACCESS ONLY" sign to be installed	Low	Client advised	Outstanding	OH&S REGULATIONS 3.55 & 3.11
18	Building: Target Location Reference: <a href="#">L18</a> Task: Access to the A/c units

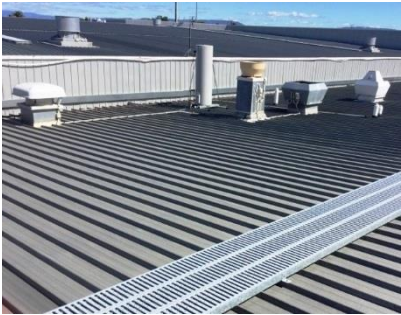
No safe access to the A/c units	Trips, Slips and Falls	N/A	Low	Supply walkway to the A/c units	Low	Client advised	Outstanding	-
24	Building: General Stores Location Reference: <a href="#">L24</a> Task: Restrict access to the roof

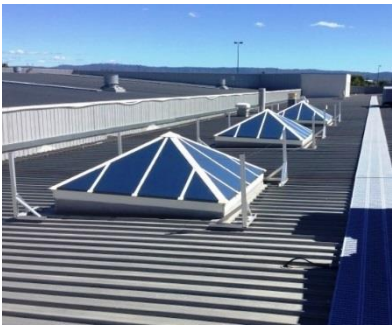
Brittle roof (Non-Trafficable roof)	Fall hazard	Awareness induction	High	"WARNING-KEEP OFF-BRITTLE AND FRAGILE ROOF" signs to be installed	Low	Client advised	Outstanding	OH&S REGULATIONS 3.57

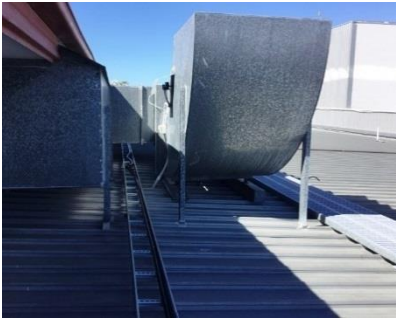
No safe access to the A/c units	Trips, Slips and Falls	N/A	Low	Supply walkway to the A/c units	Low	Client advised	Outstanding	-
26	Building: General Stores Location Reference: <a href="#">L26</a> Task: Access to the roof

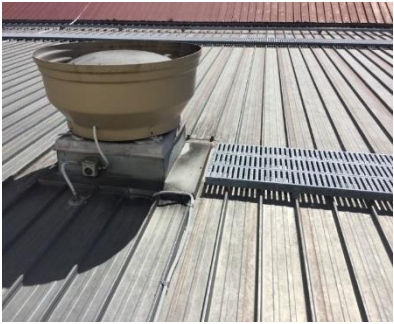
No safe access to the A/c unit	Trips, Slips and Falls	N/A	Low	Supply walkway to the A/c unit	Low	Client advised	Outstanding	-
28	Building: General Stores Location Reference: <a href="#">L28</a> Task: Access to the roof

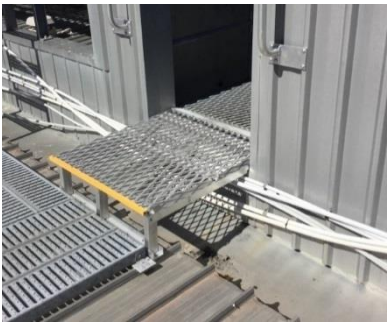
Handrail is missing at landing	Trips, Slips and Falls	Awareness induction	Med	Handrail to be installed	Low	Client advised	Outstanding	OH&S REGULATIONS 3.7  AS/NZS 1657-2013 4.4

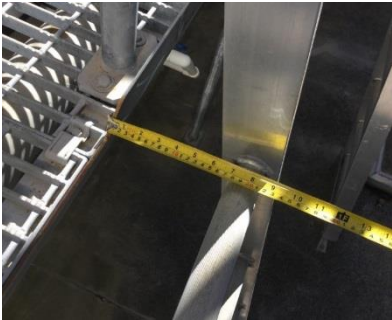
Bottom rung height is less than required minimum and gap between the top rung and landing is greater than required maximum	Trips, Slips and Falls	Awareness induction	Med	Existing ladder to be re-installed with landing platforms	Low	Client advised	Outstanding	OH&S REGULATIONS 3.7  AS/NZS 1657-2013 7.4.3.4 & 7.4.8.4
32	Building: General Stores Location Reference: <a href="#">L29</a> Task: Access to the roof

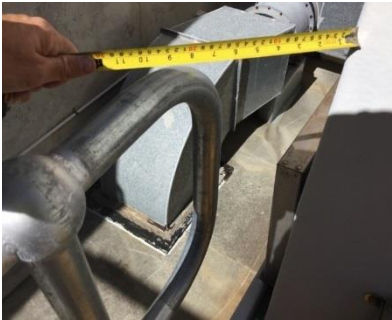
Handrail section is missing	Trips, Slips and Falls	Awareness induction	Med	Handrail section to be installed to close the gap	Low	Client advised	Outstanding	OH&S REGULATIONS 3.7  AS/NZS 1657-2013 4.4
34	Building: General Stores Location Reference: <a href="#">L30</a> Task: Access to the plant deck

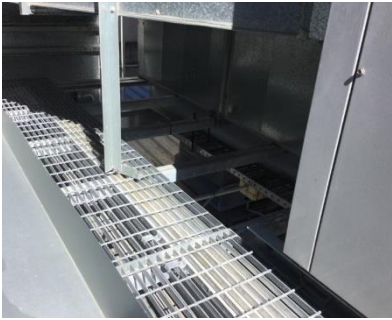
Gap between the grating panel and unit is greater than required minimum	Trips, Slips and Falls	Awareness induction	Med	Additional grating/mesh to be installed	Low	Client advised	Outstanding	OH&S REGULATIONS 3.7  AS/NZS 1657-2013 3.2.3.4
40	Building: General Stores Location Reference: <a href="#">L32</a> Task: Access to the roof

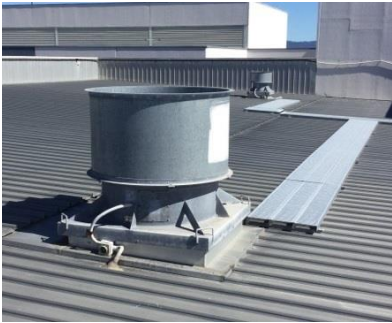
No safe access to the A/c unit	Trips, Slips and Falls	N/A	Low	Supply walkway to the A/c unit	Low	Client advised	Outstanding	-
44	Building: General Stores Location Reference: <a href="#">L35</a> Task: Access to the A/c unit

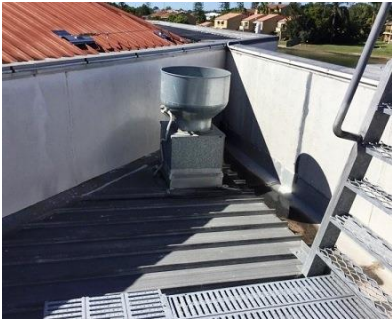
No safe access to the A/c unit	Trips, Slips and Falls	N/A	Low	Supply walkway to the A/c unit	Low	Client advised	Outstanding	-
52	Building: General Stores Location Reference: <a href="#">L41</a> Task: Access to the roof

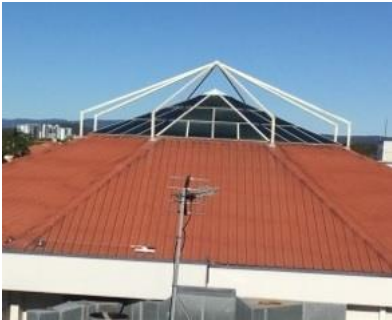
Brittle roof (Non-trafficable roof)	Trips, Slips and Falls	Awareness induction	High	"WARNING-KEEP OFF-BRITTLE AND FRAGILE ROOF" signs to be installed	Low	Client advised	Outstanding	OH&S REGULATIONS 3.57
58	Building: General Stores Location Reference: <a href="#">L47</a> Task: Access to the A/c units

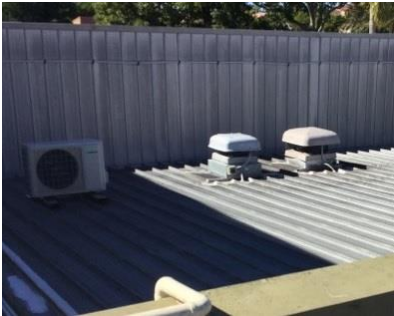
No safe access to the A/c units	Trips, Slips and Falls	N/A	Low	Supply walkway to the A/c units	Low	Client advised	Outstanding	-
60	Building: General Stores Location Reference: <a href="#">L49</a> Task: Access to the roof

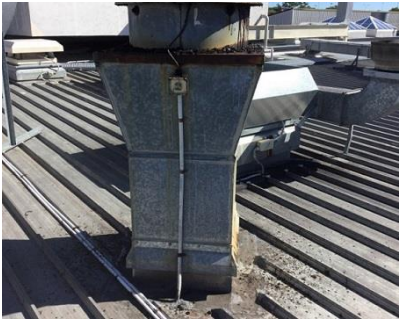
No safe access to the A/c units	Trips, Slips and Falls	N/A	Low	Supply walkway to the A/c units	Low	Client advised	Outsta nding	-
62	Building: General Stores Location Reference: <a href="#">L51</a> Task: Access to the A/c units

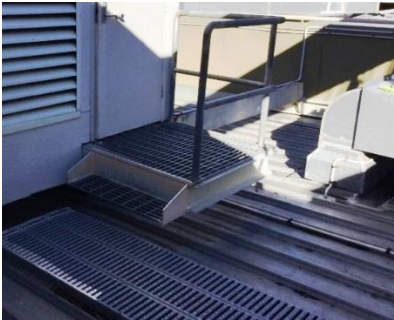
Landing at base is less than required minimum	Trips, Slips and Falls	Awareness induction	Med	Additional walkway section at base to be installed	Low	Client advised	Outstanding	OH&S REGULATIONS 3.7  AS/NZS 1657-2013 7.3.6
68	Building: General Stores Location Reference: <a href="#">L57</a> Task: Access to the roof

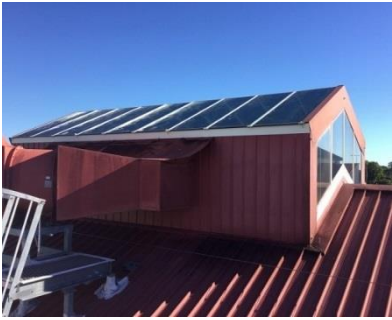
Brittle roof (Non-Trafficable roof)	Fall hazard	Awareness induction	High	"WARNING-KEEP OFF-BRITTLE AND FRAGILE ROOF" signs to be installed	Low	Client advised	Outsta nding	OH&S REGULATIONS 3.57
72	Building: General Stores Location Reference: <a href="#">L61</a> Task: Access to the A/c unit

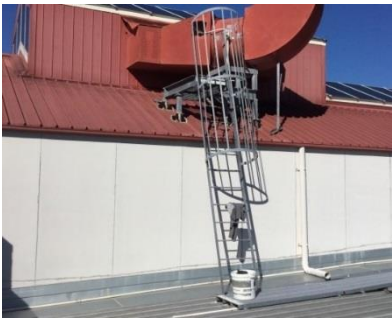
Non complaint ladder	Trips, Slips and Falls	Awareness induction	Med	Existing ladder to be removed and New ladder including landing platform and handrails to be installed	Low	Client advised	Outsta nding	OH&S REGULATIONS 3.7  AS/NZS 1657-2013 7.4.3.1 & 7.4.3.2

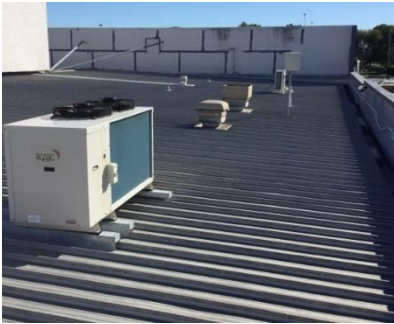
No safe access to the A/c units	Trips, Slips and Falls	N/A	Low	Supply walkway to the A/c units	Low	Client advised	Outstanding	-
80	Building: General Stores Location Reference: <a href="#">L74</a> Task: Restrict access to the roof

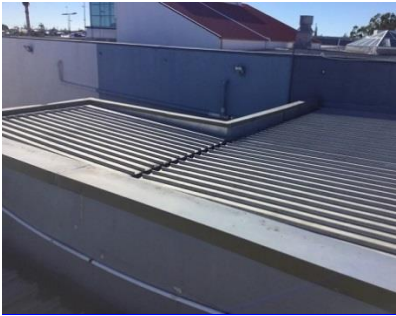
Not enough anchors installed for safe access	Trips, Slips and Falls	Awareness induction	High	Fall arrest anchors to be installed	Low	Client advised	Outstanding	OH&S REGULATIONS 3.55
82	Building: General Stores Location Reference: <a href="#">L76</a> Task: Access to the roof

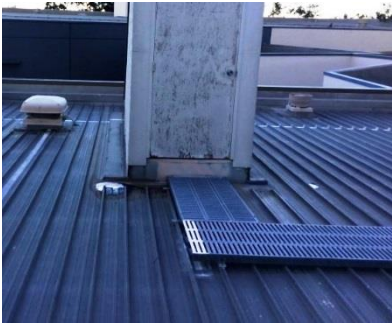
No safe access to the A/c units	Trips, Slips and Falls	N/A	Low	Supply walkway to the A/c units	Low	Client advised	Outstanding	-
90	Building: General Stores Location Reference: <a href="#">L84</a> Task: Access to the roof

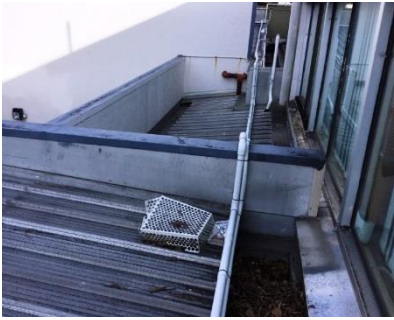
No safe access to the roof	Trips, Slips and Falls	Awareness induction	Med	Access ladder including handrails to be installed	Low	Client advised	Outstanding	OH&S REGULATIONS 3.7  AS/NZS 1657-2013 3.1.4
94	Building: General Stores Location Reference: <a href="#">L91</a> Task: Access to the A/c unit

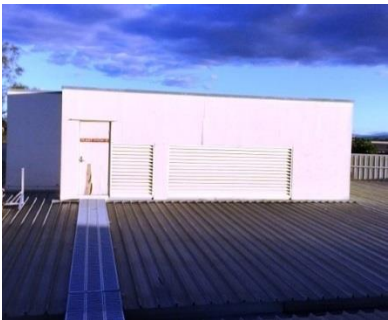
No height safety system installed	Trips, Slips and Falls	Awareness induction	High	Fall arrest anchors, anchor stop and ladder access bracket to be installed	Low	Client advised	Outstanding	OH&S REGULATIONS 3.55

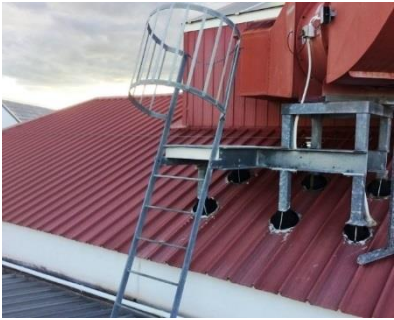
Non-compliant ladder	Trips, Slips and Falls	Awareness induction	Med	Existing ladder to be removed and Access ladder including handrails to be installed	Low	Client advised	Outsta nding	OH&S REGULATIONS 3.7  AS/NZS 1657- 2013 3.1.4
98	Building: General Stores Location Reference: <a href="#">L95</a> Task: Restrict access to the roof

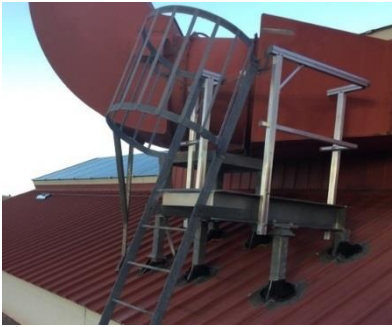
Non-compliant ladder	Trips, Slips and Falls	Awareness induction	Med	Existing ladder to be removed and Access ladder including handrails to be installed	Low	Client advised	Outsta nding	OH&S REGULATIONS 3.7  AS/NZS 1657- 2013 3.1.4
100	Building: General Stores Location Reference: <a href="#">L97</a> Task: Access to the A/c unit

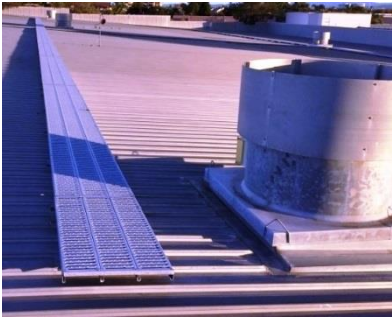
No safe access to the A/c units	Trips, Slips and Falls	N/A	Low	Supply walkway to the A/c units	Low	Client advised	Outstanding	-
102	Building: BIG W Location Reference: <a href="#">L99</a> Task: Access to the roof

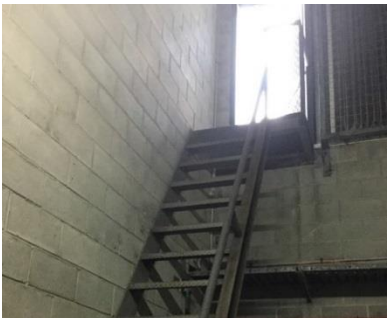
Midrail and toeboard is missing at landing	Head Injury	Awareness induction	Med	Midrail and toeboard to be installed	Low	Client advised	Outstanding	OH&S REGULATIONS 3.7  AS/NZS 1657-2013 4.4

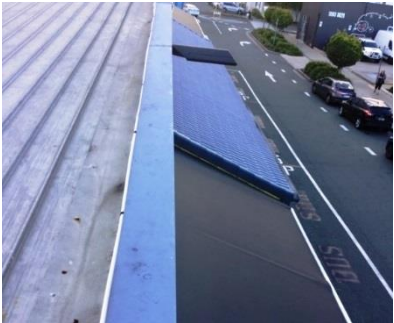
No height safety system installed (No serviceable items on roof)	Trips, Slips and Falls	Awareness induction	High	"EWP ACCESS ONLY" signs to be installed	Low	Client advised	Outstanding	OH&S REGULATIONS 3.55 & 3.11
110	Building: Woolworths Location Reference: <a href="#">L107</a> Task: Access to the A/c units

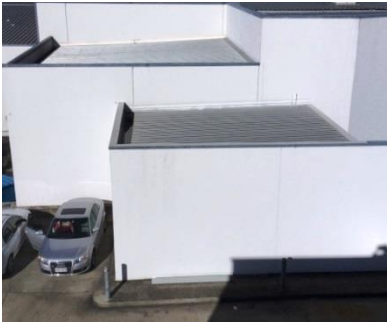
No height safety system installed (No serviceable items on roof)	Trips, Slips and Falls	Awareness induction	High	"EWP ACCESS ONLY" signs to be installed	Low	Client advised	Outstanding	OH&S REGULATIONS 3.55 & 3.11
112	Building: Woolworths Location Reference: <a href="#">L109</a> Task: Access to the plant deck

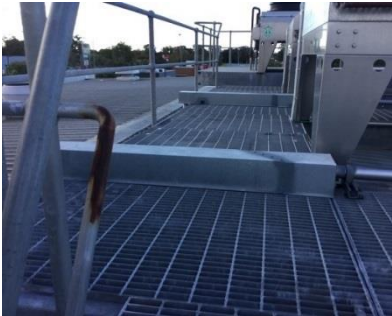
Pipe covers is present over walkway path	Trips, Slips and Falls	Awareness induction	Med	High visibility safety yellow tape to be installed	Low	Client advised	Outstanding	OH&S REGULATIONS 3.6
114	Building: Woolworths Location Reference: <a href="#">L109</a> Task: Access to the plant deck

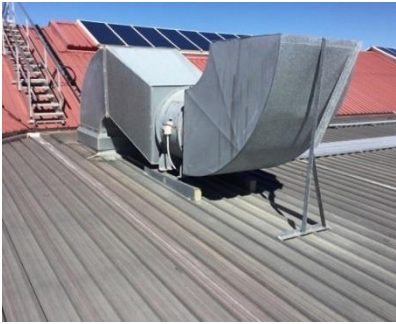
No safe access to the A/c unit	Trips, Slips and Falls	N/A	Low	Supply walkway to the A/c unit	Low	Client advised	Outstanding	-
124	Building: General Stores Location Reference: <a href="#">L125</a> Task: Access to the roof

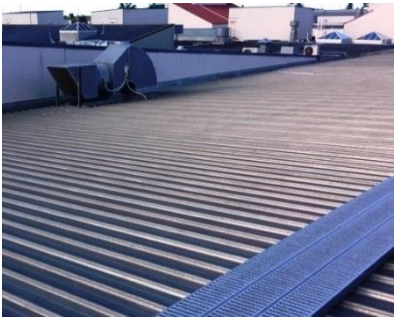
No safe access to the A/c unit	Trips, Slips and Falls	N/A	Low	Supply walkway to the A/c unit	Low	Client advised	Outstanding	-
126	Building: General Stores Location Reference: <a href="#">L127</a> Task: Access to the A/c unit

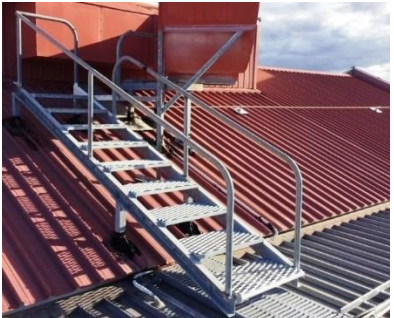
Bottom tread height is less than required minimum and midrail is missing	Trips, Slips and Falls	Awareness induction	Med	Landing platform at base and mid rails to be installed	Low	Client advised	Outstanding	OH&S REGULATIONS 3.7  AS/NZS 1657-2013 7.2.4 & 4.4

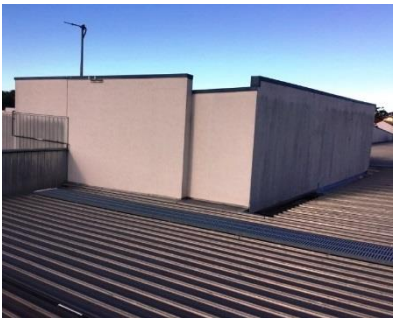
No height safety system installed	Trips, Slips and Falls	Awareness induction	High	Fall arrest anchors and anchor strop to be installed	Low	Client advised	Outstanding	OH&S REGULATIONS 3.55

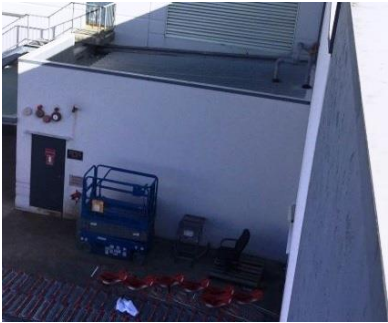
No height safety system is installed (No serviceable items)	Trips, Slips and Falls	Awareness induction	High	"EWP Access Only" sign to be installed	Low	Client advised	Outsta nding	OH&S REGULATIONS 3.55 & 3.11
130	Building: General Stores Location Reference: <a href="#">L135</a> Task: Restrict access to the roof

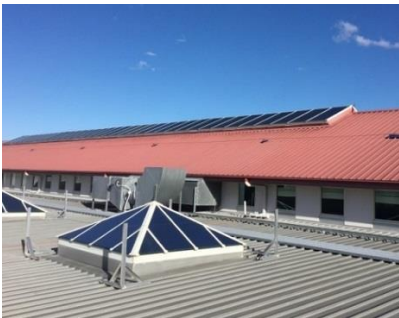
Brittle roof (Non-Trafficable roof)	Fall Hazard	Awareness induction	High	"Warning-Keep Off- Brittle and Fragile Roof" signs to be installed	Low	Client advised	Outsta nding	OH&S REGULATIONS 3.57

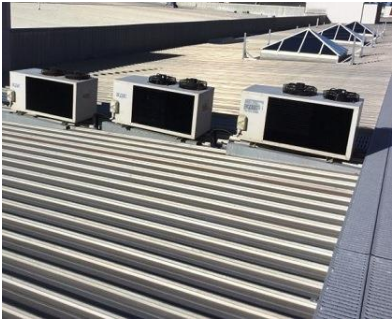
No safe access to the A/c units	Trips, Slips and Falls	N/A	Low	Supply walkway to the A/c units	Low	Client advised	Outstanding	-
138	Building: General Stores Location Reference: <a href="#">L146</a> Task: Access to the A/c unit

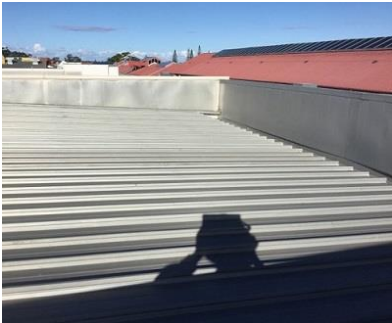
No safe access to the roof	Trips, Slips and Falls	Awareness induction	Med	Access ladder including handrails to be installed	Low	Client advised	Outstanding	OH&S REGULATIONS 3.7  AS/NZS 1657-2013 3.1.4
140	Building: General Stores Location Reference: <a href="#">L147</a> Task: Access to the A/c units

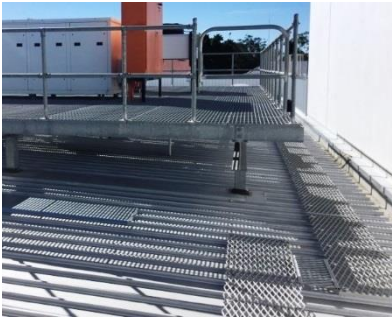
No safe access to the plant deck	Trips, Slips and Falls	Awareness induction	Med	Access ladder including landing platform and handrails to be installed	Low	Client advised	Outstanding	OH&S REGULATIONS 3.7  AS/NZS 1657-2013 3.1.4
148	Building: ALDI Location Reference: <a href="#">L155</a> Task: Access to the A/c unit

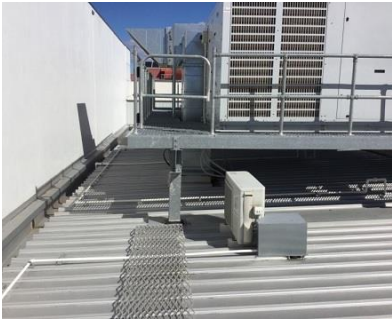
No safe access to the plant deck	Trips, Slips and Falls	Awareness induction	Med	Access ladder including landing platforms and handrails to be installed	Low	Client advised	Outstanding	OH&S REGULATIONS 3.7  AS/NZS 1657-2013 3.1.4
150	Building: ALDI Location Reference: <a href="#">L155</a> Task: Access to the plant deck

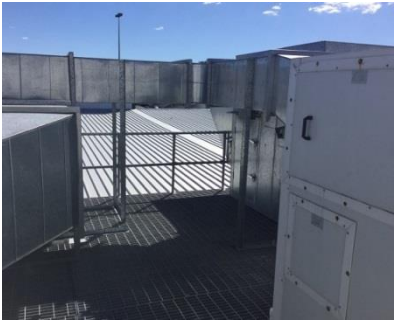
Headroom is less than required minimum	Trips, Slips and Falls	Awareness induction	Med	Low headroom signs and high visibility safety yellow tape to be installed	Low	Client advised	Outstanding	OH&S REGULATIONS 3.6  AS/NZS 1657-2013 3.1.5
152	Building: ALDI Location Reference: <a href="#">L156</a> Task: Restrict access to the roof

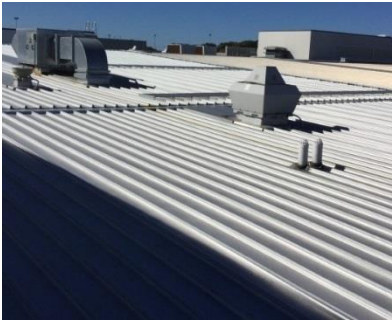
No safe access to the A/c units	Trips, Slips and Falls	N/A	Low	Supply walkway to the A/c units	Low	Client advised	Outstanding	-
154	Building: Coles Location Reference: <a href="#">L158</a> Task: Access to the A/c unit

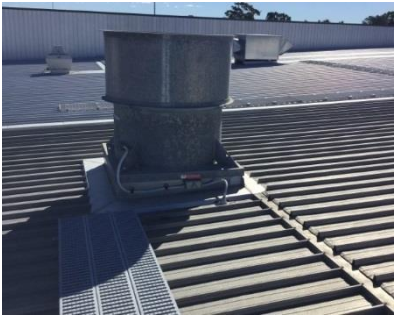
No safe access to the A/c unit	Trips, Slips and Falls	N/A	Low	Supply walkway to the A/c unit	Low	Client advised	Outsta nding	-
156	Building: Coles Location Reference: <a href="#">L159</a> Task: Access to the A/c unit

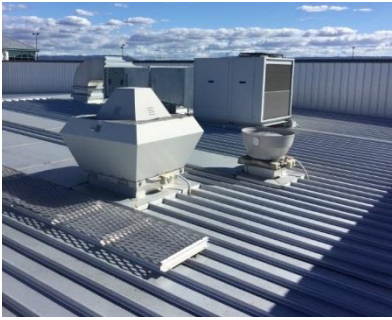
No safe access to the A/c units	Trips, Slips and Falls	N/A	Low	Supply walkway to the A/c units	Low	Client advised	Outstanding	-
160	Building: Coles Location Reference: <a href="#">L162</a> Task: Access to the A/c units

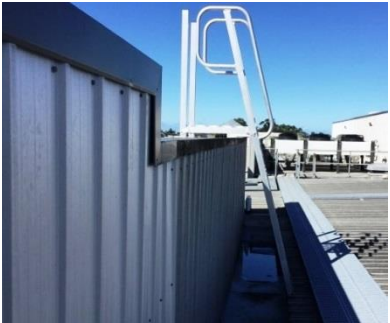
Bottom rung height is less than required minimum, handrails projecting towards the user and static line is missing	Trips, Slips and Falls	Awareness induction	Med	Existing handrails to be removed. Landing platforms, preformed handrails and static line to be installed	Low	Client advised	Outstanding	OH&S REGULATIONS 3.7  AS/NZS 1657-2013 7.4.3.4 & 7.4.8.5
162	Building: Coles Location Reference: <a href="#">L164</a> Task: Access to the roof
