# Roof Safety Report

**Runaway Bay Centre,  
QLD 4216**

Prepared By: Safemaster Safety Products  
Date: 24-10-2019

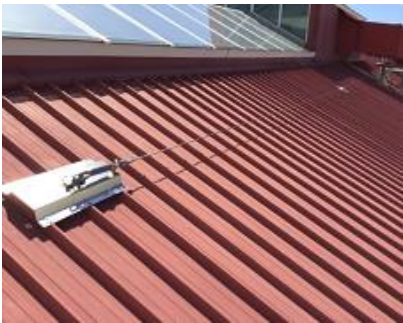
No	Photo of Hazard	Details of Hazard	Details of Risk	Existing/ Immediate Control Measure	Current Risk Level	Proposed Permanent Solution	Residual Risk Assessment	Details of Action Taken	Status	Reference
208	Building: General Stores Location Reference: <a href="#">L138, L139, L133, L134, L122 &amp; L123</a> Task: Access to the roof

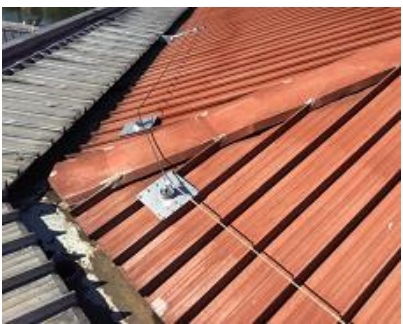
Static line over 10 years old	Trips, Slips and Falls	Awareness induction	High	Existing static lines (x6) to be replaced	Low	Client advised	Outstanding	OH&S REGULATIONS 3.55  AS/NZS 1891.4:2009 6.3 (vi)
209	Building: General Stores Location Reference: <a href="#">L45</a> Task: Access to the roof

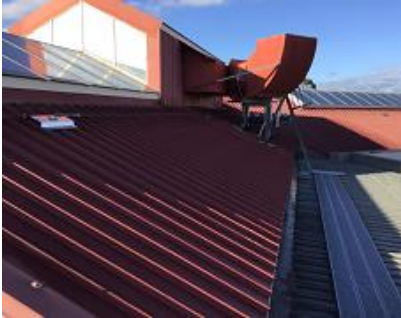
No	Photo of Hazard	Details of Hazard	Details of Risk	Existing/ Immediate Control Measure	Curren t Risk Level	Proposed Permanent Solution	Residu al Risk Assess ment	Details of Action Taken	Status	Reference
210	Building: General Stores Location Reference: <a href="#">L89</a> Task: Access to the roof

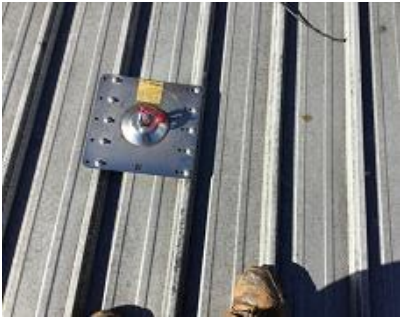
Static line over 10 years old	Trips, Slips and Falls	Awareness induction	High	Existing static lines (x2) to be replaced	Low	Client advised	Outstanding	OH&S REGULATIONS 3.55  AS/NZS 1891.4:2009 6.3 (vi)
211	Building: General Stores Location Reference: <a href="#">L91</a> Task: Access to the roof

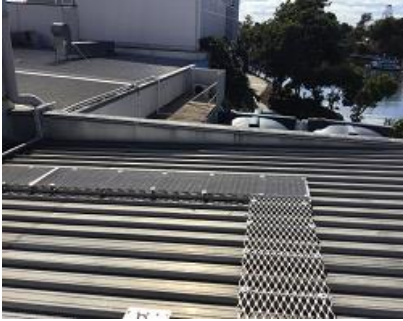
No	Photo of Hazard	Details of Hazard	Details of Risk	Existing/ Immediate Control Measure	Curren t Risk Level	Proposed Permanent Solution	Residu al Risk Assess ment	Details of Action Taken	Status	Reference
212	Building: General Stores Location Reference: <a href="#">L91</a> Task: Access to the roof

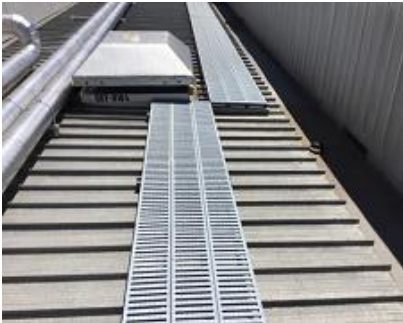
Gap between walkway and fall edge is less than required minimum	Trips, Slips and Falls	Awareness induction	Med	Handrail to be installed	Low	Client advised	Outstanding	OH&S REGULATIONS 3.7  AS/NZS 1657-2018 5.4.1
213	Building: General Stores Location Reference: <a href="#">L101</a> Task: Access to the roof

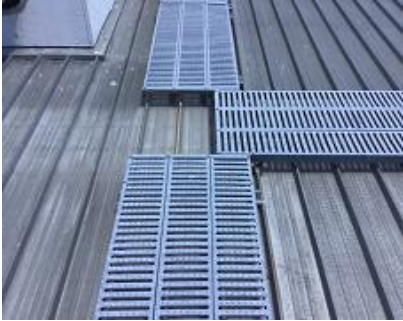
No	Photo of Hazard	Details of Hazard	Details of Risk	Existing/ Immediate Control Measure	Curren t Risk Level	Proposed Permanent Solution	Residu al Risk Assess ment	Details of Action Taken	Status	Reference
214	Building: General Stores Location Reference: <a href="#">L101</a> Task: Access to the roof

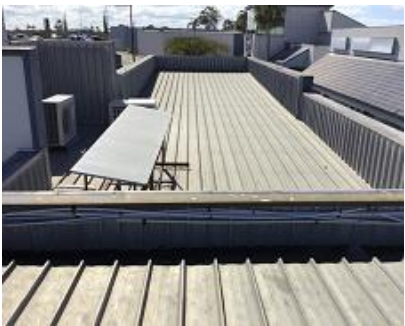
No	Photo of Hazard	Details of Hazard	Details of Risk	Existing/ Immediate Control Measure	Curren t Risk Level	Proposed Permanent Solution	Residu al Risk Assess ment	Details of Action Taken	Status	Reference
216	Building: General Stores Location Reference: <a href="#">L105</a> Task: Access to the roof

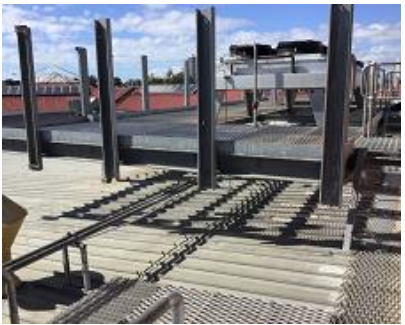
Variation in height between different roof levels	Trips, Slips and Falls	Awareness induction	Med	Access ladder to be installed	Low	Client advised	Outstanding	OH&S REGULATIONS 3.7  AS/NZS 1657-2018 3.1.4
217	Building: General Stores Location Reference: <a href="#">L111</a> Task: Access to the roof

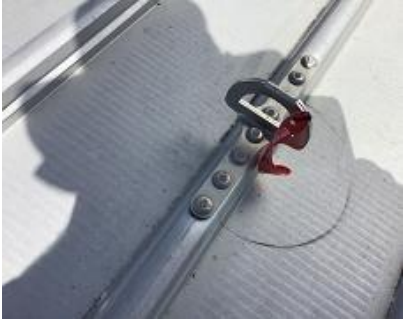
No	Photo of Hazard	Details of Hazard	Details of Risk	Existing/ Immediate Control Measure	Curren t Risk Level	Proposed Permanent Solution	Residu al Risk Assess ment	Details of Action Taken	Status	Reference
218	Building: General Stores Location Reference: <a href="#">L151</a> Task: Access to the roof

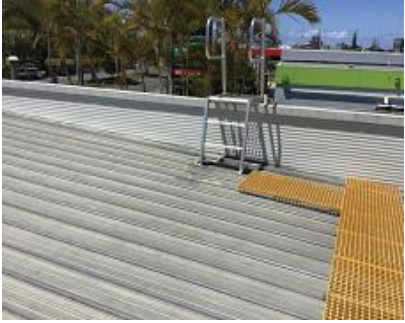
No	Photo of Hazard	Details of Hazard	Details of Risk	Existing/ Immediate Control Measure	Curren t Risk Level	Proposed Permanent Solution	Residu al Risk Assess ment	Details of Action Taken	Status	Reference
220	Building: General Stores Location Reference: <a href="#">L203</a> Task: Access to the roof

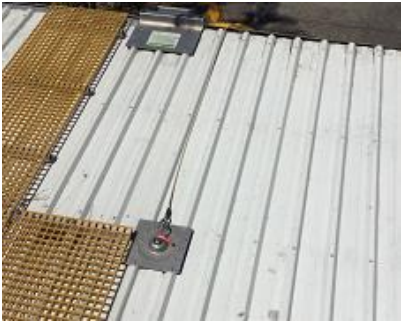
No landing platform installed at base	Trips, Slips and Falls	Awareness induction	Med	Landing to be installed	Low	Client advised	Outstanding	OH&S REGULATIONS 3.7  AS/NZS 1657-2018 3.1.4
221	Building: General Stores Location Reference: <a href="#">L204</a> Task: Access to the roof
