# Roof Safety Report

**The Galleries, NSW 2000**

Prepared By: Safemaster Safety Products  
Date: 19 November 2018

14/10/2018

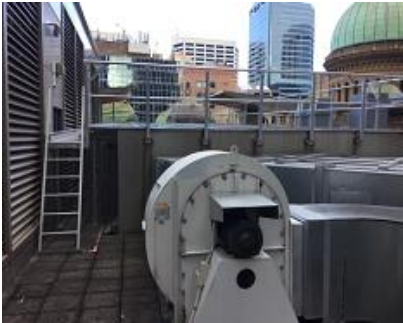
No	Photo of Hazard	Details of Hazard	Details of Risk	Existing/ Immediate Control Measure	Curre nt Risk Level	Proposed Permanent Solution	Resid ual Risk Asse sme nt	Details of Action Taken	Status	Reference
01	Building: General Stores Location Reference: <a href="#">L01</a> Task: Access to the roof

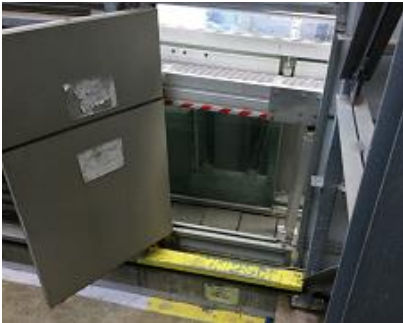
Gap between handrail and mid rail is greater than required maximum and toe board is missing	Trips, Slips and Falls	Awareness induction	Med	Existing mid rail to be re-positioned and toe board to be installed	Low	Client advised	Outstanding	OH&S REGULATIONS 3.7  AS/NZS 1657-2013 4.4 & 4.6
02	Building: General Stores Location Reference: <a href="#">L01</a> Task: Access to the roof

No safe access to the roof and head room is less than required minimum	Trips, Slips and Falls	Awareness induction	Med	Single step and low headroom signs to be installed	Low	Client advised	Outstanding	OH&S REGULATIONS 3.7 & 3.11  AS/NZS 1657-2013 3.1.4

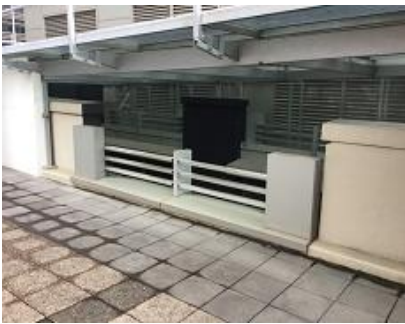
No	Photo of Hazard	Details of Hazard	Details of Risk	Existing/ Immediate Control Measure	Curre nt Risk Level	Proposed Permanent Solution	Resid ual Risk Asse sme nt	Details of Action Taken	Status	Reference
03	Building: General Stores Location Reference: <a href="#">L01</a> Task: Access to the roof

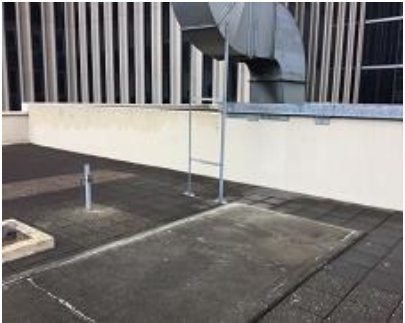
UN-protected fall edge is present	Trips, Slips and Falls	Awareness induction	High	Handrail to be installed	Low	Client advised	Outstanding	OH&S REGULATIONS 3.55
04	Building: General Stores Location Reference: <a href="#">L02</a> Task: Access to the roof

Variation in height between roofs are greater than required maximum	Trips, Slips and Falls	Awareness induction	Med	Access ladder to be installed	Low	Client advised	Outstanding	OH&S REGULATIONS 3.7  AS/NZS 1657-2013 3.1.4

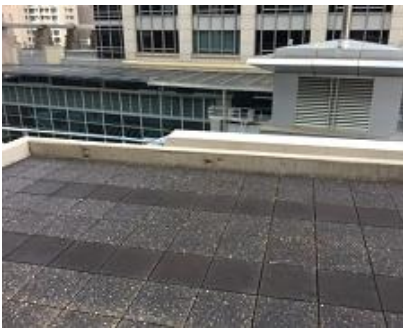
No	Photo of Hazard	Details of Hazard	Details of Risk	Existing/ Immediate Control Measure	Curre nt Risk Level	Proposed Permanent Solution	Resid ual Risk Asse sme nt	Details of Action Taken	Status	Reference
05	Building: General Stores Location Reference: <a href="#">L02</a> Task: Access to the roof

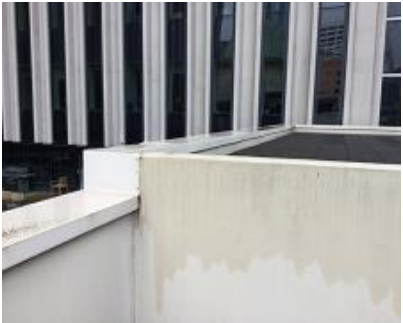
No height safety system installed	Trips, Slips and Falls	Awareness induction	High	Handrail to be installed	Low	Client advised	Outstanding	OH&S REGULATIONS 3.55
06	Building: General Stores Location Reference: <a href="#">L02</a> Task: Access to the roof

No height safety system installed	Trips, Slips and Falls	Awareness induction	High	Handrail to be installed	Low	Client advised	Outstanding	OH&S REGULATIONS 3.55

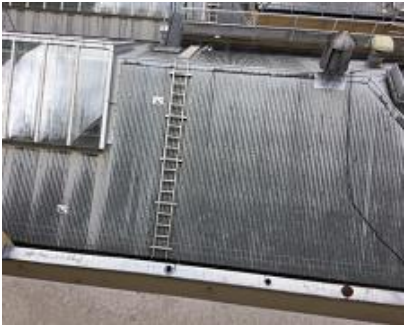
No	Photo of Hazard	Details of Hazard	Details of Risk	Existing/ Immediate Control Measure	Curre nt Risk Level	Proposed Permanent Solution	Resid ual Risk Asse sme nt	Details of Action Taken	Status	Reference
07	Building: General Stores Location Reference: <a href="#">L04</a> Task: Access to the roof

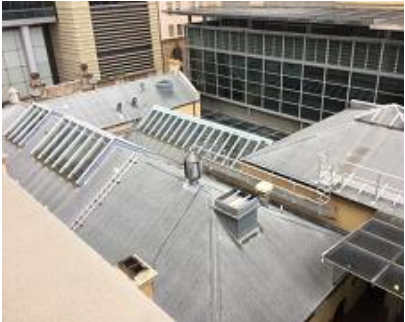
Non-complaint ladder is present	Trips, Slips and Falls	Awareness induction	Med	Existing ladder to be replaced with steps	Low	Client advised	Outstanding	OH&S REGULATIONS 3.7  AS/NZS 1657-2013 7.4
08	Building: General Stores Location Reference: <a href="#">L04</a> Task: Restrict access to the roof

Brittle and Fragile roof sections are present	Trips, Slips and Falls	Restrict Access	High	"Brittle and Fragile Roof" signs to be installed	Low	Client advised	Outstanding	OH&S REGULATIONS 3.57

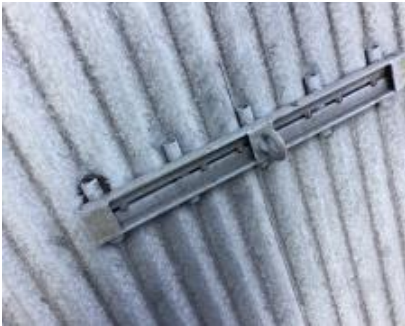
No	Photo of Hazard	Details of Hazard	Details of Risk	Existing/ Immediate Control Measure	Curre nt Risk Level	Proposed Permanent Solution	Resid ual Risk Asse sme nt	Details of Action Taken	Status	Reference
09	Building: General Stores Location Reference: <a href="#">L04</a> Task: Access to the roof

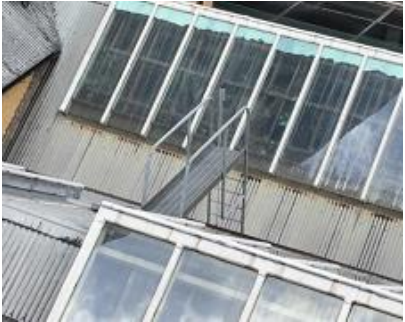
Non-complaint anchor point is present	Trips, Slips and Falls	Awareness induction	High	Existing anchor point to be replaced	Low	Client advised	Outstanding	OH&S REGULATIONS 3.55
10	Building: General Stores Location Reference: <a href="#">L05</a> Task: Access to the roof

Mid rail is missing for landing	Trips, Slips and Falls	Awareness induction	Med	Mid rail to be installed	Low	Client advised	Outstanding	OH&S REGULATIONS 3.7  AS/NZS 1657-2013 4.4

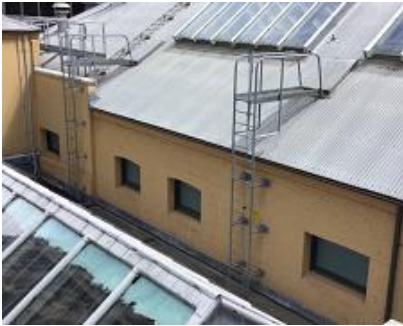
No	Photo of Hazard	Details of Hazard	Details of Risk	Existing/ Immediate Control Measure	Curre nt Risk Level	Proposed Permanent Solution	Resid ual Risk Asse sme nt	Details of Action Taken	Status	Reference
11	Building: General Stores Location Reference: <a href="#">L05</a> Task: Access to the roof

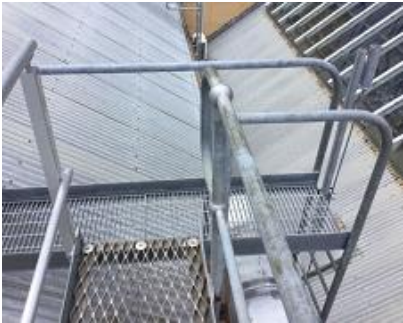
No slip resistance on ladder rungs, bottom rung height is less than required minimum and static line is over the 10 years (x2)	Trips, Slips and Falls	Awareness induction	Med	Non-slip rung caps, landing platform including handrail at base to be installed and static line to be replaced for ladders (x2)	Low	Client advised	Outstanding	OH&S REGULATIONS 3.7  AS/NZS 1657-2013 7.4.3.1 & 7.4.3.4
12	Building: General Stores Location Reference: <a href="#">L05</a> Task: Access to the roof

Mid rail is missing for landing	Trips, Slips and Falls	Awareness induction	Med	Mid rail to be installed	Low	Client advised	Outstanding	OH&S REGULATIONS 3.7  AS/NZS 1657-2013 4.4

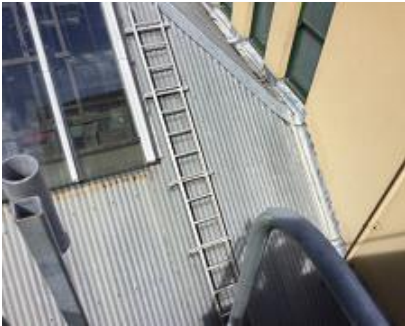
No	Photo of Hazard	Details of Hazard	Details of Risk	Existing/ Immediate Control Measure	Curre nt Risk Level	Proposed Permanent Solution	Resid ual Risk Asse sme nt	Details of Action Taken	Status	Reference
13	Building: General Stores Location Reference: <a href="#">L05</a> Task: Access to the roof

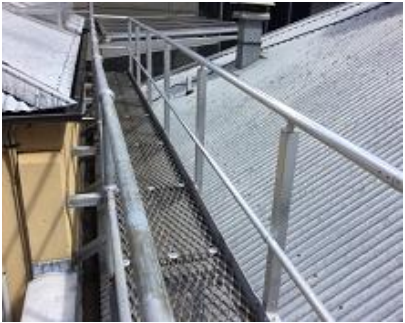
Non-complaint ladder is present	Trips, Slips and Falls	Awareness induction	Med	Existing ladder to be replaced with steps	Low	Client advised	Outstanding	OH&S REGULATIONS 3.7  AS/NZS 1657-2013 7.4
14	Building: General Stores Location Reference: <a href="#">L06</a> Task: Access to the roof

Gap between handrail and mid rail is greater than required maximum	Trips, Slips and Falls	Awareness induction	Med	Mid rail to be re-positioned	Low	Client advised	Outstanding	OH&S REGULATIONS 3.7  AS/NZS 1657-2013 4.4

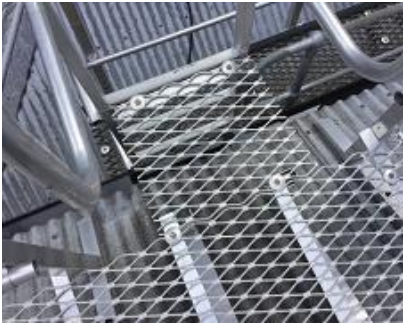
No	Photo of Hazard	Details of Hazard	Details of Risk	Existing/ Immediate Control Measure	Curre nt Risk Level	Proposed Permanent Solution	Resid ual Risk Asse sme nt	Details of Action Taken	Status	Reference
15	Building: General Stores Location Reference: <a href="#">L06</a> Task: Access to the roof

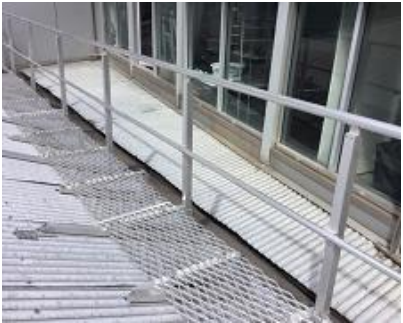
Landing is not fully secured	Trips, Slips and Falls	Awareness induction	Med	Landing to be fully secured	Low	Client advised	Outsta nding	OH&S REGULATIONS 3.7  AS/NZS 1657- 2013 7.3.6
16	Building: General Stores Location Reference: <a href="#">L06</a> Task: Access to the roof

Gap between handrail and mid rail is greater than required maximum	Trips, Slips and Falls	Awareness induction	Med	Mid rail to be re- positioned	Low	Client advised	Outsta nding	OH&S REGULATIONS 3.7  AS/NZS 1657- 2013 4.4

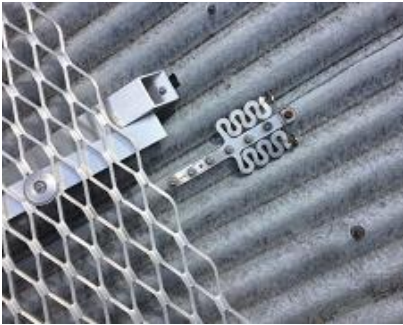
No	Photo of Hazard	Details of Hazard	Details of Risk	Existing/ Immediate Control Measure	Curre nt Risk Level	Proposed Permanent Solution	Resid ual Risk Asse sme nt	Details of Action Taken	Status	Reference
17	Building: General Stores Location Reference: <a href="#">L06</a> Task: Access to the roof

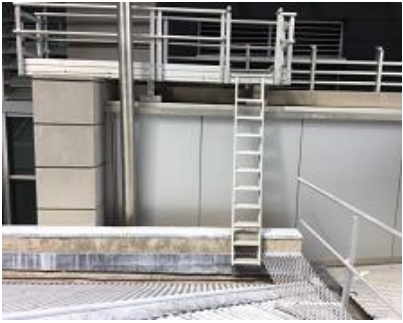
Non-complaint anchor points are present	Trips, Slips and Falls	Awareness induction	High	Anchor points to be replaced	Low	Client advised	Outstanding	OH&S REGULATIONS 3.55
18	Building: General Stores Location Reference: <a href="#">L07</a> Task: Access to the roof

Non-complaint ladder is present	Trips, Slips and Falls	Awareness induction	Med	Existing ladder to be replaced	Low	Client advised	Outstanding	OH&S REGULATIONS 3.7  AS/NZS 1657-2013 7.3

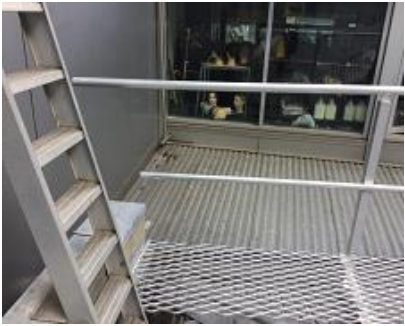
No	Photo of Hazard	Details of Hazard	Details of Risk	Existing/ Immediate Control Measure	Curre nt Risk Level	Proposed Permanent Solution	Resid ual Risk Asse sme nt	Details of Action Taken	Status	Reference
19	Building: General Stores Location Reference: <a href="#">L07</a> Task: Access to the roof

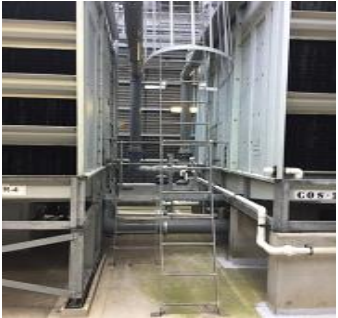
Handrail section not fully secured	Trips, Slips and Falls	Awareness induction	Med	Handrail post to be installed	Low	Client advised	Outstanding	OH&S REGULATIONS 3.7  AS/NZS 1657-2013 4.4
20	Building: General Stores Location Reference: <a href="#">L08</a> Task: Access to the roof

No slip resistance on ladder rungs and bottom rung height is less than required minimum (x2)	Trips, Slips and Falls	Awareness induction	Med	Non-slip rung caps and landing platforms to be installed (x2)	Low	Client advised	Outstanding	OH&S REGULATIONS 3.7  AS/NZS 1657-2013 7.4.3.1 & 7.4.3.4

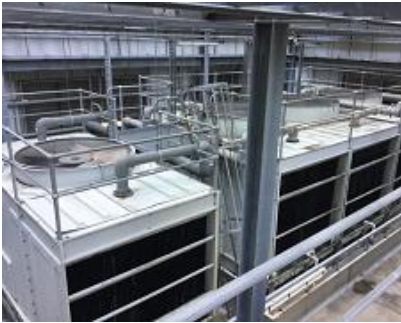
No	Photo of Hazard	Details of Hazard	Details of Risk	Existing/ Immediate Control Measure	Curre nt Risk Level	Proposed Permanent Solution	Resid ual Risk Asse sme nt	Details of Action Taken	Status	Reference
21	Building: General Stores Location Reference: <a href="#">L08</a> Task: Access to the roof

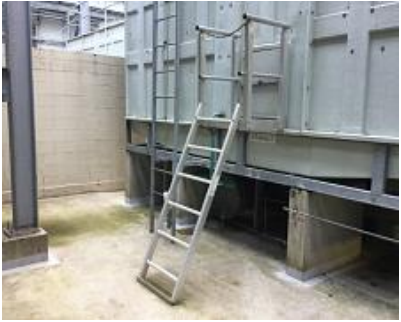
Toe board is missing for handrails	Trips, Slips and Falls	Awareness induction	Med	Toe board to be installed	Low	Client advised	Outstanding	OH&S REGULATIONS 3.7  AS/NZS 1657-2013 4.6
22	Building: General Stores Location Reference: <a href="#">L08</a> Task: Access to the roof

Non-complaint ladder is present	Trips, Slips and Falls	Awareness induction	Med	Existing ladder to be replaced	Low	Client advised	Outstanding	OH&S REGULATIONS 3.7  AS/NZS 1657-2013 7.4

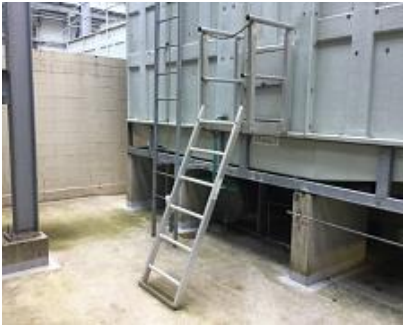
No	Photo of Hazard	Details of Hazard	Details of Risk	Existing/ Immediate Control Measure	Curre nt Risk Level	Proposed Permanent Solution	Resid ual Risk Asse sme nt	Details of Action Taken	Status	Reference
23	Building: General Stores Location Reference: <a href="#">L08</a> Task: Access to the roof

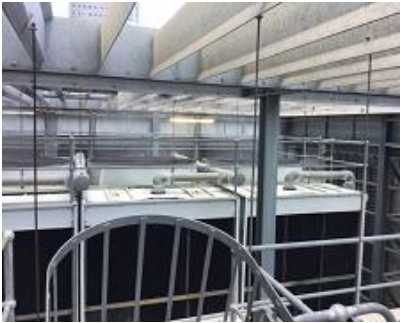
No slip resistance on ladder rungs and bottom rung height is less than required minimum and no landing at top	Trips, Slips and Falls	Awareness induction	Med	Non-slip rung caps and landing platforms at top and base to be installed	Low	Client advised	Outstanding	OH&S REGULATIONS 3.7  AS/NZS 1657-2013 7.4.3.1 & 7.4.3.4
24	Building: General Stores Location Reference: <a href="#">L08</a> Task: Access to the roof

Toe board is missing for handrails	Trips, Slips and Falls	Awareness induction	Med	Toe board to be installed	Low	Client advised	Outstanding	OH&S REGULATIONS 3.7  AS/NZS 1657-2013 4.6

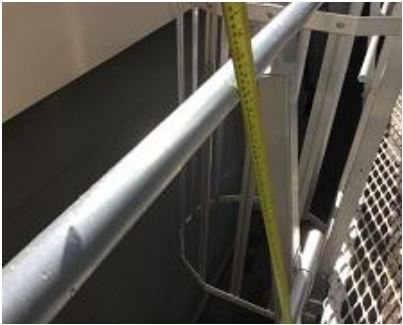
No	Photo of Hazard	Details of Hazard	Details of Risk	Existing/ Immediate Control Measure	Curre nt Risk Level	Proposed Permanent Solution	Resid ual Risk Asse sme nt	Details of Action Taken	Status	Reference
25	Building: General Stores Location Reference: <a href="#">L09</a> Task: Access to the roof

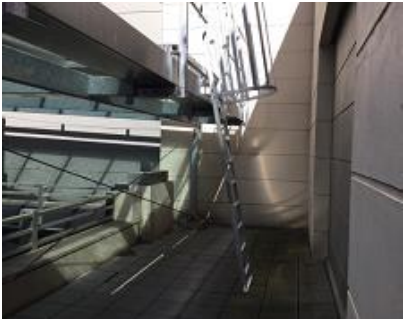
Handrail height is greater than required maximum and gap between handrail and mid rail is greater than required maximum	Trips, Slips and Falls	Awareness induction	Med	Existing handrail to be modified and re-installed. Mid rail to be re-positioned	Low	Client advised	Outstanding	OH&S REGULATIONS 3.7  AS/NZS 1657-2013 4.4 & 5.6.2
26	Building: General Stores Location Reference: <a href="#">L09</a> Task: Access to the roof

Gap between ladder and structure is less than required minimum	Trips, Slips and Falls	Awareness induction	Med	Existing ladder to be re-installed with landing platforms and brackets	Low	Client advised	Outstanding	OH&S REGULATIONS 3.7  AS/NZS 1657-2013 7.4.8.4

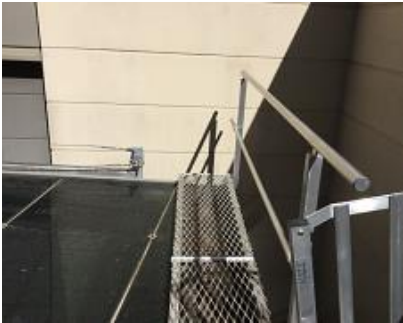
No	Photo of Hazard	Details of Hazard	Details of Risk	Existing/ Immediate Control Measure	Curre nt Risk Level	Proposed Permanent Solution	Resid ual Risk Asse sme nt	Details of Action Taken	Status	Reference
27	Building: General Stores Location Reference: <a href="#">L09</a> Task: Access to the roof

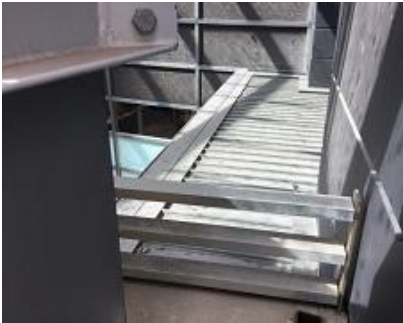
Un-protected fall edge is present	Trips, Slips and Falls	Awareness induction	High	Handrail to be installed	Low	Client advised	Outstanding	OH&S REGULATIONS 3.7  AS/NZS 1657-2013 4.4
28	Building: General Stores Location Reference: <a href="#">L10</a> Task: Access to the roof

Un-protected fall edge is present	Trips, Slips and Falls	Awareness induction	High	Handrail to be installed	Low	Client advised	Outstanding	OH&S REGULATIONS 3.55

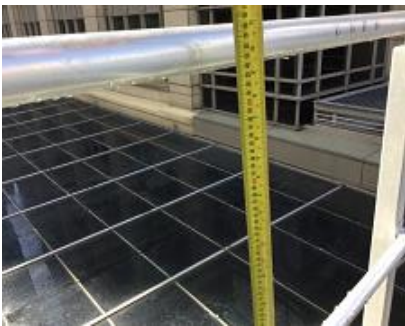
No	Photo of Hazard	Details of Hazard	Details of Risk	Existing/ Immediate Control Measure	Curre nt Risk Level	Proposed Permanent Solution	Resid ual Risk Asse sme nt	Details of Action Taken	Status	Reference
29	Building: General Stores Location Reference: <a href="#">L12</a> Task: Access to the roof

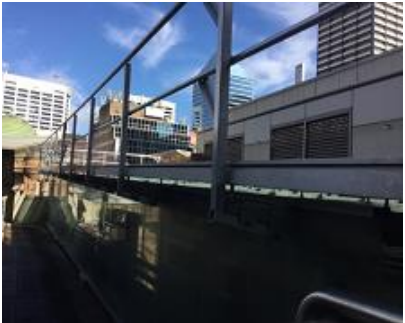
Gap between handrail and mid rail is greater than required maximum	Trips, Slips and Falls	Awareness induction	Med	Mid rail to be re-positioned	Low	Client advised	Outstanding	OH&S REGULATIONS 3.7  AS/NZS 1657-2013 4.4
30	Building: General Stores Location Reference: <a href="#">L13</a> Task: Access to the roof

Toe board is missing for handrail	Trips, Slips and Falls	Awareness induction	Med	Toe board to be installed	Low	Client advised	Outstanding	OH&S REGULATIONS 3.7  AS/NZS 1657-2013 4.6
