Roof Safety Report

**Victoria Park Central,
WA 6100**

Prepared By: Safemaster Safety Products
Date: 30-August-2018

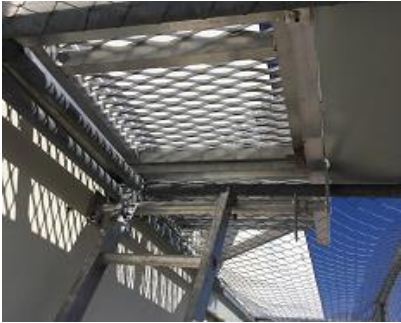
No	Photo of Hazard	Details of Hazard	Details of Risk	Existing/ Immediate Control Measure	Curren t Risk Level	Proposed Permanent Solution	Residu al Risk Assess ment	Details of Action Taken	Status	Reference
29	Building: General Stores Location Reference: L01 Task: Access to the roof

Gas struts are missing for hatch to access safely	Trips, Slips and Falls	Awareness induction	Med	Gas struts to be installed	Low	Client advised	Outstanding	OH&S REGULATIONS 3.7
30	Building: General Stores Location Reference: L01 Task: Access to the roof

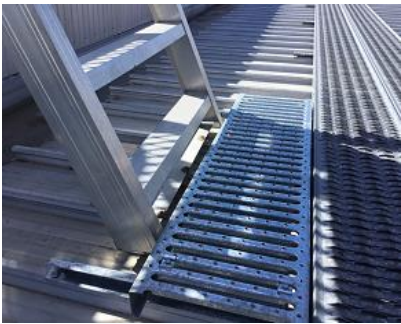
Bottom tread height is less than required minimum	Trips, Slips and Falls	Awareness induction	Med	Landing platform and additional walkway sections to be installed	Low	Client advised	Outstanding	OH&S REGULATIONS 3.7 AS/NZS 1657-2013 7.4.3.4

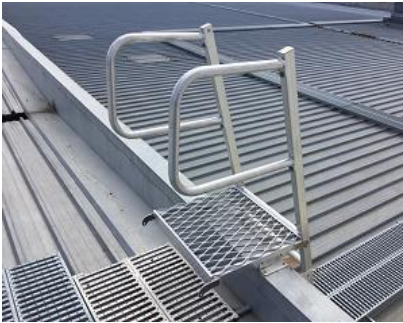
No	Photo of Hazard	Details of Hazard	Details of Risk	Existing/ Immediate Control Measure	Curren t Risk Level	Proposed Permanent Solution	Residu al Risk Assess ment	Details of Action Taken	Status	Reference
31	Building: General Stores Location Reference: L04 Task: Access to the roof

Landing is less than required minimum	Trips, Slips and Falls	Awareness induction	Med	Existing landing to be replaced	Low	Client advised	Outstanding	OH&S REGULATIONS 3.7 AS/NZS 1657-2018 7.3.6
32	Building: General Stores Location Reference: L05 Task: Access to the roof

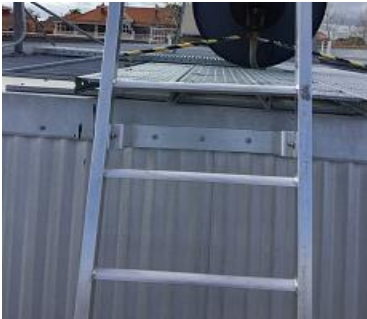
Top rung not levelled with landing	Trips, Slips and Falls	Awareness induction	Med	Existing ladder to be re-installed with landing platform and brackets	Low	Client advised	Outstanding	OH&S REGULATIONS 3.7 AS/NZS 1657-2013 7.4.3.3

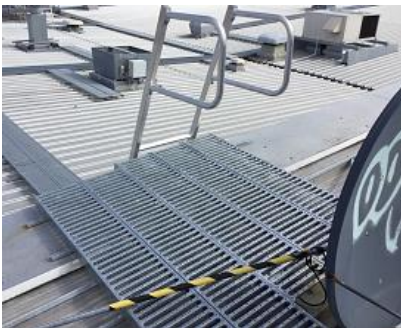
No	Photo of Hazard	Details of Hazard	Details of Risk	Existing/ Immediate Control Measure	Curren t Risk Level	Proposed Permanent Solution	Residu al Risk Assess ment	Details of Action Taken	Status	Reference
33	Building: General Stores Location Reference: L05 Task: Access to the roof

Gap between walkway and fall edge is less than required minimum	Trips, Slips and Falls	Awareness induction	Med	Handrail to be installed	Low	Client advised	Outstanding	OH&S REGULATIONS 3.7 AS/NZS 1657-2018 4.4
34	Building: General Stores Location Reference: L06 Task: Restrict access to the roof

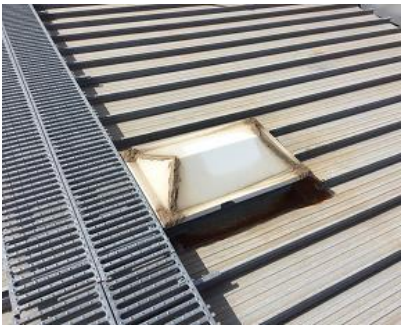
Brittle roof section is present	Trips, Slips and Falls	Restrict Access	High	"Brittle and Fragile Roof" sign to be installed	Low	Client advised	Outstanding	OH&S REGULATIONS 3.57

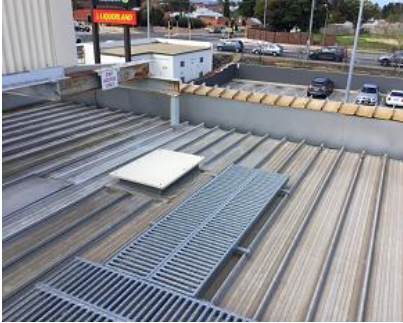
No	Photo of Hazard	Details of Hazard	Details of Risk	Existing/ Immediate Control Measure	Curren t Risk Level	Proposed Permanent Solution	Residu al Risk Assess ment	Details of Action Taken	Status	Reference
35	Building: General Stores Location Reference: L06 Task: Access to the roof

Gap between walkway and fall edge is less than required minimum	Trips, Slips and Falls	Awareness induction	Med	Handrail to be installed	Low	Client advised	Outstanding	OH&S REGULATIONS 3.7 AS/NZS 1657-2018 4.4
36	Building: General Stores Location Reference: L06 Task: Access to the roof

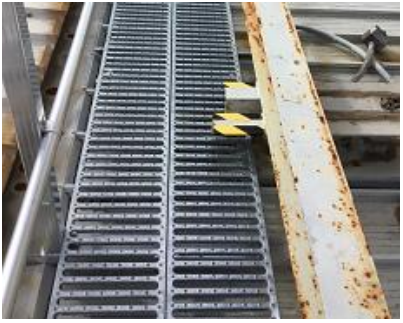
Trip hazard is present	Trips, Slips and Falls	Awareness induction	Med	"Trip Hazard" signs to be installed	Low	Client advised	Outstanding	OH&S REGULATIONS 3.7 & 3.11

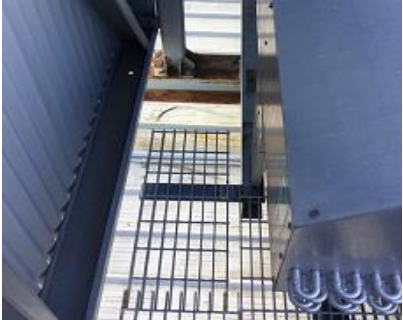
No	Photo of Hazard	Details of Hazard	Details of Risk	Existing/ Immediate Control Measure	Curren t Risk Level	Proposed Permanent Solution	Residu al Risk Assess ment	Details of Action Taken	Status	Reference
37	Building: General Stores Location Reference: L06 Task: Access to the roof

Variation in height between plant deck and roof is greater than required maximum	Trips, Slips and Falls	Awareness induction	Med	Handrail to be installed	Low	Client advised	Outstanding	OH&S REGULATIONS 3.7 AS/NZS 1657-2018 4.4
38	Building: General Stores Location Reference: L10 Task: Access to the roof

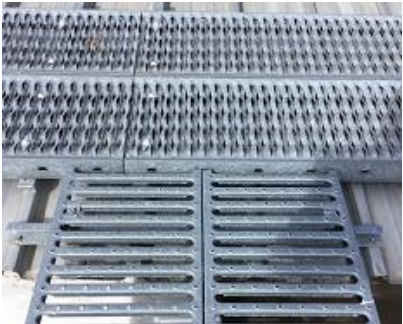
Variation in height between walkway panels are greater than required maximum	Trips, Slips and Falls	Awareness induction	Med	High visibility safety yellow nosing to be installed	Low	Client advised	Outstanding	OH&S REGULATIONS 3.7 AS/NZS 1657-2013 3.3.4

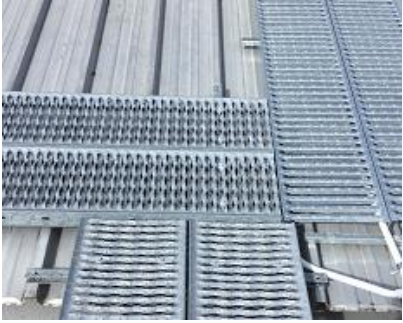
No	Photo of Hazard	Details of Hazard	Details of Risk	Existing/ Immediate Control Measure	Current Risk Level	Proposed Permanent Solution	Residual Risk Assessment	Details of Action Taken	Status	Reference
39	Building: General Stores Location Reference: L1 Task: Access to the roof

Variation in height between walkway panels are greater than required maximum	Trips, Slips and Falls	Awareness induction	Med	High visibility safety yellow nosing's to be installed	Low	Client advised	Outstanding	OH&S REGULATIONS 3.7 AS/NZS 1657-2013 3.3.4
