# Roof Safety Report

**Villawood Immigration  
Detention Centre - NSW 2163**

Prepared By: Safemaster Safety Products  
Date: 20-02-2020

22-01-2020

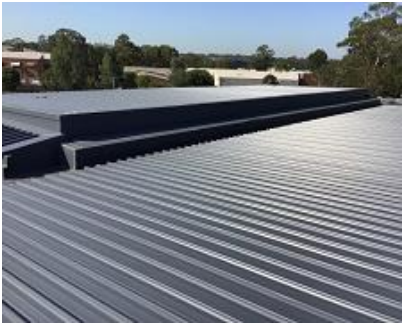
Variation in height between roofs are greater than required maximum	Trips, Slips and Falls	Awareness induction	Med	Access ladder to be installed	Low	Client advised	Outstanding	OH&S REGULATIONS 3.7  AS1657-2018 3.1.4
02	Building: General Stores Location Reference: <a href="#">L02</a> Task: Access to the roof

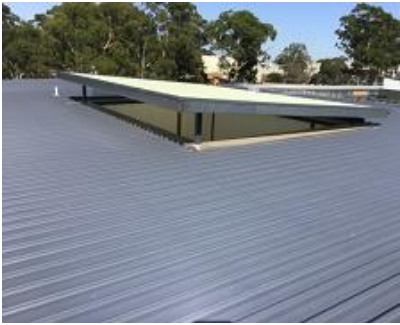
Brittle and fragile roof section is present	Trips, Slips and Falls	Restrict Access	High	"Brittle and Fragile Roof" signs to be installed	Low	Client advised	Outstanding	OH&S REGULATIONS 3.57
04	Building: General Stores Location Reference: <a href="#">L03</a> Task: Access to the roof

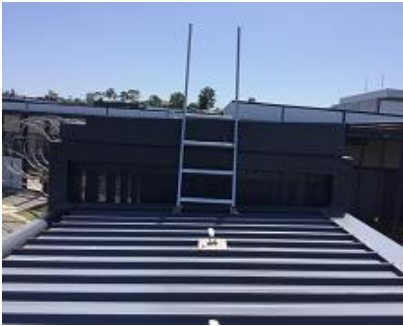
Top rung not levelled with landing and bottom rung height is less than required minimum	Trips, Slips and Falls	Awareness induction	Med	Existing ladder to be re-installed with landing platforms and brackets	Low	Client advised	Outstanding	OH&S REGULATIONS 3.7  AS1657-2018 7.4.3.3 & 7.4.3.4
06	Building: General Stores Location Reference: <a href="#">L06</a> Task: Access to the roof

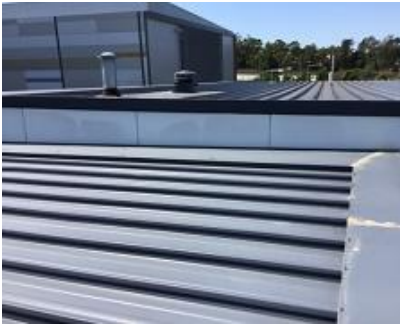
Variation in height between roofs are greater than required maximum	Trips, Slips and Falls	Awareness induction	Med	Single step to be installed	Low	Client advised	Outstanding	OH&S REGULATIONS 3.7  AS1657-2018 3.1.4
08	Building: General Stores Location Reference: <a href="#">L06</a> Task: Access to the roof

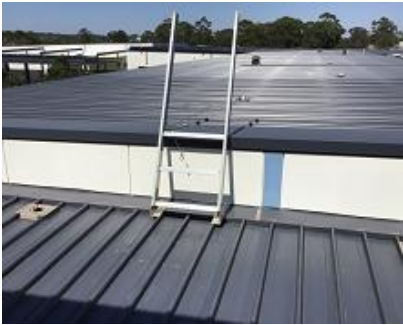
Top rung not levelled with landing and bottom rung height is less than required minimum	Trips, Slips and Falls	Awareness induction	Med	Existing ladder to be re-installed with landing platforms and brackets	Low	Client advised	Outstanding	OH&S REGULATIONS 3.7  AS1657-2018 7.4.3.3 & 7.4.3.4
10	Building: General Stores Location Reference: <a href="#">L08</a> Task: Access to the roof

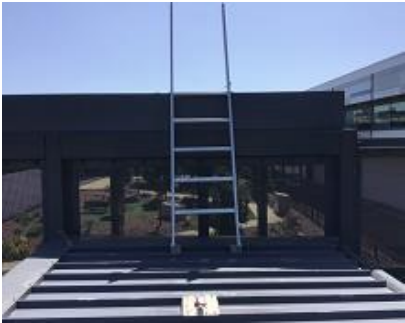
Top rung not levelled with landing and bottom rung height is less than required minimum	Trips, Slips and Falls	Awareness induction	Med	Existing ladder to be re-installed with landing platforms and brackets	Low	Client advised	Outstanding	OH&S REGULATIONS 3.7  AS1657-2018 7.4.3.3 & 7.4.3.4
12	Building: General Stores Location Reference: <a href="#">L11</a> Task: Access to the roof

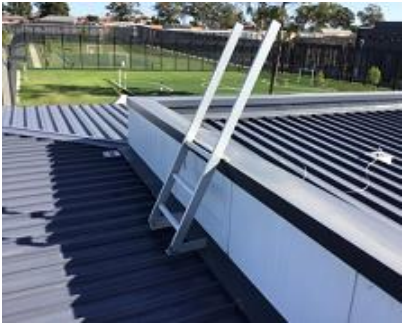
Top rung not levelled with landing and bottom rung height is less than required minimum and return ladder not installed	Trips, Slips and Falls	Awareness induction	Med	Existing ladder to be replaced with parapet ladder	Low	Client advised	Outstanding	OH&S REGULATIONS 3.7  AS1657-2018 7.4.3.3 & 7.4.3.4

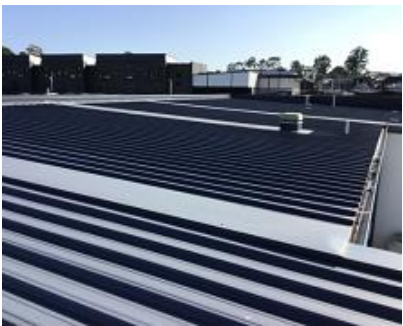
Not enough anchors installed to protect the fall edge	Trips, Slips and Falls	Awareness induction	High	Anchors to be installed	Low	Client advised	Outstanding	OH&S REGULATIONS 3.55
14	Building: General Stores Location Reference: <a href="#">L13</a> Task: Access to the roof

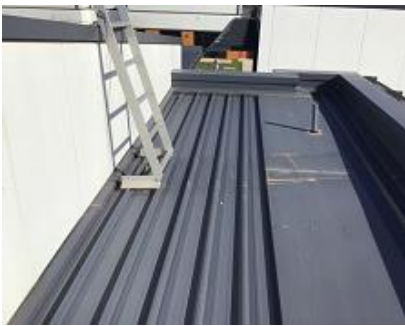
Not enough anchors installed to protect the fall edge	Trips, Slips and Falls	Awareness induction	High	Anchors to be installed	Low	Client advised	Outstanding	OH&S REGULATIONS 3.55
16	Building: General Stores Location Reference: <a href="#">L14</a> Task: Access to the roof

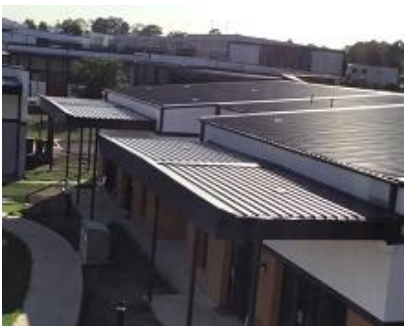
Variation in height between roofs are greater than required maximum	Trips, Slips and Falls	Awareness induction	Med	Access ladders (x2) to be installed	Low	Client advised	Outstanding	OH&S REGULATIONS 3.7  AS1657-2018 3.1.4
18	Building: General Stores Location Reference: <a href="#">L15</a> Task: Access to the roof

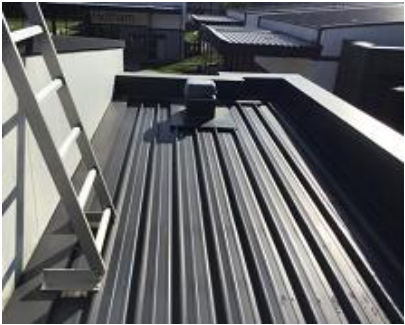
Not enough anchors installed to protect the fall edge	Trips, Slips and Falls	Awareness induction	High	Anchors to be installed	Low	Client advised	Outstanding	OH&S REGULATIONS 3.55
20	Building: General Stores Location Reference: <a href="#">L16</a> Task: Access to the roof

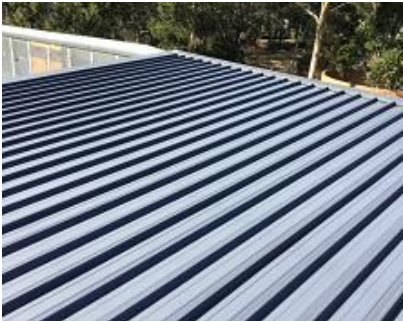
Not enough anchors installed to protect the fall edge	Trips, Slips and Falls	Awareness induction	High	Anchors to be installed	Low	Client advised	Outstanding	OH&S REGULATIONS 3.55
22	Building: General Stores Location Reference: <a href="#">L18</a> Task: Access to the roof

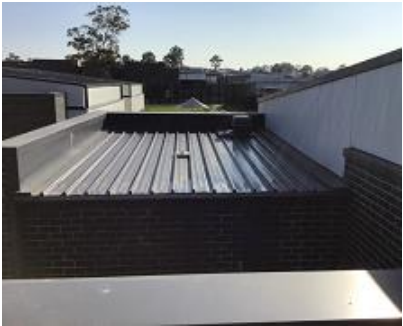
Variation in height between roofs are greater than required maximum	Trips, Slips and Falls	Awareness induction	Med	Access ladder to be installed	Low	Client advised	Outstanding	OH&S REGULATIONS 3.7  AS1657-2018 3.1.4
24	Building: General Stores Location Reference: <a href="#">L19</a> Task: Access to the roof

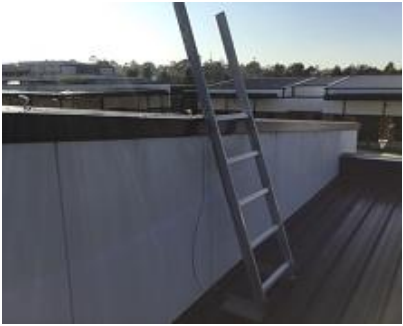
Top rung not levelled with landing and bottom rung height is less than required minimum	Trips, Slips and Falls	Awareness induction	Med	Existing ladder to be re-installed with landing platforms and brackets	Low	Client advised	Outstanding	OH&S REGULATIONS 3.7  AS1657-2018 7.4.3.3 & 7.4.3.4
26	Building: General Stores Location Reference: <a href="#">L20</a> Task: Access to the roof

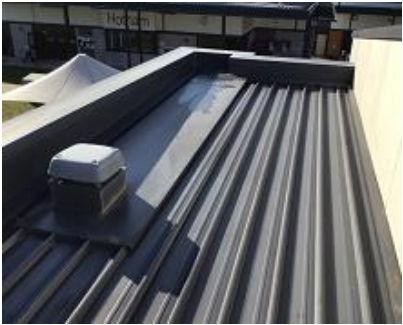
Not enough anchors installed to protect the fall edge	Trips, Slips and Falls	Awareness induction	High	Anchors to be installed	Low	Client advised	Outstanding	OH&S REGULATIONS 3.55
28	Building: General Stores Location Reference: <a href="#">L23</a> Task: Access to the roof

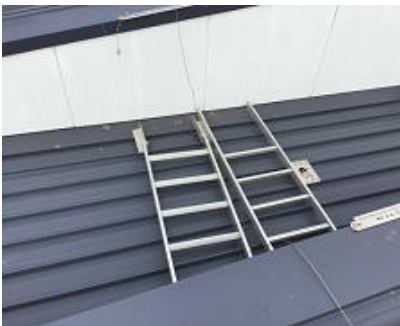
Ladders not secured and non-complaint	Trips, Slips and Falls	Awareness induction	Med	Existing ladders (x2) to be replaced	Low	Client advised	Outstanding	OH&S REGULATIONS 3.7  AS1657-2018 3.1.4
30	Building: General Stores Location Reference: <a href="#">L24</a> Task: Access to the roof

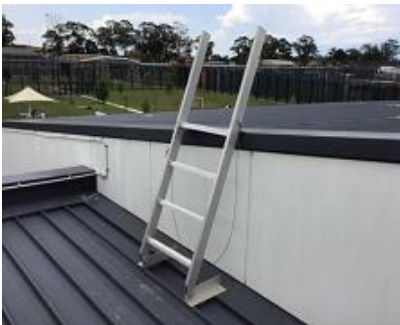
Ladders not secured and non-complaint	Trips, Slips and Falls	Awareness induction	Med	Existing ladders to be replaced	Low	Client advised	Outstanding	OH&S REGULATIONS 3.7  AS1657-2018 3.1.4

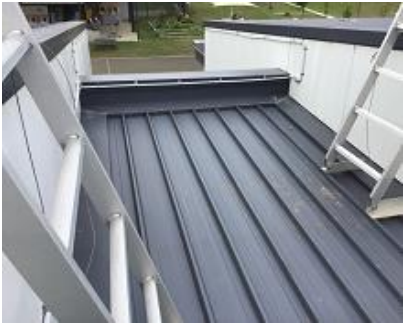
Not enough anchors installed to protect the fall edge	Trips, Slips and Falls	Awareness induction	High	Anchors to be installed	Low	Client advised	Outstanding	OH&S REGULATIONS 3.55
32	Building: General Stores Location Reference: <a href="#">L24</a> Task: Access to the roof

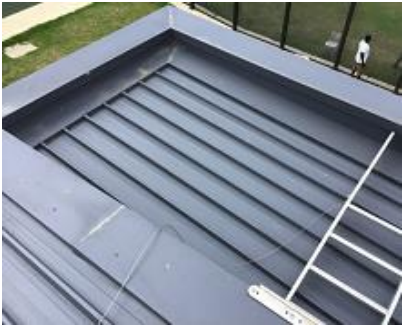
Not enough anchors installed to protect the fall edge	Trips, Slips and Falls	Awareness induction	High	Anchors to be installed	Low	Client advised	Outstanding	OH&S REGULATIONS 3.55
34	Building: General Stores Location Reference: <a href="#">L25</a> Task: Access to the roof

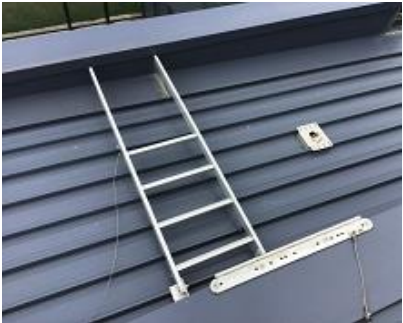
Ladders not secured and non-complaint	Trips, Slips and Falls	Awareness induction	Med	Existing ladder to be replaced	Low	Client advised	Outstanding	OH&S REGULATIONS 3.7 AS1657-2018 3.1.4

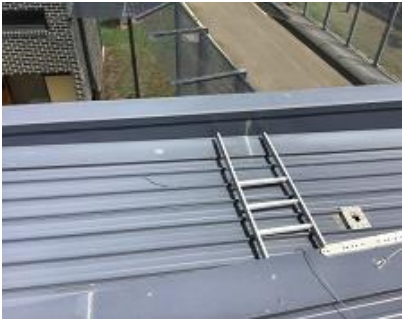
Not enough anchors installed to protect the fall edge	Trips, Slips and Falls	Awareness induction	High	Anchors to be installed	Low	Client advised	Outstanding	OH&S REGULATIONS 3.55
36	Building: General Stores Location Reference: <a href="#">L26</a> Task: Access to the roof

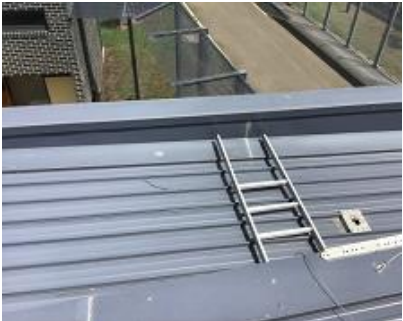
Ladders not secured and non-complaint	Trips, Slips and Falls	Awareness induction	Med	Existing ladder to be replaced	Low	Client advised	Outstanding	OH&S REGULATIONS 3.7 AS1657-2018 3.1.4

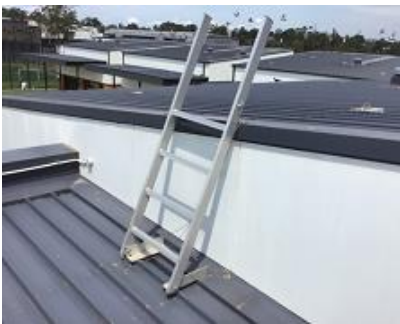
Ladders not secured and non-complaint	Trips, Slips and Falls	Awareness induction	Med	Existing ladders (x2) to be replaced	Low	Client advised	Outstanding	OH&S REGULATIONS 3.7  AS1657-2018 3.1.4
38	Building: General Stores Location Reference: <a href="#">L28</a> Task: Access to the roof

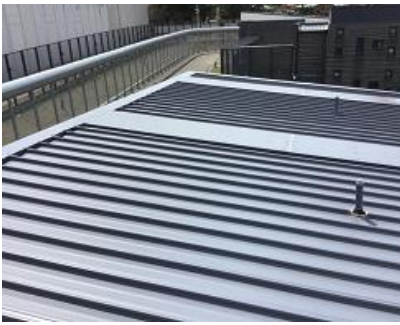
Not enough anchors installed to protect the fall edge	Trips, Slips and Falls	Awareness induction	High	Anchors to be installed	Low	Client advised	Outstanding	OH&S REGULATIONS 3.55

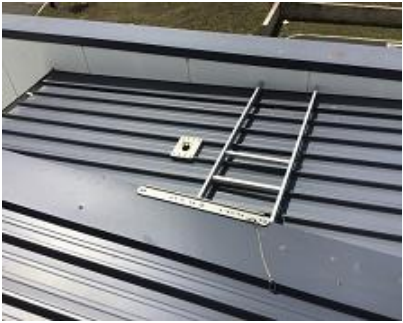
Ladders not secured and non-complaint	Trips, Slips and Falls	Awareness induction	Med	Existing ladders to be replaced	Low	Client advised	Outstanding	OH&S REGULATIONS 3.7  AS1657-2018 3.1.4
40	Building: General Stores Location Reference: <a href="#">L30</a> Task: Access to the roof

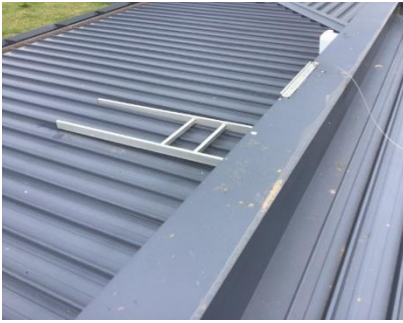
Ladders not secured and non-complaint	Trips, Slips and Falls	Awareness induction	Med	Existing ladders to be replaced	Low	Client advised	Outstanding	OH&S REGULATIONS 3.7  AS1657-2018 3.1.4

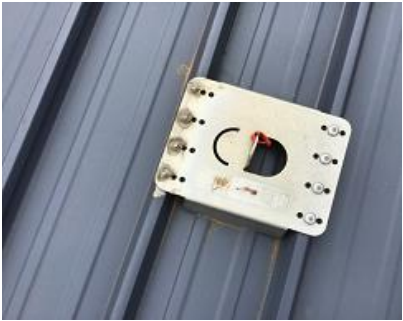
Anchor installed in-correctly	Trips, Slips and Falls	Awareness induction	High	Existing anchor to be replaced	Low	Client advised	Outstanding	OH&S REGULATIONS 3.55
42	Building: General Stores Location Reference: <a href="#">L32</a> Task: Access to the roof

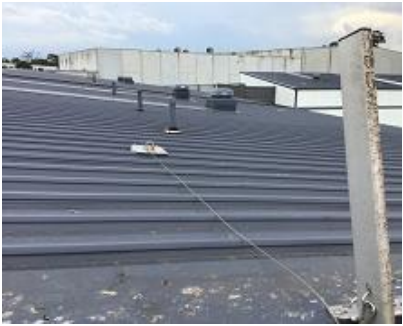
Not enough anchors installed to protect the fall edge	Trips, Slips and Falls	Awareness induction	High	Anchors to be installed	Low	Client advised	Outstanding	OH&S REGULATIONS 3.55
46	Building: General Stores Location Reference: <a href="#">L34</a> Task: Access to the roof

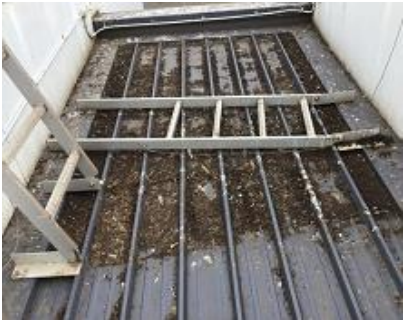
Ladders not secured and non-complaint	Trips, Slips and Falls	Awareness induction	Med	Existing ladders (x2) to be replaced	Low	Client advised	Outstanding	OH&S REGULATIONS 3.7 AS1657-2018 3.1.4

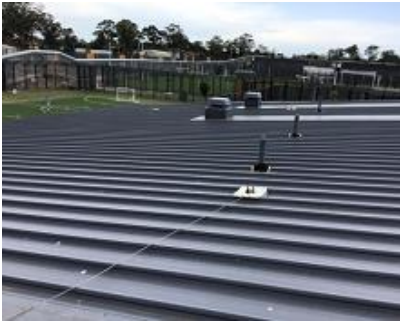
Not enough anchors installed to protect the fall edge	Trips, Slips and Falls	Awareness induction	High	Anchors to be installed	Low	Client advised	Outstanding	OH&S REGULATIONS 3.55
48	Building: General Stores Location Reference: <a href="#">L34</a> Task: Access to the roof

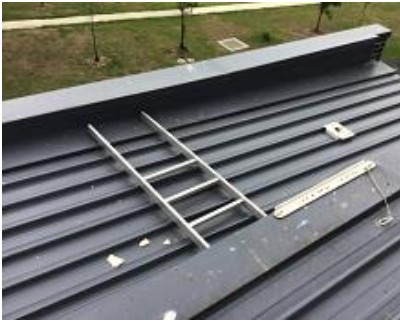
Not enough anchors installed to protect the fall edge	Trips, Slips and Falls	Awareness induction	High	Anchors to be installed and existing ladder to be replaced	Low	Client advised	Outstanding	OH&S REGULATIONS 3.7 & 3.55  AS1657-2018 3.1.4

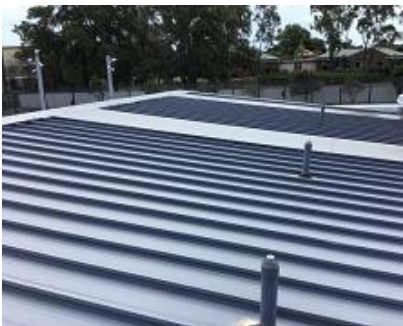
Not enough anchors installed to protect the fall edge	Trips, Slips and Falls	Awareness induction	High	Anchors to be installed	Low	Client advised	Outstanding	OH&S REGULATIONS 3.55
52	Building: General Stores Location Reference: <a href="#">L36</a> Task: Access to the roof

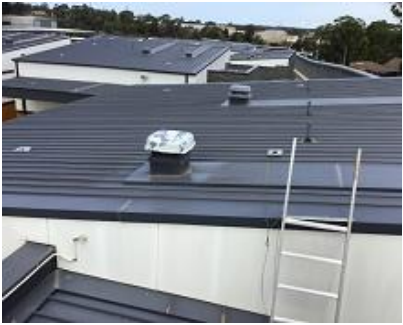
Not enough anchors installed to protect the fall edge	Trips, Slips and Falls	Awareness induction	High	Anchors to be installed	Low	Client advised	Outstanding	OH&S REGULATIONS 3.55
54	Building: General Stores Location Reference: <a href="#">L37</a> Task: Access to the roof

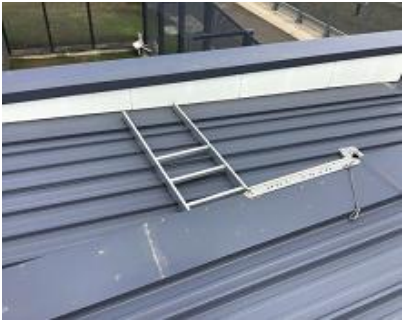
Ladders not secured and non-complaint	Trips, Slips and Falls	Awareness induction	Med	Existing ladders to be replaced	Low	Client advised	Outstanding	OH&S REGULATIONS 3.7 AS1657-2018 3.1.4

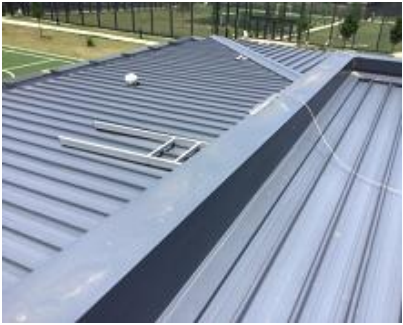
Ladders not secured and non-complaint	Trips, Slips and Falls	Awareness induction	Med	Existing ladders to be replaced	Low	Client advised	Outstanding	OH&S REGULATIONS 3.7  AS1657-2018 3.1.4
56	Building: General Stores Location Reference: <a href="#">L39</a> Task: Access to the roof

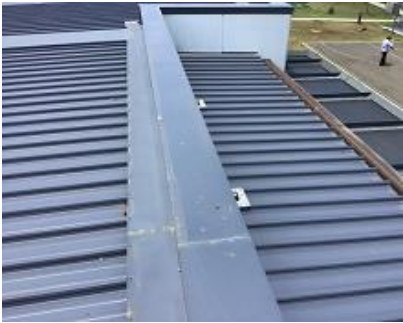
Variation in height between roofs are greater than required maximum	Trips, Slips and Falls	Awareness induction	Med	Access ladders to be installed	Low	Client advised	Outstanding	OH&S REGULATIONS 3.7  AS1657-2018 3.1.4

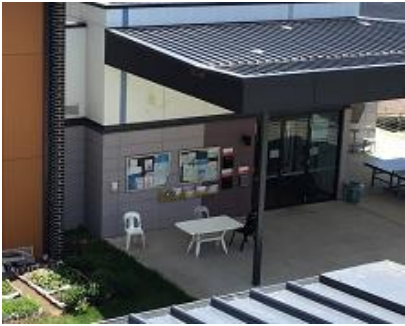
No ladder bracket and sign are installed	Trips, Slips and Falls	Awareness induction	High	Ladder bracket and sign to be installed	Low	Client advised	Outstanding	OH&S REGULATIONS 3.55
58	Building: General Stores Location Reference: <a href="#">L41</a> Task: Access to the roof

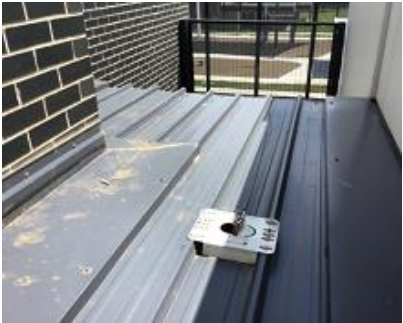
No ladder bracket is installed	Trips, Slips and Falls	Awareness induction	High	Ladder bracket to be installed	Low	Client advised	Outstanding	OH&S REGULATIONS 3.55
60	Building: General Stores Location Reference: <a href="#">L42</a> Task: Access to the roof

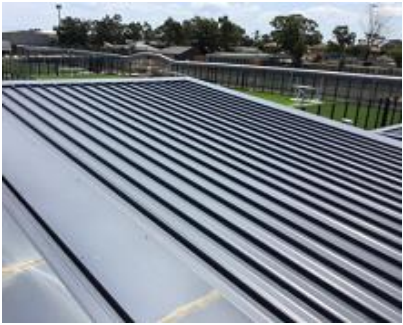
Not enough anchors installed to protect the fall edge	Trips, Slips and Falls	Awareness induction	High	Anchors to be installed	Low	Client advised	Outstanding	OH&S REGULATIONS 3.55
62	Building: General Stores Location Reference: <a href="#">L43</a> Task: Access to the roof

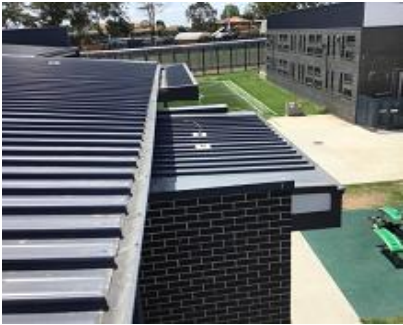
Anchor strop is not adequate and ladder bracket not installed	Trips, Slips and Falls	Awareness induction	High	Ladder bracket and strop to be installed	Low	Client advised	Outstanding	OH&S REGULATIONS 3.55
64	Building: General Stores Location Reference: <a href="#">L44</a> Task: Access to the roof

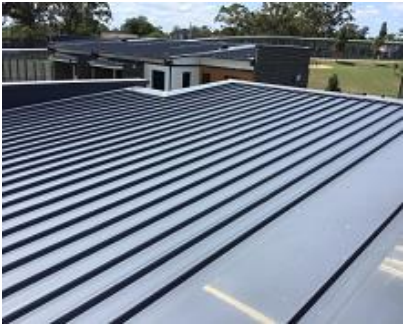
Not enough anchors installed to protect the fall edge	Trips, Slips and Falls	Awareness induction	High	Anchors to be installed	Low	Client advised	Outstanding	OH&S REGULATIONS 3.55
66	Building: General Stores Location Reference: <a href="#">L45</a> Task: Access to the roof

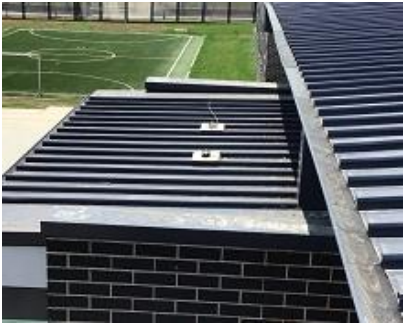
Ladder bracket not installed	Trips, Slips and Falls	Awareness induction	High	Ladder bracket to be installed	Low	Client advised	Outstanding	OH&S REGULATIONS 3.55
68	Building: General Stores Location Reference: <a href="#">L46</a> Task: Access to the roof

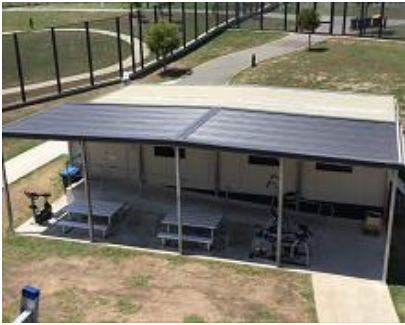
No height safety system installed	Trips, Slips and Falls	Awareness induction	High	Ladder bracket, sign, strop and anchors to be installed	Low	Client advised	Outstanding	OH&S REGULATIONS 3.55
70	Building: General Stores Location Reference: <a href="#">L48</a> Task: Access to the roof

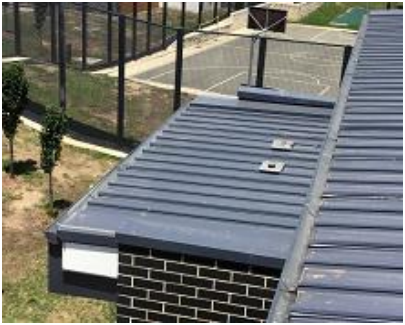
Ladder bracket not installed	Trips, Slips and Falls	Awareness induction	High	Ladder bracket to be installed	Low	Client advised	Outstanding	OH&S REGULATIONS 3.55
72	Building: General Stores Location Reference: <a href="#">L49</a> Task: Access to the roof

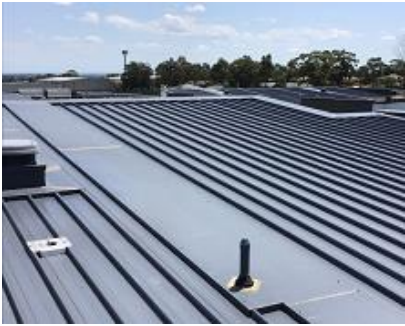
Not enough anchors installed to protect the fall edge	Trips, Slips and Falls	Awareness induction	High	Anchors to be installed	Low	Client advised	Outstanding	OH&S REGULATIONS 3.55
74	Building: General Stores Location Reference: <a href="#">L50</a> Task: Access to the roof

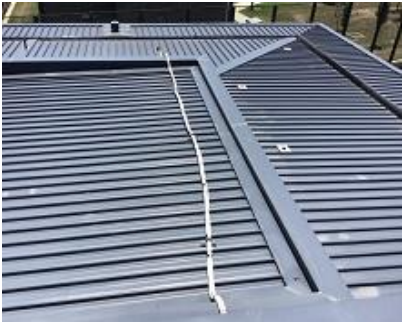
Variation in height between roofs are greater than required maximum	Trips, Slips and Falls	Awareness induction	Med	Access ladders to be installed	Low	Client advised	Outstanding	OH&S REGULATIONS 3.7  AS1657-2018 3.1.4
76	Building: General Stores Location Reference: <a href="#">L51</a> Task: Access to the roof

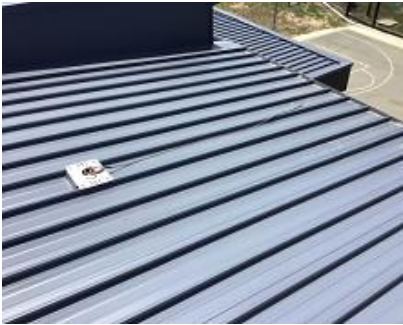
Roof access point is too high to use portable ladder	Trips, Slips and Falls	Awareness induction	High	Strop and sign to be removed. Access ladder from lower roof to be installed	Low	Client advised	Outstanding	OH&S REGULATIONS 3.55
78	Building: General Stores Location Reference: <a href="#">L51</a> Task: Access to the roof

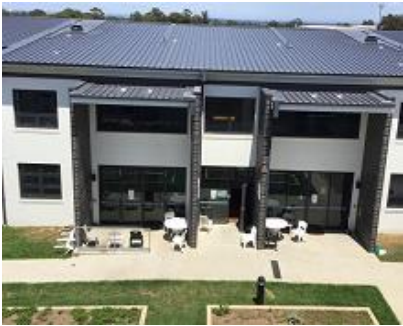
Ladder bracket not installed	Trips, Slips and Falls	Awareness induction	High	Ladder brackets to be installed	Low	Client advised	Outstanding	OH&S REGULATIONS 3.55
80	Building: General Stores Location Reference: <a href="#">L53</a> Task: Access to the roof

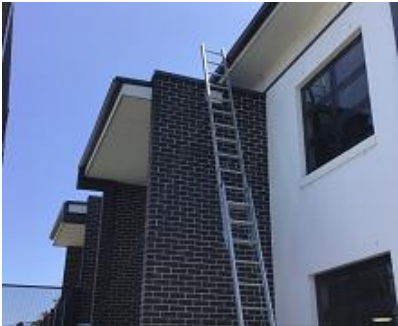
Ladder bracket not installed	Trips, Slips and Falls	Awareness induction	High	Ladder brackets to be installed	Low	Client advised	Outstanding	OH&S REGULATIONS 3.55
82	Building: General Stores Location Reference: <a href="#">L54</a> Task: Access to the roof
