# Roof Safety Report

**Warriewood Square,  
NSW 2102**

Prepared By: Safemaster Safety Products  
Date: 05-11-2019

**ADDITIONAL FINDINGS & RECOMMENDATIONS**

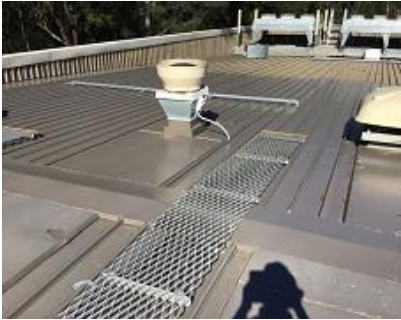
No	Photo of Hazard	Details of Hazard	Details of Risk	Existing/ Immediate Control Measure	Curren t Risk Level	Proposed Permanent Solution	Residu al Risk Assess ment	Details of Action Taken	Status	Reference
105	Building: General Stores Location Reference: <a href="#">L05</a> Task: Access to the roof

Not enough anchors installed	Trips, Slips and Falls	Awareness induction	High	Anchors to be installed	Low	Client advised	Outstanding	OH&S REGULATIONS 3.55
106	Building: General Stores Location Reference: <a href="#">L03</a> Task: Restrict access to the roof

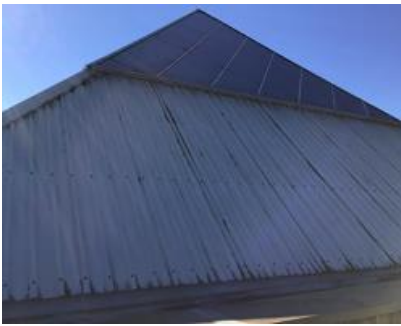
Brittle and Fragile roof sections are present	Trips, Slips and Falls	Restrict Access	High	"Brittle and Fragile Roof" signs to be installed	Low	Client advised	Outstanding	OH&S REGULATIONS 3.57

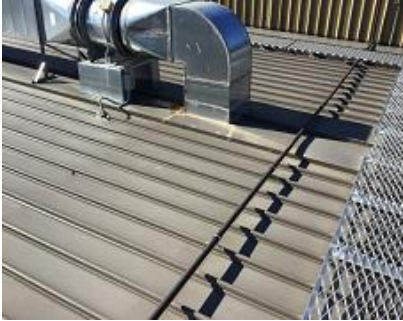
No	Photo of Hazard	Details of Hazard	Details of Risk	Existing/ Immediate Control Measure	Curren t Risk Level	Proposed Permanent Solution	Residu al Risk Assess ment	Details of Action Taken	Status	Reference
107	Building: General Stores Location Reference: <a href="#">L03</a> Task: Access to the A/c units

No safe access to the A/c units	Trips, Slips and Falls	N/A	Low	Supply walkway and step bridge to the A/c units	Low	Client advised	Outstanding	-
108	Building: General Stores Location Reference: <a href="#">L12</a> Task: Access to the roof

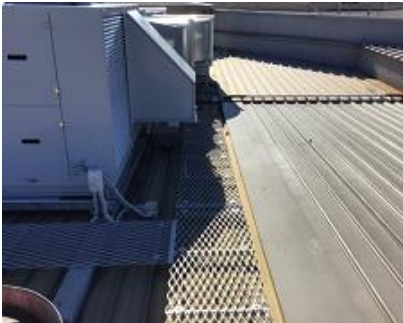
Duct protrudes over the walkway path	Trips, Slips and Falls	Awareness induction	Med	Additional walkway section to be installed	Low	Client advised	Outstanding	OH&S REGULATIONS 3.7  AS/NZS 1657-2018 3.1.5

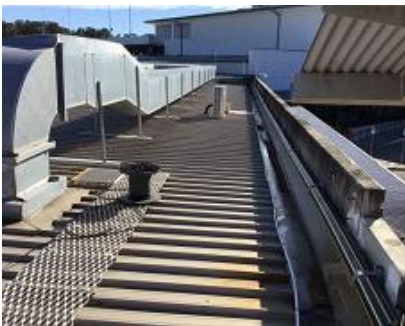
No	Photo of Hazard	Details of Hazard	Details of Risk	Existing/ Immediate Control Measure	Curren t Risk Level	Proposed Permanent Solution	Residu al Risk Assess ment	Details of Action Taken	Status	Reference
109	Building: General Stores Location Reference: <a href="#">L22</a> Task: Access to the A/c units

No safe access to the A/c units	Trips, Slips and Falls	N/A	Low	Supply walkway to the A/c units	Low	Client advised	Outstanding	-
110	Building: General Stores Location Reference: <a href="#">L24</a> Task: Access to the roof

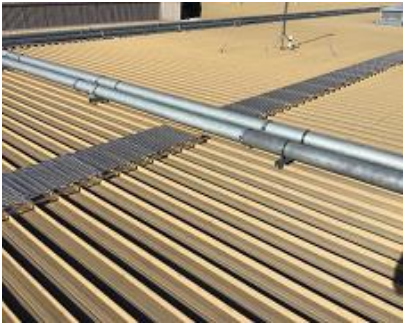
Pipe installed over the walkway path	Trips, Slips and Falls	Awareness induction	Med	Step bridge to be installed	Low	Client advised	Outstanding	OH&S REGULATIONS 3.7  AS/NZS 1657-2018 3.1.4

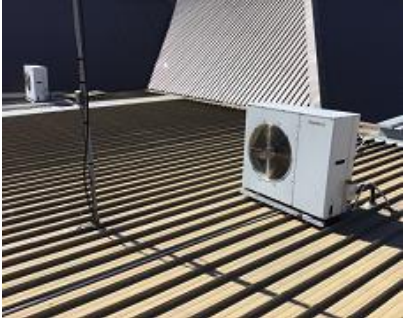
No	Photo of Hazard	Details of Hazard	Details of Risk	Existing/ Immediate Control Measure	Curren t Risk Level	Proposed Permanent Solution	Residu al Risk Assess ment	Details of Action Taken	Status	Reference
111	Building: General Stores Location Reference: <a href="#">L55</a> Task: Access to the A/c units

No safe access to the A/c units	Trips, Slips and Falls	N/A	Low	Supply walkway to the A/c units	Low	Client advised	Outstanding	-
