# Roof Safety Report

Warwick Grove,

Prepared By: Safemaster Safety Products  
Date: 24-10-2020

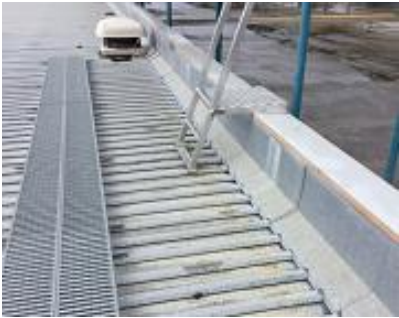
Existing ladder and ladder bracket in same location	Trips, Slips and Falls	Awareness induction	Med	Existing ladder bracket to be removed and installed beside ladder	Low	Client advised	Out-standing	AS 1657-2018 7.4.8.1  OH&S REGULATIONS 3.7

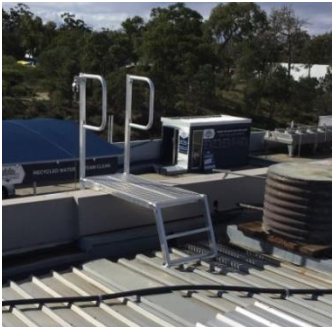
No	Photo of Hazard	Details of Hazard	Details of Risk	Existing/ Immediate Control Measure	Curren t Risk Level	Proposed Permanent Solution	Residu al Risk Assess ment	Details of Action Taken	Status	Reference
06	Building: General Stores Location Reference: <a href="#">L6</a> Task: Access to the roof

Fall prevention anchor is missing	Fall hazard	Awarness induction	Med	Fall prevention anchor and anchor strop to be installed	Low	Client advised	Out-standing	OH&S REGULATIONS 3.55

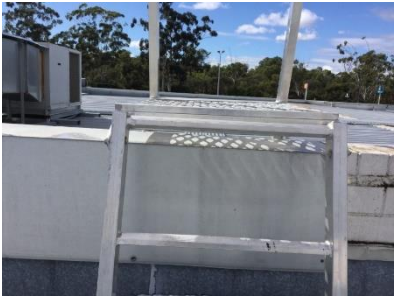
No	Photo of Hazard	Details of Hazard	Details of Risk	Existing/ Immediate Control Measure	Curren t Risk Level	Proposed Permanent Solution	Residu al Risk Assess ment	Details of Action Taken	Status	Reference
15	Building: General Stores Location Reference: <a href="#">L14</a> Task: Access to the roof

Top rung not levelled with landing	Trips, Slips and Falls	Awarness induction	Med	Existing ladder section to be removed and new ladder to be installed	Low	Client advised	Out-standing	AS 1657-2018 7.4.3.3
16	Building: General Stores Location Reference: <a href="#">L15</a> Task: Access to the roof

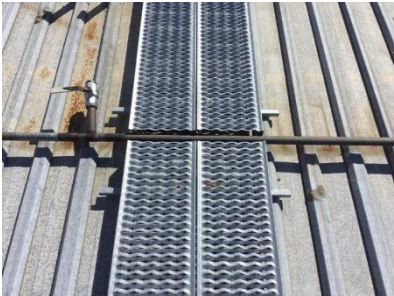
No	Photo of Hazard	Details of Hazard	Details of Risk	Existing/ Immediate Control Measure	Curren t Risk Level	Proposed Permanent Solution	Residu al Risk Assess ment	Details of Action Taken	Status	Reference
18	Building: General Stores Location Reference: <a href="#">L17</a> Task: Access to the roof

Pipes installed over walkway	Trips, Slips and Falls	Awarness induction	Med	High visibility safety yellow nosing and "CAUTION TRIP HAZARD" sign to be installed	Low	Client advised	Out- standin g	OH&S REGULATIONS 3.6 & 3.11

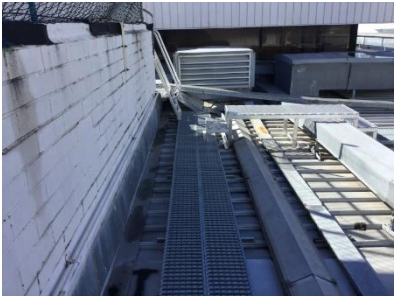
Landing is less than required minimum	Trips, Slips and Falls	Awarness induction	Med	Additional walkway sections to be installed and High visibility safety yellow nosings to be installed	Low	Client advised	Out-standing	AS 1657-2018 7.3.6
22	Building: General Stores Location Reference: <a href="#">L20</a> Task: Access to the roof

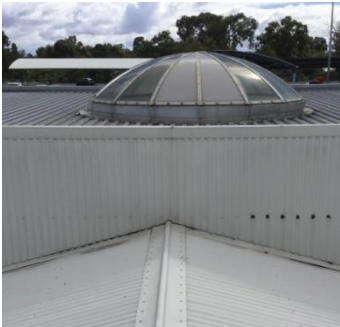
No	Photo of Hazard	Details of Hazard	Details of Risk	Existing/ Immediate Control Measure	Curren t Risk Level	Proposed Permanent Solution	Residu al Risk Assess ment	Details of Action Taken	Status	Reference
25	Building: General Stores Location Reference: <a href="#">L24</a> Task: Access to the roof

No safe access system installed	Fall hazard	Awarness induction	Med	Access ladder to be installed	Low	Client advised	Out-standing	OH&S REGULATIONS 3.7
26	Building: General Stores Location Reference: <a href="#">L25</a> Task: Access to the roof

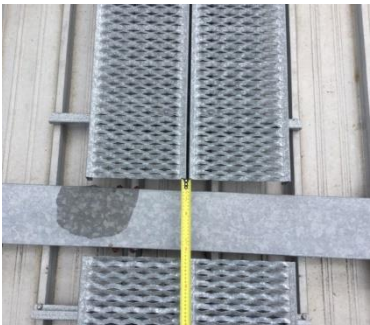
Cable tray over walkway	Trips, Slips and Falls	Awarness induction	Med	New walkway section to be installed with high visibility safety yellow nosings over existing walkway	Low	Client advised	Out-standing	AS 1657-2018 3.3.4 OH&S REGULATIONS 3.6

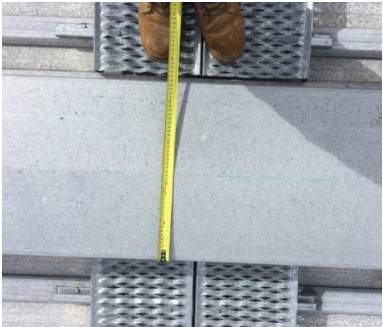
No	Photo of Hazard	Details of Hazard	Details of Risk	Existing/ Immediate Control Measure	Curren t Risk Level	Proposed Permanent Solution	Residu al Risk Assess ment	Details of Action Taken	Status	Reference
27	Building: General Stores Location Reference: <a href="#">L26</a> Task: Access to the roof

Cable tray over walkway	Trips, Slips and Falls	Awarness induction	Med	New walkway section to be installed with high visibility safety yellow nosings over existing walkway	Low	Client advised	Out- standin g	AS 1657- 2018 3.3.4  OH&S REGULATIONS 3.6
28	Building: General Stores Location Reference: <a href="#">L27</a> Task: Access to the A/c unit

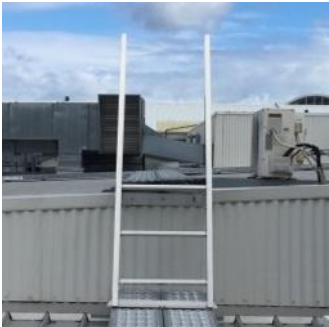
No	Photo of Hazard	Details of Hazard	Details of Risk	Existing/ Immediate Control Measure	Curren t Risk Level	Proposed Permanent Solution	Residu al Risk Assess ment	Details of Action Taken	Status	Reference
29	Building: General Stores Location Reference: <a href="#">L28</a> Task: Access to the roof

Top rung not levelled with landing	Trips, Slips and Falls	Awareness induction	Med	Existing ladder section to be removed and new ladder to be installed	Low	Client advised	Out-standing	AS 1657-2018 7.4.3.3

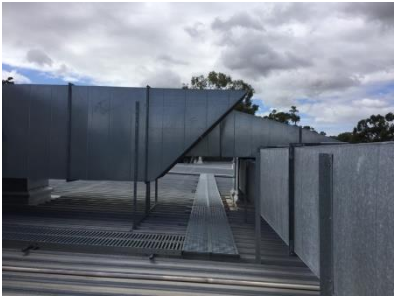
No	Photo of Hazard	Details of Hazard	Details of Risk	Existing/ Immediate Control Measure	Curren t Risk Level	Proposed Permanent Solution	Residu al Risk Assess ment	Details of Action Taken	Status	Reference
31	Building: General Stores Location Reference: <a href="#">L30</a> Task: Access to the roof

Low headroom	Head injury	Awareness induction	Med	"CAUTION LOW HEAD ROOM SIGN" and high visibility safety yellow tape to be installed	Low	Client advised	Out- standin g	AS 1657- 2018 3.1.5

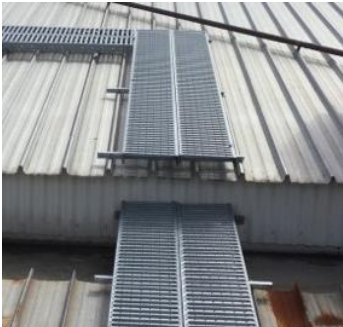
No	Photo of Hazard	Details of Hazard	Details of Risk	Existing/ Immediate Control Measure	Curren t Risk Level	Proposed Permanent Solution	Residu al Risk Assess ment	Details of Action Taken	Status	Reference
35	Building: General Stores Location Reference: <a href="#">L35</a> Task: Access to the roof

Variation in height and gap between the platforms are greater than required maximum	Trips, Slips and Falls	Awareness induction	Med	High visibility safety yellow nosing to be installed	Low	Client advised	Out-standing	OH&S REGULATIONS 3.6

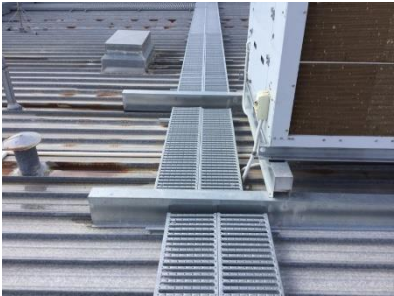
Variation in height between walkway and adjacent levels are greater than required maximum	Trips, Slips and Falls	Awareness induction	Med	High visibility safety yellow nosing's to be installed	Low	Client advised	Outstanding	AS 16572018 3.3.4  OH&S REGULATIONS 3.6

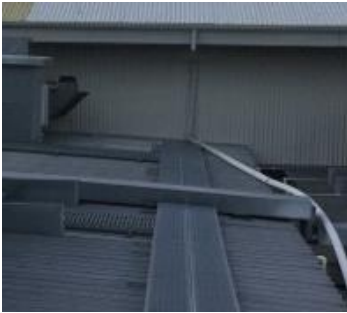
No	Photo of Hazard	Details of Hazard	Details of Risk	Existing/ Immediate Control Measure	Curren t Risk Level	Proposed Permanent Solution	Residu al Risk Assess ment	Details of Action Taken	Status	Reference
39	Building: General Stores Location Reference: <a href="#">L39</a> Task: Access to the roof

Variation in height between walkway and adjacent levels are greater than required maximum	Trips, Slips and Falls	Awareness induction	Med	Step with high visibility safety yellow nosing's to be installed	Low	Client advised	Outstanding	AS 16572018 3.3.4  OH&S REGULATIONS 3.6
40	Building: General Stores Location Reference: <a href="#">L40</a> Task: Access to the roof

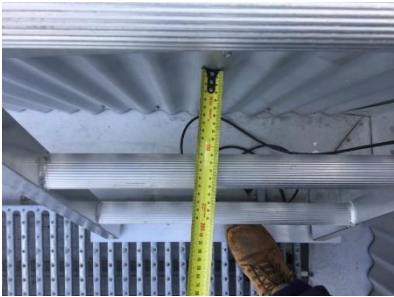
No	Photo of Hazard	Details of Hazard	Details of Risk	Existing/ Immediate Control Measure	Curren t Risk Level	Proposed Permanent Solution	Residu al Risk Assess ment	Details of Action Taken	Status	Reference
41	Building: General Stores Location Reference: <a href="#">L41</a> Task: Access to the roof

Clearance between the back edge of rung and permanent structure is less than required minimum and Landing is less than required minimum	Trips, Slips and Falls	Awareness induction	Med	Ladder to be relocated and Existing ladder platform to be removed and New platforms to be installed	Low	Client advised	Outstanding	AS 16572018 7.4.5
42	Building: General Stores Location Reference: <a href="#">L42</a> Task: Access to the roof

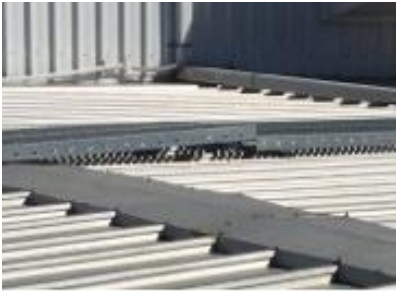
No	Photo of Hazard	Details of Hazard	Details of Risk	Existing/ Immediate Control Measure	Curren t Risk Level	Proposed Permanent Solution	Residu al Risk Assess ment	Details of Action Taken	Status	Reference
45	Building: General Stores Location Reference: <a href="#">L45</a> Task: Access to the roof

Walkway not fixed to roof sheet	Trips, Slips and Falls	Awareness induction	Med	Walkway to be fixed to roof with new channels as required	Low	Client advised	Outstanding	OH&S REGULATIONS 3.6
46	Building: General Stores Location Reference: <a href="#">L46</a> Task: Access to the roof

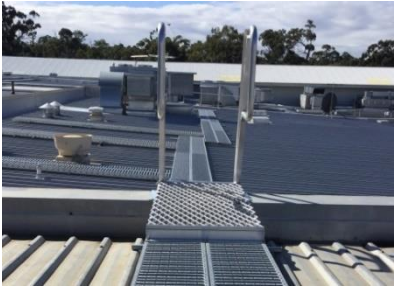
No	Photo of Hazard	Details of Hazard	Details of Risk	Existing/ Immediate Control Measure	Curren t Risk Level	Proposed Permanent Solution	Residu al Risk Assess ment	Details of Action Taken	Status	Reference
49	Building: General Stores Location Reference: <a href="#">L53</a> Task: Access to the roof

Variation in height between walkway and adjacent levels are greater than required maximum	Trips, Slips and Falls	Awareness induction	Med	High visibility safety yellow nosing to be installed	Low	Client advised	Outstanding	AS 16572018 3.3.4  OH&S REGULATIONS 3.6

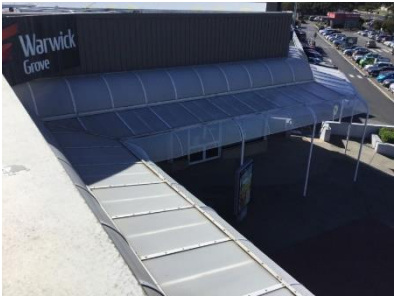
No height safety system installed (no serviceable items)	Trips, Slips and Falls	Awareness induction	High	"EWP ACCESS ONLY" sign to be installed	Low	Client advised	Outstanding	OH&S REGULATIONS 3.11

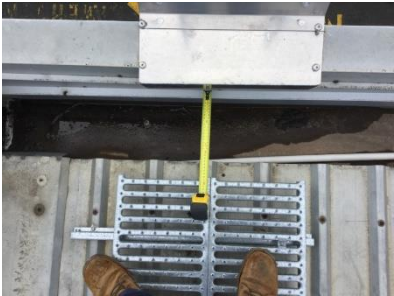
Missing walkway	Trips, Slips and Falls	Awareness induction	Med	Walkway to be extended and ladder bracket to be re- located beside the walkway for safe access	Low	Client advised	Outsta nding	AS 16572018 7.3.6  OH&S REGULATIONS 3.7

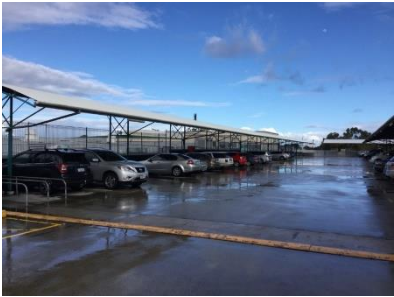
No height safety system installed (no serviceable items)	Trips, Slips and Falls	Awareness induction	High	"EWP ACCESS ONLY" sign to be installed	Low	Client advised	Outstanding	OH&S REGULATIONS 3.11 & 3.55
64	Building: General Stores Location Reference: <a href="#">L89</a> Task: Restrict access to the roof

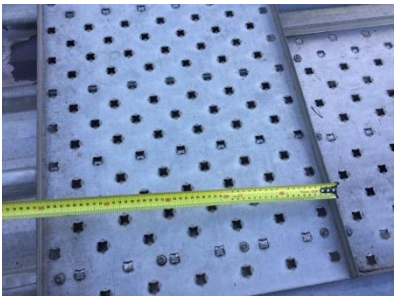
Walkway width is less than required minimum	Trips, Slips and Falls	Awareness induction	High	Existing walkway sections to be removed and New walkway to be installed	Low	Client advised	Outstanding	AS 16572018 5.1.3

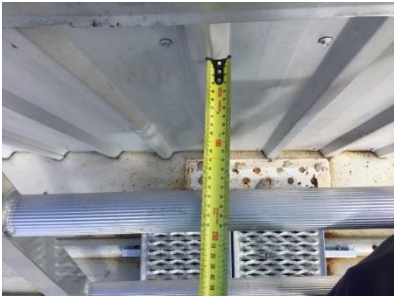
Clearance between the back edge of rung and permanent structure is less than required minimum	Trips, Slips and Falls	Awareness induction	Med	Existing ladder to be re-fitted with new long bracket and ladder head platform	Low	Client advised	Outstanding	AS 16572018 7.4.5
68	Building: General Stores Location Reference: <a href="#">L93</a> Task: Restrict access to the roof

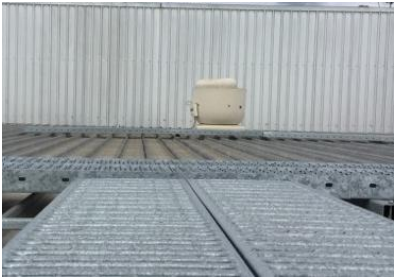
Variation in height between walkway and adjacent levels are greater than required maximum	Trips, Slips and Falls	Awareness induction	Med	High visibility safety yellow nosing to be installed	Low	Client advised	Outstanding	AS 16572018 3.3.4  OH&S REGULATIONS 3.6

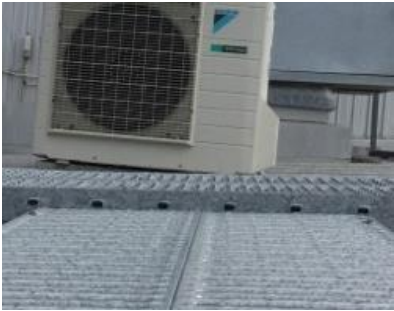
Variation in height between walkway and adjacent levels are greater than required maximum	Trips, Slips and Falls	Awareness induction	High	High visibility safety yellow nosing to be installed	Low	Client advised	Outstanding	AS 16572018 3.3.4  OH&S REGULATIONS 3.6

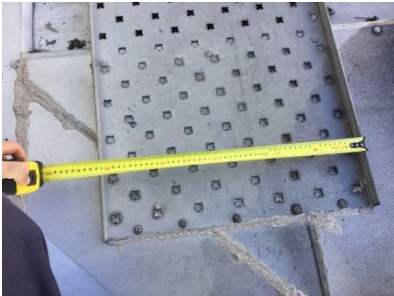
Walkway width is less than required minimum (no serviceable items)	Trips, Slips and Falls	Awareness induction	Med	Existing walkway sections to be removed	Low	Client advised	Outstanding	AS 16572018 5.1.3

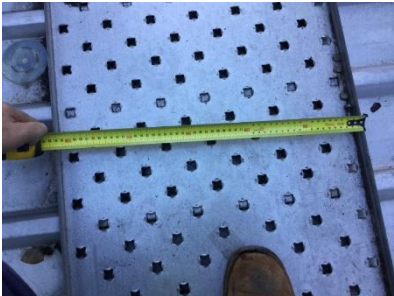
Walkway width is less than required minimum	Trips, Slips and Falls	Awareness induction	Med	Existing walkway sections to be removed and new walkway to be installed	Low	Client advised	Outstanding	AS 16572018 5.1.3

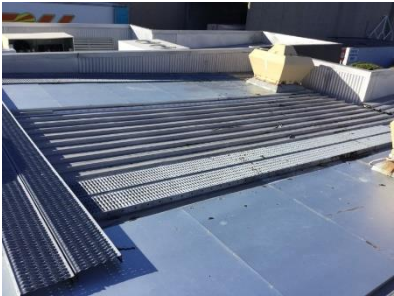
Walkway installed incorrectly	Trips, Slips and Falls	Awareness induction	Med	Re-install walkway with new brackets	Low	Client advised	Outsta nding	OH&S REGULATIONS 3.6

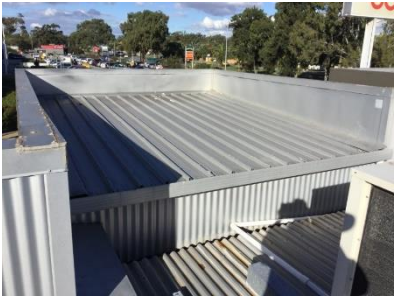
Step height is greater than required maximum	Trips, Slips and Falls	Awareness induction	Med	Step to be installed	Low	Client advised	Outstanding	AS 1657-2018 3.1.4  OH&S REGULATIONS 3.7
88	Building: General Stores Location Reference: <a href="#">L113</a> Task: Access to the roof

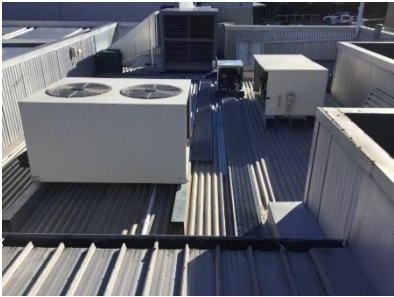
Walkway width is less than required minimum	Trips, Slips and Falls	Awareness induction	Med	Supply walkway to A/C units	Low	Client advised	Outstanding	AS 1657-2018 5.1.3  OH&S REGULATIONS 3.6
90	Building: General Stores Location Reference: <a href="#">L114</a> Task: Restrict access to the roof

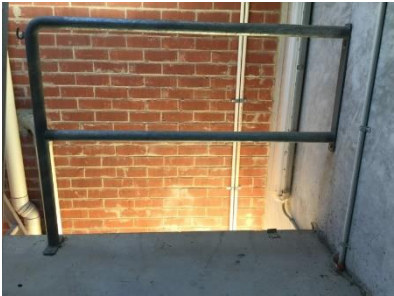
Toe board is missing	Trips, Slips and Falls	Awareness induction	Med	Toe board to be installed to existing handrail posts	Low	Client advised	Outsta nding	AS 16572018 4.6

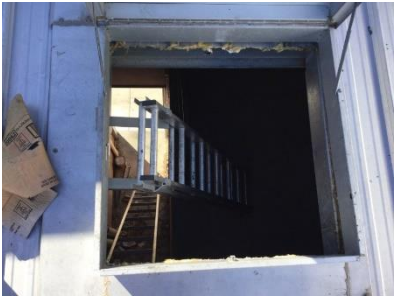
Headroom is less than required minimum	Trips, Slips and Falls	Awareness induction	Med	"CAUTION LOW HEADROOM" sign and High visibility safety yellow tape to be installed	Low	Client advised	Outstanding	AS 16572018 3.1.5

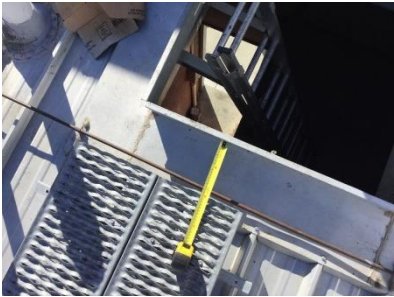
Missing walkway section	Trips, Slips and Falls	Awareness induction	Med	Supply walkway to close the gap	Low	Client advised	Outsta nding	OH&S REGULATIONS 3.7
96	Building: General Stores Location Reference: <a href="#">L117</a> Task: Access to the roof

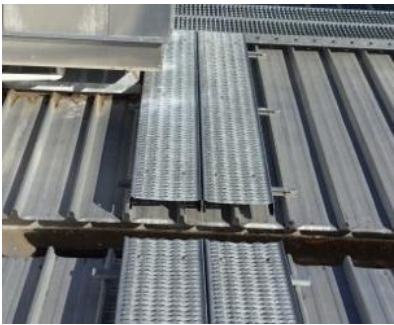
Variation in height between walkway and adjacent level are greater than required maximum	Trips, Slips and Falls	Awareness induction	Med	Walkway to be installed with high visibility safety yellow nosing	Low	Client advised	Outsta nding	OH&S REGULATIONS 3.6

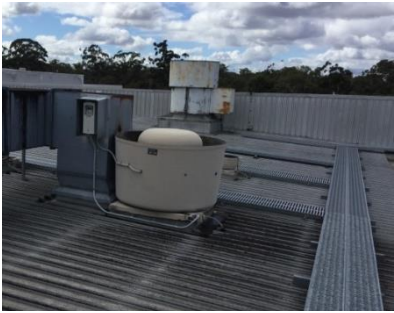
Roof walkway not installed for the safe access and egress to the new A/C unit	Trips, Slips and Falls	N/A	Low	Supply walkway to A/C unit	Low	Client advised	Outstanding	OH&S REGULATIONS 3.7  AS 1657-2018 7.3.3.1
100	Building: General Stores Location Reference: <a href="#">L61</a> Task: Restrict access to the roof

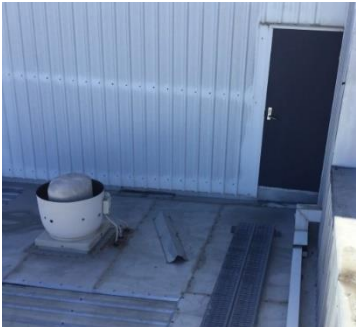
Roof walkway not installed for the safe access and egress to the new A/C unit	Trips, Slips and Falls	N/A	Low	Supply walkway to A/C unit	Low	Client advised	Outstanding	OH&S REGULATIONS 3.7  AS 1657-2018 7.3.3.1
102	Building: General Stores Location Reference: <a href="#">L73</a> Task: Access to the roof

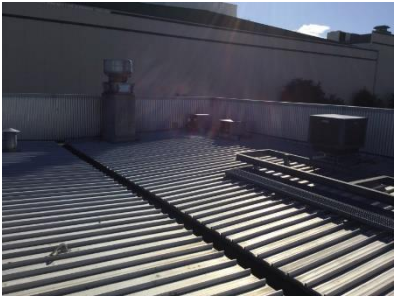
Roof walkway not installed for the safe access and egress to the new A/C unit	Trips, Slips and Falls	N/A	Low	Supply walkway to A/C units	Low	Client advised	Outstanding	-
106	Building: General Stores Location Reference: <a href="#">L118</a> Task: Restrict access to the roof

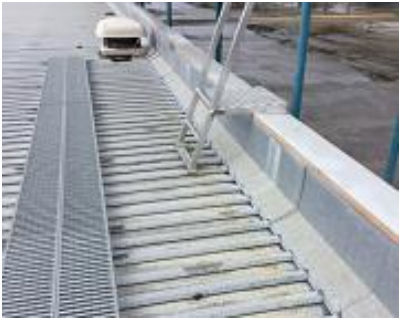
No safe access to the A/c unit	Trips, Slips and Falls	N/A	Low	Supply walkway to the A/c unit	Low	Client advised	Outstanding	-
109	Building: General Stores Location Reference: <a href="#">L06</a> Task: Access to the roof

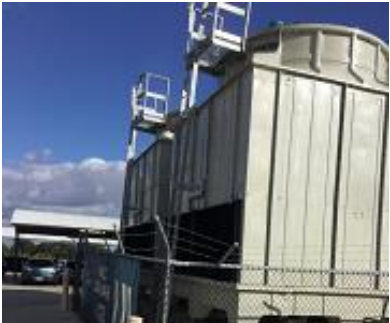
Vertical fall arrest static line is missing	Trips, Slips and Falls	Awareness induction	Med	Vertical fall arrest static line to be installed	Low	Client advised	Outstanding	OH&S REGULATIONS 3.7
111	Building: General Stores Location Reference: <a href="#">L12</a> Task: Access to the tank

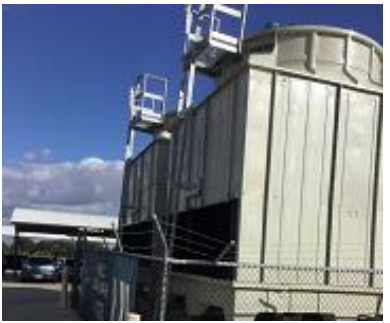
Vertical fall arrest static line is missing	Trips, Slips and Falls	Awareness induction	Med	Vertical fall arrest static line to be installed	Low	Client advised	Outstanding	OH&S REGULATIONS 3.7

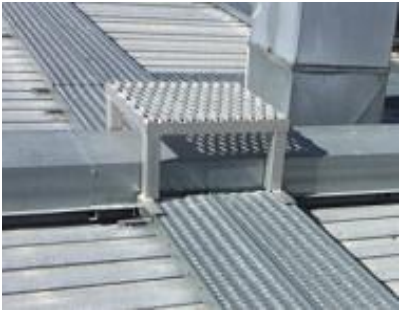
Step height is greater than required maximum	Trips, Slips and Falls	Awareness induction	Med	Existing step to be modified to comply	Low	Client advised	Outstanding	OH&S REGULATIONS 3.7  AS 1657-2018 3.1.4

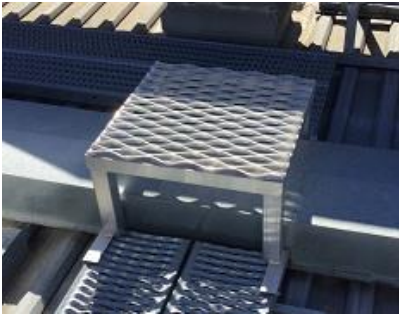
Step height is greater than required maximum	Trips, Slips and Falls	Awareness induction	Med	Existing step to be modified to comply	Low	Client advised	Outstanding	OH&S REGULATIONS 3.7  AS 1657-2018 3.1.4
115	Building: General Stores Location Reference: <a href="#">L124</a> Task: Access to the roof

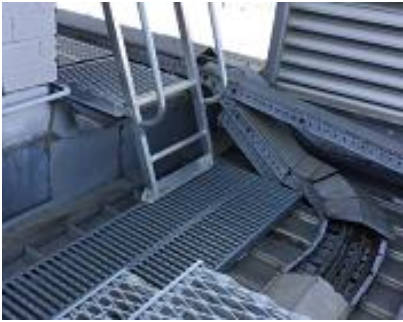
Landing is less than required minimum, bottom rung height is less than required minimum and handrail projecting towards the user	Trips, Slips and Falls	Awareness induction	Med	Existing ladder to be removed and new ladder to be installed	Low	Client advised	Outstanding	OH&S REGULATIONS 3.7  AS 1657-2018 7.3.6, 7.4.3.4 & 7.4.8.5
117	Building: General Stores Location Reference: <a href="#">L125</a> Task: Access to the roof

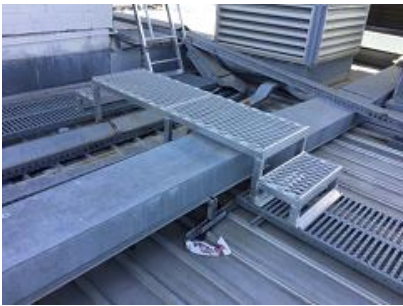
Handrail is missing at platform	Trips, Slips and Falls	Awareness induction	Med	Handrails to be installed	Low	Client advised	Outstanding	OH&S REGULATIONS 3.7  AS 1657-2018 4.4

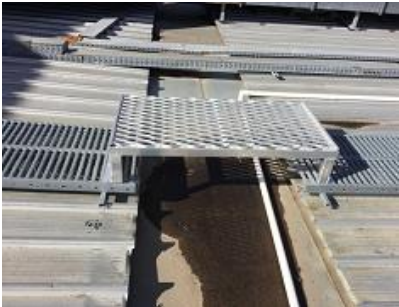
Handrail is missing at platform	Trips, Slips and Falls	Awareness induction	Med	Handrails to be installed	Low	Client advised	Outsta nding	OH&S REGULATIONS 3.7  AS 1657-2018 4.4

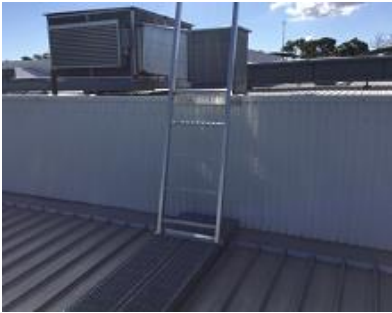
Bottom rung height is less than required minimum	Trips, Slips and Falls	Awareness induction	Med	Landing platform to be installed	Low	Client advised	Outstanding	OH&S REGULATIONS 3.7  AS 1657-2018 7.4.3.4
121	Building: General Stores Location Reference: <a href="#">L28</a> Task: Access to the roof

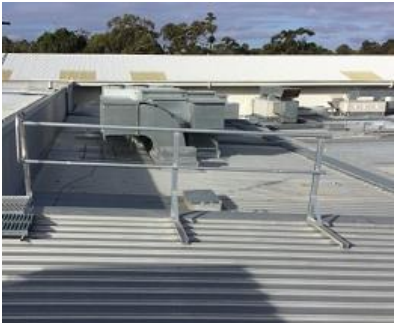
Sharp edges on handrails, gap between rails are greater than required minimum and handrail post is missing at one end	Trips, Slips and Falls	Awareness induction	Med	Tek screws to be replaced with rivets, Midrail to be re-positioned and handrail post to be installed	Low	Client advised	Outstanding	OH&S REGULATIONS 3.7  AS 1657-2018 5.6 & 4.4
123	Building: General Stores Location Reference: <a href="#">L41</a> Task: Access to the roof

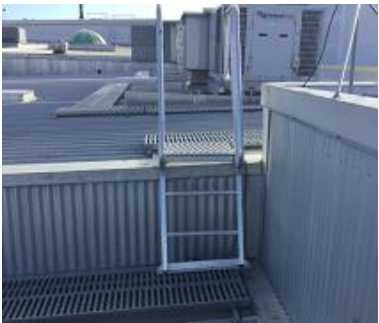
Landing at base is less than required minimum and handrails projecting towards the user	Trips, Slips and Falls	Awareness induction	Med	Existing handrails to be removed. Landing platform and handrails to be installed	Low	Client advised	Outstanding	OH&S REGULATIONS 3.7  AS 1657-2018 7.3.6 & 7.4.8.5

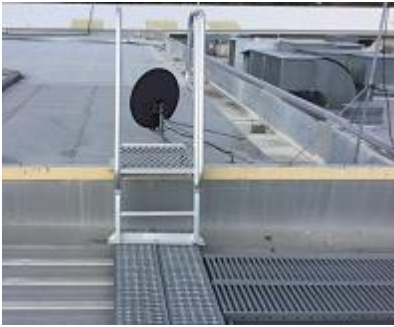
Bottom rung height is less than required minimum, landing is less than required minimum and handrails projecting towards the user	Trips, Slips and Falls	Awareness induction	Med	Existing handrails to be removed. Landing platforms and handrails to be installed	Low	Client advised	Outstanding	OH&S REGULATIONS 3.7  AS 1657-2018 7.4.3.4, 7.3.6 & 7.4.8.5
125	Building: General Stores Location Reference: <a href="#">L53</a> Task: Access to the roof

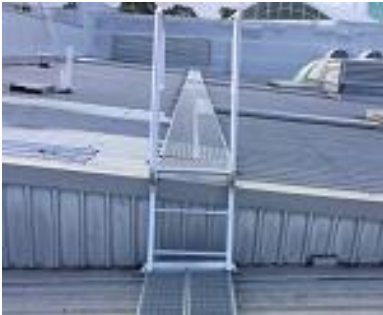
Bottom rung height is less than required minimum	Trips, Slips and Falls	Awareness induction	Med	Landing platform to be installed	Low	Client advised	Outstanding	OH&S REGULATIONS 3.7  AS 1657-2018 7.4.3.4

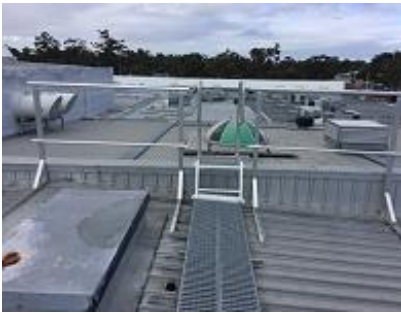
Gap between rails is greater than required minimum and Sharp edges on handrails	Trips, Slips and Falls	Awareness induction	Med	Tek screws to be replaced with rivets. Midrails to be re-positioned	Low	Client advised	Outstanding	OH&S REGULATIONS 3.7  AS 1657-2018 4.4 & 5.6
129	Building: General Stores Location Reference: <a href="#">L62</a> Task: Access to the roof

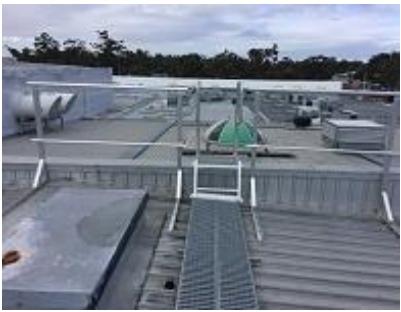
Bottom rung height is less than required minimum	Trips, Slips and Falls	Awareness induction	Med	Landing platform to be installed	Low	Client advised	Outstanding	OH&S REGULATIONS 3.7  AS 1657-2018 7.4.3.4

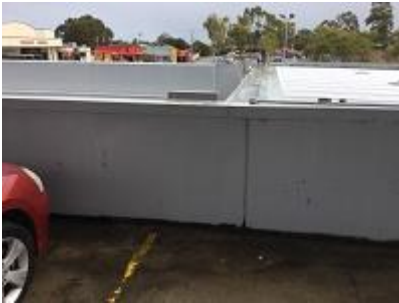
Ladder bracket not in use	Trips, Slips and Falls	Restrict Access	Med	Ladder access bracket to be removed	Low	Client advised	Outsta nding	OH&S REGULATIONS 3.7
